Final Drainage Report

Arvidson Subdivision

Project No. 61049

June 12, 2017

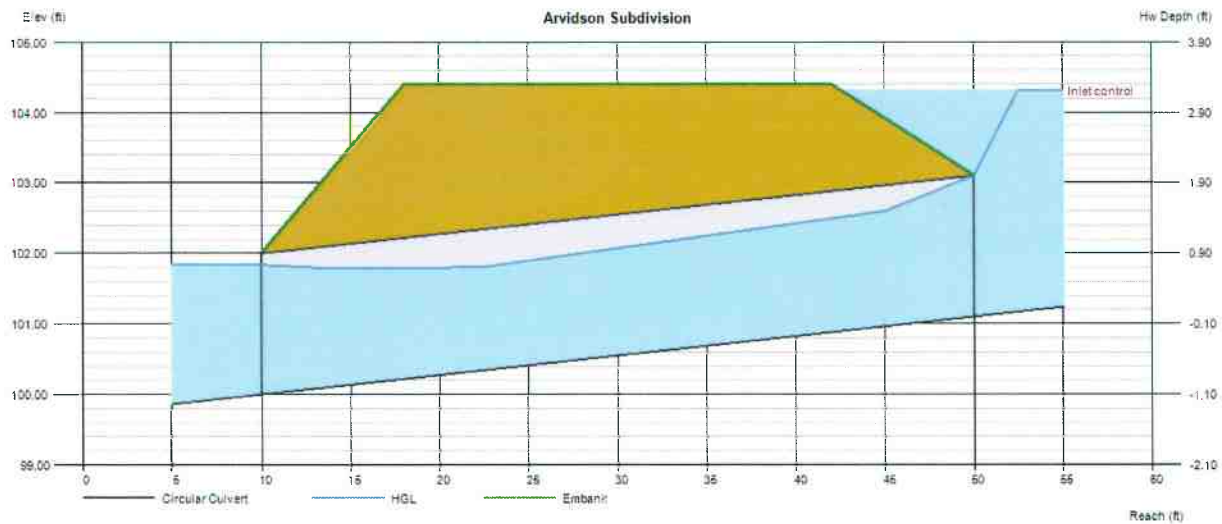
Calculations
 Qmin (cfs) = 5.00
 Qmax (cfs) = 24.20
 Tailwater Elev (ft) = (dc+D)/2

Highlighted
 Qtotal (cfs) = 22.00
 Qpipe (cfs) = 22.00
 Qovertop (cfs) = 0.00
 Veloc Dn (ft/s) = 7.28
 Veloc Up (ft/s) = 7.84
 HGL Dn (ft) = 101.84
 HGL Up (ft) = 102.77
 Hw Elev (ft) = 104.31
 Hw/D (ft) = 1.61
 Flow Regime = Inlet Control

The existing 24" Corrugated Metal Pipe (CMP) pipe culvert located at the low point on the north side of Wakonda Way will continue to be utilized for draining the flows from sub-basins OSA1, A2 and A3 from the north side of Wakonda Way to the property to the south as in the existing conditions. The proposed subdivision has negligible effects on stormwater flows from the property.

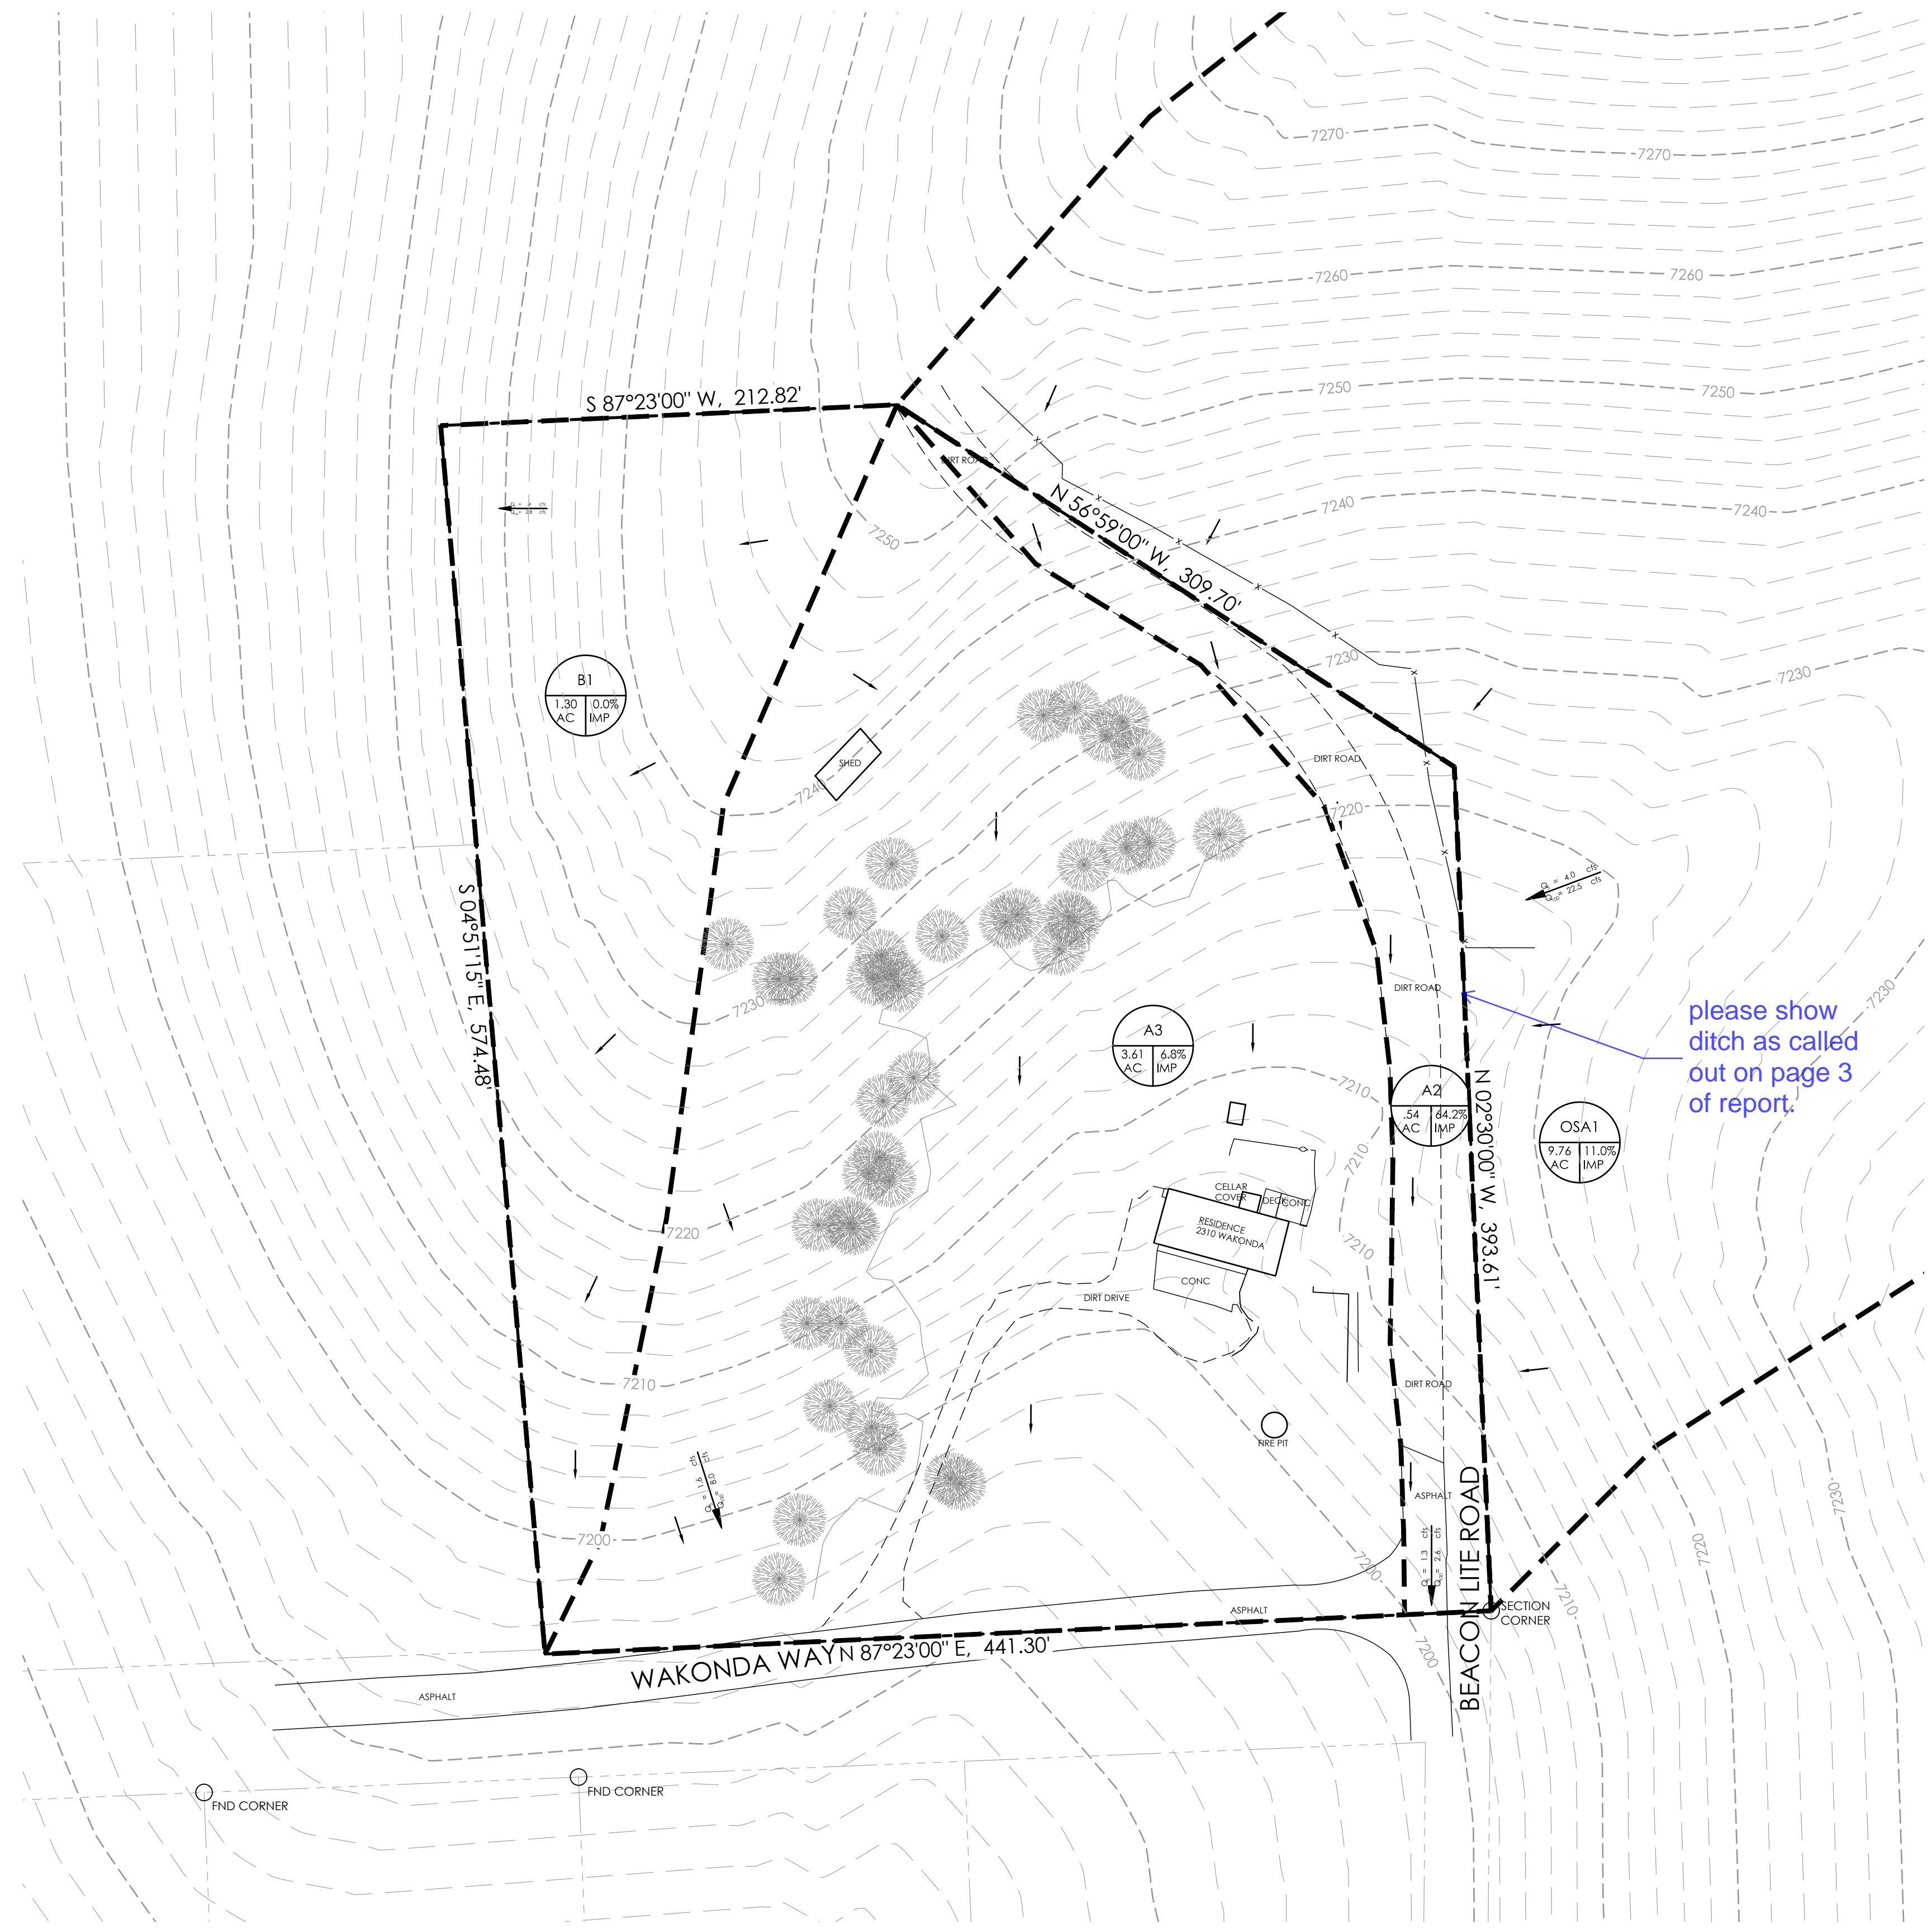
please show on plan

please show ditch as called out on page 3 of report.

The existing and proposed drainage hydrologic conditions are described in more detail below. Input data and results for all calculations are included in the **Appendix**. Drainage maps for the hydrology are also included in the **Appendix**.
