## Final Acceptance Punchlist

### El Paso County – Department of Public Works – Stormwater Section

| Project Name: | Widefield Park & Rec Improvements |
| Walk-through Number: | 1st |

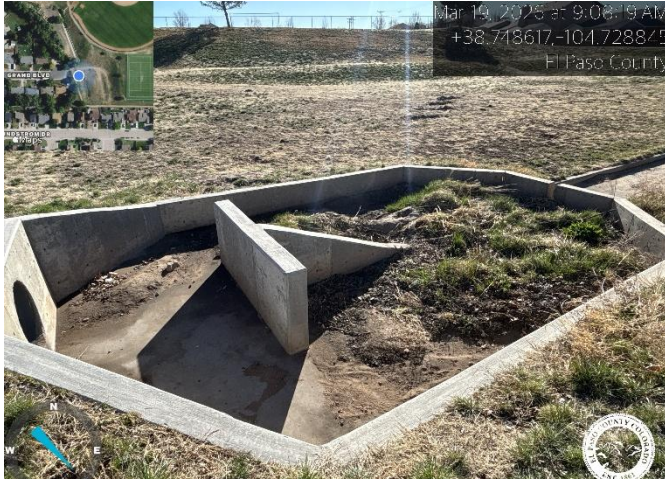
**Photo 1:** Remove sediment from Forebay.

- Trickle channel
  - Remove sediment. Dispose of sediment outside of pond. See photo 3.
- Forebay
  - Remove sediment. Dispose of sediment outside of pond. See photo 1.

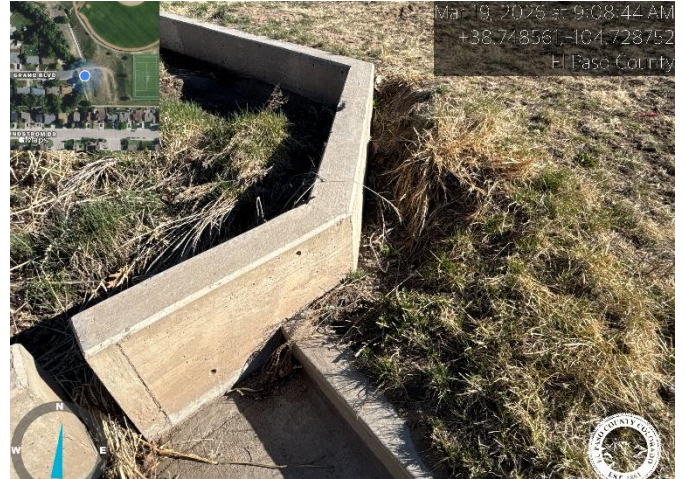
**Photo 2:** Repair Forebay erosion and repair erosion.

- Repair erosion on each side and stabilize. Consult Engineer of Record regarding installation of riprap at these two locations. See photo 2.
  - Clean out Drainage Ditch before pond Forebay. See photo 10.

KHA Response: Stabilization of erosion via rip rap is recommended.

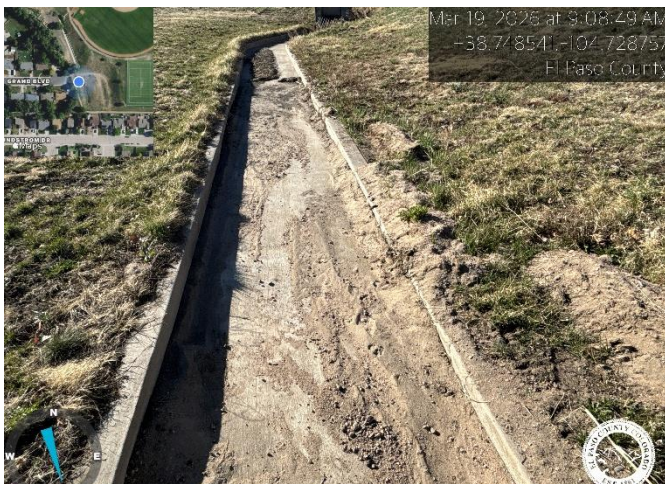
**Photo 3:** Remove sediment from Trickel Channel.

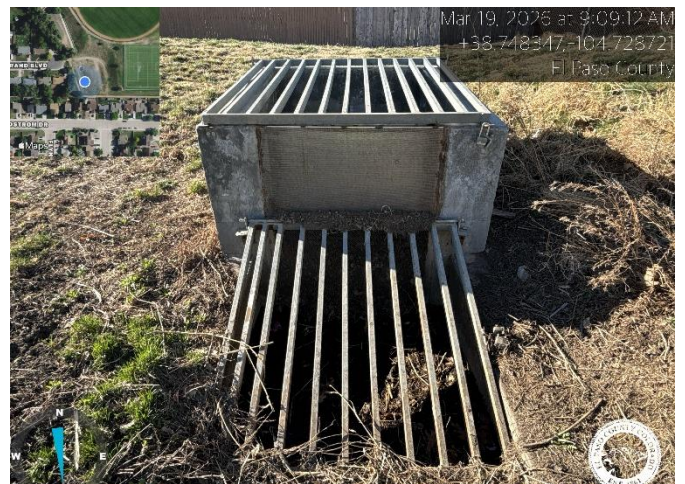
**Photo 4:** Clean Trash Rack and repair lock mechanism.

- Outlet Structure
  - Clean Trash Rack and repair lock mechanism. See photo 4.
  - Clean debris from Microscreen. Microscreen is a different material than called out on plans. Plans call for Johnson Vee Wire No. 93. Send updated detail on current screen material or replace per plans. See photo 5.

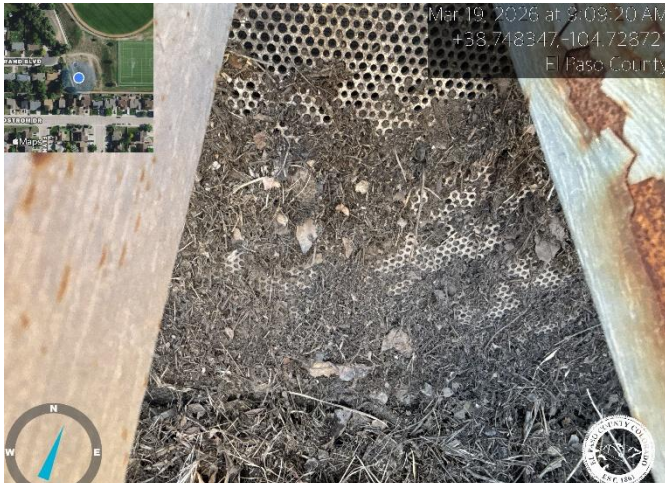
**Photo 5:** Clean Micro Screen.

KHA Response: McNichols perforated metal screen is an acceptable substitution.

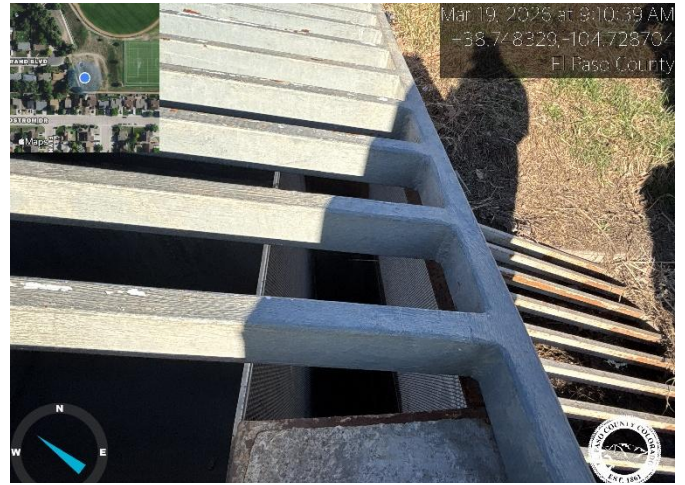
**Photo 6:** Add concrete crossmember to top of Outlet Structure.

**Final Acceptance**  
**South Side**  
we only requested that the crossmember gap (ie: the gap at the top of the outlet structure between the orifice plate and the microscreen, in the horizontal plane) be covered up, not anything in the vertical plane. Please clarify why this was done. Sheet #C7.5]:

- Add concrete crossmember to top of outlet structure where missing between microscreen and orifice plate. See photo 6.
  - Orifice Plate Gasket is inadequate and needs to be replaced. See photo 7.

KHA Response: Steel cross member solution proposed by the contractor is acceptable and outlet structure will function as hydraulically intended.

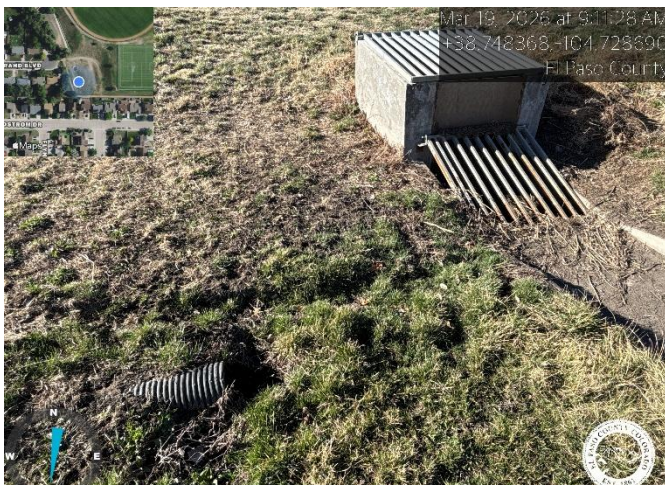
**Photo 7:** Inlet pipe in pond bottom not shown on plan. Show on as-builts.

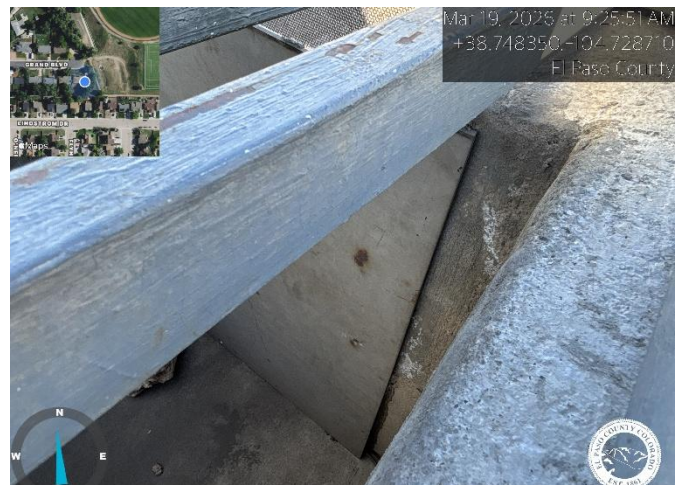
**Photo 8:** Orifice Plate Gasket is inadequate.

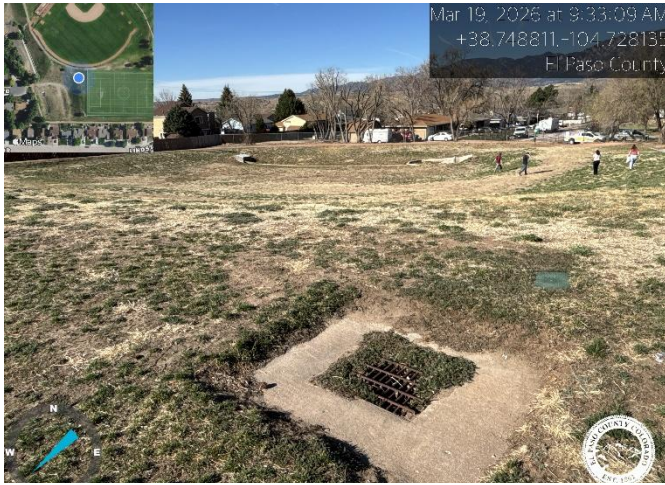
**Photo 9:** 2 Inlet drains. East side of pond, show on as-builts.

Were flows to these inlets not intended to be conveyed to and treated/detained by the pond? Please discuss in the pond cert letter.

- Elevation of Emergency Spillway, show on as built.
- Area drains
  - 2 Inlet drains. South side above pond, show on as built.

KHA Response: North area drain is filled with sediment and non-functional. North drain and associated pipe are to be abandoned in place. South area drain and pipe is functioning and will remain. A revision of the CD Sheet C7.4 (Pond Grading) has been reprinted showing these pipes for documentation purposes.

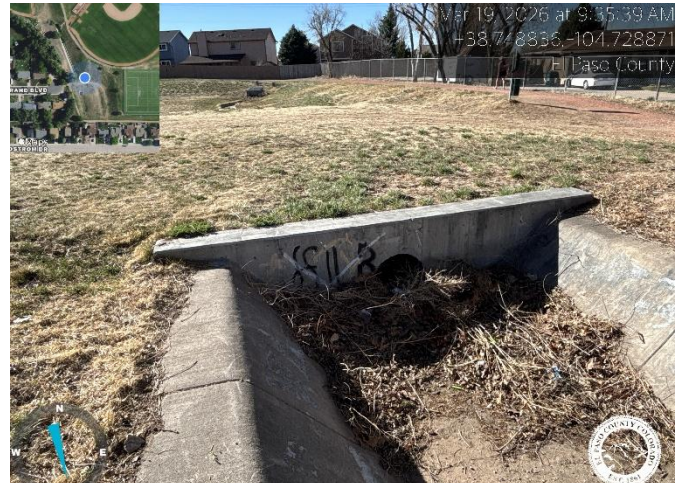
**Photo 10:** Clean out Drainage Ditch before pond.

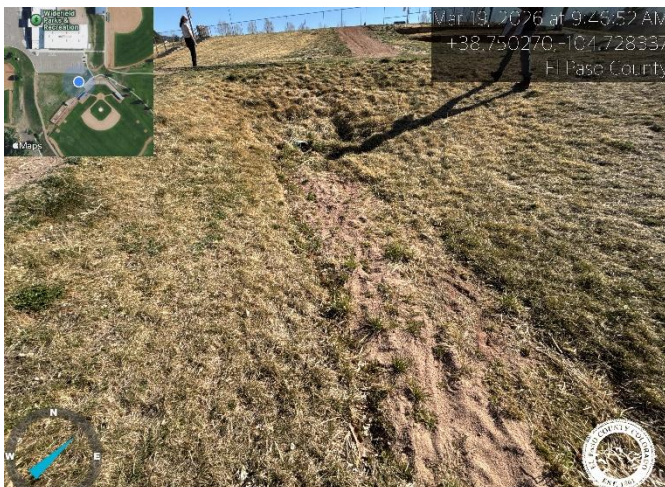
**Photo 11:** Southeast of parking area. Monitor erosion for future problems.

- Ditch at southeast corner of parking area. Monitor erosion for future problems. No action required.
- Northeast of building. Vegetation has not met requirements. Grading plan shows vegetation in this area but about ½ acre of gravel is present. Show on As Builts and update pond calcs or remove gravel and revegetate. See Note 1 below.
- Submit a spec sheet and PO/receipt for the grass seed mix that was purchased and used.

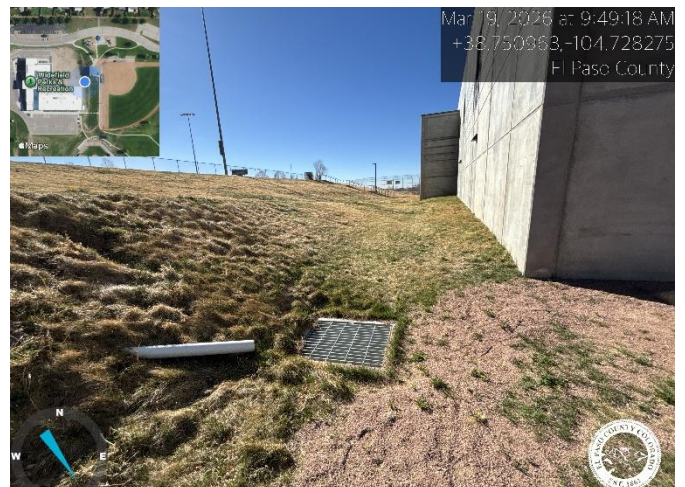
**Photo 12:** Inlet northeast area. No action needed.

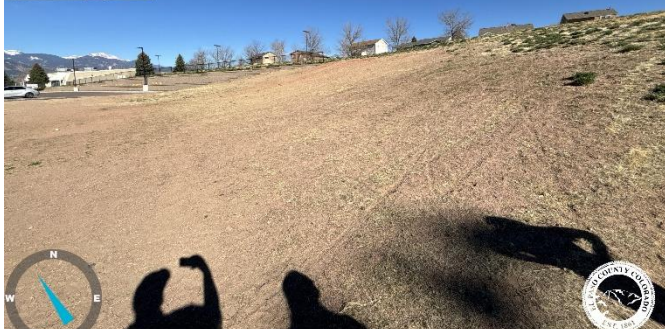
**Photo 13:** Northeast of building. Vegetation has not met requirements. Update Pond Calcs and As Builts to show this impervious area or stabilize.

KHA Response: GEC Plans show a generic grass hatch to indicate Final Stabilization per the Final Landscape Plans. Final Landscape Plans were approved showing crusher fines in this area. Constructed condition conforms to the design as approved.

Please confirm that drainage report calcs show the area with gravel

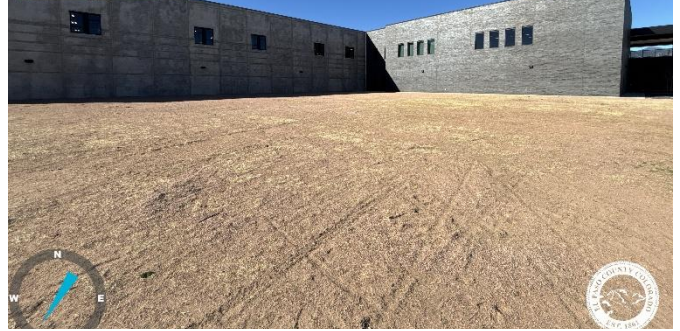
**Photo 14:** Northeast of building. Vegetation has not met requirements. Update Pond Calcs and As Builts to show this impervious area or stabilize.
