***WASTEWATER DISPOSAL REPORT***

***William Guman and Associates, Ltd.  
Esteban Rodriguez Subdivision***

***EPC Parcel #: 4300000534, 4300000537, 4300000538***

**June 2023**

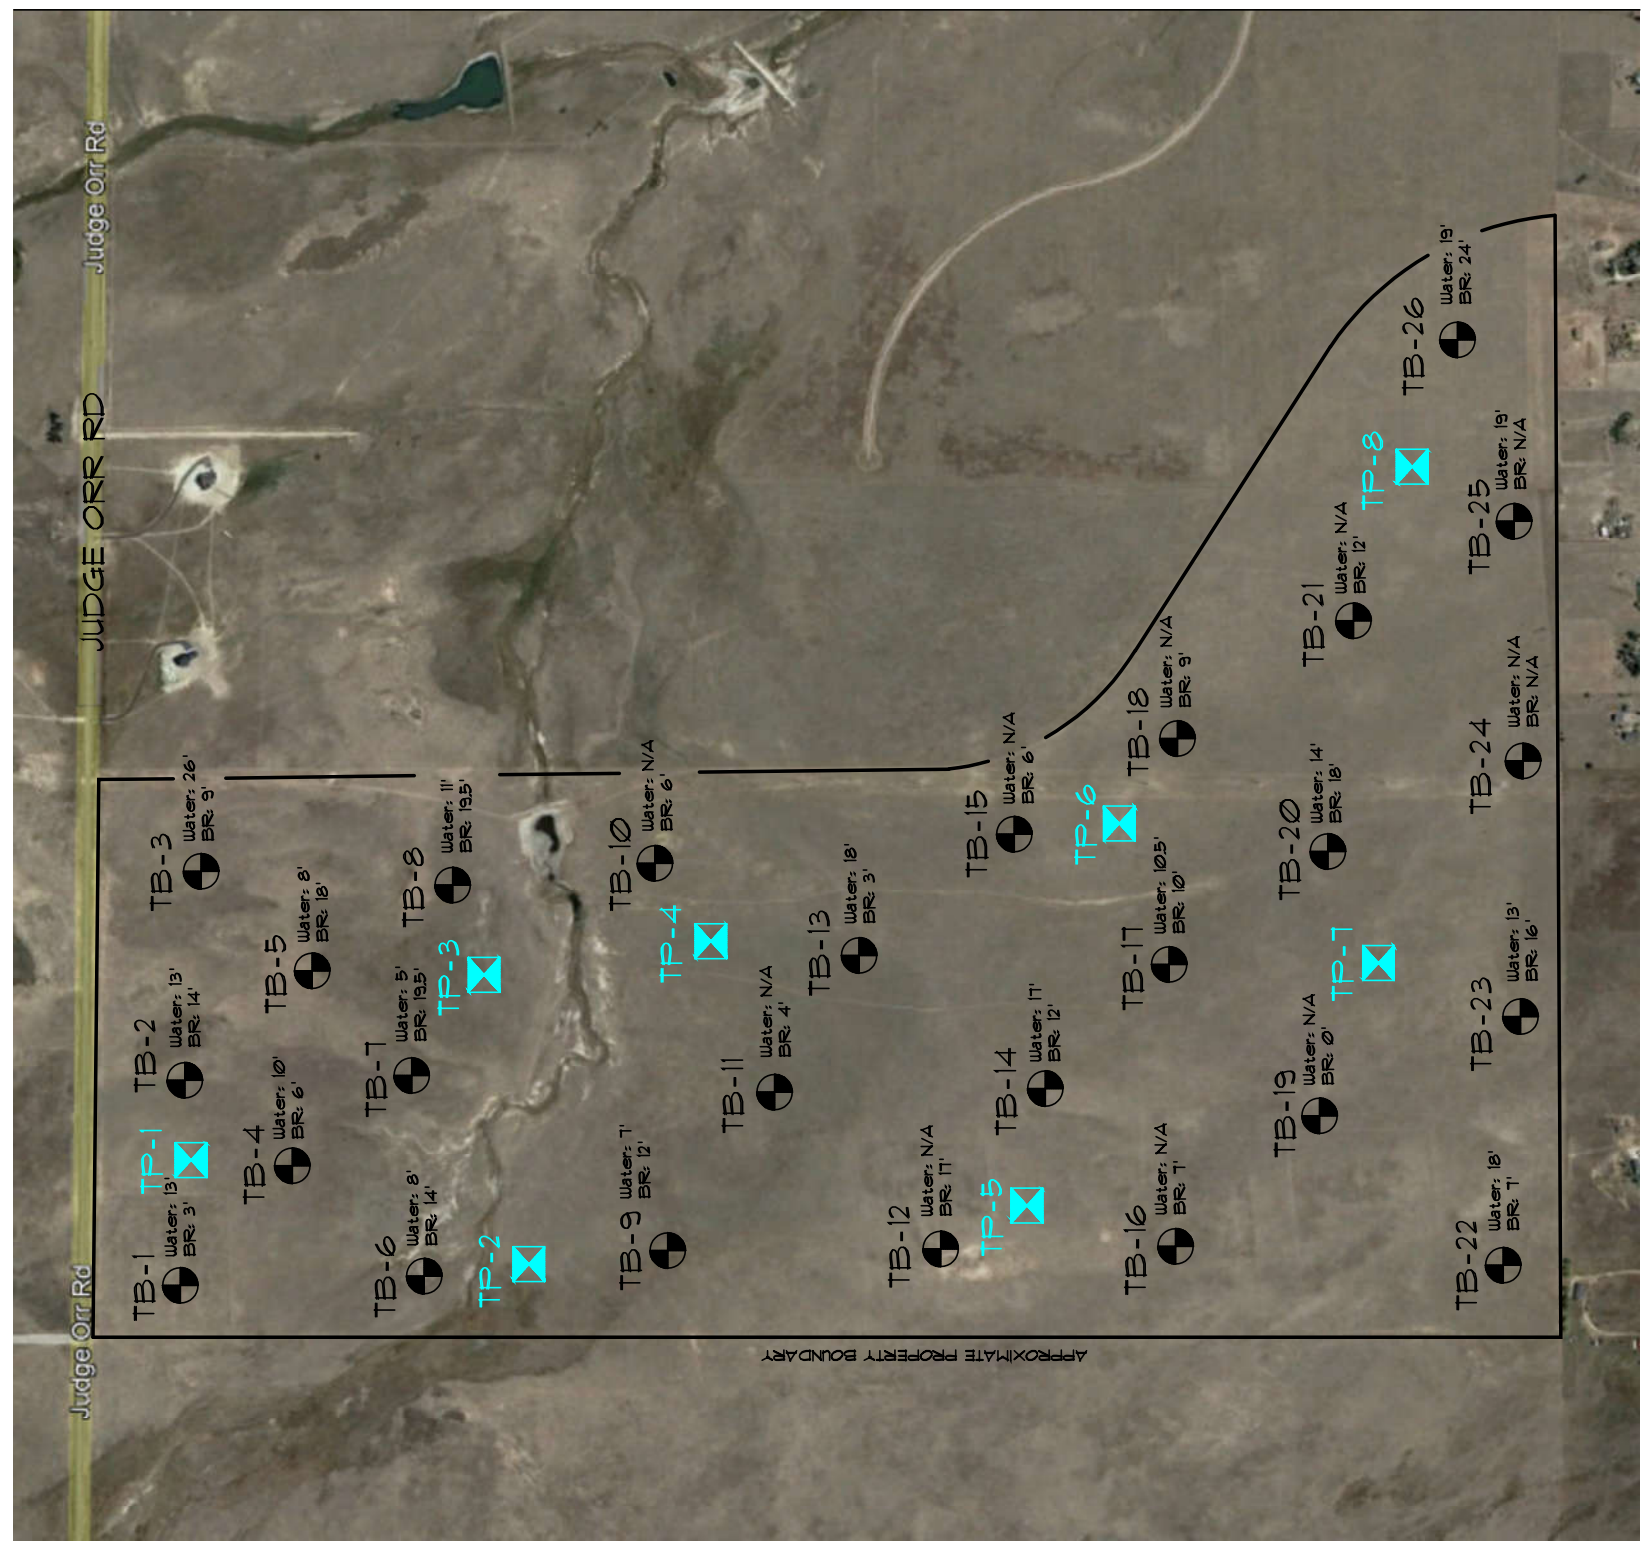
DENOTES APPROXIMATE  
 LOCATION OF TEST PIT

DENOTES APPROXIMATE  
 LOCATION OF TEST BORINGS

The subsurface conditions were explored by drilling twenty-six (26) exploratory borings on February 2, 3, and 6, 2023, extending to depths of approximately 20 to 35 feet below the existing ground surface. Eight (8) test pits to depths of 6 to 8 feet were observed on February 24, 2023. The test borings and test pits were spaced to provide preliminary soil information across the site for future residential foundations and on-site wastewater treatment systems. The Test Boring/Test Pit Layout Plan is presented in Figure 3.

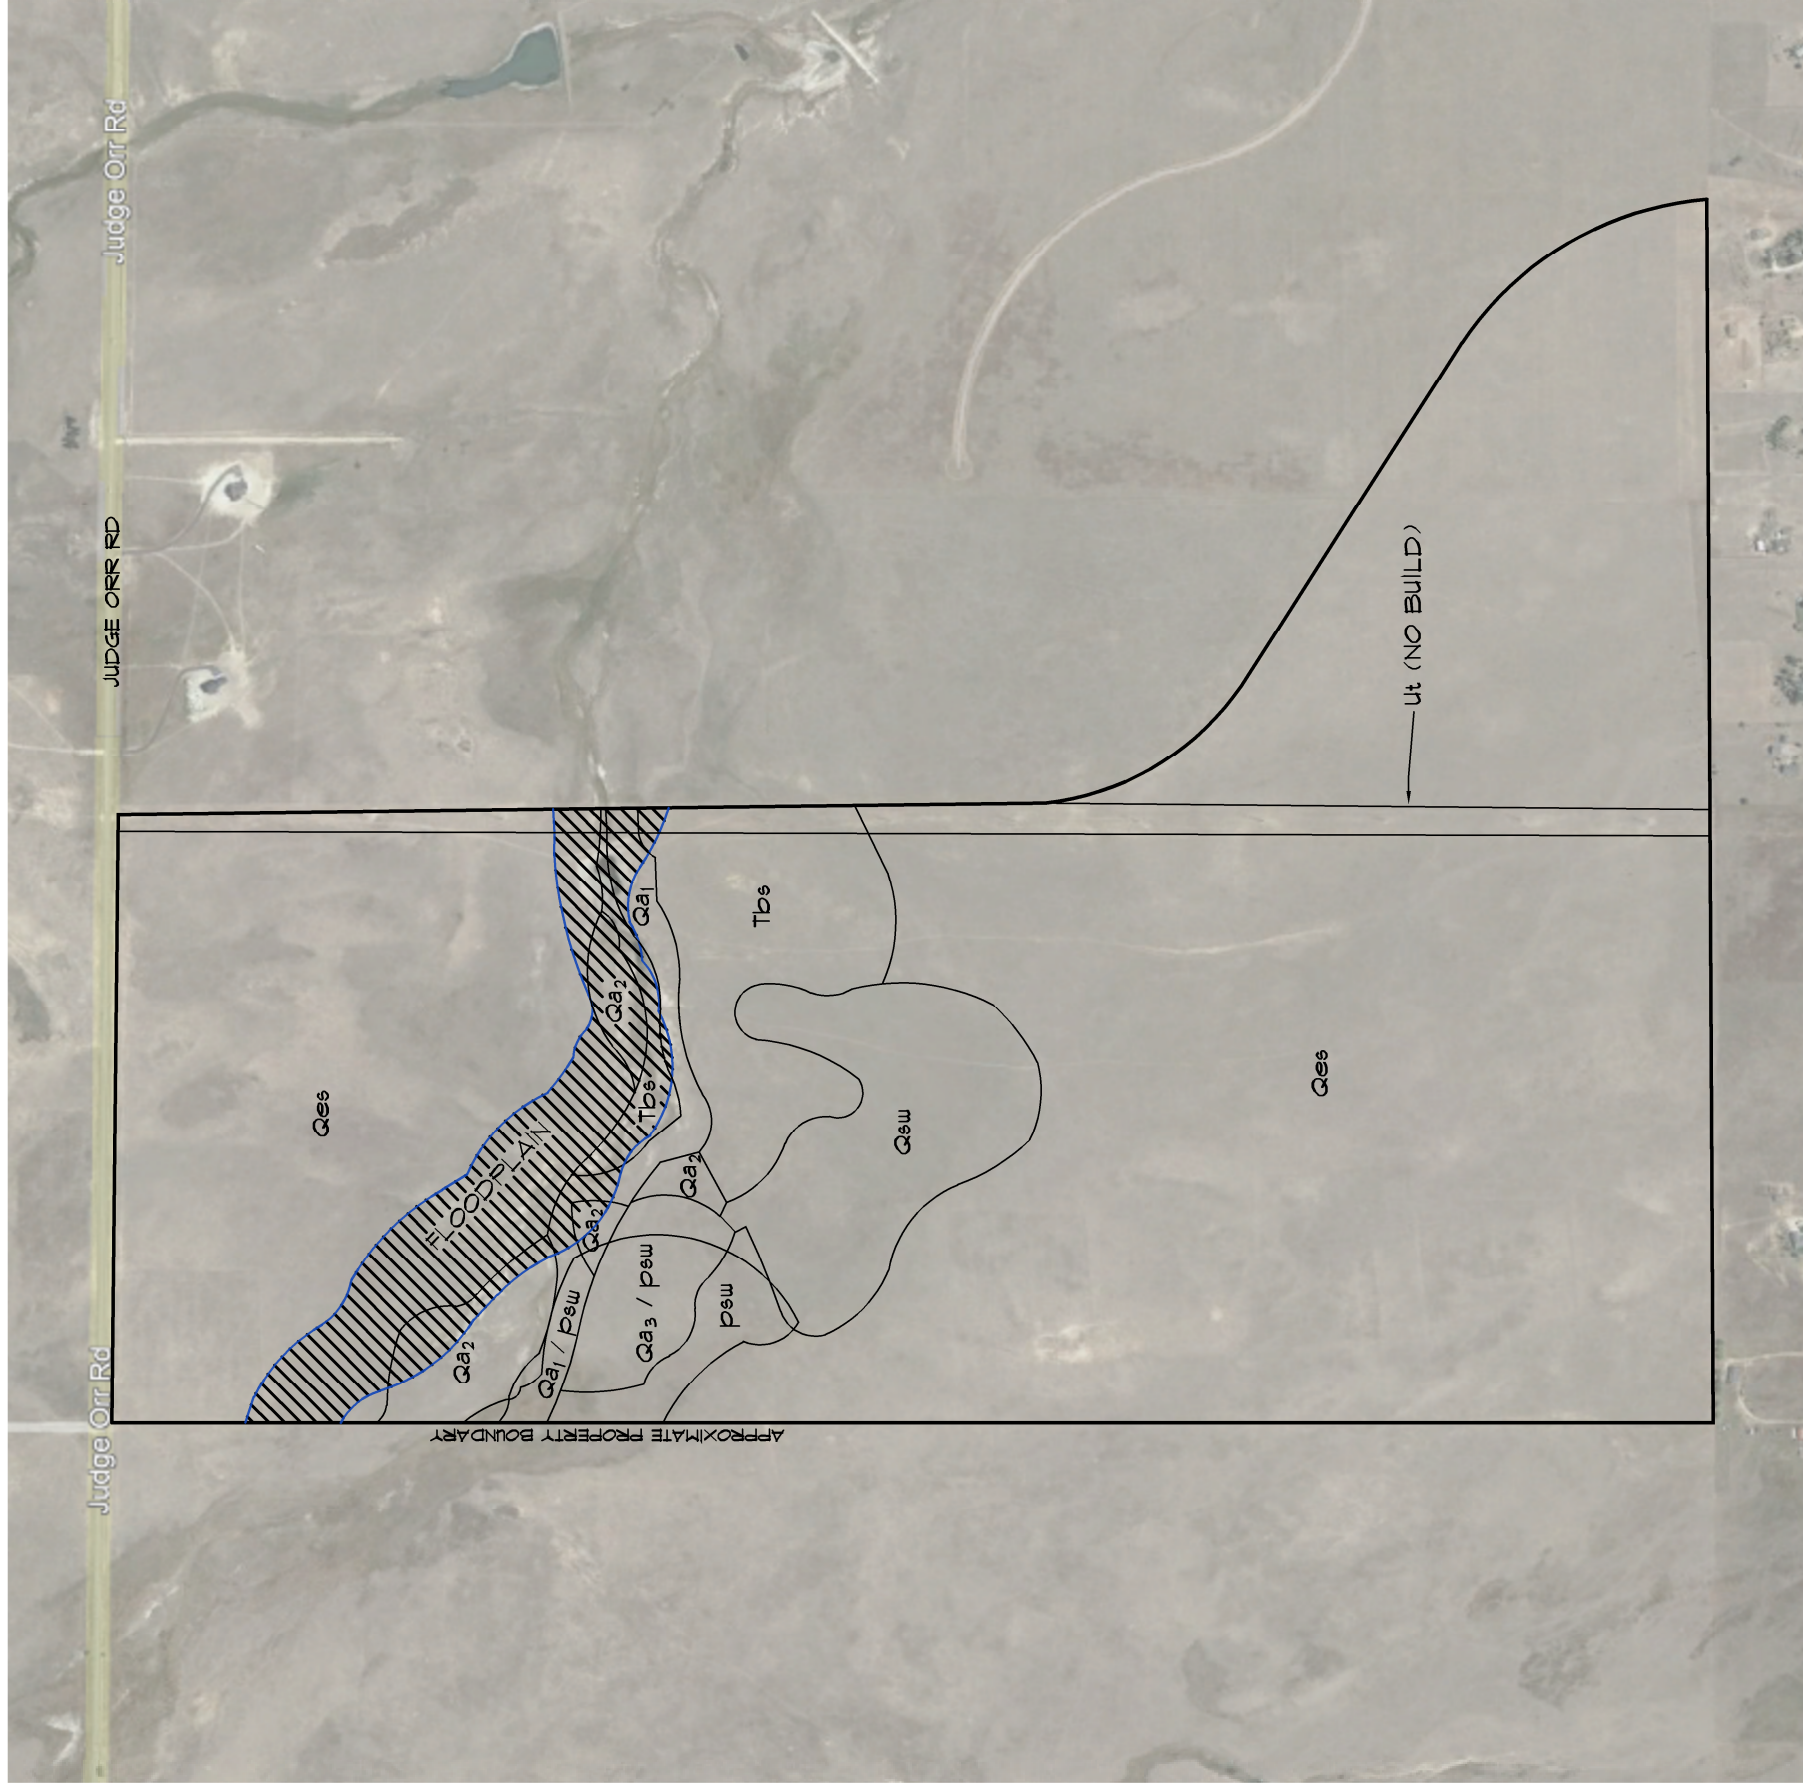
## GEOLOGIC CONDITIONS

- Qes** - Eolian Sand (Holocene to upper Pleistocene) Fine to coarse grained sand. Unit is faintly stratified, non-cohesive, and drains well. Unit may exceed 5 feet in thickness

Based on our field observations and review of relevant geologic maps, we identified the geologic conditions (listed below) affecting the development, as shown on the Engineering and Geology Map, Figure 28.

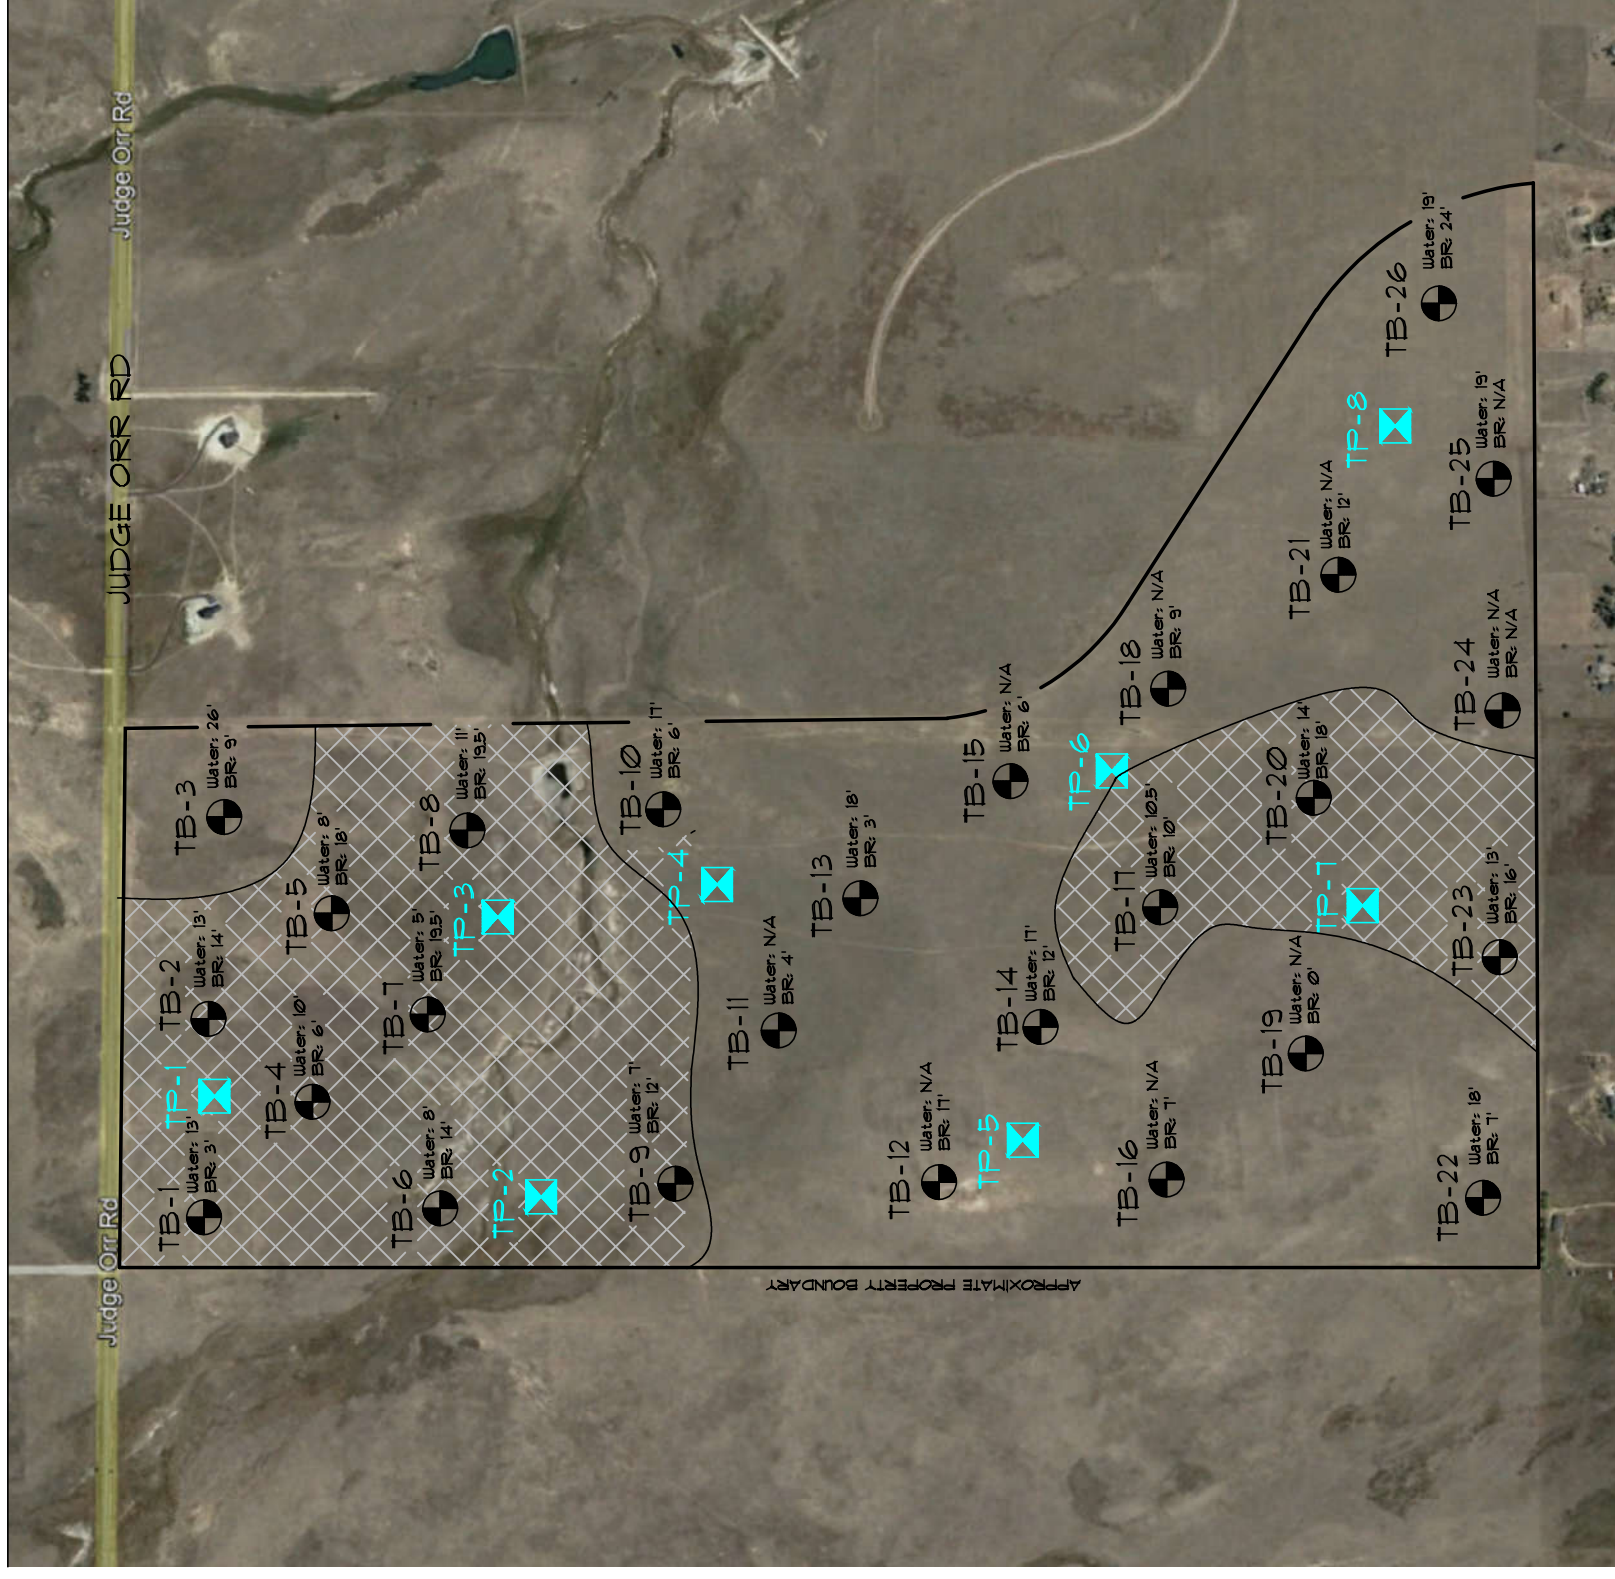
● DENOTES APPROXIMATE LOCATION OF TEST BORINGS

✕ DENOTES APPROXIMATE LOCATION OF TEST PITS

AREAS WHERE GROUNDWATER IS LESS THAN 15 FEET FROM THE SURFACE. ADDITIONAL INVESTIGATIONS MAY BE PROPOSED TO DETERMINE BASEMENT FEASIBILITY.

Based on our knowledge of the area and engineering design and construction techniques commonly employed in the El Paso County area at this time, it is our opinion that basements should be restricted in areas where groundwater was encountered at 15 feet or shallower. Additional recommendations are presented in **Section 8.4**. Shallow groundwater conditions are anticipated to be found at the time of the site-specific subsurface soil investigations.

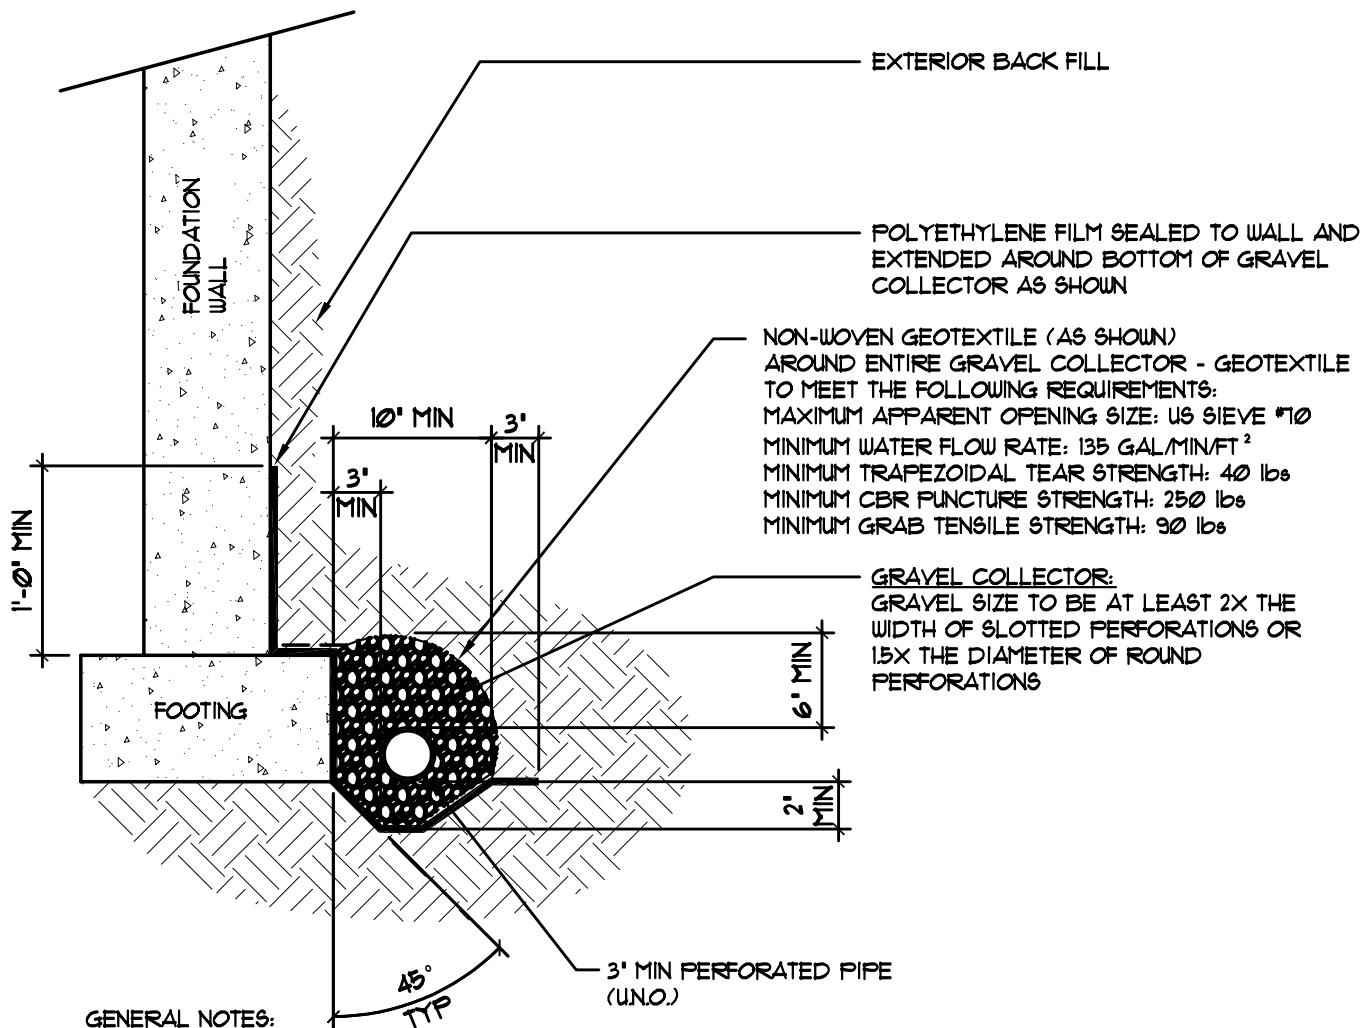
FIG No. 32

1. BOTTOM OF DRAIN PIPE SHALL BE AT OR BELOW BOTTOM OF FOOTING AT ALL LOCATIONS
2. ALL DRAIN PIPE SHALL BE PERFORATED PLASTIC, WITH THE EXCEPTION OF THE DISCHARGE PORTION WHICH SHALL BE SOLID, NON-PERFORATED PIPE.

3. DRAIN PIPE SHALL HAVE POSITIVE FALL THROUGHOUT.
4. DRAIN PIPE SHALL BE PROVIDED WITH A FREE GRAVITY OUTFALL, IF POSSIBLE. IF A GRAVITY OUTFALL CANNOT BE ACHIEVED, THEN A SUMP PIT AND PUMP SHALL BE USED. THE OUTFALL SHOULD EXTEND PAST BACKFILL ZONES AND DISCHARGE TO A LOCATION THAT IS GRADED TO DIRECT WATER OFF-SITE.

PERIMETER DRAIN

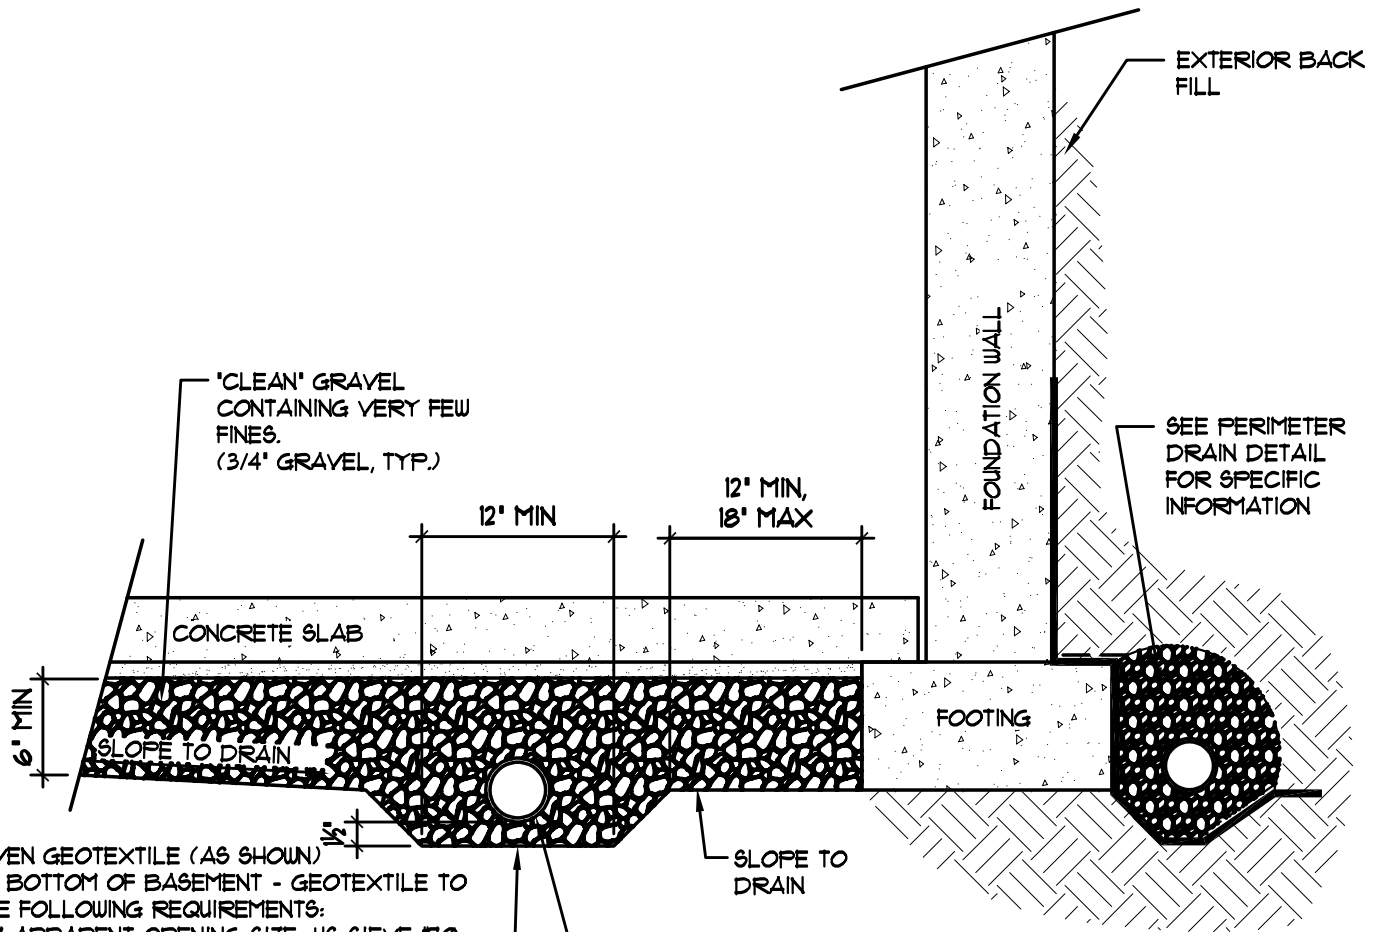
NON-WOVEN GEOTEXTILE (AS SHOWN) ACROSS BOTTOM OF BASEMENT - GEOTEXTILE TO MEET THE FOLLOWING REQUIREMENTS:  
 MAXIMUM APPARENT OPENING SIZE: US SIEVE #10  
 MINIMUM WATER FLOW RATE: 135 GAL/MIN/FT<sup>2</sup>  
 MINIMUM TRAPEZOIDAL TEAR STRENGTH: 40 lbs  
 MINIMUM CBR PUNCTURE STRENGTH: 250 lbs  
 MINIMUM GRAB TENSILE STRENGTH: 90 lbs

3' DIAMETER RIGID PERFORATED PIPE CONNECTED TO A SUITABLE GRAVITY OUTFALL SUCH AS AN UNDERDRAIN LOCATED IN THE UTILITY TRENCH IN THE STREET WITH A MIN. GRADE OF PIPE = 15%. IF A FREE GRAVITY OUTFALL CANNOT BE ACHIEVED, A SUMP PIT AND PUMP SHOULD BE PROVIDED.

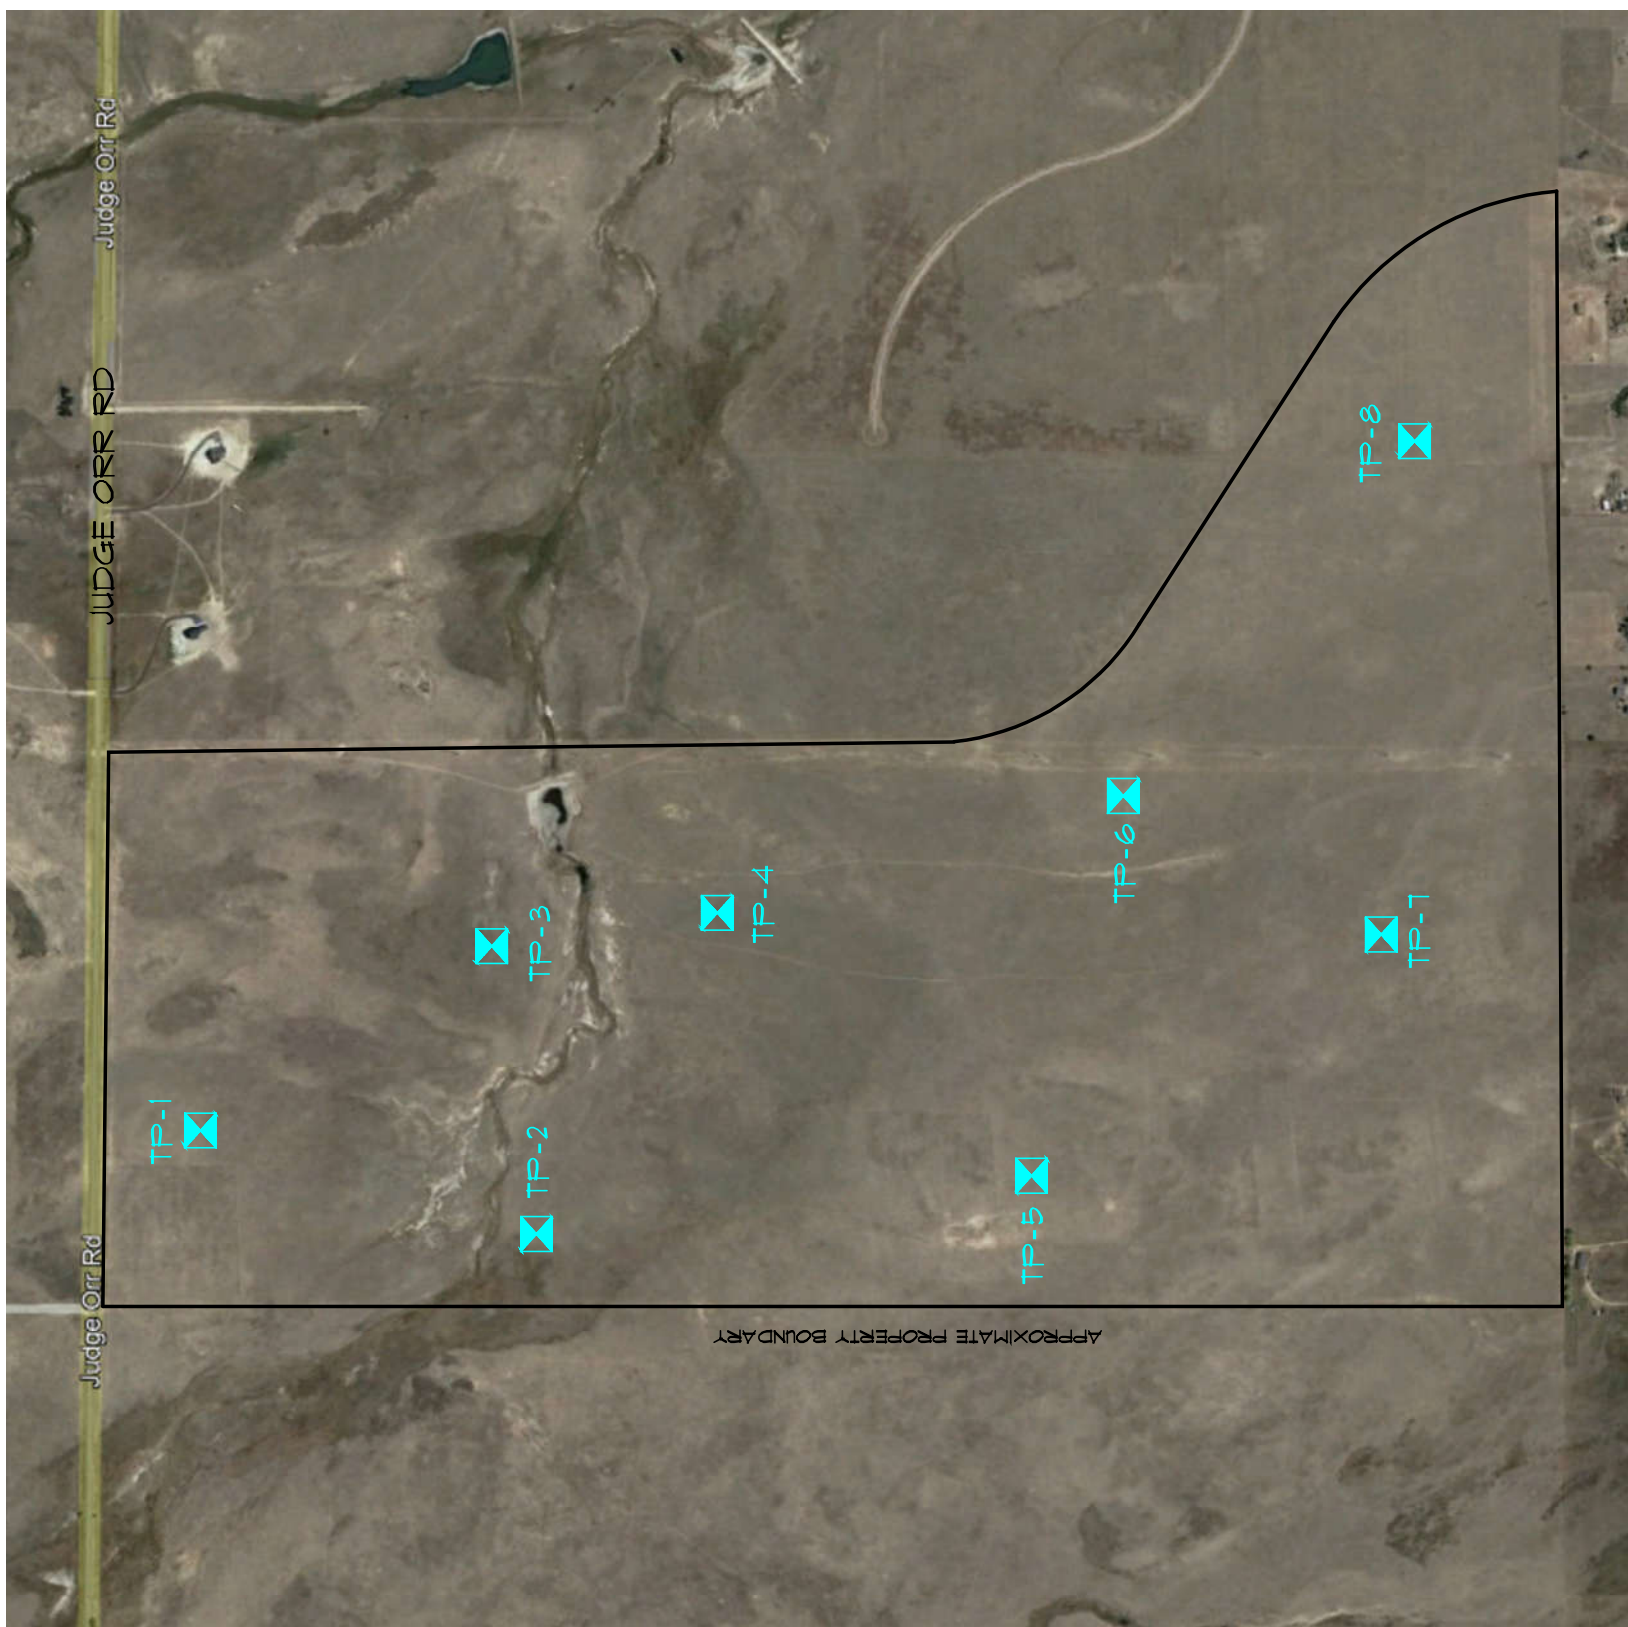
SHEET No.  
**FIG-3**

TEST PIT  
LAYOUT PLAN

APPROXIMATE PROPERTY BOUNDARY
