Job No. 177644

July 31, 2020  
Revised July 27, 2021

Re: Wastewater Study  
11750 Green Acres Ln  
EPC 5215000035  
El Paso County, Colorado

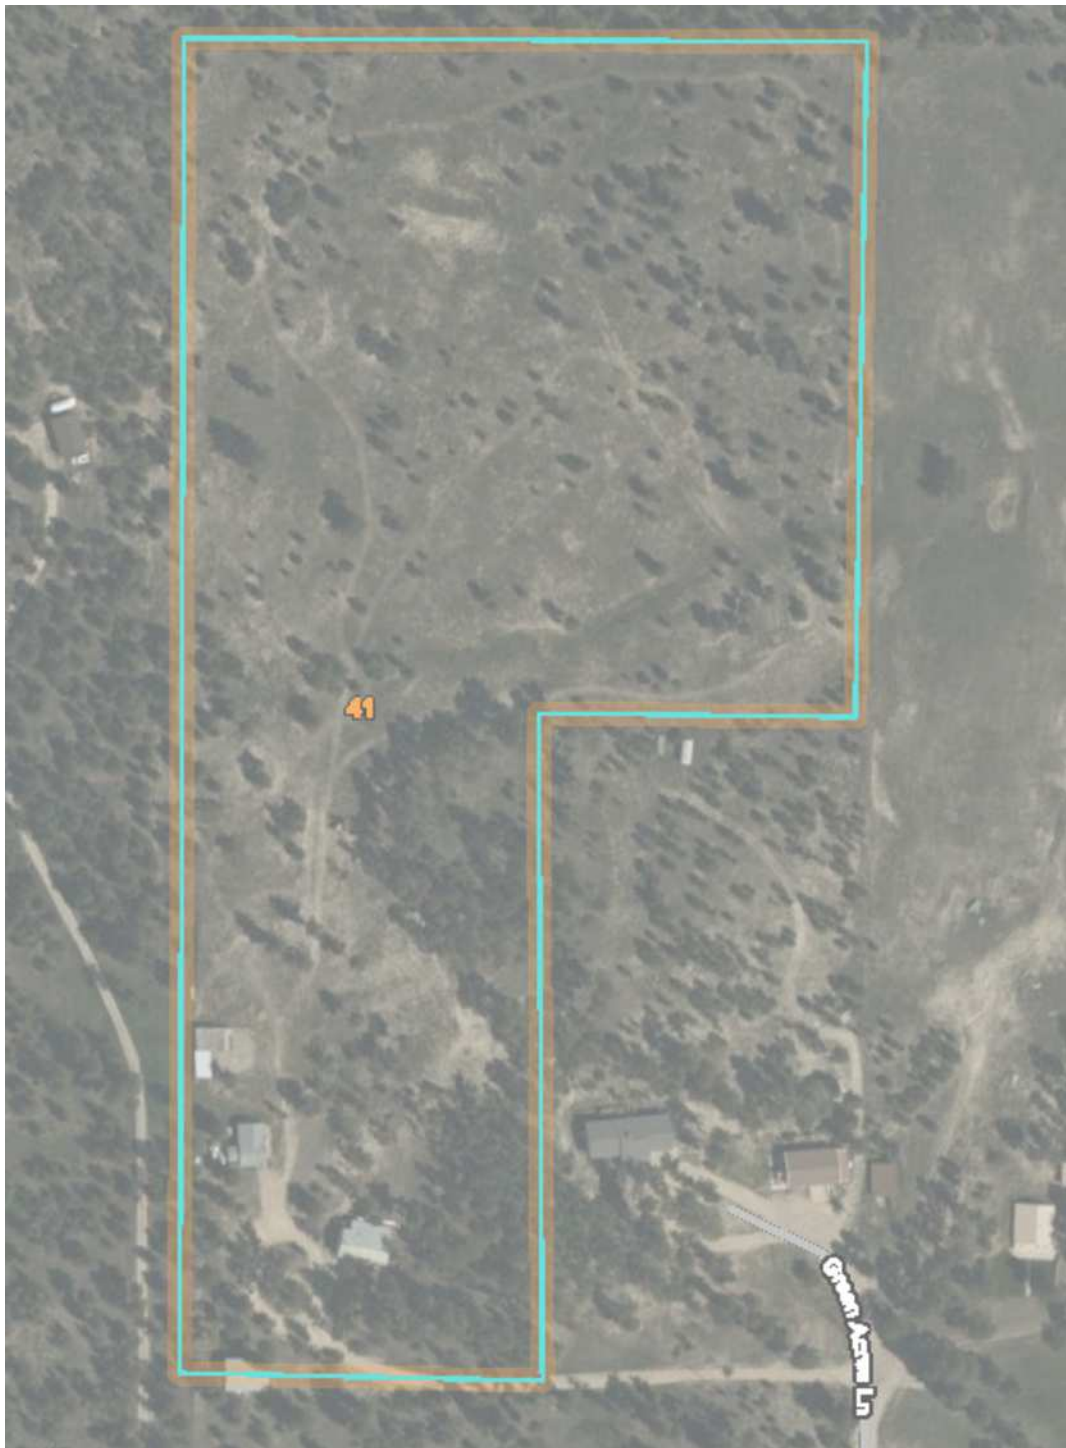
FIG No. 3

The soil conditions as indicated by the NRCS data are anticipated to consist of Kettle gravelly loamy sand with 8 to 40 percent slopes. The Kettle gravelly loamy sand was mapped by the USDA to encompass the majority of the property. Properties of the loamy sand include, somewhat excessively drained soils, depth of the water table is anticipated to be greater than 80 inches, runoff is anticipated to be medium, frequency of flooding and/or ponding is none, and landforms include hills. The USDA Soil Map and full Map Unit Descriptions are presented in Figures 3 and 4, respectively.

- 41 - Kettle gravelly loamy sand
