Pavement Study

Falcon Meadows at Bent Grass, Filing No. 1

El Paso County, Colorado

Project Number 214061-P2
September 15, 2021
Revised October 1, 2021

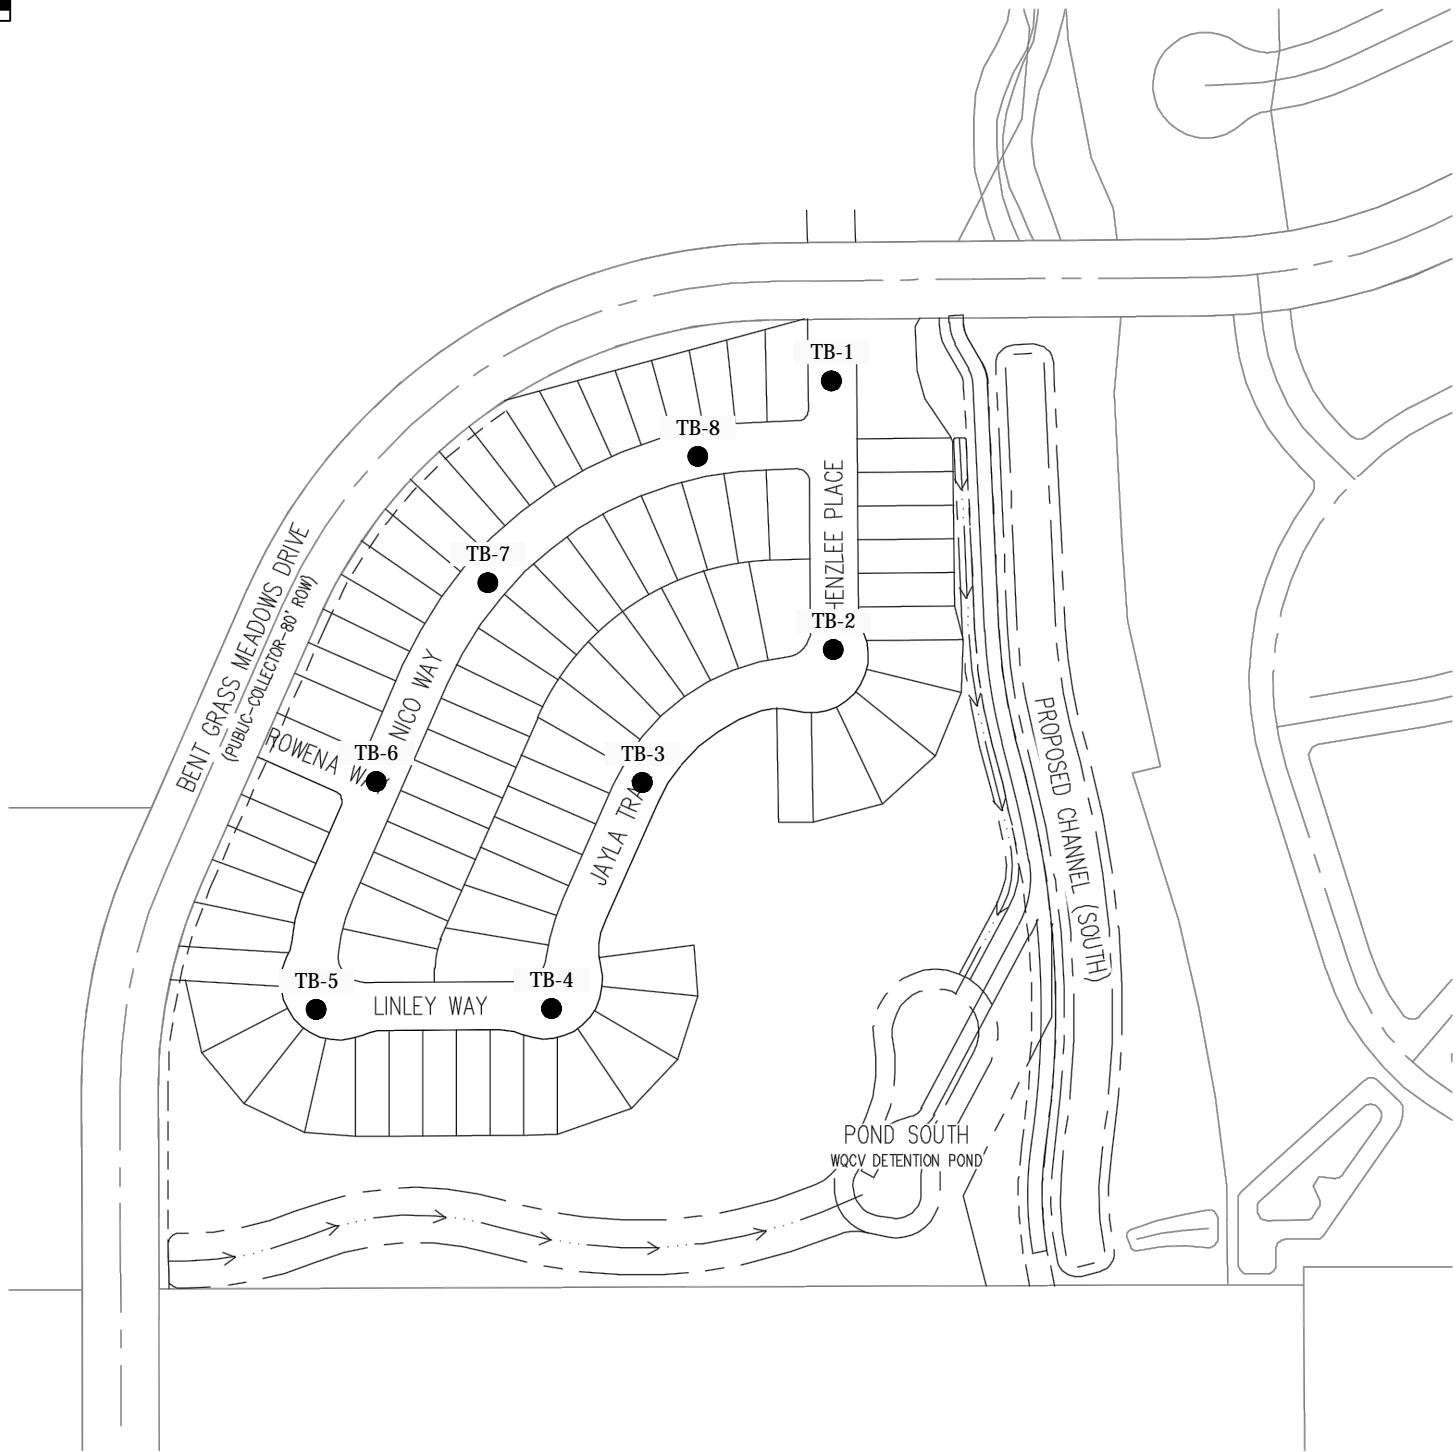
- NOTES:
- 1. TEST BORINGS WERE OVERLAID ON THE "WATER AND WASTE WATER CONSTRUCTION PLANS BENT GRASS RESIDENTIAL FILING NO. 3", PREPARED BY GALLOWAY, PROJECT/JOB NUMBER CLH000018, DATED FEBRUARY 18, 2021.
 - 2. ALL LOCATIONS ARE APPROXIMATE.

The subgrade soils were sampled by drilling eight test borings within the proposed roadway alignments approximately 250 lineal feet apart (see Figure 1). The test borings were drilled using a 4-inch diameter continuous flight auger powered by a truck-mounted drill rig. The test borings were drilled to depths of approximately 5 or 10 feet with disturbed bulk samples collected in the upper 5 feet of rough subgrade elevation. Samples of the subsurface materials were also obtained using a Modified California sampler which was driven into the soil by dropping a 140-pound hammer through a free fall of 30 inches. The Modified California sampler is a 2.5-inch outside diameter by 2-inch inside diameter device. The number of blows required for the sampler to penetrate 12 inches and/or the number of inches that the sampler is driven by 50 blows gives an indication of the consistency or relative density of the subsurface materials encountered. Results of the penetration tests are presented on the "Test Boring Logs", Figures 2 through 4. Ground water was not encountered at the time of drilling.

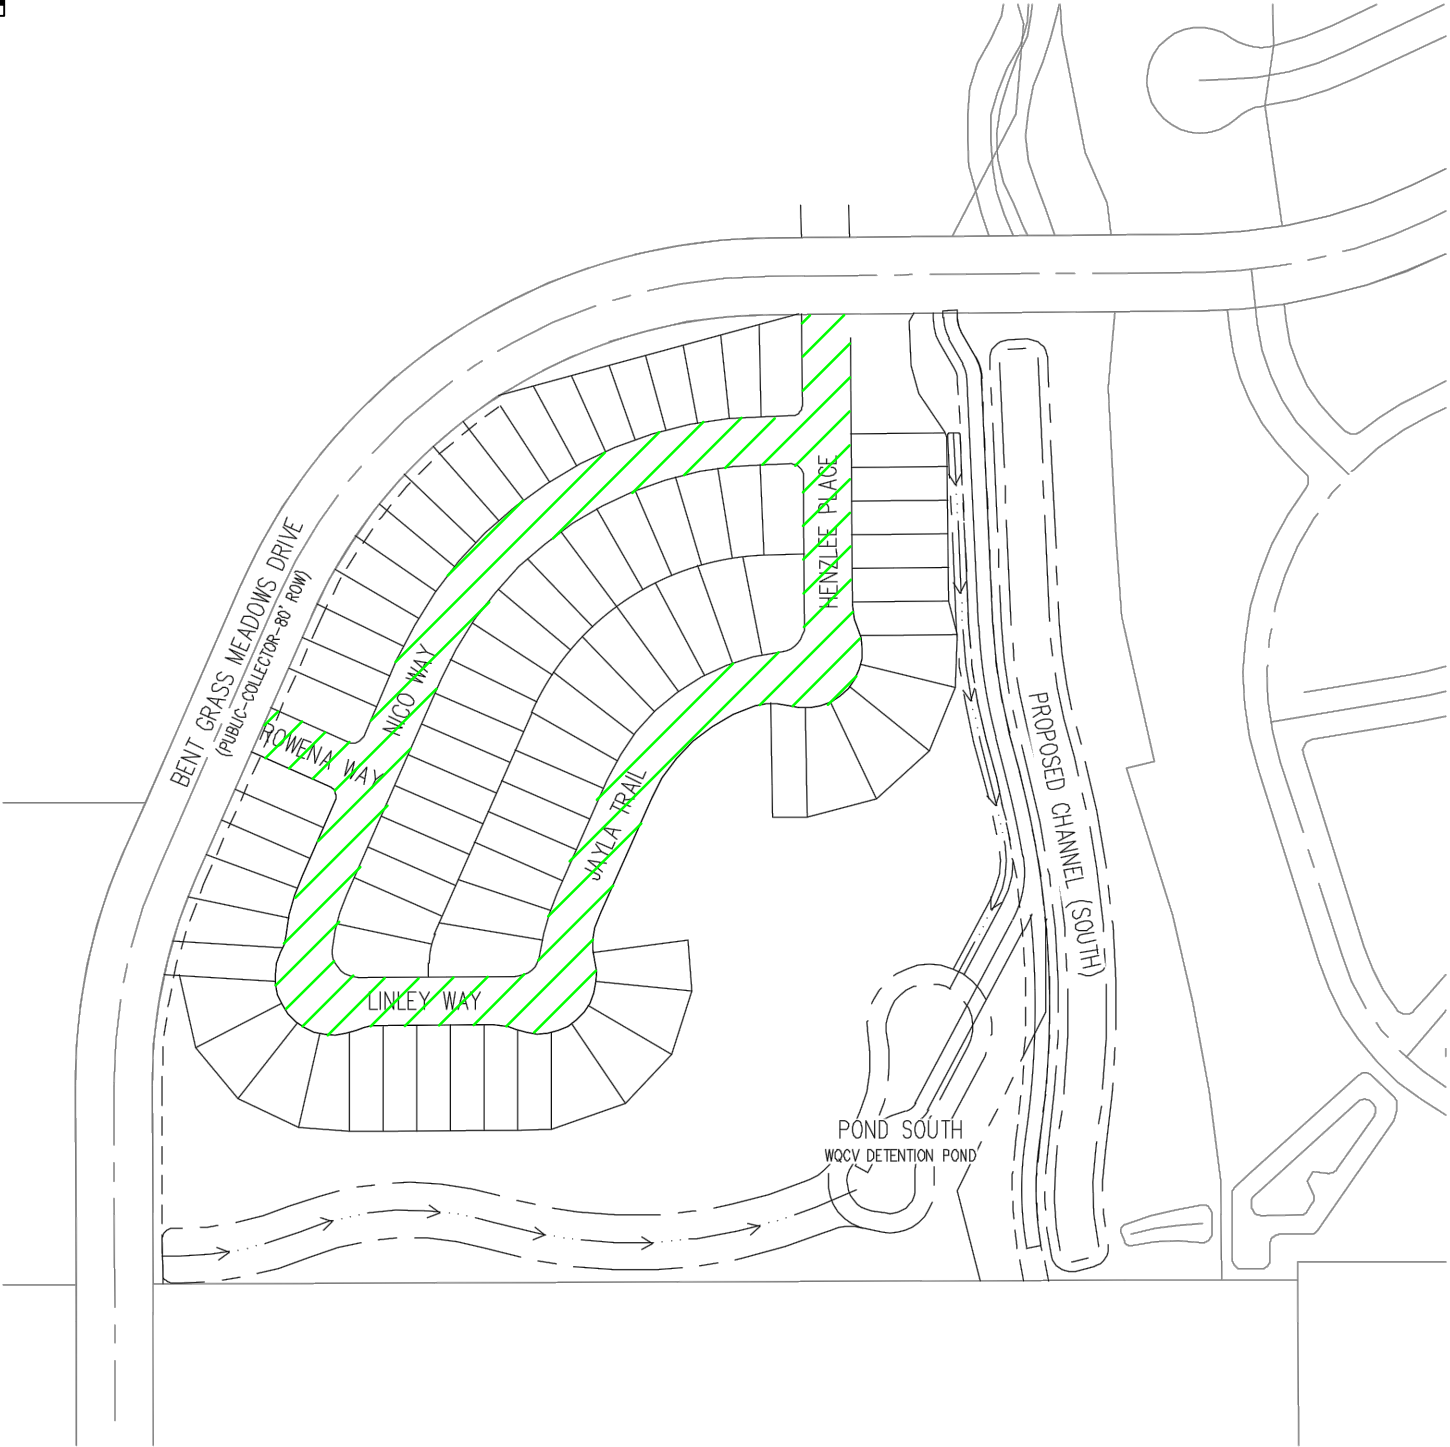
PROJECT NO. 214061 P2
FIGURE 1A

LOCAL RESIDENTIAL
(ESAL = 292,000; MR = 7,953 psi)

ALT	ACS (IN)	ABC (IN)	TOTAL (IN)
A	3.5	9.0	12.5

ACS - ASPHALT CONCRETE SURFACE
ABC - AGGREGATE BASE COURSE

PAVEMENT THICKNESS
RECOMMENDATIONS

The pavement thickness recommendations have been calculated using the 1993 AASHTO Pavement Design, DARWin Pavement Design and Analysis System computer program. Based on the design criteria referenced above and the calculations from Figure B-1 (see Appendix B), the revised recommended pavement thicknesses are provided in the table below and on Figure 1A.

Roadway Classification	Alternate	ACS (in.)	ABC (in.)	Total (in.)
Local Residential (ESAL = 292,000; M_R = 7,953 psi)	A	3.5	9.0	12.5

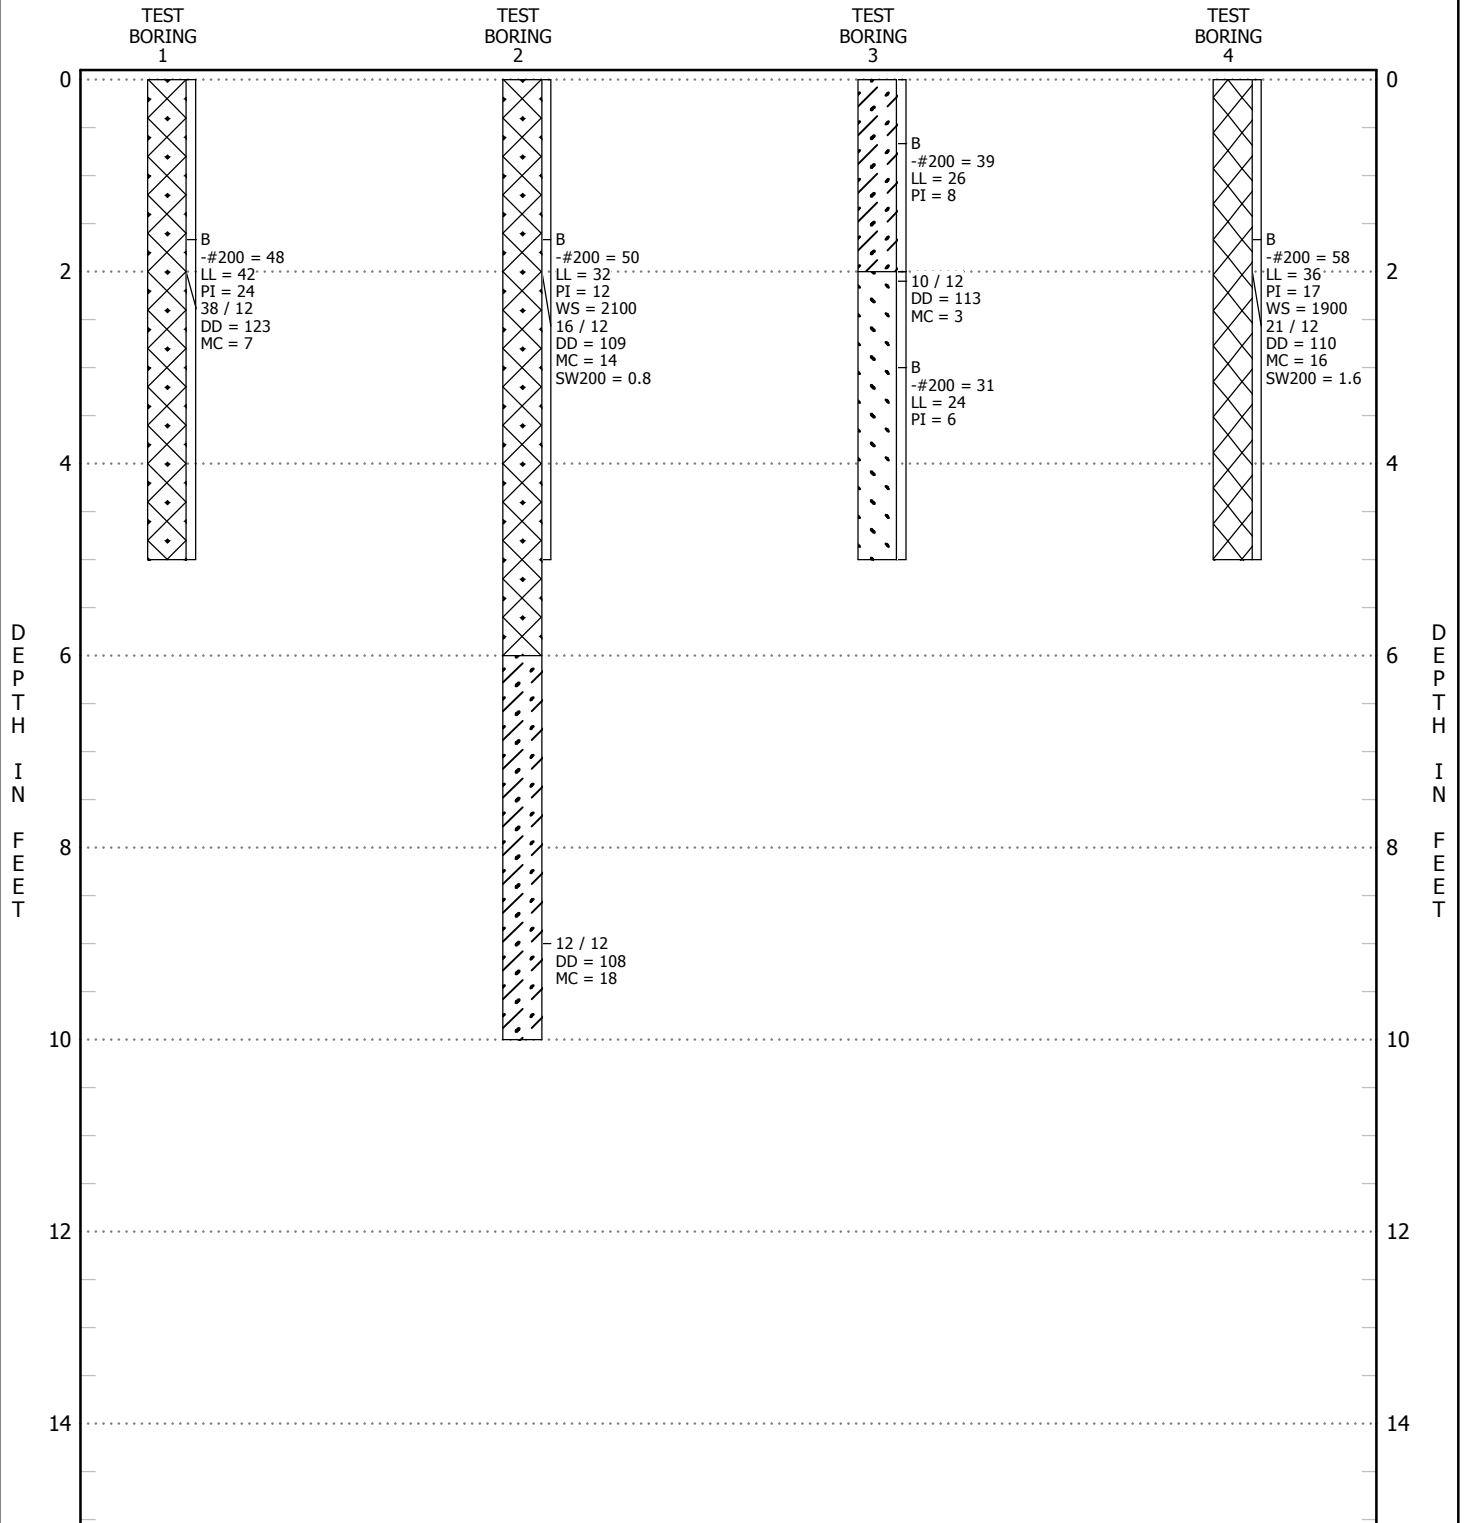
FIGURE 2

TEST BORING LOGS

The samples obtained during drilling were returned to the laboratory where they were visually classified by a geotechnical engineer. Laboratory testing was then assigned to specific samples to evaluate their engineering properties. The laboratory tests included gradation analysis and Atterberg limits to evaluate grain size distribution and plasticity. Swell-consolidation tests were conducted to evaluate the effect of wetting under load on selected samples. The dry density from Test Boring No. 8 at a depth of approximately 2 feet may not be accurate as the sample classified as sand and may have been disturbed during transport to our laboratory. Representative samples were tested for water-soluble sulfate concentration. Selected subgrade materials were tested for Standard Proctor and resilient modulus to determine the subgrade support strength. The test results are summarized on Figures 2 through 4 and presented in Appendix A.

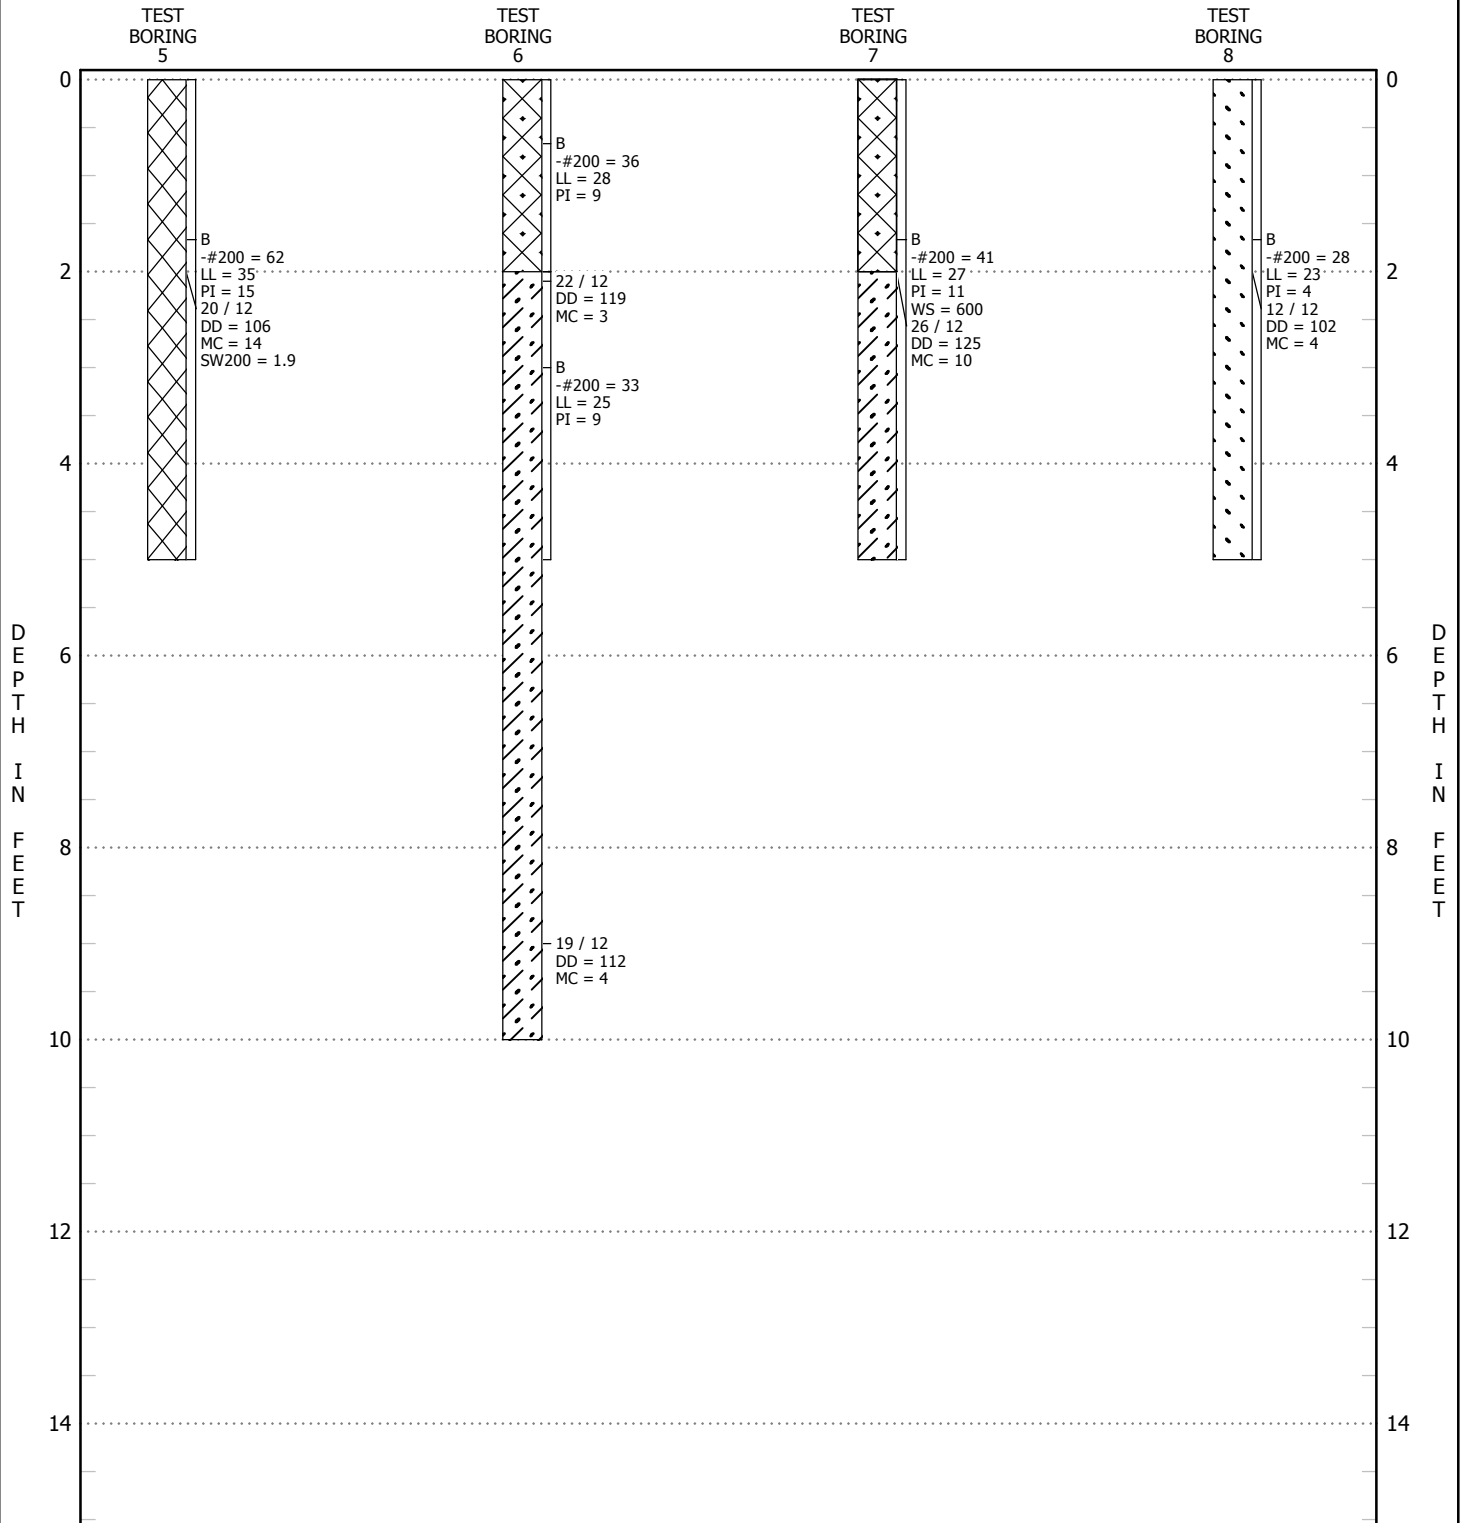
FIGURE 3

TEST BORING LOGS

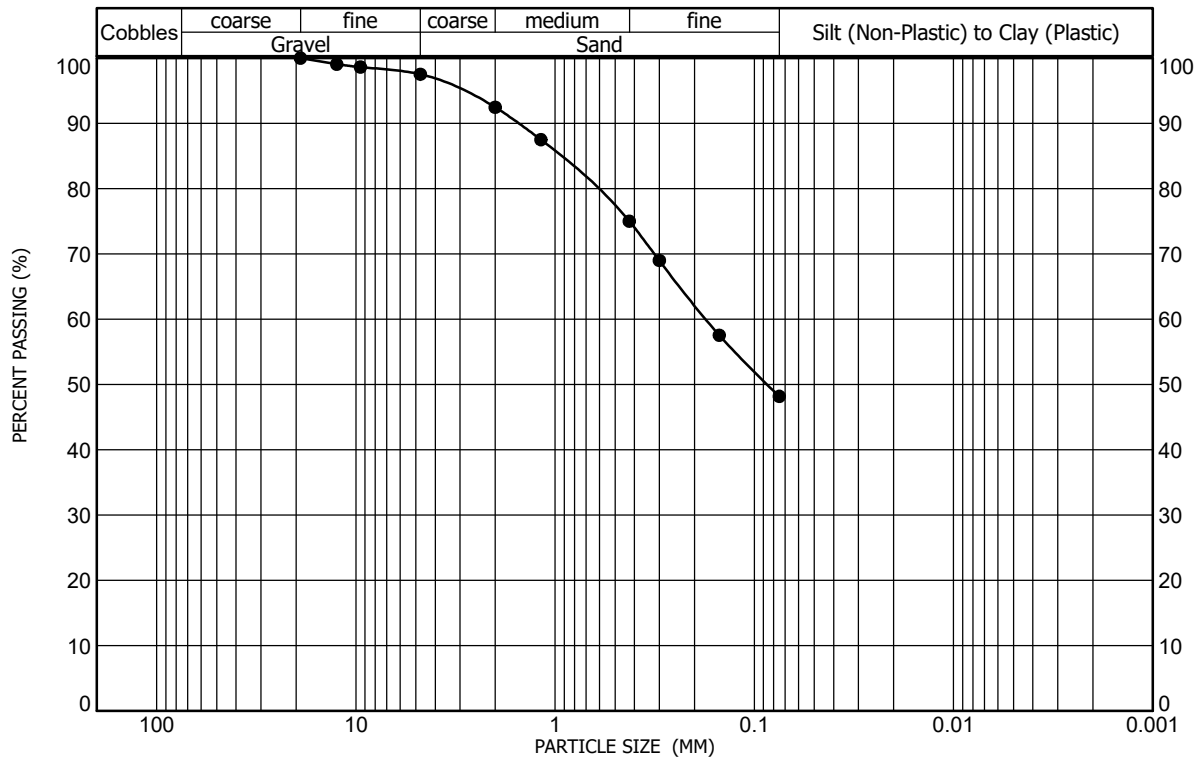
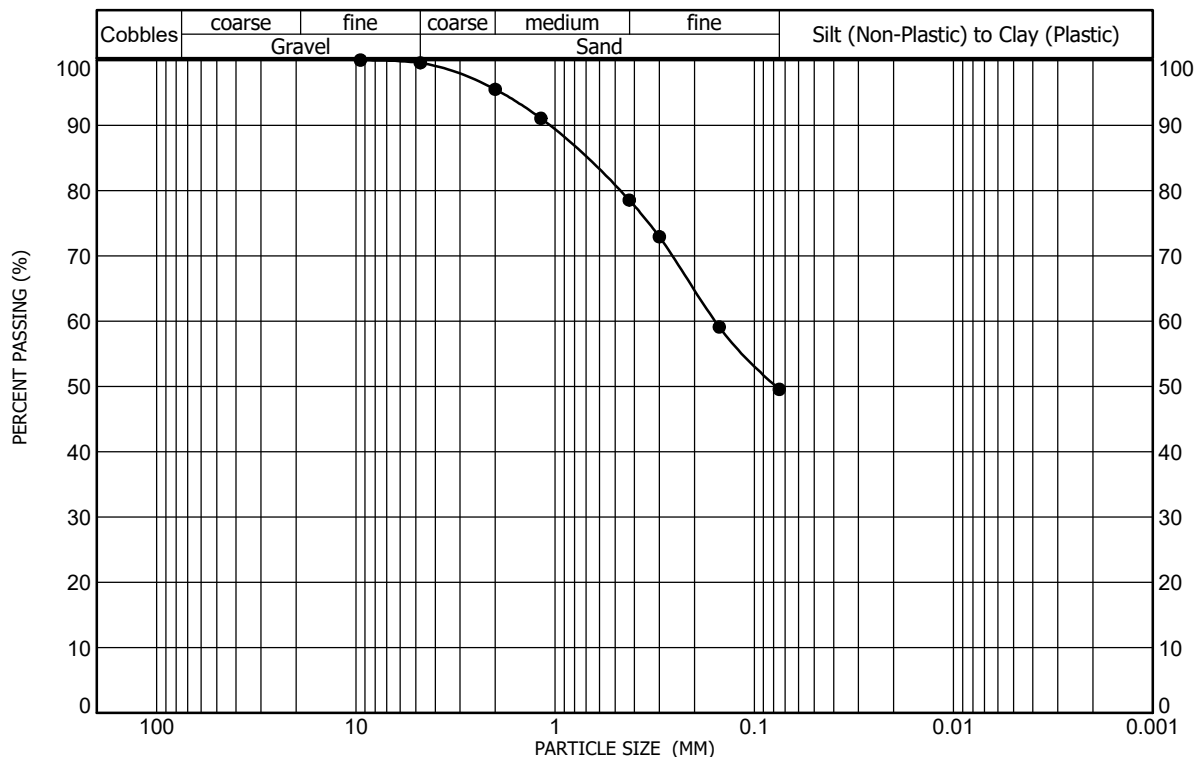
FIGURE A-1

Sample Location Test Boring No. 1 at a depth of 0 feet to 5 feet Gravel (%) 2 Liquid Limit 42
 Sample Description Fill, sand, very clayey Sand (%) 49 Plasticity Index 24
 Classification A-7-6(7), CLAYEY SAND(SC) Clay/Silt (%) 48

Sample Location Test Boring No. 2 at a depth of 0 feet to 5 feet Gravel (%) 0 Liquid Limit 32
 Sample Description Fill, sand, very clayey Sand (%) 50 Plasticity Index 12
 Classification A-6(3), CLAYEY SAND(SC) Clay/Silt (%) 50

GRADATION AND ATTERBERG TEST RESULTS

The subgrade soils encountered consisted of very sandy clay fill, very clayey sand fill with gravel, silty to clayey sand, and clayey to very clayey sand. According to the AASHTO Soil Classification system, the soils from the bulk samples collected classified as A-2-4 (0), A-4 (0), A-6 (1 to 7), and A-7-6 (7). Based upon field observations, fill was encountered in six of the eight test borings to depths ranging from approximately 2 to 6 feet below rough subgrade elevation. The fill encountered is considered documented as representatives from AGW performed moisture and density testing during mass grading of the site. Silty to clayey sand was encountered in two of the test borings at surface elevation and at a depth of approximately 2 feet. Clayey to very clayey sand was encountered in four test borings at surface elevation and at depths of approximately 2 and 6 feet. Bedrock was not encountered to the depths drilled. Ground water was not encountered at the time of drilling.

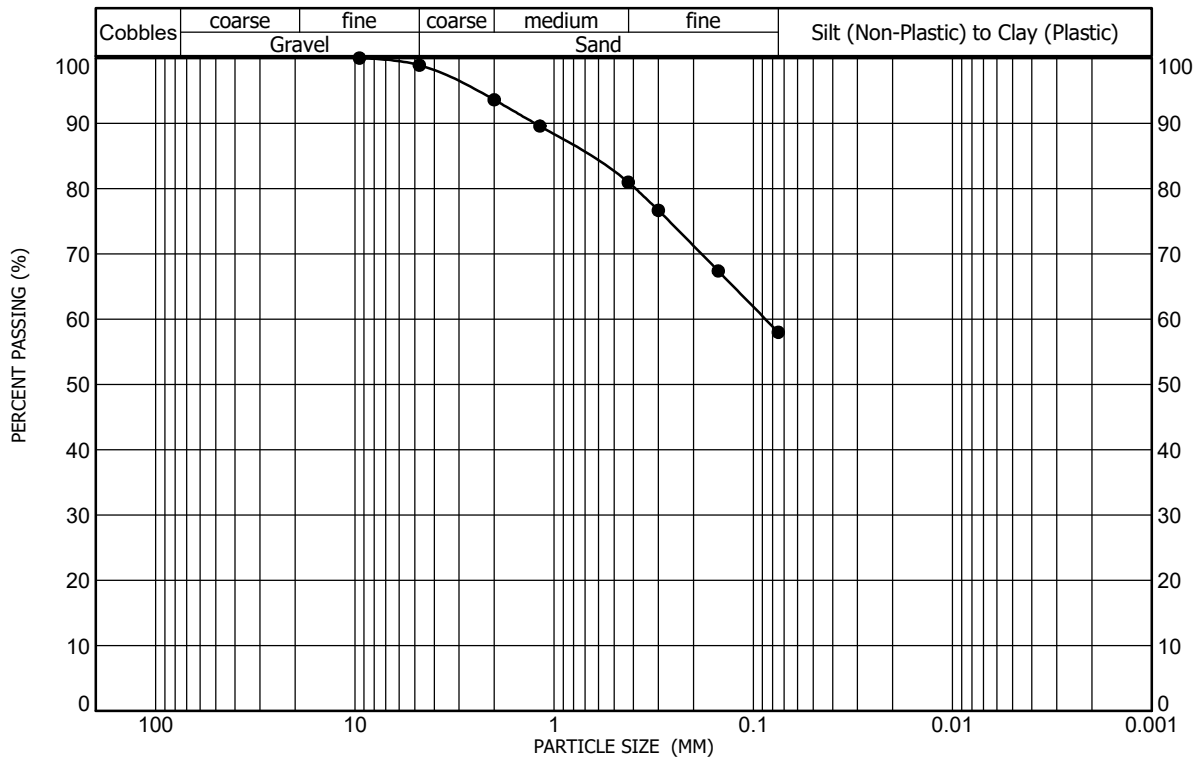
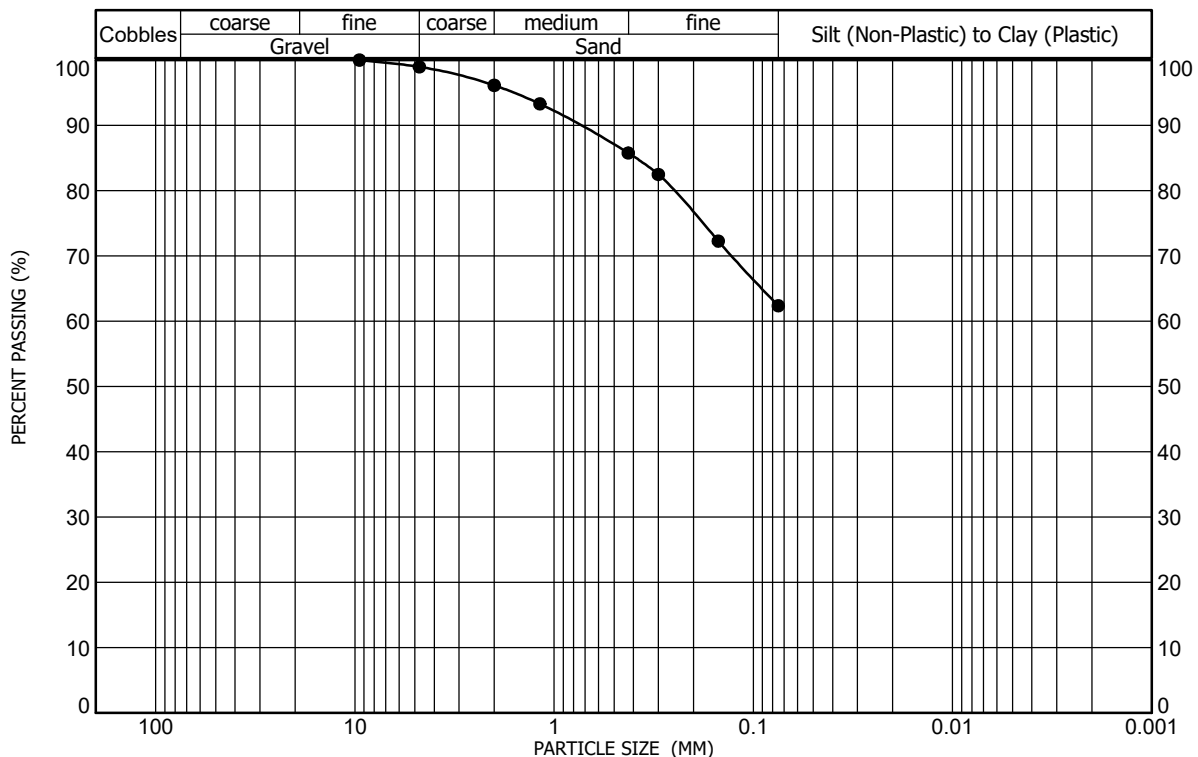
FIGURE A-3

Sample Location Test Boring No. 4 at a depth of 0 feet to 5 feet Gravel (%) 1 Liquid Limit 36
 Sample Description Fill, clay, very sandy Sand (%) 41 Plasticity Index 17
 Classification A-6(7), SANDY LEAN CLAY(CL) Clay/Silt (%) 58

Sample Location Test Boring No. 5 at a depth of 0 feet to 5 feet Gravel (%) 1 Liquid Limit 35
 Sample Description Fill, clay, very sandy Sand (%) 37 Plasticity Index 15
 Classification A-6(7), SANDY LEAN CLAY(CL) Clay/Silt (%) 62

GRADATION AND ATTERBERG TEST RESULTS

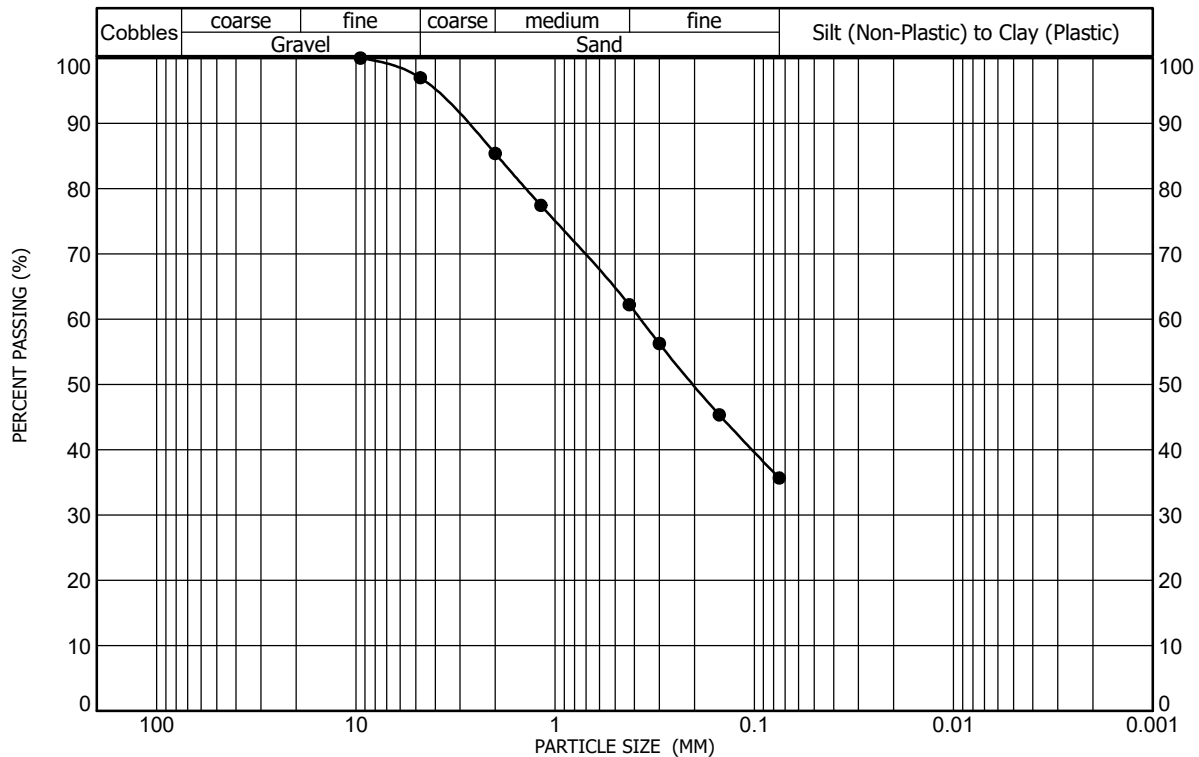
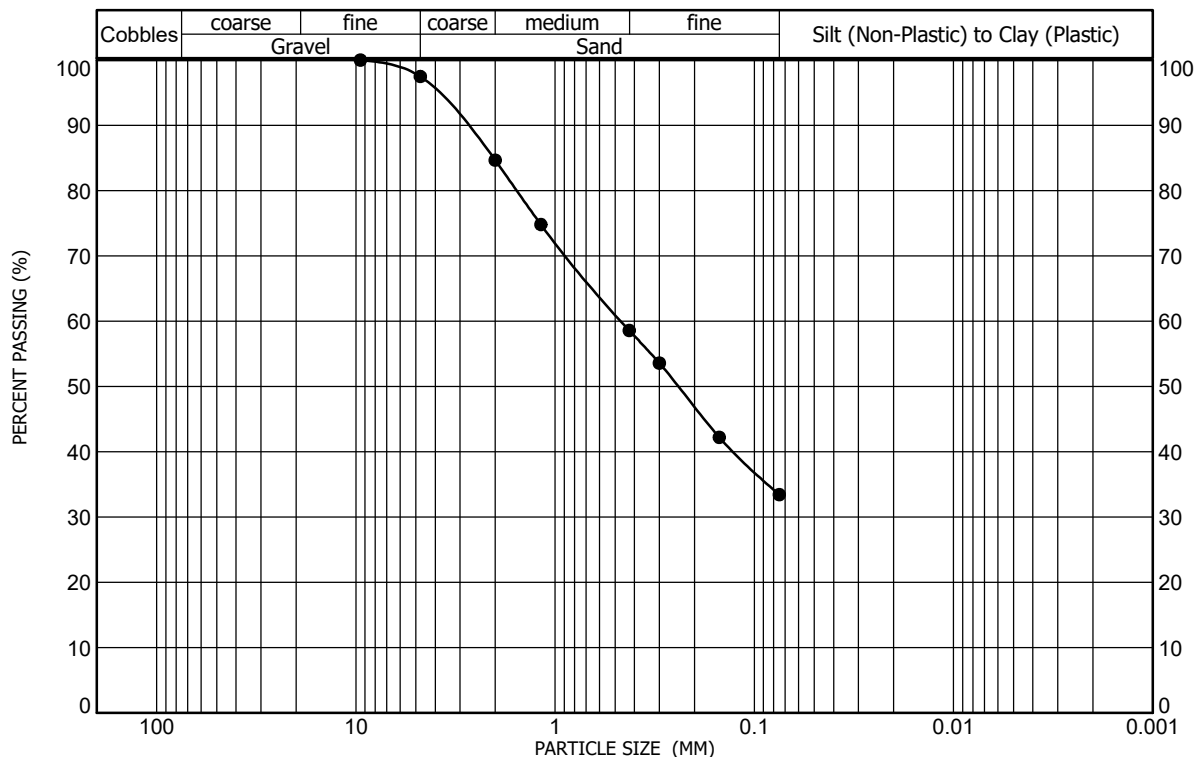
FIGURE A-4

Sample Location Test Boring No. 6 at a depth of 0 feet to 2 feet Gravel (%) 3 Liquid Limit 28
 Sample Description Fill, sand, very clayey Sand (%) 61 Plasticity Index 9
 Classification A-4(0), CLAYEY SAND(SC) Clay/Silt (%) 36

Sample Location Test Boring No. 6 at a depth of 2 feet to 5 feet Gravel (%) 3 Liquid Limit 25
 Sample Description Sand, very clayey Sand (%) 64 Plasticity Index 9
 Classification A-2-4(0), CLAYEY SAND(SC) Clay/Silt (%) 33

GRADATION AND ATTERBERG TEST RESULTS

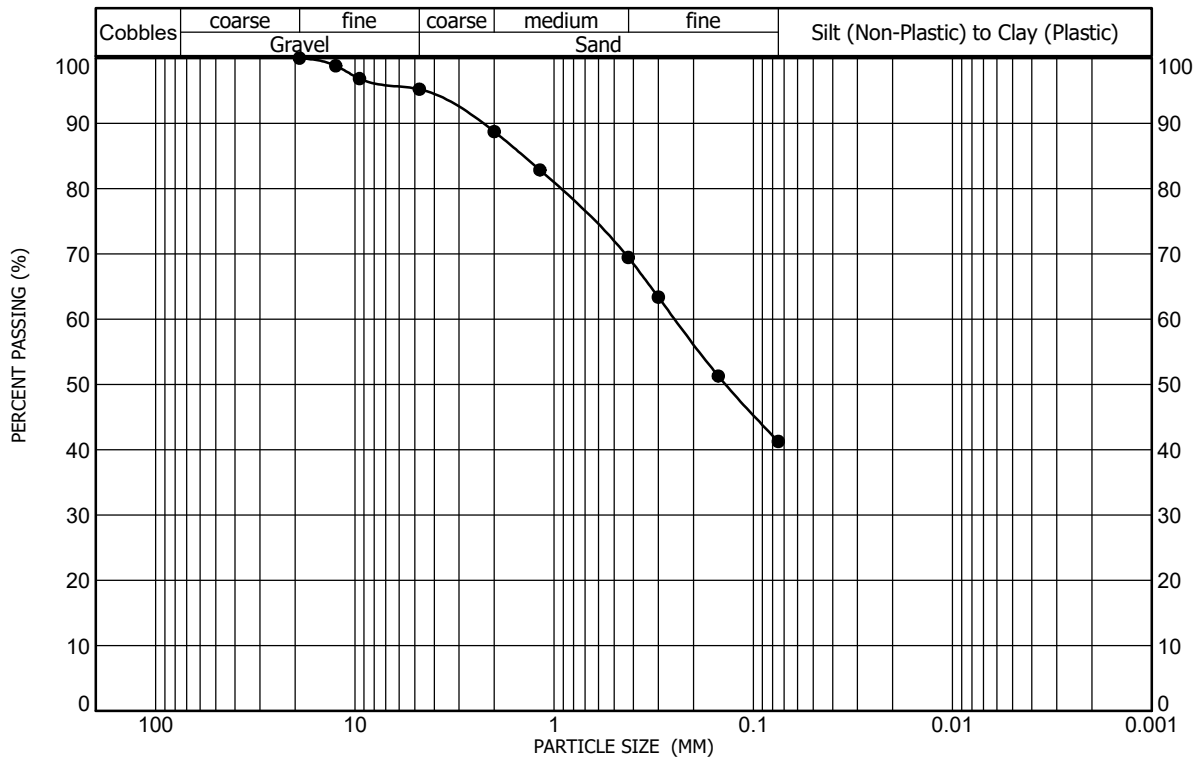
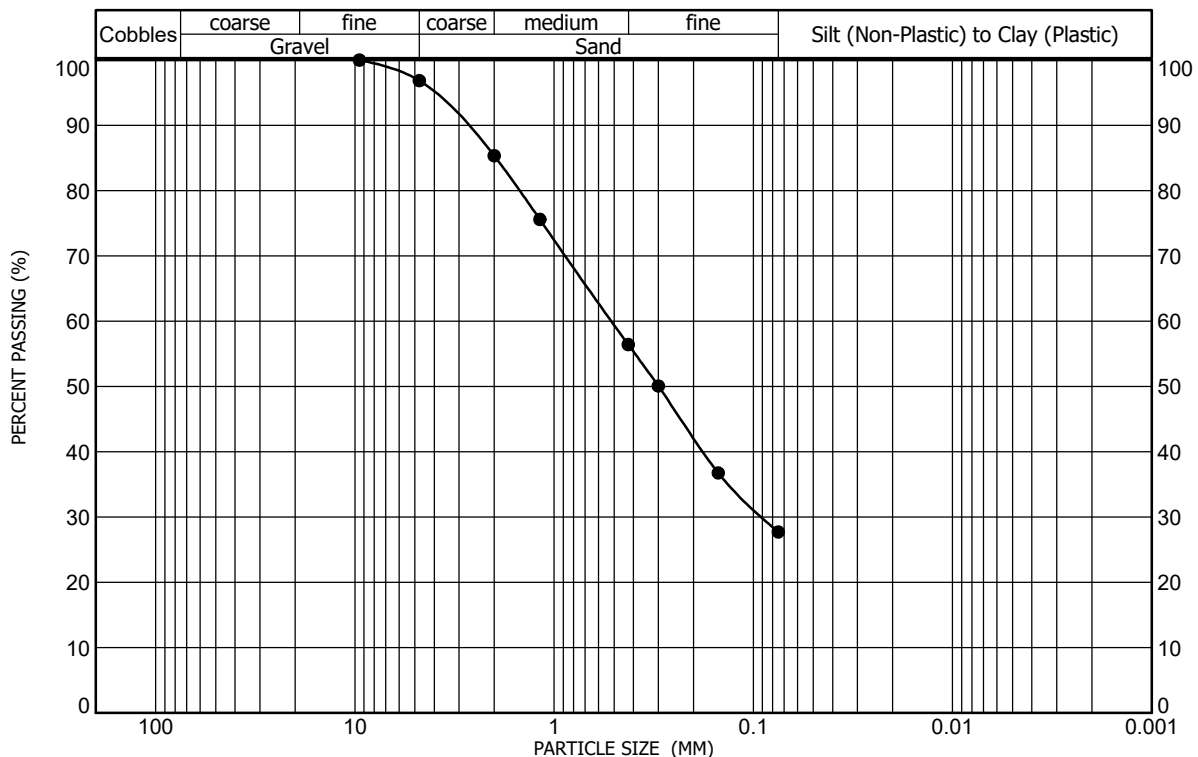
FIGURE A-5

Sample Location _____ Test Boring No. 7 at a depth of 0 feet to 5 feet _____ Gravel (%) 5 Liquid Limit 27
 Sample Description _____ Fill, sand, very clayey, slightly gravelly _____ Sand (%) 54 Plasticity Index 11
 Classification _____ A-6(1), CLAYEY SAND(SC) _____ Clay/Silt (%) 41

Sample Location _____ Test Boring No. 8 at a depth of 0 feet to 5 feet _____ Gravel (%) 3 Liquid Limit 23
 Sample Description _____ Sand, silty/clayey _____ Sand (%) 69 Plasticity Index 4
 Classification _____ A-2-4(0), SILTY, CLAYEY SAND(SC-SM) _____ Clay/Silt (%) 28

GRADATION AND ATTERBERG TEST RESULTS

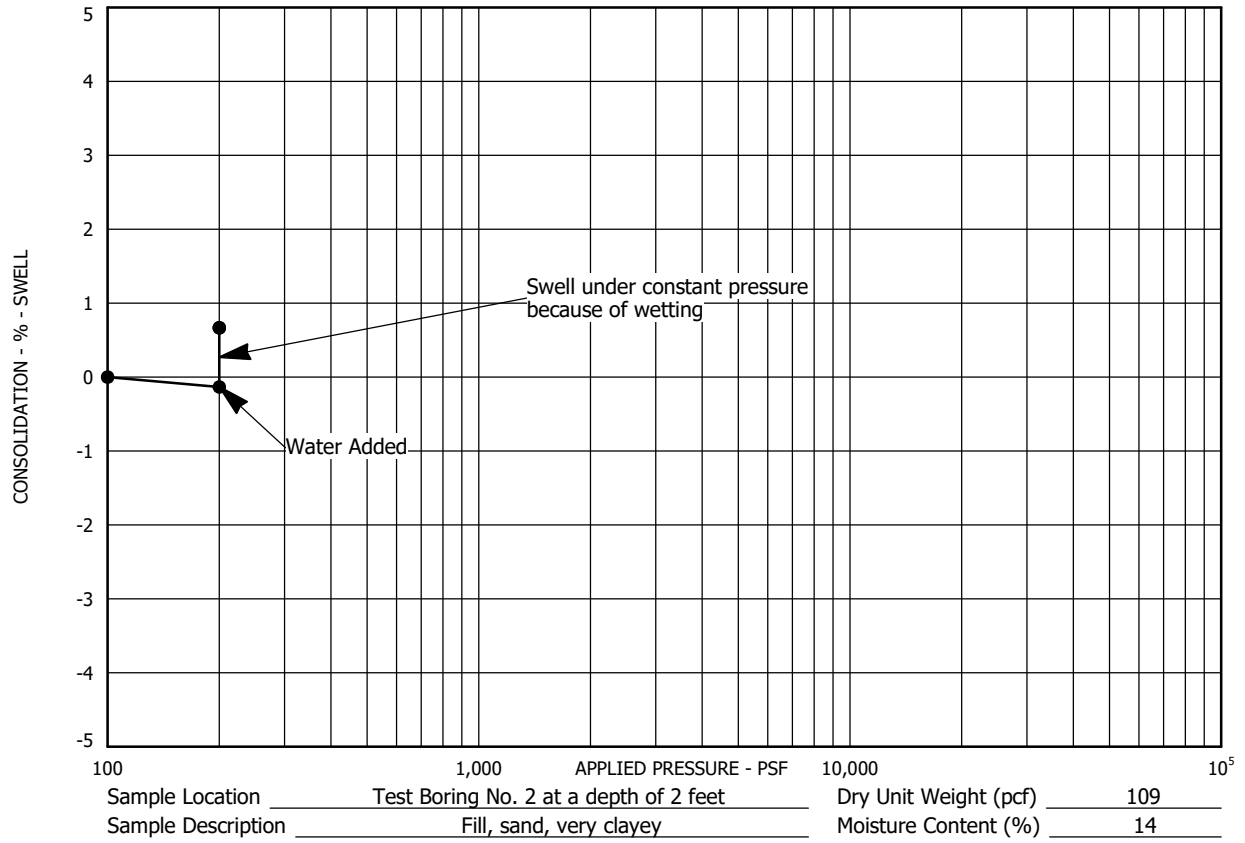
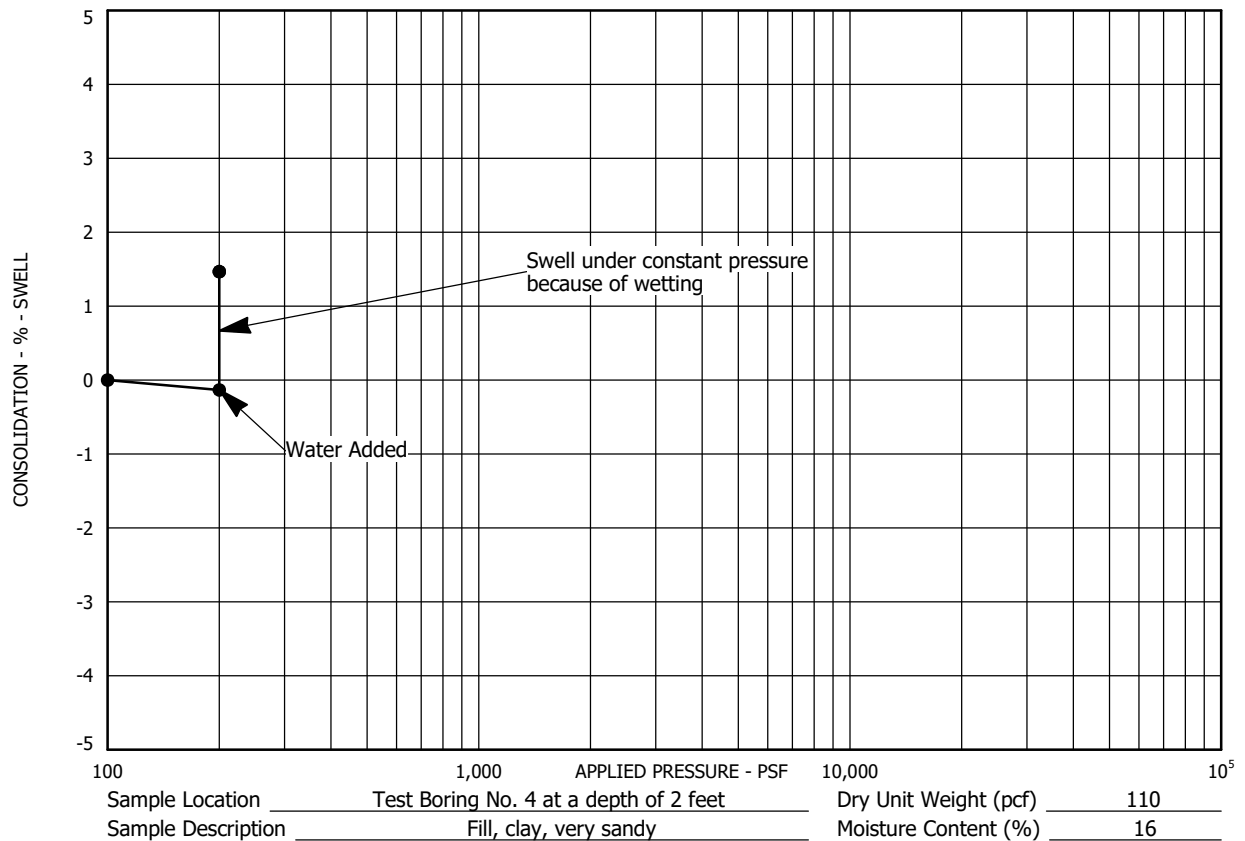
FIGURE A-6

SWELL - CONSOLIDATION TEST RESULTS

The "Manual" stipulates subgrade soils requiring expansive subgrade mitigation should be addressed in the pavement design. The soils encountered at the site exhibited Plasticity Indices (PI) ranging from 4 to 24. These soils are considered to exhibit low to moderate plasticity. Swell-consolidation tests were conducted to determine expansion potential under a surcharge load of 200 pounds per square foot (psf). These test results exhibited 0.8 to 1.9% expansion potential (see Appendix A). Based on our sampling and laboratory testing, expansive subgrade mitigation is not required per the "Manual" as the expansion potential was below 2%.

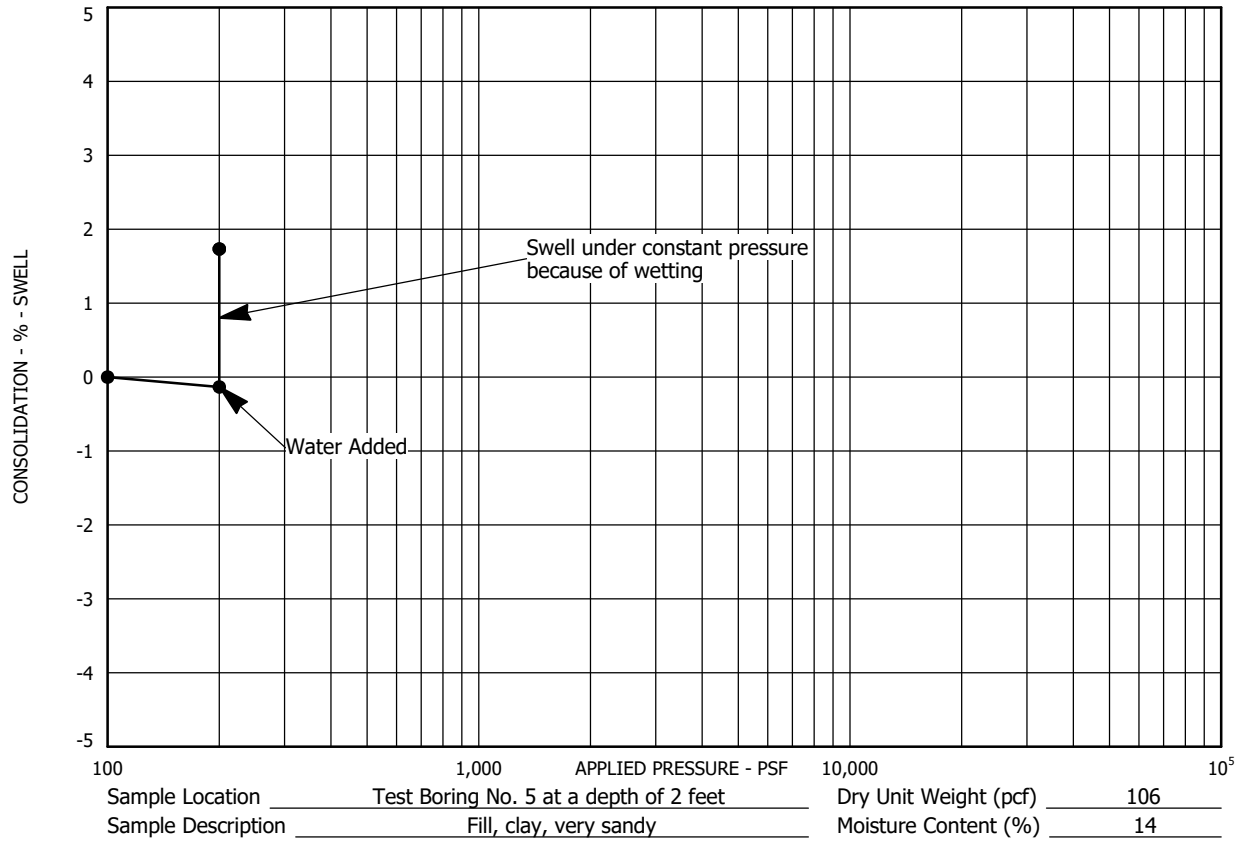
SWELL - CONSOLIDATION TEST RESULTS
FIGURE A-7
