Pavement Study

Falcon Meadows at Bent Grass, Filing No. 1

El Paso County, Colorado

Project Number 214061-P2
September 15, 2021
Revised October 1, 2021

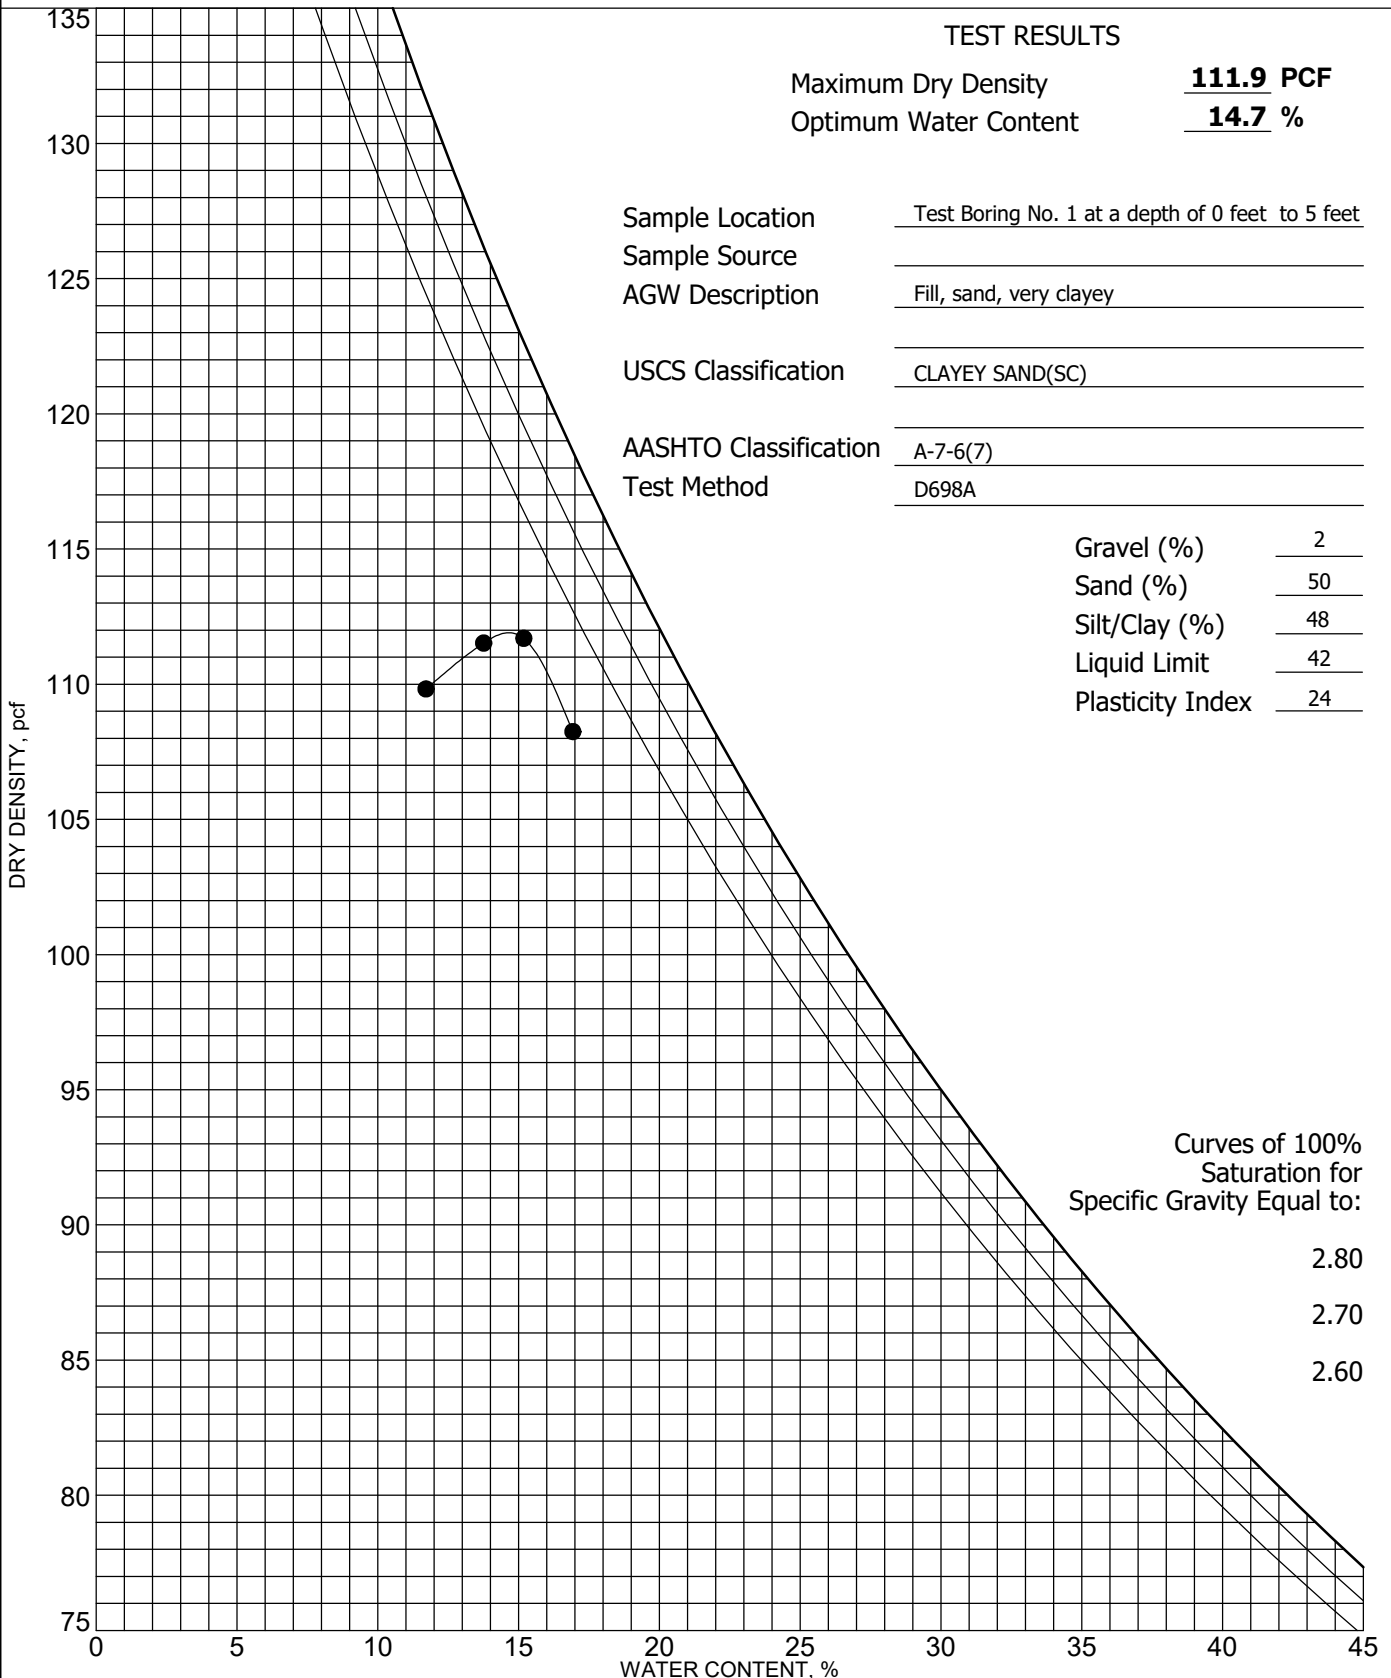
FIGURE A-8

Maximum Dry Density **111.9 PCF**
Optimum Water Content **14.7 %**

Sample Location Test Boring No. 1 at a depth of 0 feet to 5 feet

Curves of 100%
Saturation for
Specific Gravity Equal to:

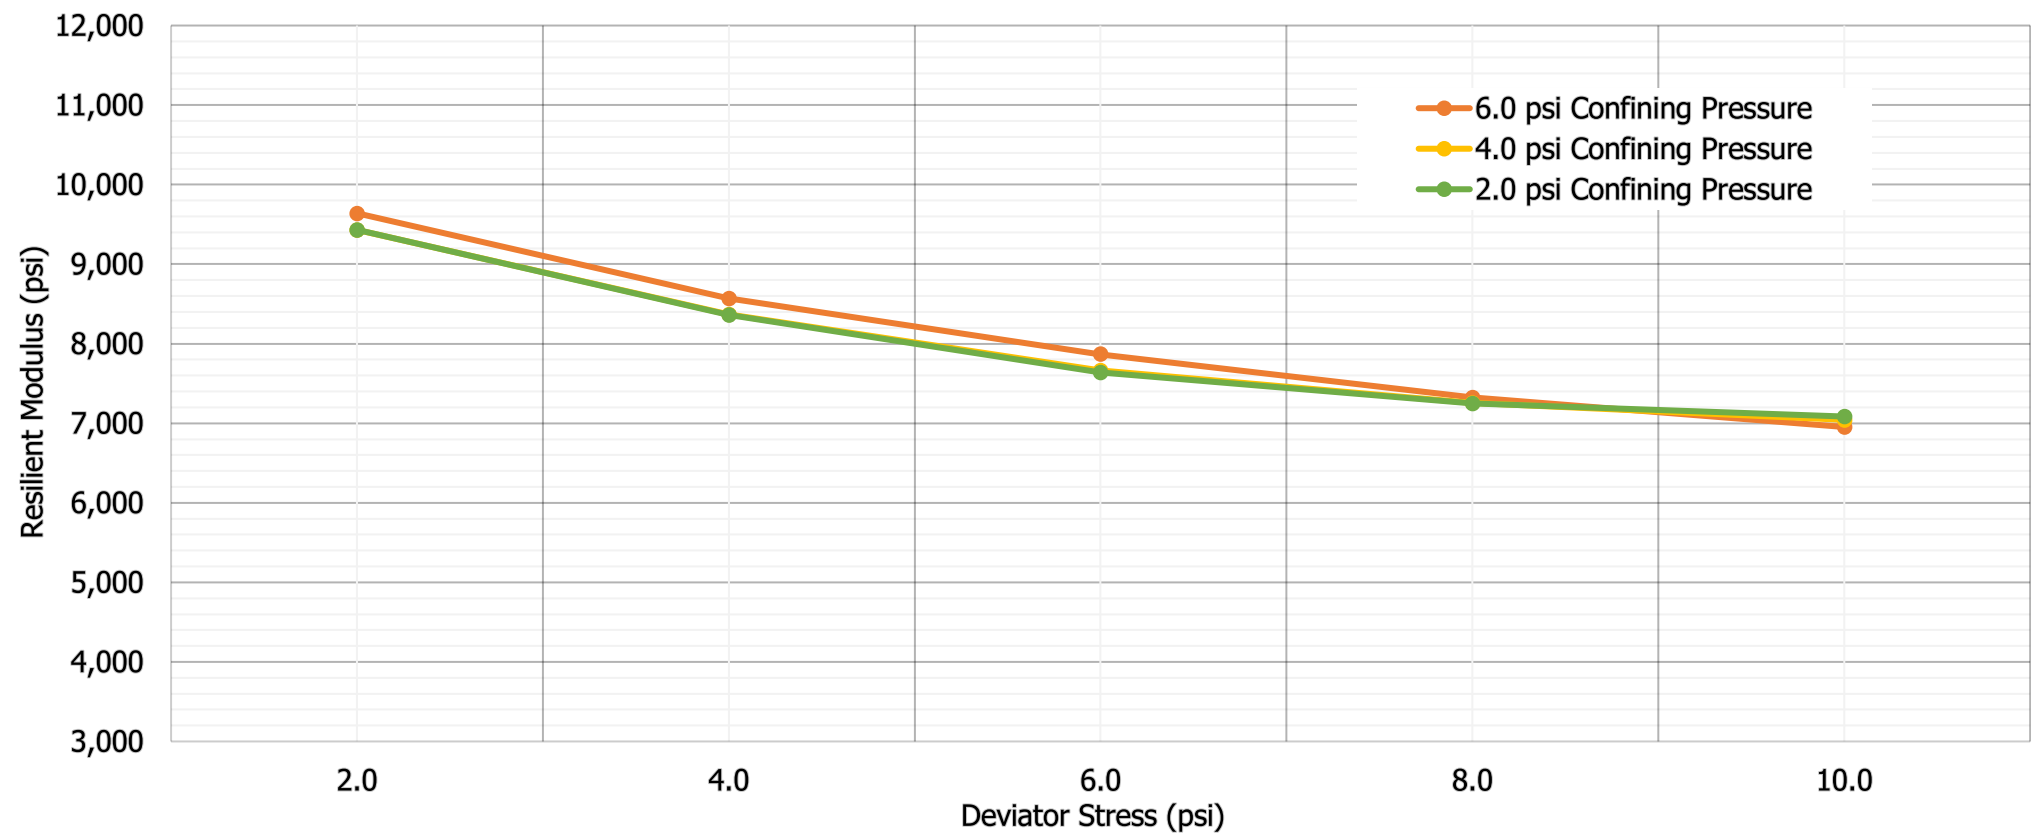
Resilient Modulus Vs. Deviator Stress Graph

Sample Location TB-1
Soil Description Sand, very clayey
Height (in) 5.6
Diameter (in) 2.8
Area (in^2) 6.2
Volume (in^3) 34.5
Remold Dry Density (pcf) 107.4
Remold Moisture (%) 15.1
Percent Compaction (%) 96
Moisture Content after (%) -

AASHTO Classification A-7-6 (7)
-No. 200 (%) 48
Liquid Limit 42
Plastic Limit 18
Plasticity Index 24
Proctor Type ASTM D698
Proctor Max Dry Density (pcf) 111.9
Optimum Moisture (%) 14.7
Material Type 2

Resilient Modulus 7,953 psi (average of test sequences 11, 12, 13, 14, 15)
Notes

The pavement subgrade support strength of soils is based on the resilient modulus (M_R). The resilient modulus is a measure of the elastic property of soil, which is dependent upon moisture content, density, and the applied stress level. The poorest soils were encountered in Test Boring No. 1 (0-5') as representative of A-7-6 (7) soils. These soils were tested for Standard Proctor (ASTM D698) and exhibited a maximum dry density of 111.9 pcf at an optimum moisture content of 14.7%. Resilient modulus testing was performed on a sample remolded to at least 95% of Standard Proctor (ASTM D698) maximum dry density at approximately optimum moisture content. The results of the resilient modulus testing yielded a value of 7,953 psi (see Appendix A). We find this resilient modulus value to be reasonable. We understand the El Paso County review comments indicated to provide the R-value that was used for the calculations. A direct resilient modulus test was performed rather than an R-value test, which is typically converted to a resilient modulus value. For this reason, we cannot provide an exact R-value test result.
