## SOILS AND GEOLOGY STUDY

**Crossroads Commercial**  
**Parcel No. 5408007005**  
**El Paso County, Colorado**

**JOB NO. 177025**

**August 18, 2020**  
**Revised March 3, 2021**  
PCD File No. SP2011

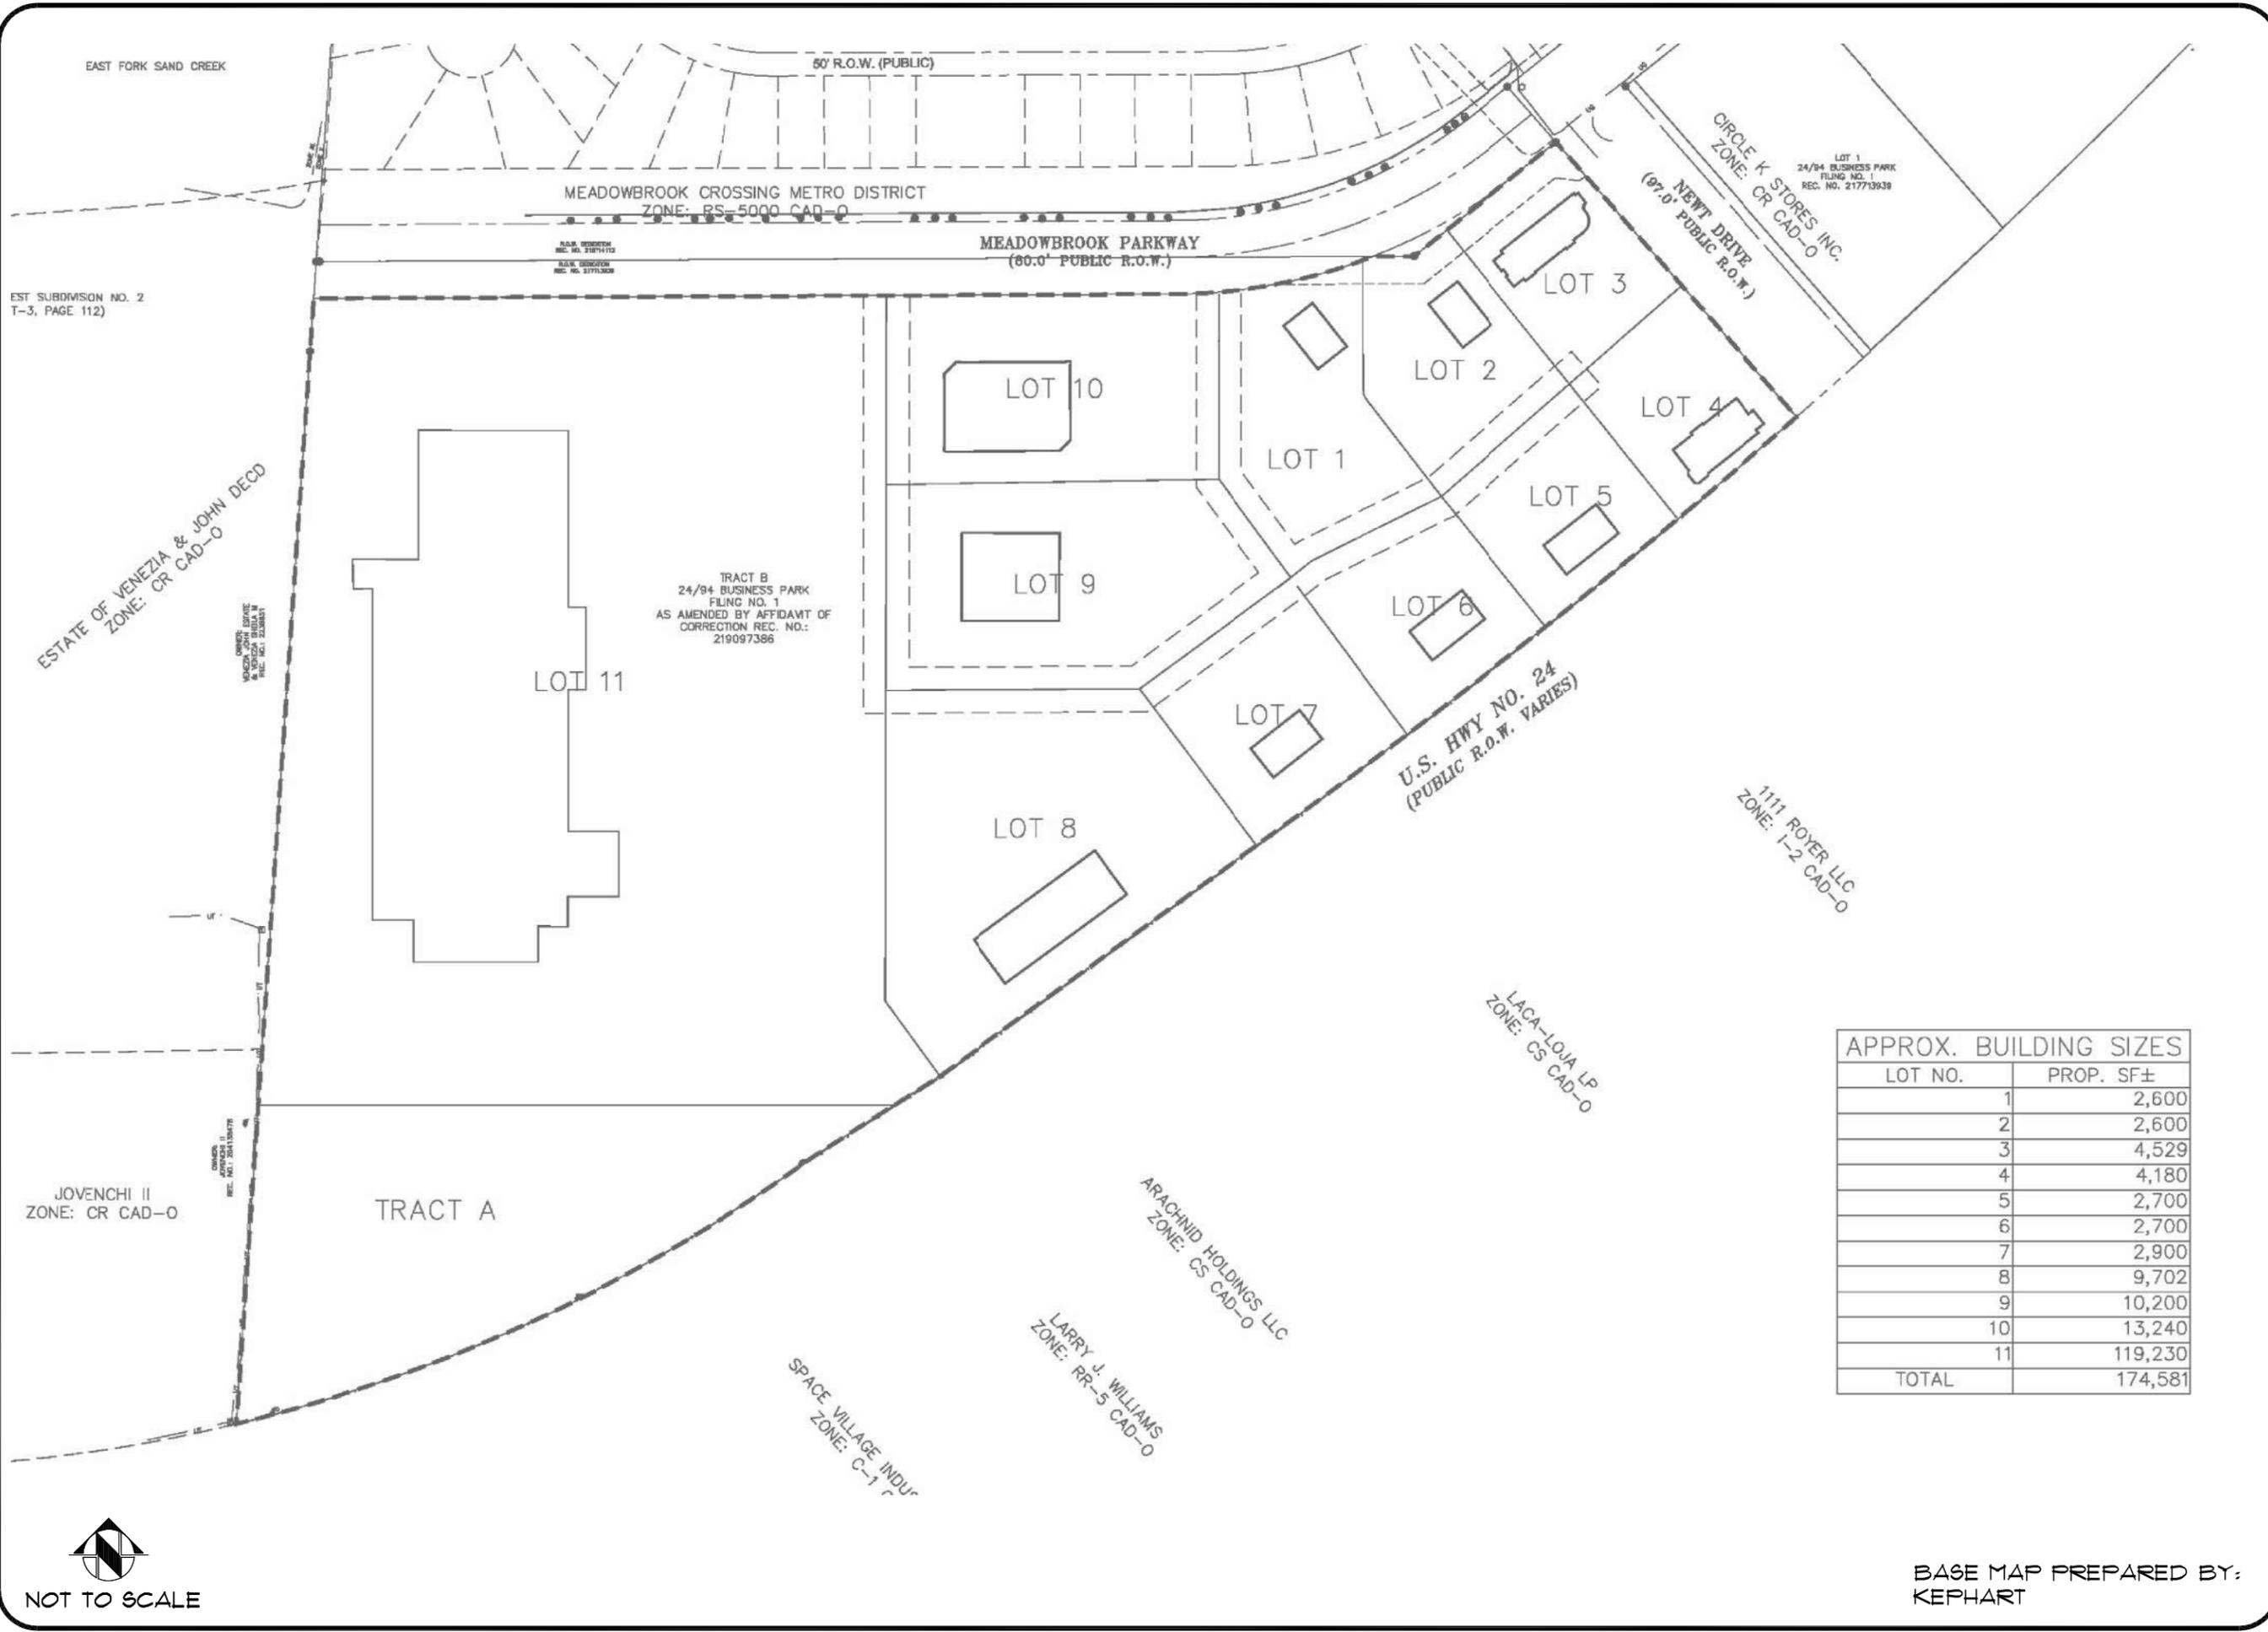
SHEET No.  
**FIG-2**

PROPOSED  
CONCEPT PLAN

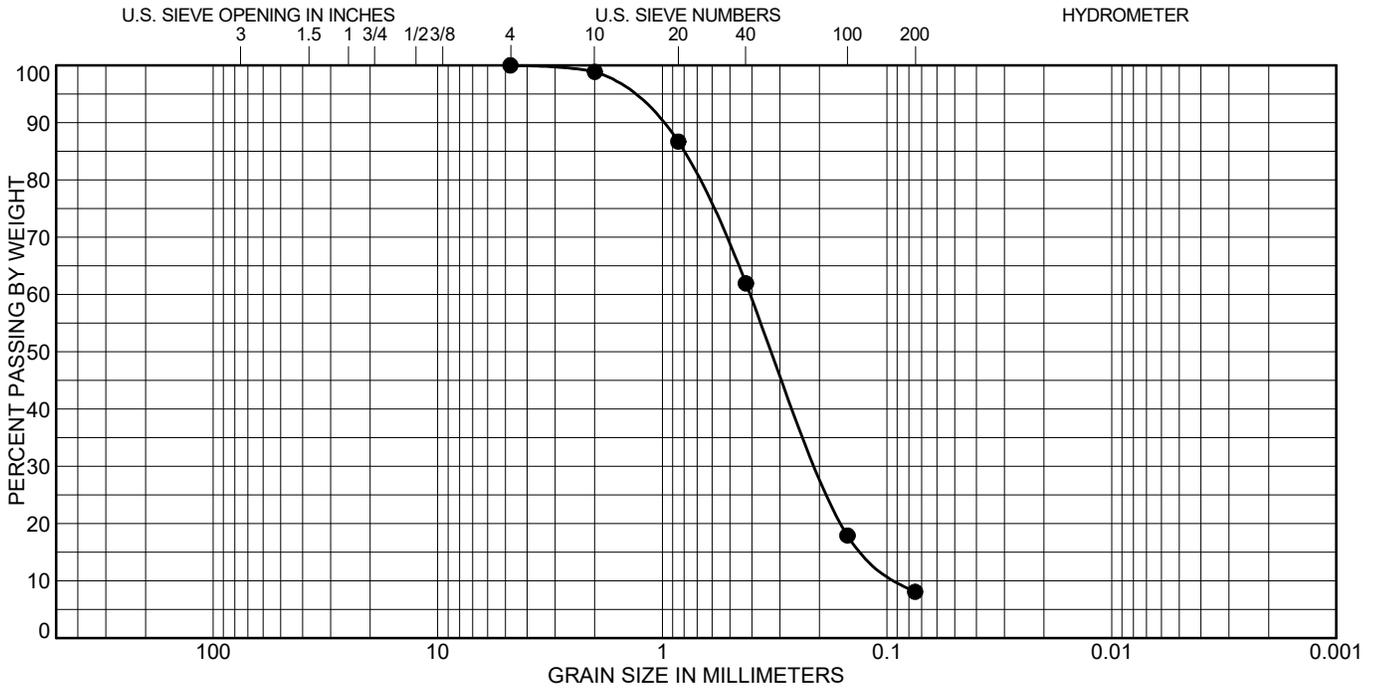
JOB No. 177025  
 FIGURE No. 12  
 DATE Aug/18/2020

COBBLES	GRAVEL		SAND			SILT OR CLAY
	coarse	fine	coarse	medium	fine

Test Boring	Depth (ft)	Classification	LL	PL	PI
● 6	4.0	POORLY GRADED SAND with SILT(SP-SM)	NP	NP	NP

Soil laboratory testing was performed as part of this investigation. Laboratory testing included moisture content, grain-size analysis, and Atterberg Limits. A Summary of Laboratory Test Results is presented in Figure 10 (two pages). Soil Classification Data is presented in Figures 11 through 13.

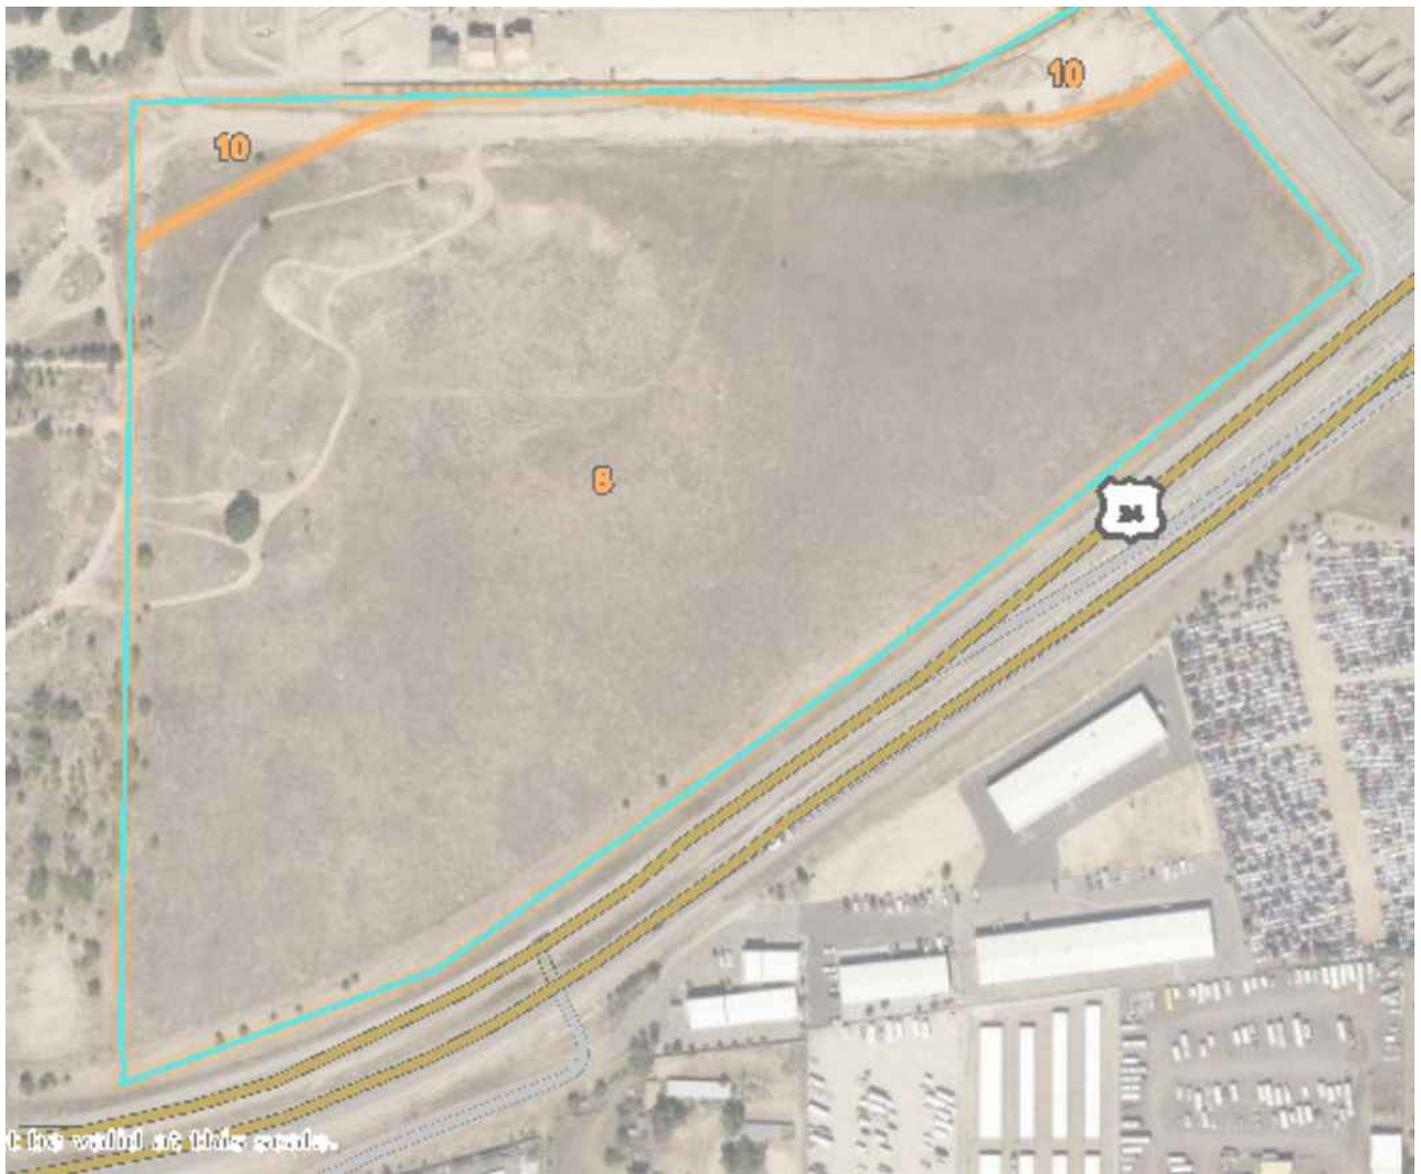
**FIG No. 14**

Map Unit Symbol	Map Unit Name	Acres In AOI	Percent of AOI
8	Blakeland loamy sand, 1 to 9 percent slopes	32.0	94.0%
10	Blendon sandy loam, 0 to 3 percent slopes	2.0	6.0%
<b>Totals for Area of Interest</b>		<b>34.1</b>	<b>100.0%</b>

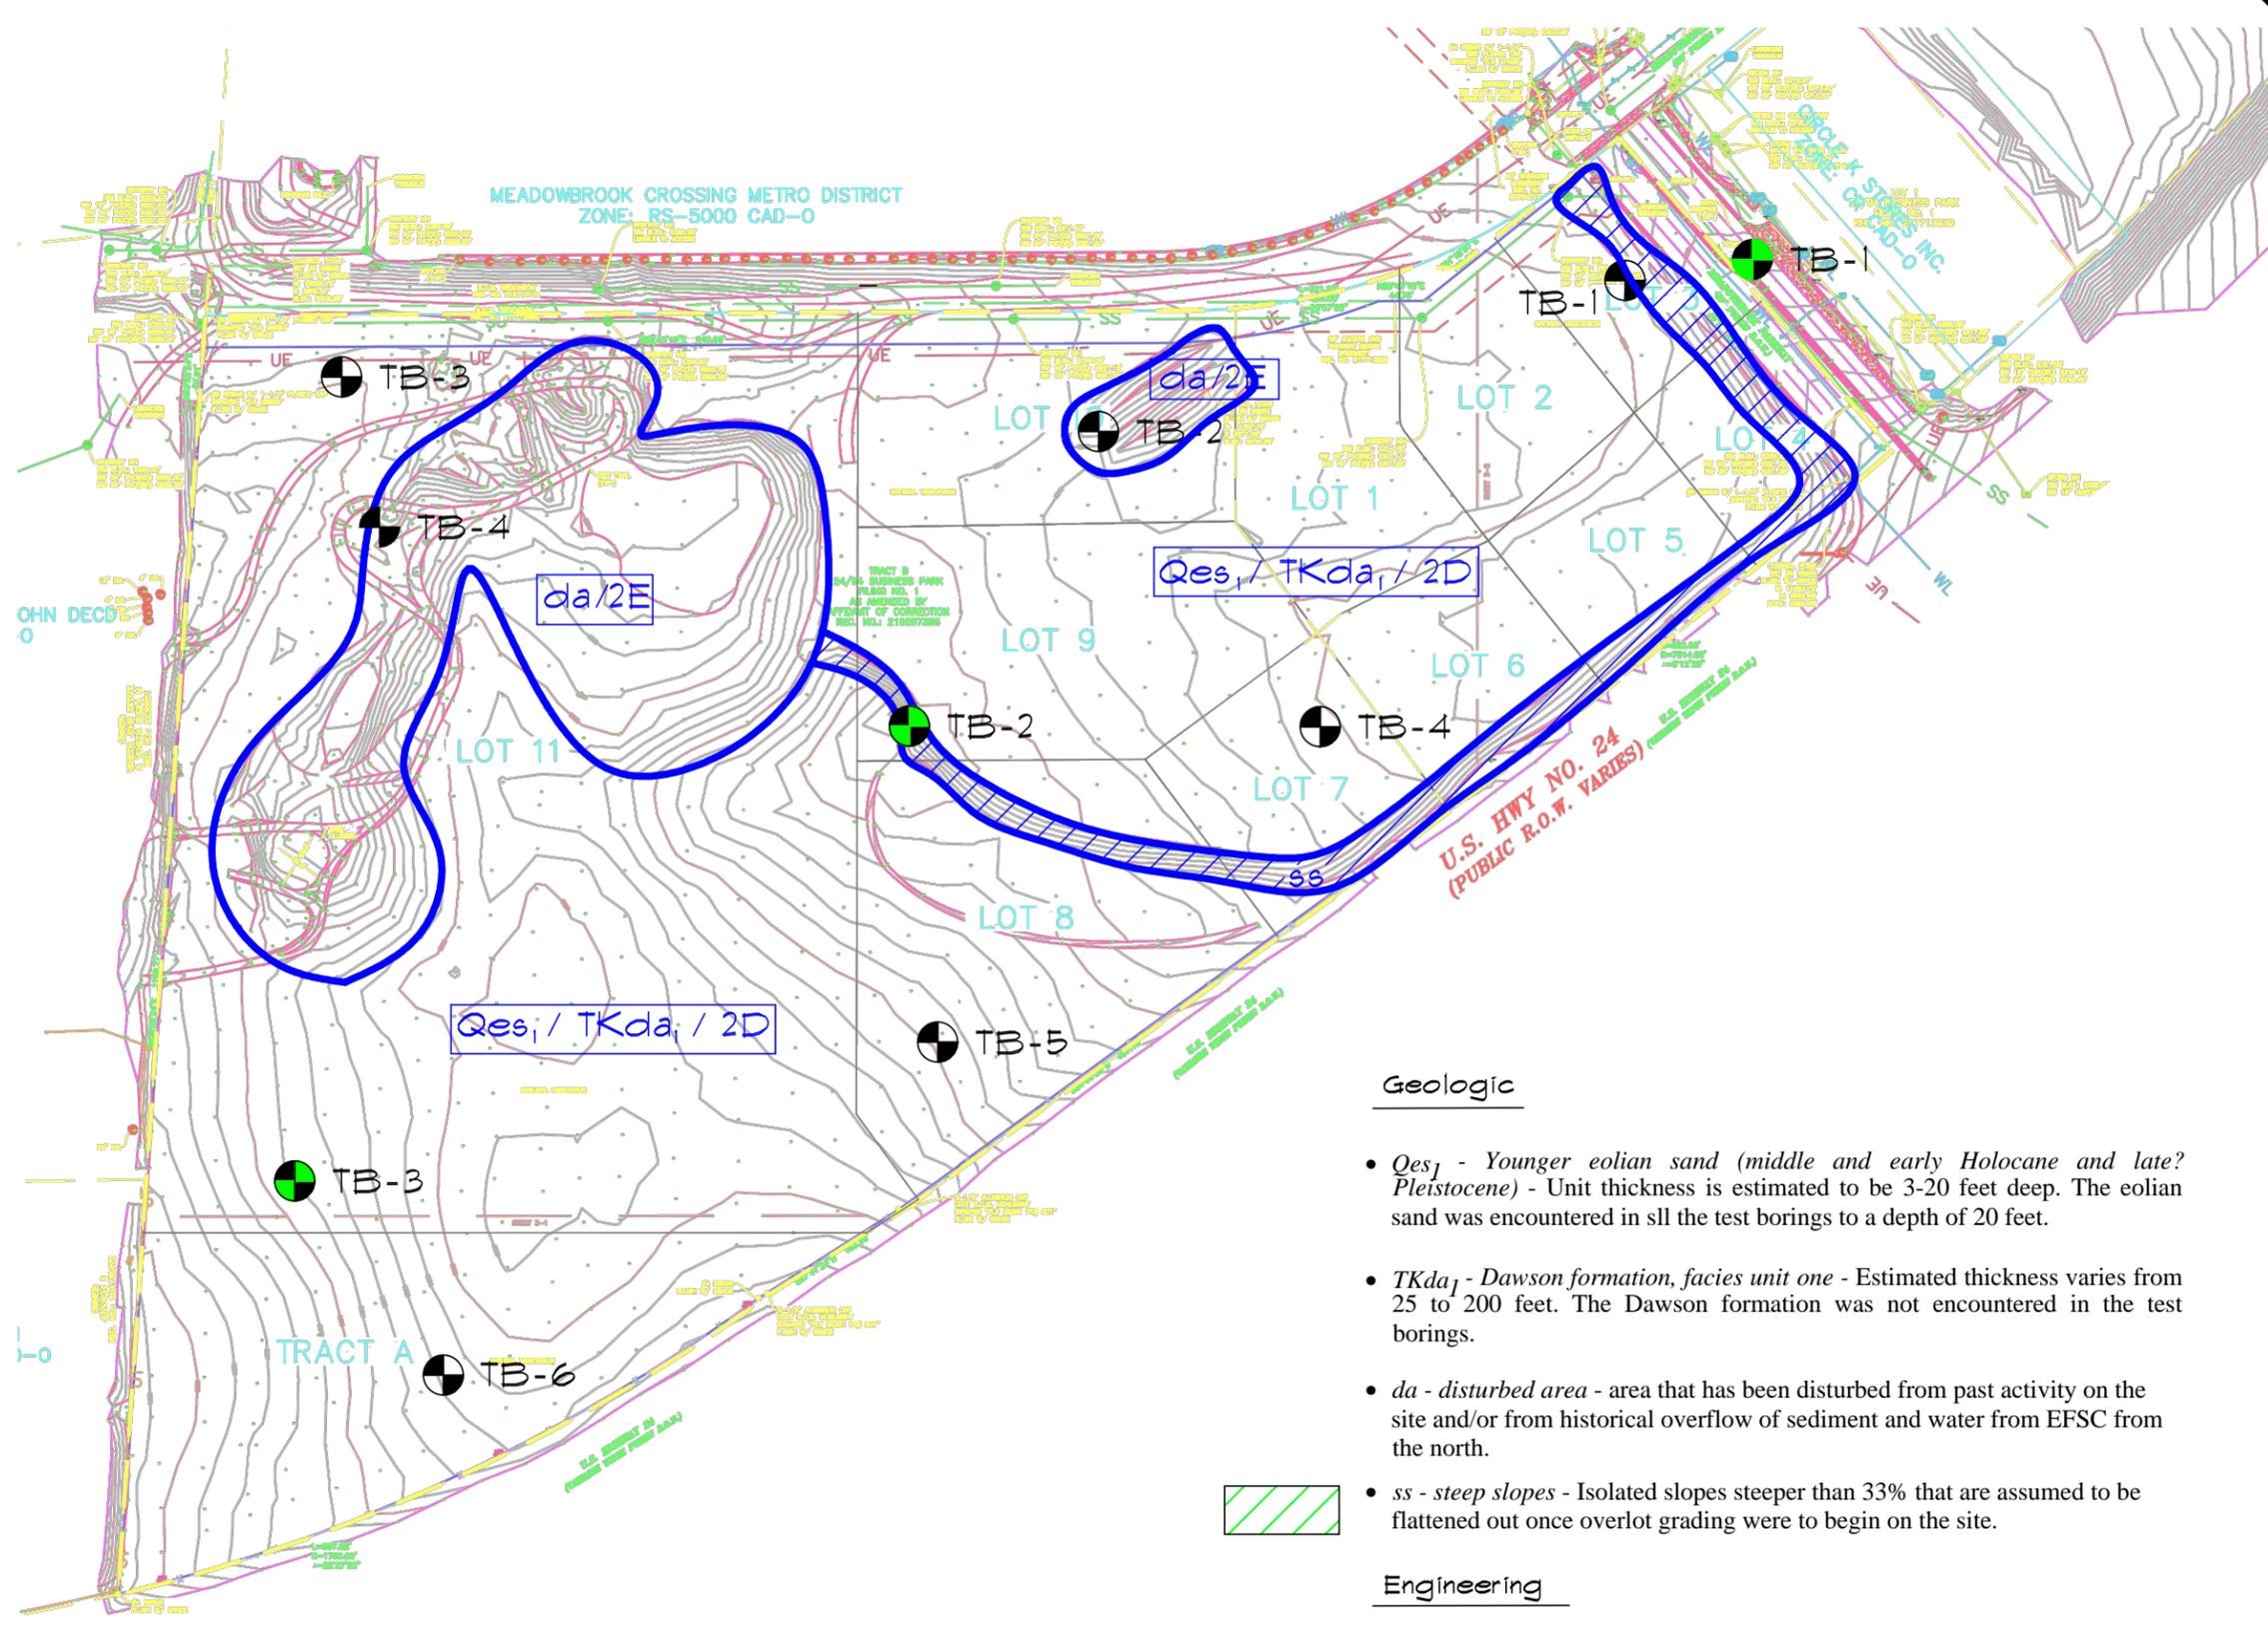
Geologic

- *Qes<sub>1</sub>* - Younger eolian sand (middle and early Holocene and late? Pleistocene) - Unit thickness is estimated to be 3-20 feet deep. The eolian sand was encountered in all the test borings to a depth of 20 feet.
- *TKda<sub>1</sub>* - Dawson formation, facies unit one - Estimated thickness varies from 25 to 200 feet. The Dawson formation was not encountered in the test borings.
- *da* - disturbed area - area that has been disturbed from past activity on the site and/or from historical overflow of sediment and water from EFSC from the north.
- *ss* - steep slopes - Isolated slopes steeper than 33% that are assumed to be flattened out once overlot grading were to begin on the site.

Based on our field observations, the USDA soil mapping, and the Geologic Map of the Elsmere Quadrangle, an interpreted geologic map of significant surficial deposits and features was mapped for the site. The identified geologic conditions affecting the development are presented in the Engineering and Geology Map, Figure 15.
