# ELLICOTT TOWN CENTER

## Operation and Maintenance Manual for

### Extended Detention Basins (EDBs)

June, 2009

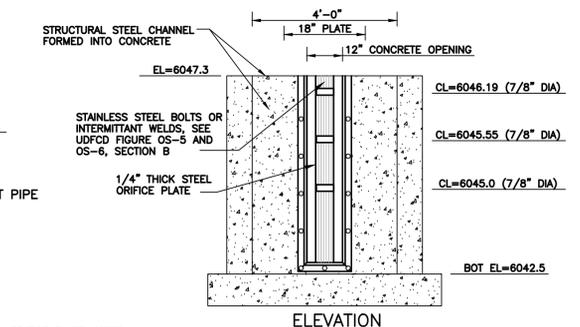
ELEVATION

- ORIFICE PLATE NOTES:
1. MINIMIZE THE NUMBER OF COLUMNS.
  2. PROVIDE GASKET MATERIAL BETWEEN THE ORIFICE PLATE AND CONCRETE.
  3. BOLT PLATE TO CONCRETE 12" MAX. ON CENTER.

- EURY AND WQCV TRASH RACKS:
1. WELL-SCREEN TRASH RACKS (FOR CIRCULAR ORIFICES) SHALL BE STAINLESS STEEL AND SHALL BE ATTACHED BY INTERMITTENT WELDS ALONG THE EDGE OF THE MOUNTING FRAME.

2. STRUCTURAL DESIGN OF TRASH RACKS SHALL BE BASED ON FULL HYDROSTATIC HEAD WITH ZERO HEAD DOWNSTREAM OF THE RACK.
- OVERFLOW TRASH RACKS:
1. ALL TRASH RACKS SHALL BE MOUNTED USING STAINLESS STEEL HARDWARE AND PROVIDED WITH HINGED AND LOCKABLE OR BOLTABLE ACCESS PANELS.

2. TRASH RACKS SHALL BE STAINLESS STEEL, ALUMINUM, OR STEEL. STEEL TRASH RACKS SHALL BE HOT DIP GALVANIZED AND MAY BE HOT POWDER COATED AFTER GALVANIZING.

3. TRASH RACKS SHALL BE DESIGNED SUCH THAT THE DIAGONAL DIMENSION OF EACH OPENING IS SMALLER THAN THE DIAMETER OF THE OUTLET PIPE.
  4. STRUCTURAL DESIGN OF TRASH RACKS SHALL BE BASED ON FULL HYDROSTATIC HEAD WITH ZERO HEAD DOWNSTREAM OF THE RACK.
