Stormwater Management Facility Operation and Maintenance (O&M) Plan Template

Urban Collection at Palmer Village

Stormwater Management Facility Inspection and Maintenance (I&M) Plan

URBAN COLLECTION AT
PALMER VILLAGE
PERMANENT BMP PLANS
POND B
CONSTRUCTION DOCUMENTS

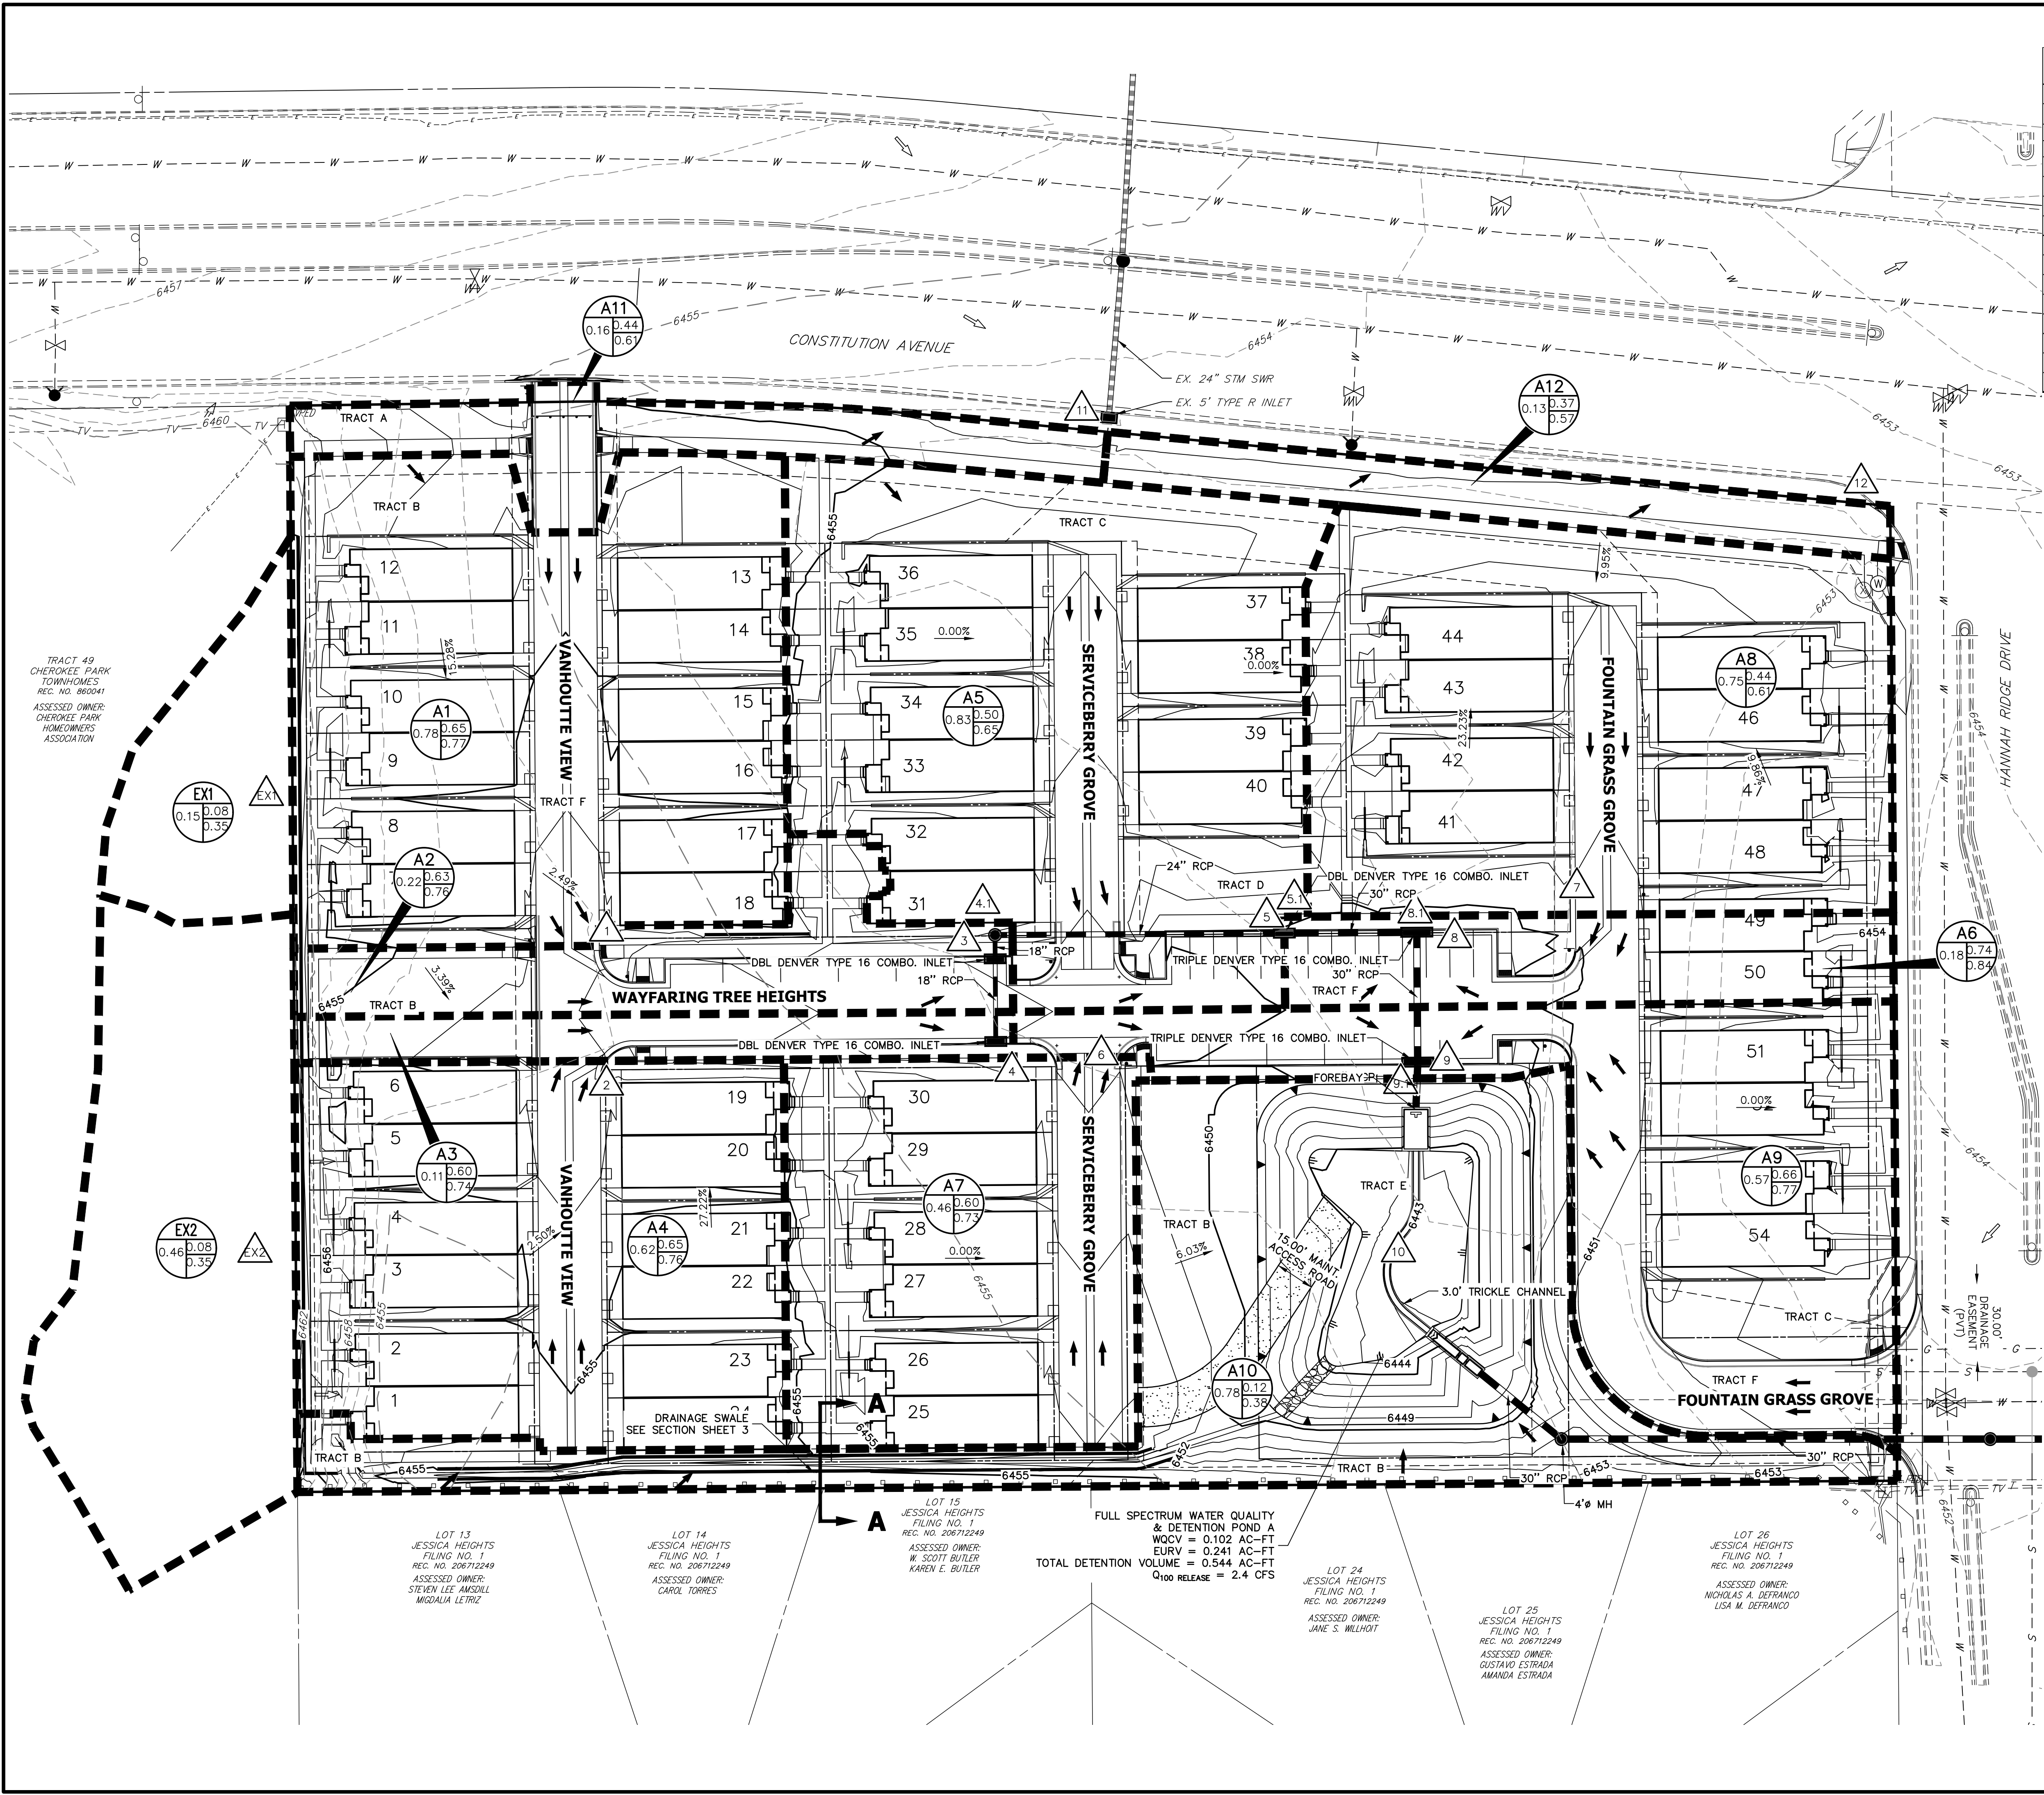
URBAN COLLECTION AT
PALMER VILLAGE
WEST DRAINAGE MAP

BASIN 'A' SUMMARY TABLE								
Tributary	Area	Percent						
Sub-basin	(acres)	Impervious	C _s	C ₁₀₀	t _c (min)	Q _s (cfs)	Q ₁₀₀ (cfs)	
EX1	0.15	0%	0.08	0.35	7.9	0.0	0.2	
EX2	0.46	0%	0.08	0.35	8.1	0.2	0.7	
A1	0.78	75%	0.65	0.77	5.5	2.6	5.1	
A2	0.22	67%	0.63	0.76	7.8	0.6	1.3	
A3	0.11	63%	0.60	0.74	6.2	0.3	0.7	
A4	0.62	75%	0.65	0.76	5.2	2.0	4.0	
A5	0.83	55%	0.50	0.65	7.0	2.0	4.2	
A6	0.18	84%	0.74	0.84	7.9	0.6	1.1	
A7	0.46	67%	0.60	0.73	5.8	1.3	2.7	
A8	0.75	48%	0.44	0.61	7.8	1.5	3.5	
A9	0.57	72%	0.66	0.77	6.9	1.8	3.5	
A10	0.78	5%	0.12	0.38	9.4	0.4	2.1	
A11	0.16	40%	0.41	0.60	9.8	0.3	0.6	
A12	0.13	39%	0.40	0.59	7.8	0.2	0.6

DESIGN POINT SUMMARY TABLE		
Design Point	Q _s (cfs)	Q ₁₀₀ (cfs)
EX1	0.04	0.2
EX2	0.2	0.7
1	2.3	4.9
2	2.0	4.7
3	3.0	6.2
4	2.4	5.7
4.1	4.8	9.4
5	2.0	4.2
5.1	6.7	13.5
6	1.8	4.8
7	1.5	3.5
8	2.4	5.9
8.1	8.8	15.0
9	3.4	9.2
9.1	11.9	23.9
10	12.1	25.7
11	0.3	0.6
12	0.2	0.6

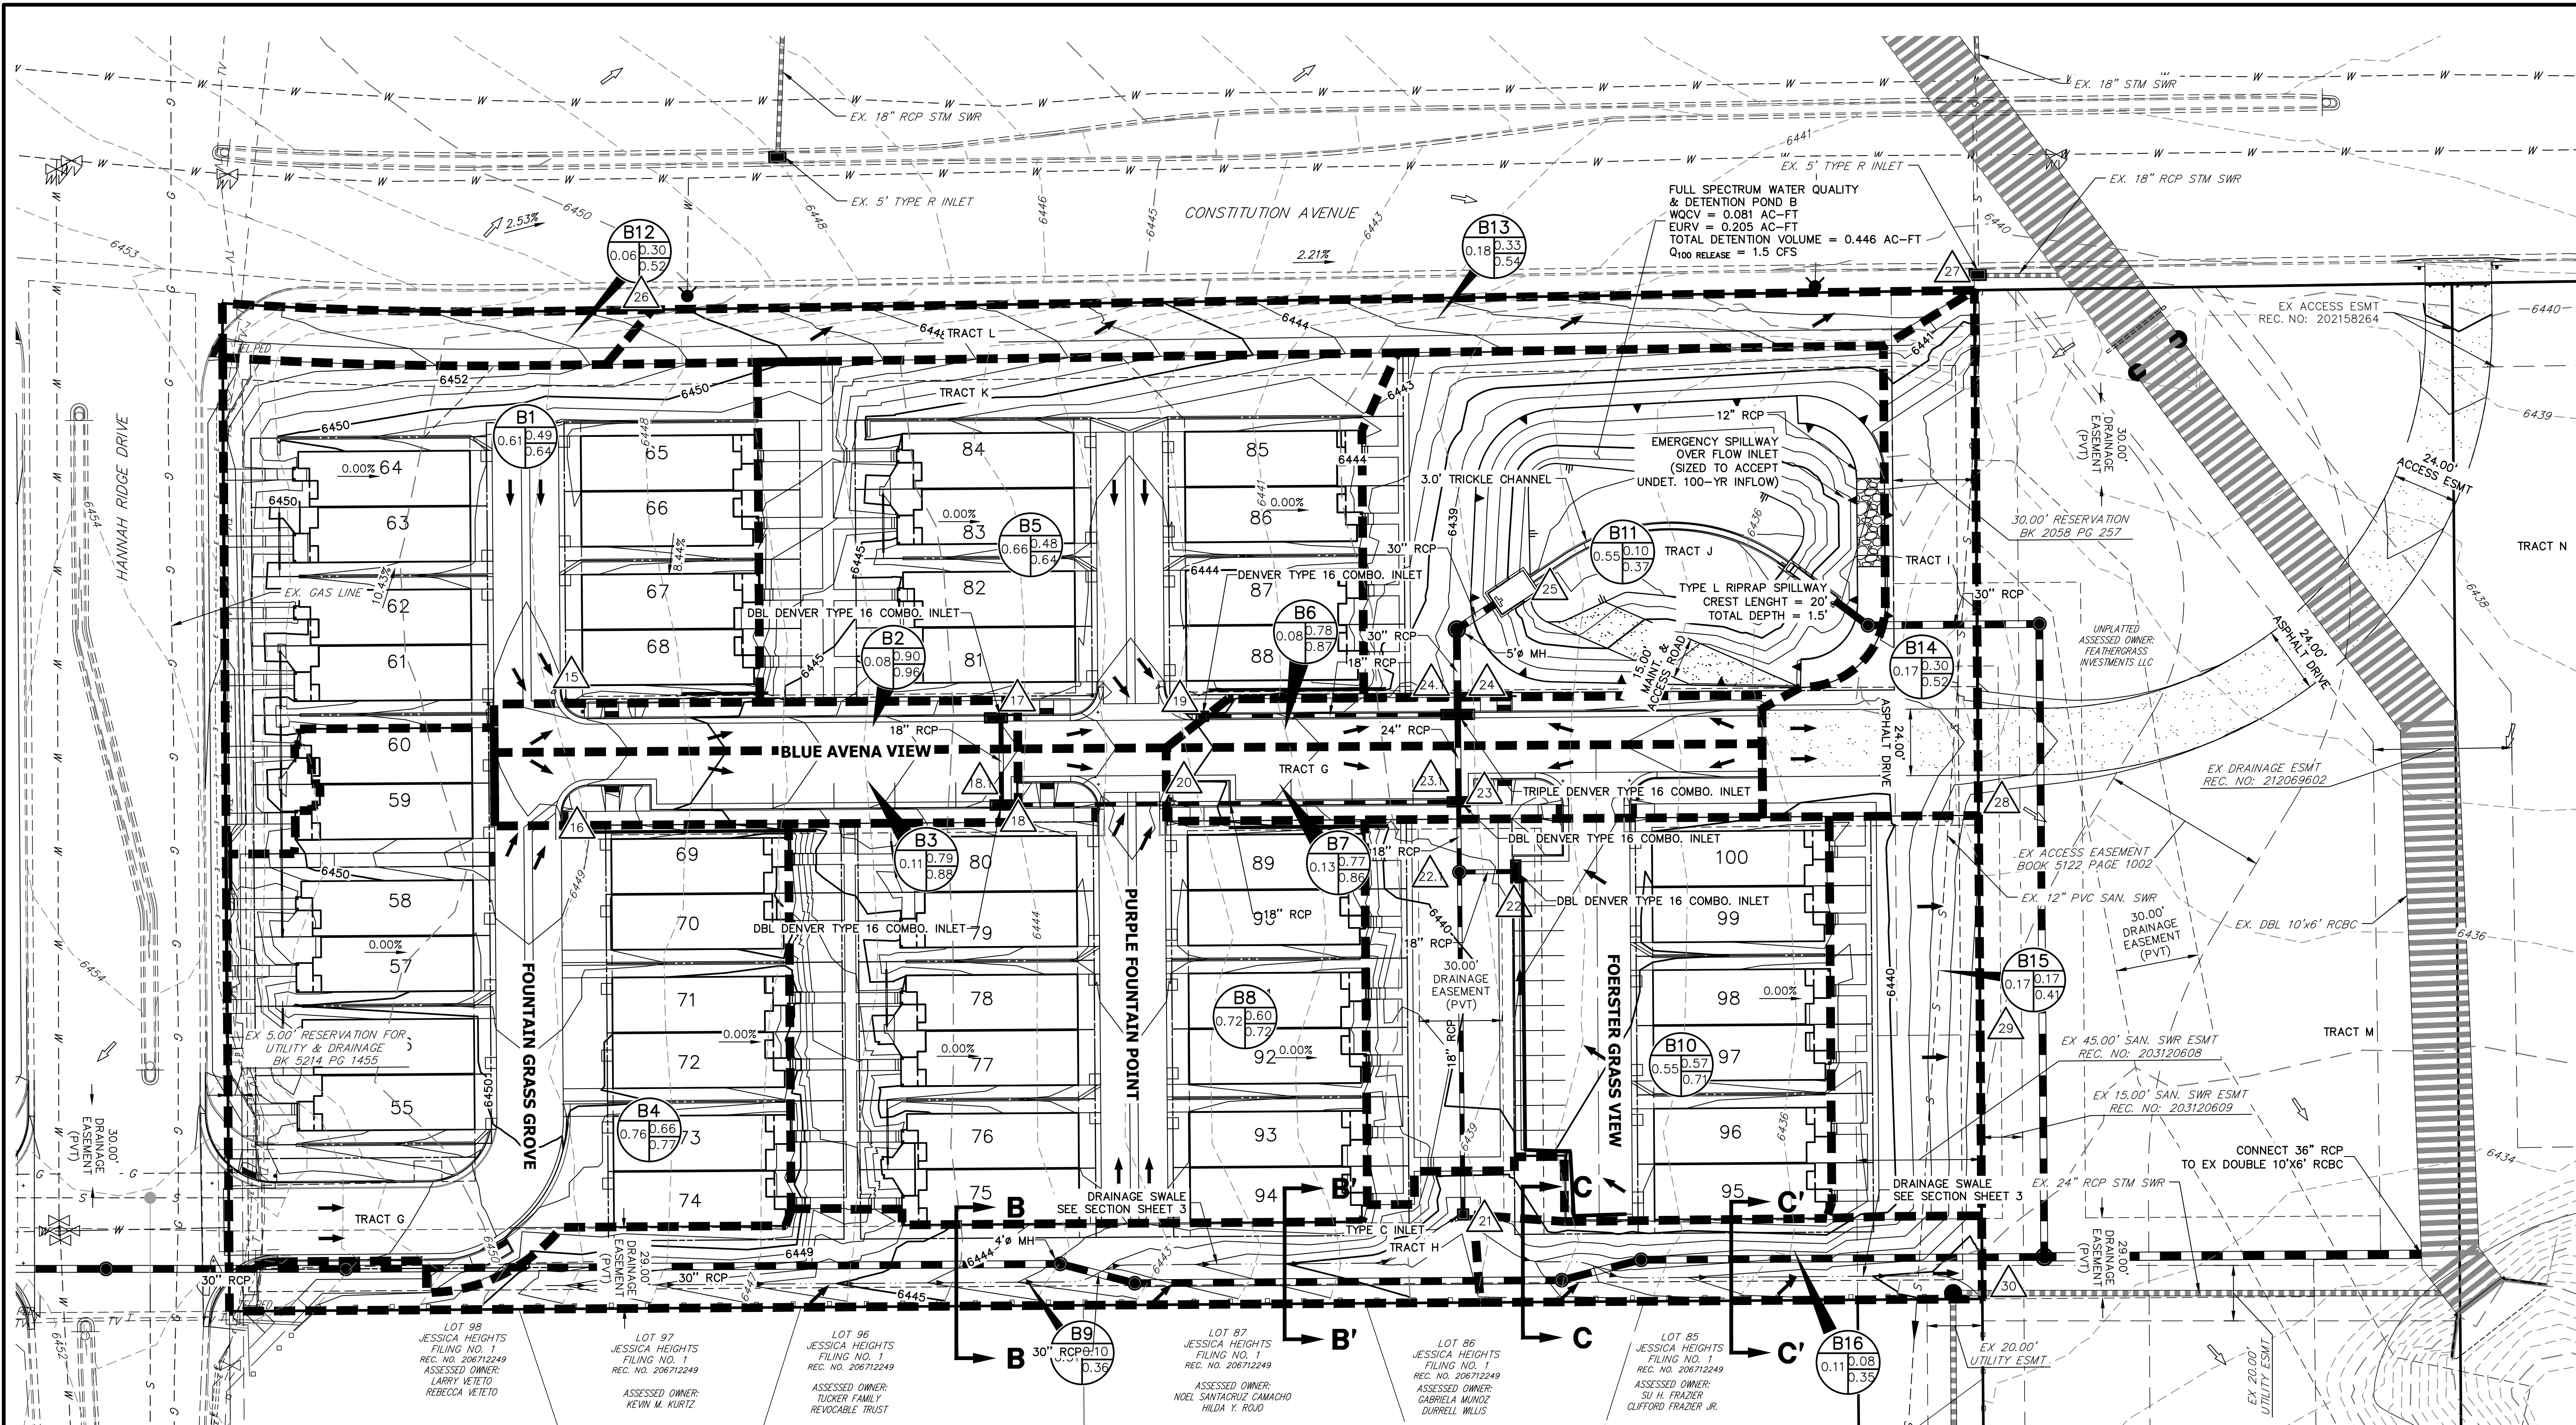
BASIN 'B' SUMMARY TABLE							
Tributary Sub-basin	Area (acres)	Percent Impervious	C _s	C ₁₀₀	t _c (min)	Q _s (cfs)	Q ₁₀₀ (cfs)
B1	0.61	55%	0.50	0.65	6.3	1.4	3.2
B2	0.08	100%	0.90	0.96	5.0	0.4	0.6
B3	0.12	87%	0.79	0.88	5.0	0.5	0.9
B4	0.76	75%	0.66	0.77	5.9	2.5	4.9
B5	0.66	53%	0.49	0.64	6.2	1.6	3.5
B6	0.08	84%	0.77	0.87	5.0	0.3	0.6
B7	0.13	88%	0.80	0.89	5.0	0.5	1.0
B8	0.72	68%	0.60	0.72	5.5	2.2	4.4
B9	0.31	2%	0.10	0.36	5.6	0.1	0.9
B10	0.55	65%	0.59	0.72	6.4	1.6	3.2
B11	0.55	3%	0.10	0.37	5.6	0.3	1.7
B12	0.06	36%	0.37	0.57	5.0	0.1	0.3
B13	0.18	39%	0.40	0.59	7.0	0.3	0.9
B14	0.17	21%	0.25	0.48	5.6	0.2	0.7
B15	0.17	11%	0.17	0.42	5.0	0.2	0.6
B16	0.11	0%	0.08	0.35	5.0	0.1	0.3

DESIGN POINT SUMMARY TABLE				
Design Point	Q _s (cfs)	Q ₁₀₀ (cfs)		
15	1.4	3.2		
16	2.5	4.9		
17	1.7	3.6		
18	2.8	5.4		
18.1	4.2	7.8		
19	1.9	4.8		
20	2.2	4.4		
21	0.1	0.9		
22	1.6	3.2		
22.1	1.7	3.5		
23	2.6	5.6		
23.1	8.2	16.5		
24	1.0	3.2		
24.1	10.2	21.5		
25	10.4	22.9		
26	0.3	1.7		
27	0.1	0.3		
28	0.3	0.9		
29	0.2	0.7		
30	0.1	0.3

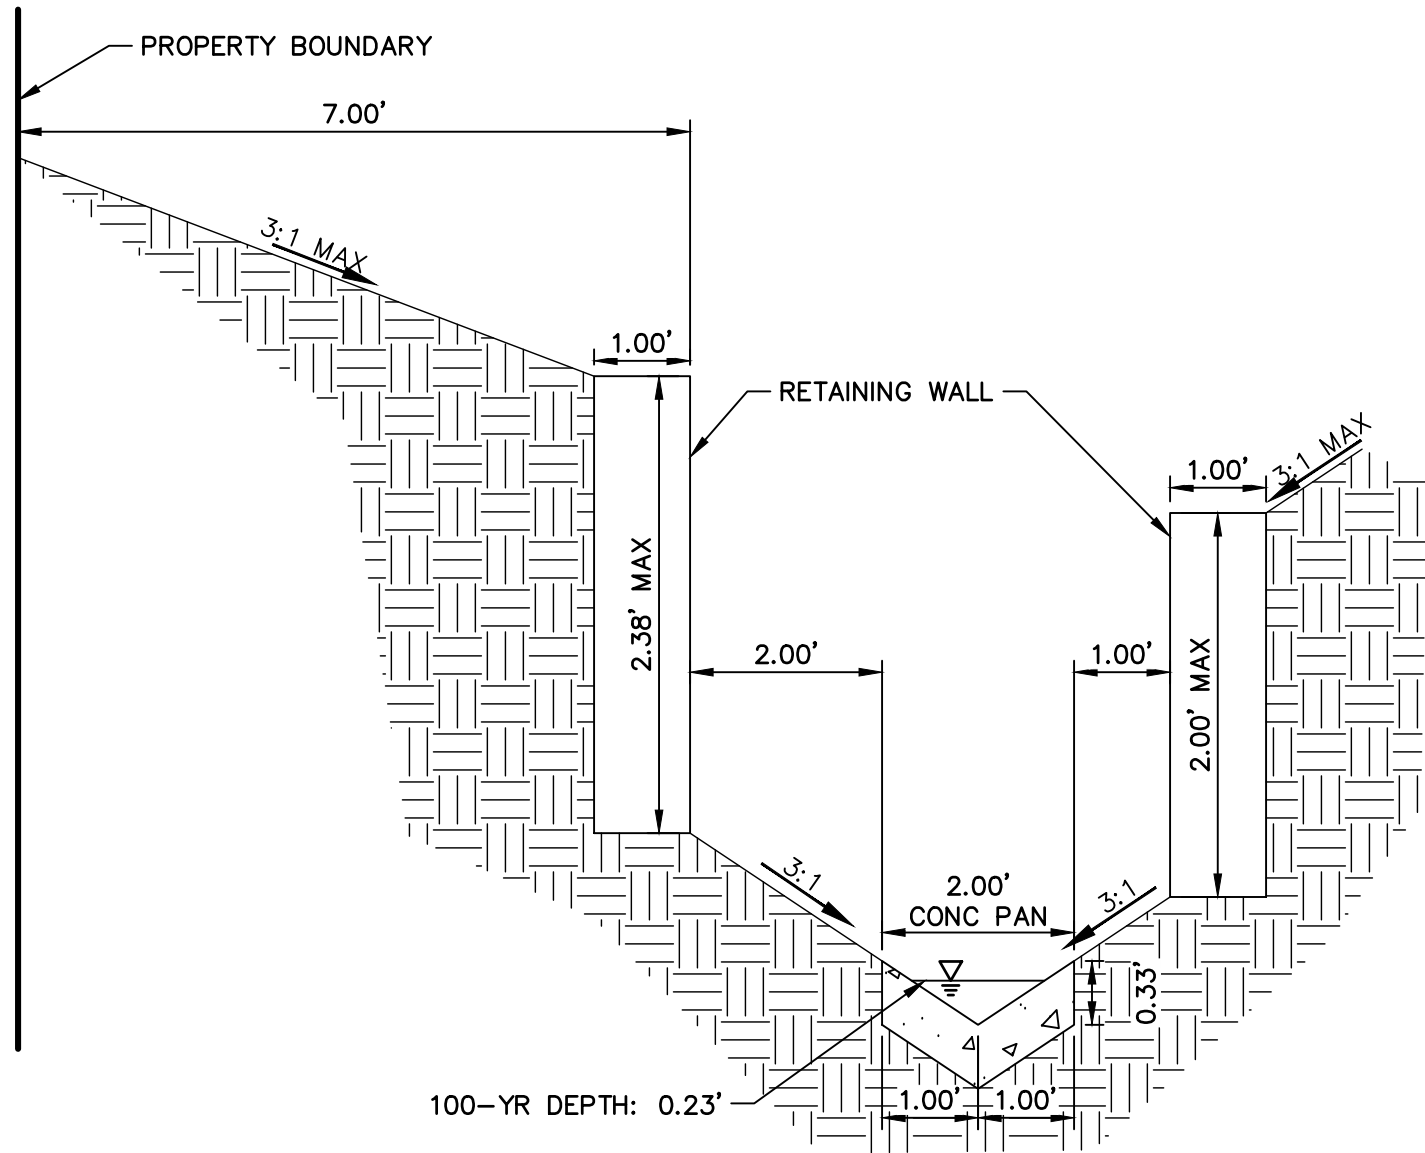
A SWALE A-A SECTION
SCALE: 1"=2' (HOR), 1"=1' (VERT)

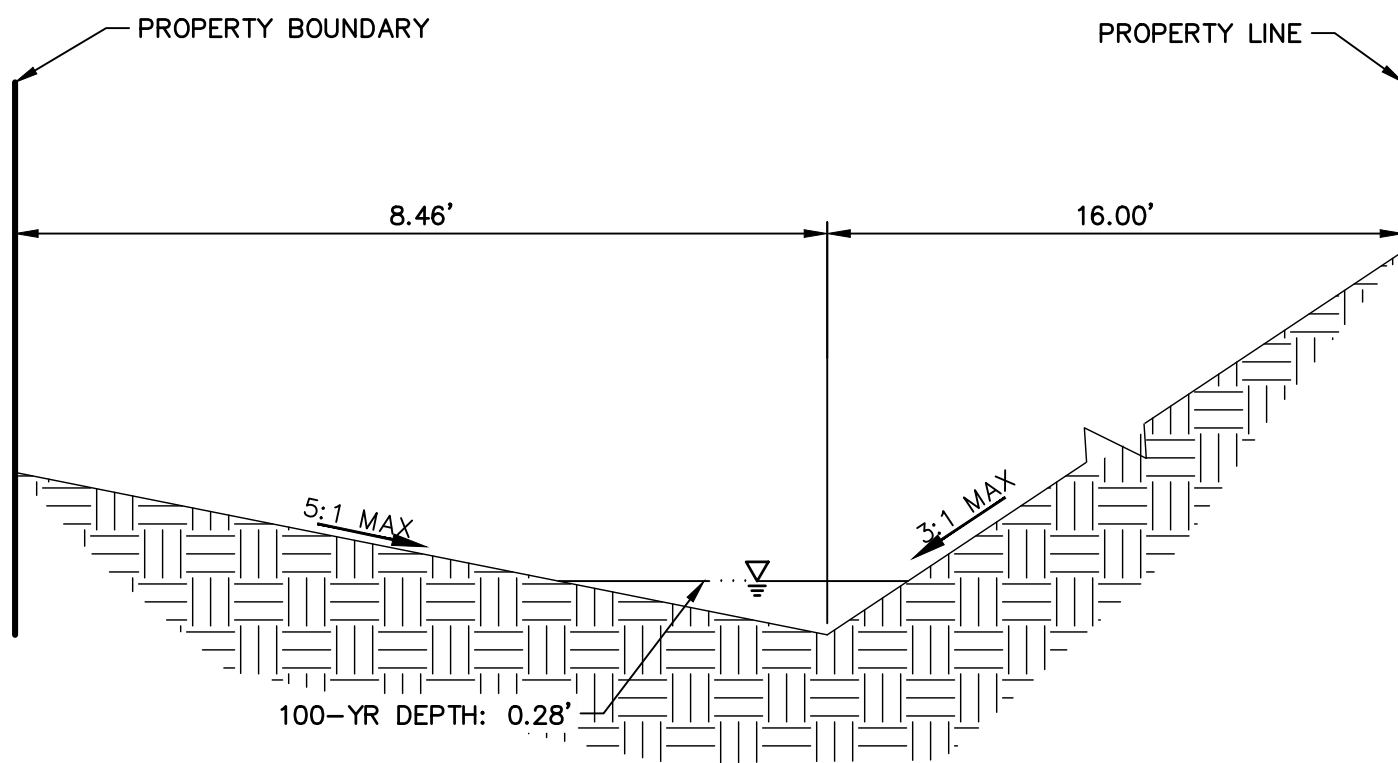
B SWALE B-B SECTION
SCALE: 1"=2' (HOR), 1"=1' (VERT)

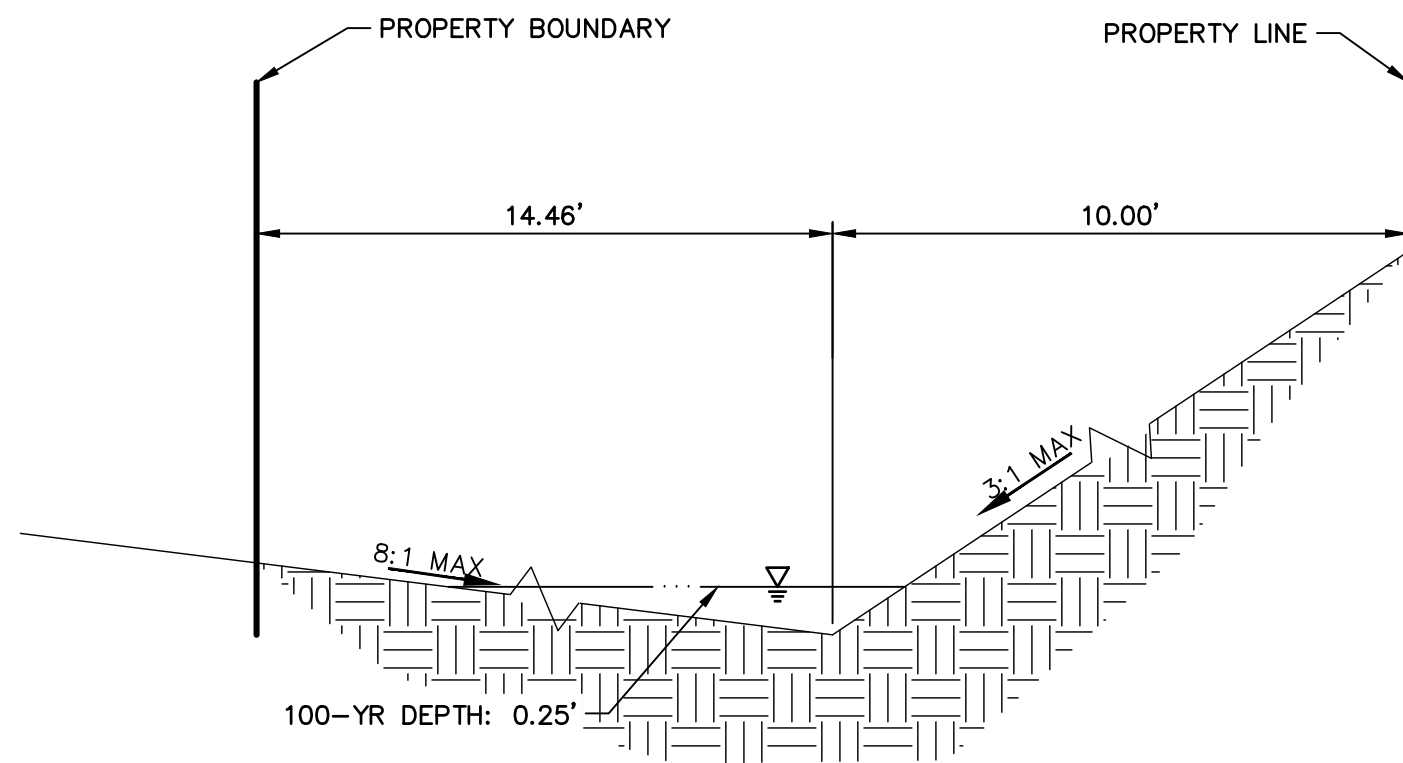
B' SWALE B'-B' SECTION
SCALE: 1"=2' (HOR), 1"=1' (VERT)

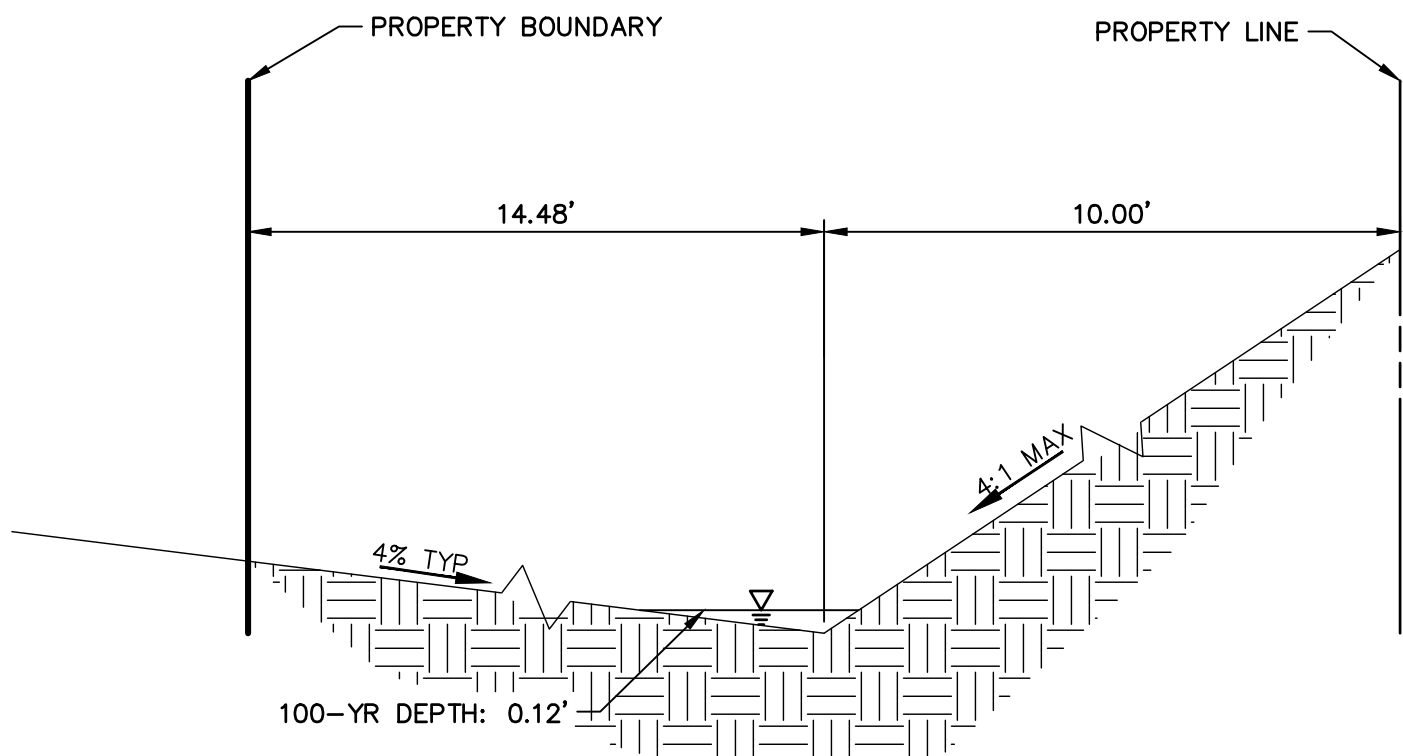
C SWALE C-C SECTION
SCALE: 1"=2' (HOR), 1"=1' (VERT)

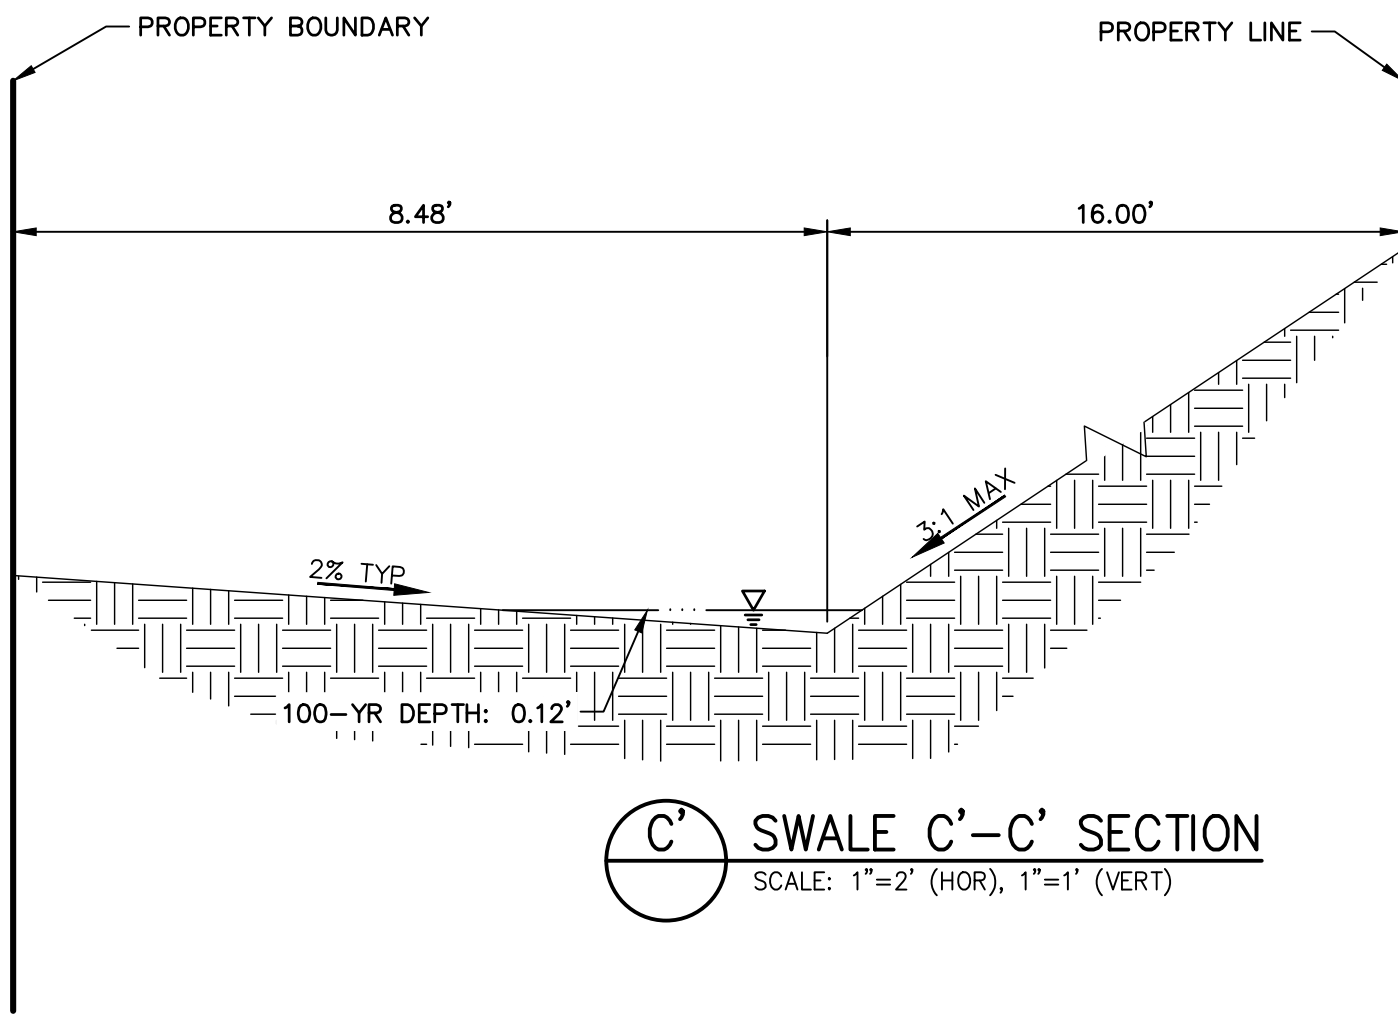
C' SWALE C'-C' SECTION
SCALE: 1"=2' (HOR), 1"=1' (VERT)

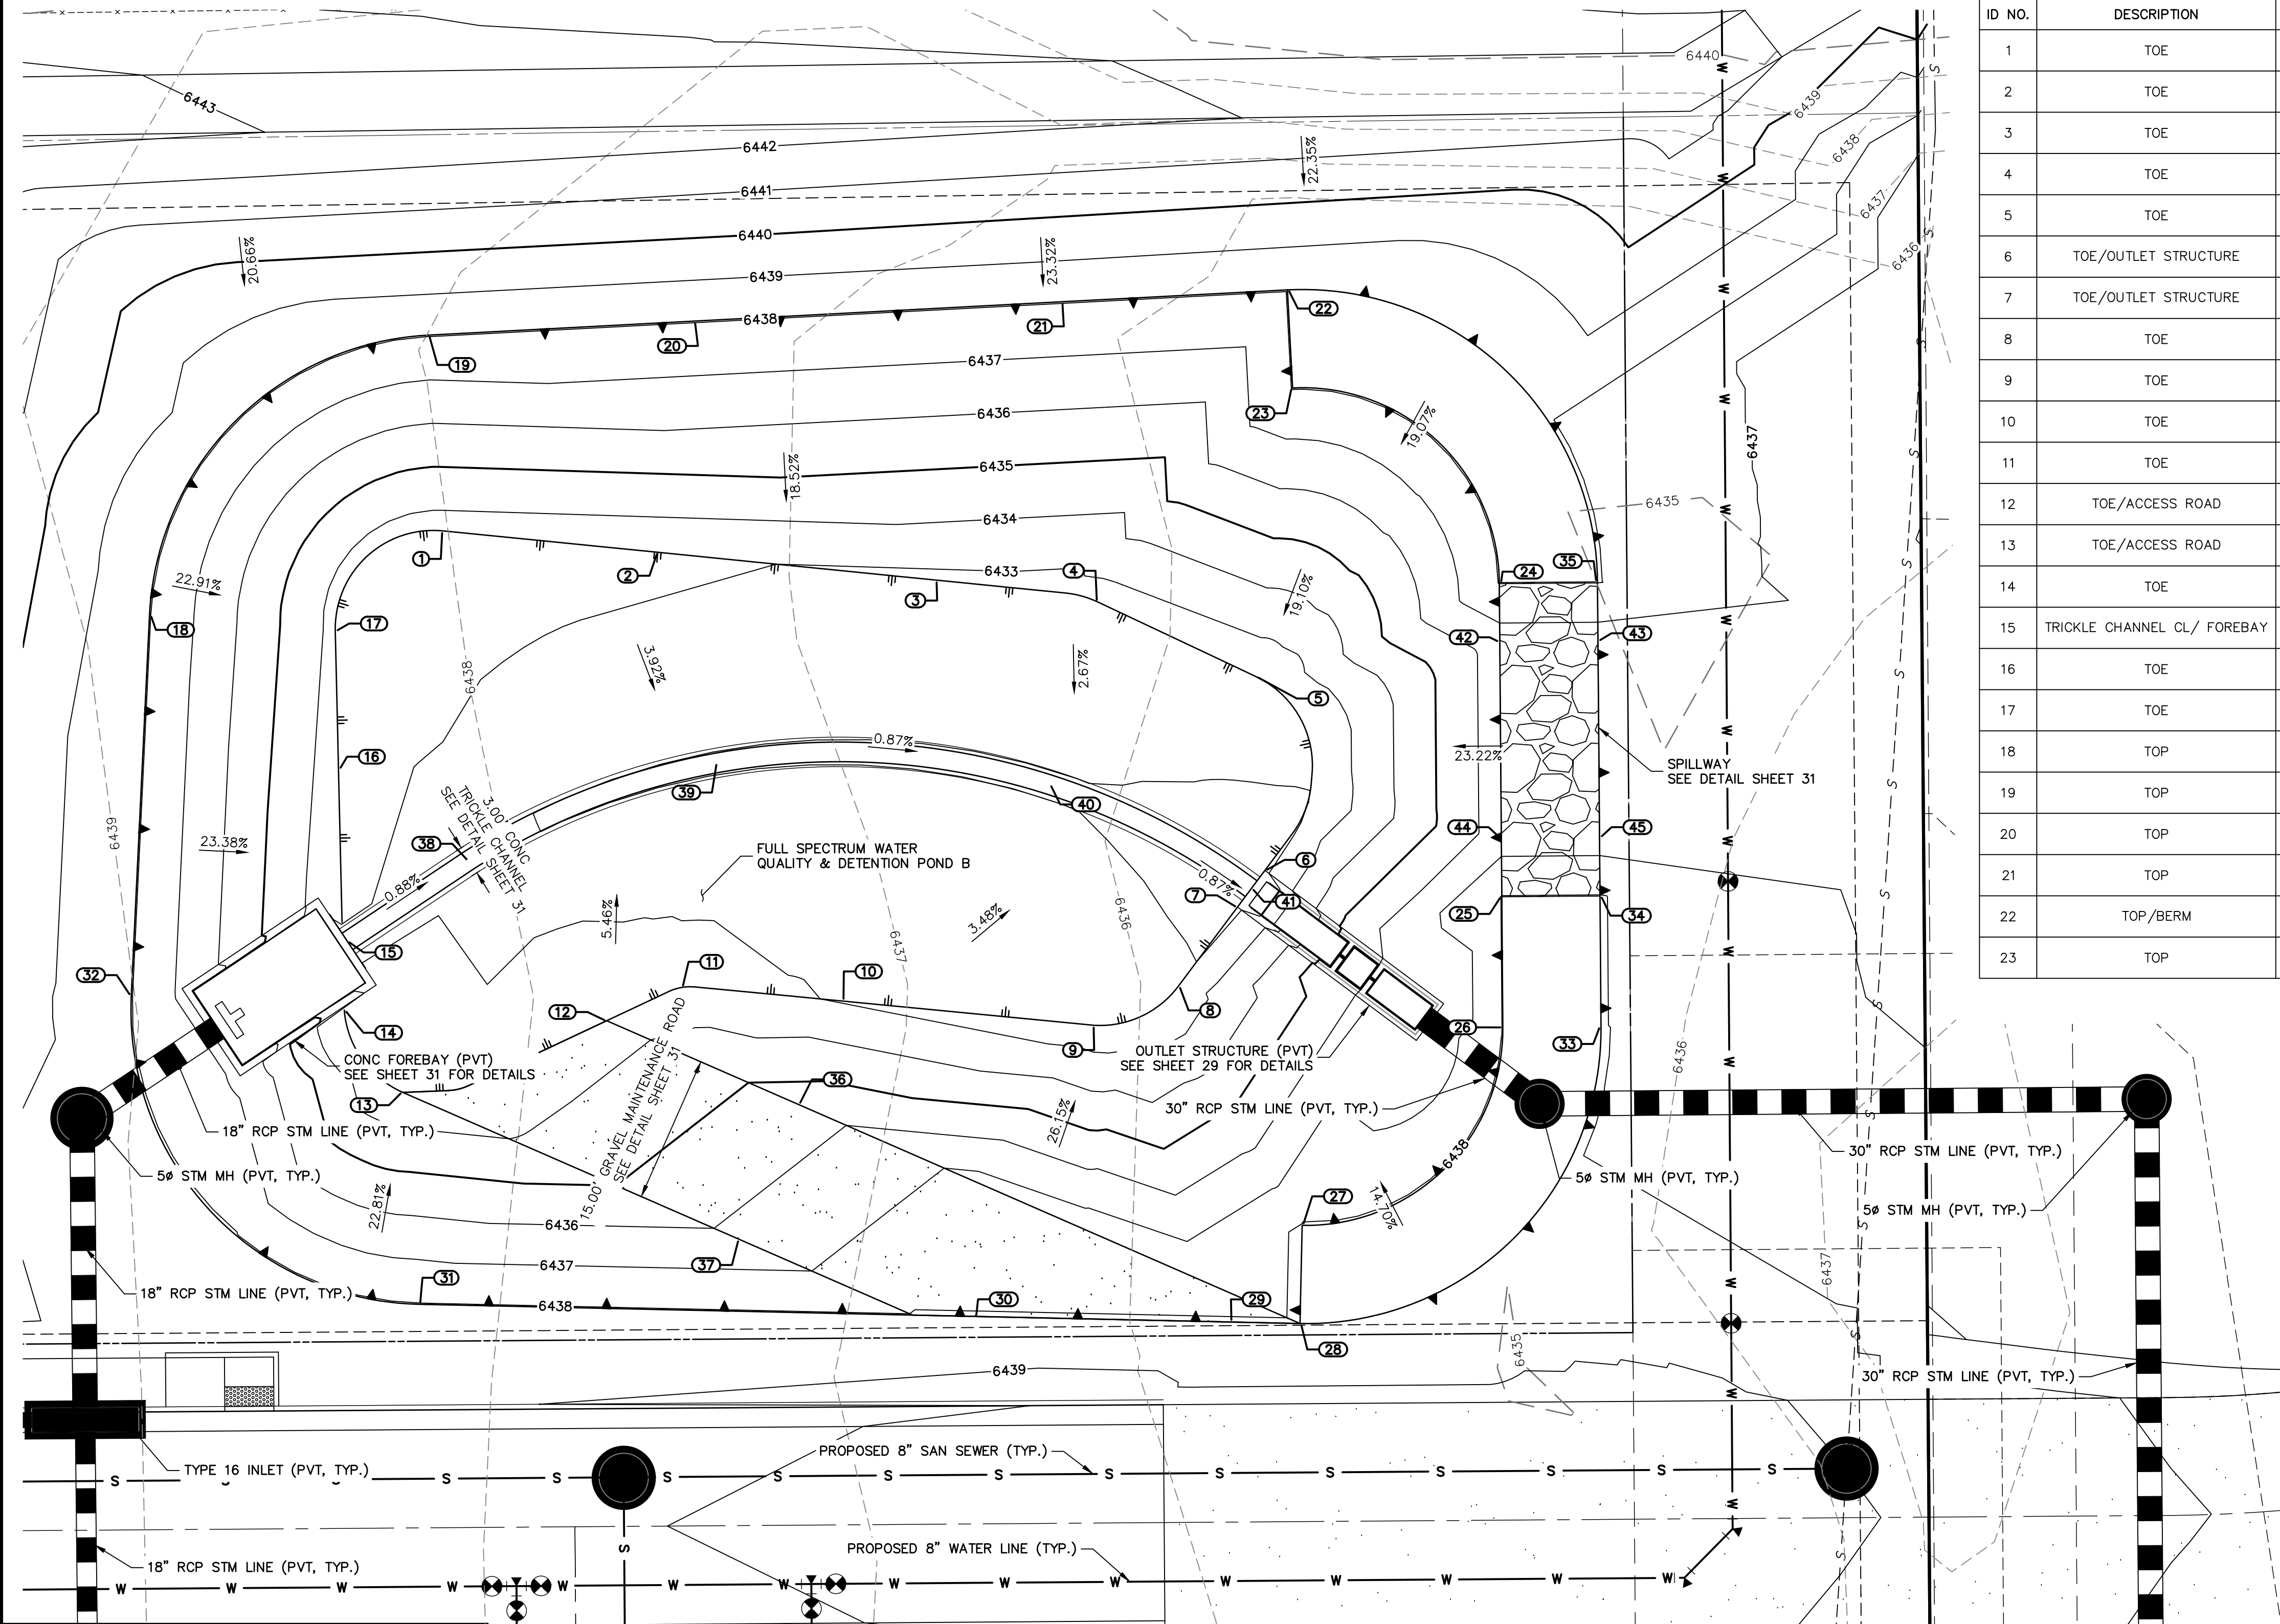
POINT TABULATION				POINT TABULATION			
ID NO.	DESCRIPTION	NORTHING/EASTING	ELEVATION	ID NO.	DESCRIPTION	NORTHING/EASTING	ELEVATION
1	TOE	N: 378235.76 E: 232380.69	6433.53	24	TOP/SPILLWAY	N: 378230.49 E: 232468.24	6438.03
2	TOE	N: 378233.57 E: 232402.61	6433.19	25	TOP/SPILLWAY	N: 378198.50 E: 232488.49	6438.03
3	TOE	N: 378230.73 E: 232431.07	6432.74	26	TOP	N: 378185.20 E: 232488.60	6438.03
4	TOE	N: 378228.52 E: 232447.35	6432.49	27	TOP	N: 378165.04 E: 232468.16	6438.03
5	TOE	N: 378220.91 E: 232463.47	6432.21	28	TOP/BERM	N: 378155.05 E: 232467.94	6438.03
6	TOE/OUTLET STRUCTURE	N: 378201.19 E: 232464.37	6431.83	29	TOP	N: 378155.20 E: 232460.83	6438.03
7	TOE/OUTLET STRUCTURE	N: 378197.45 E: 232461.58	6431.83	30	TOP/ACCESS ROAD	N: 378155.77 E: 232434.82	6438.03
8	TOE	N: 378189.41 E: 232455.57	6432.08	31	TOP	N: 378157.01 E: 232378.24	6438.03
9	TOE	N: 378185.41 E: 232447.04	6432.31	32	TOP	N: 378188.43 E: 232348.93	6438.03

10	TOE	N: 378187.88 E: 232421.35	6432.94	33	TOP/BERM	N: 378185.28 E: 232498.60	6438.03
11	TOE	N: 378189.27 E: 232404.97	6433.35	34	TOP/SPILLWAY	N: 378198.58 E: 232498.49	6438.03
12	TOE/ACCESS ROAD	N: 378185.88 E: 232397.34	6433.55	35	TOP/SPILLWAY	N: 378230.57 E: 232498.24	6438.03
13	TOE/ACCESS ROAD	N: 378178.58 E: 232376.58	6433.18	36	ACCESS ROAD	N: 378177.35 E: 232416.87	6435.51
14	TOE	N: 378186.93 E: 232370.62	6433.00	37	ACCESS ROAD	N: 378163.61 E: 232410.86	6436.26
15	TRICKLE CHANNEL CL/ FOREBAY	N: 378193.94 E: 232370.92	6433.70	38	TRICKLE CHANNEL CL	N: 378202.19 E: 232383.28	6432.07
16	TOE	N: 378211.51 E: 232370.03	6433.45	39	TRICKLE CHANNEL CL	N: 378212.14 E: 232408.64	6431.83
17	TOE	N: 378225.57 E: 232369.70	6433.72	40	TRICKLE CHANNEL CL	N: 378209.91 E: 232442.43	6431.53
18	TOP	N: 378227.16 E: 232350.78	6438.03	41	TRICKLE CHANNEL CL/OS	N: 378199.32 E: 232462.98	6431.33
19	TOP	N: 378255.69 E: 232379.17	6438.03	42	SPILLWAY CREST	N: 378224.49 E: 232488.29	6436.53

20	TOP	N: 378257.12 E: 232406.44	6438.03	43	SPILLWAY CREST	N: 378224.57 E: 232498.29	6436.53
21	TOP	N: 378259.09 E: 232443.86	6438.03	44	SPILLWAY CREST	N: 378204.50 E: 232488.45	6436.53
22	TOP/BERM	N: 378260.29 E: 232466.66	6438.03	45	SPILLWAY CREST	N: 378204.57 E: 232498.45	6436.53
23	TOP	N: 378250.31 E: 232467.19	6438.03

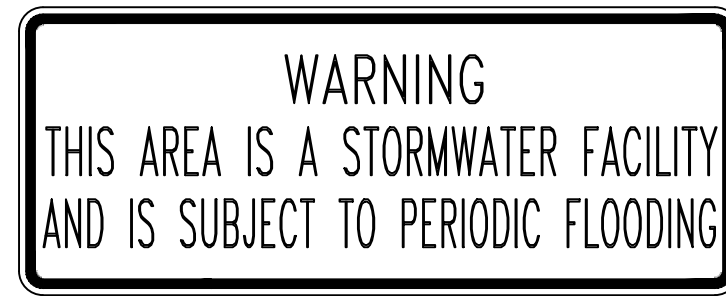
PERMANENT BMP SIGN
N.T.S.
MINIMUM AREA: 3 SQUARE FEET

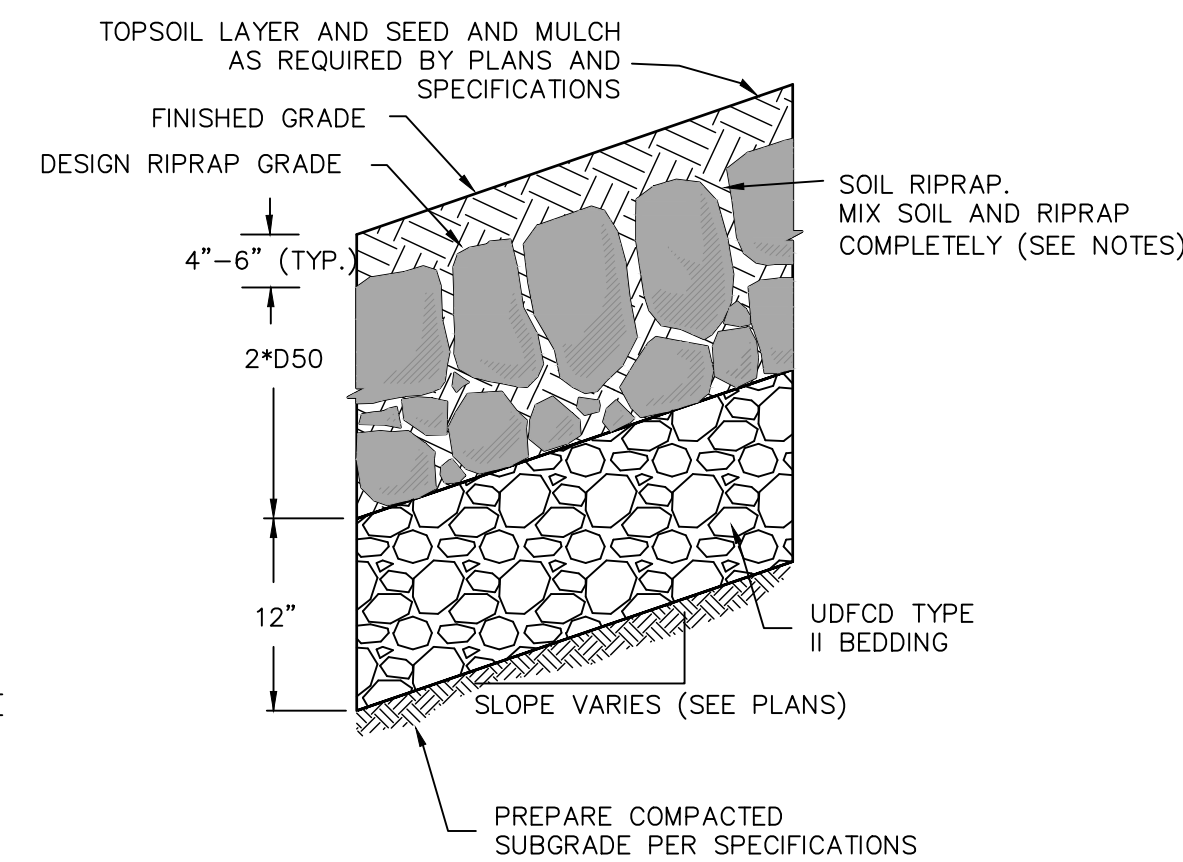
SOIL RIPRAP EMBANKMENT PROTECTION
WITH BEDDING TYP. SECTION
N.T.S.
