Preliminary Acceptance Punchlist
El Paso County – Department of Public Works - Stormwater Section

Project Name:	Rock Top
EDARP Filing Number(s):	PPR1913, CON2218
ESQCP Number:	ESQ2215
Attendees:	DPW SW: Natasha Grimaldo, Ben Jones, and Glenn Reese DPW Development Services: Brad Walters, David Parkerson, and Amanda Rivera Developer: Mitchell Dietrich and Felipe Agustin-Salgado
Date of Walk-Thru:	02/08/2024
Walk-Thru Number:	1 st

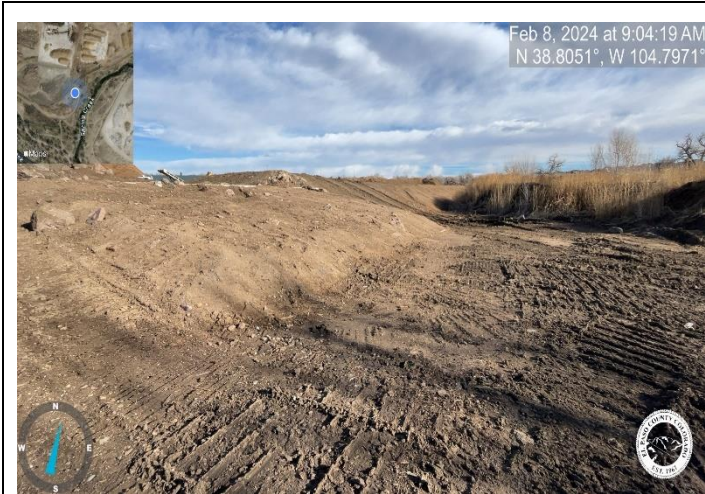
Photo 1: Pond: Grade the bottom of the Spillway to match slope shown on the Extended Detention Basin and GEC Plans. Reference sheet 3.

- Grade the bottom of the Spillway to match slope shown on the Extended Detention Basin and GEC Plans. Reference photo 1.
- Clean out sediment and debris from the forebays, outlet structure, and trickle channels. Reference photo 2.

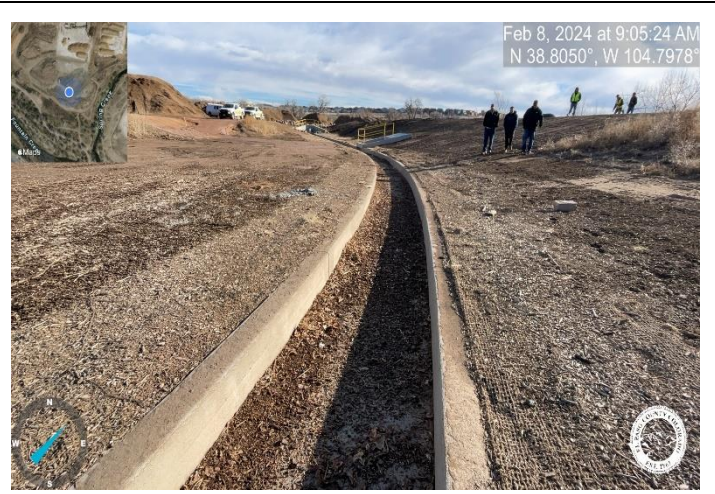
Photo 2: Clean out sediment and debris from the forebays, outlet structure and trickle channels.

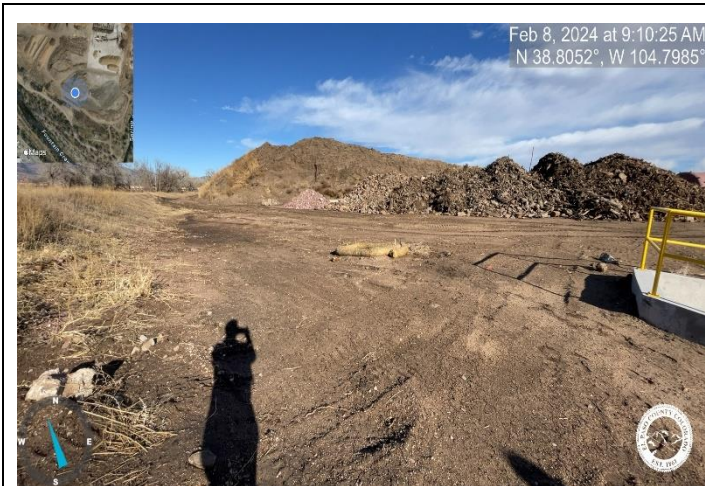
Photo 3: Flow currently bypasses inlet behind the west forebay. Regrade to promote flow into type D inlet.

- Flow currently bypasses inlet behind the west forebay. Regrade per plan to promote flow into type D inlet. Reference photo 3.
- Flow currently bypasses inlet behind the east forebay. Regrade per plan to promote flow into type D inlet. Reference photo 4.

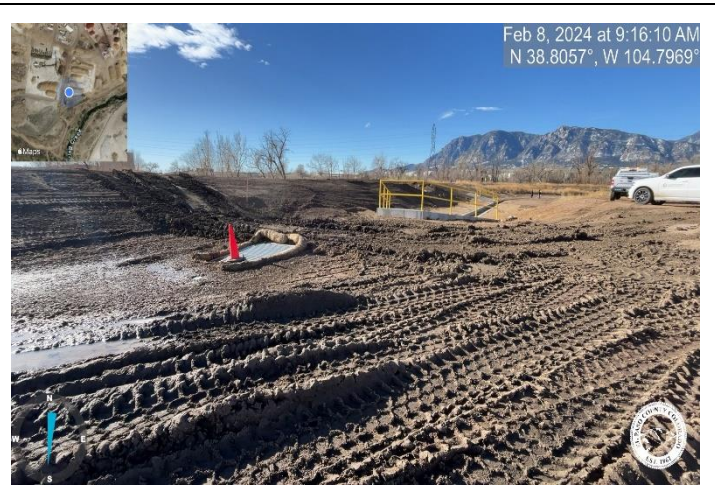
Photo 4: Flow currently bypasses inlet behind the east forebay. Regrade to promote flow into type D inlet.

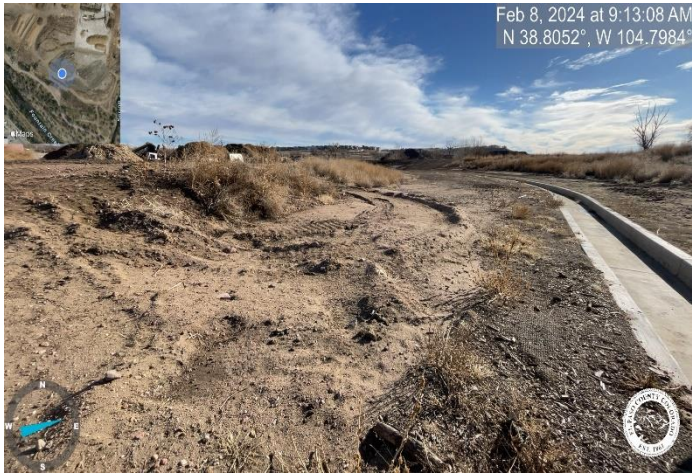
Photo 5: Fine grade pond bottom to match the approved grade.

- Fine grade pond bottom to match the approved grade. Reference photo 5.
- Repair rilling along maintenance access road. Rilling could worsen and will be required to be repaired at Final Acceptance. Reference photo 6.

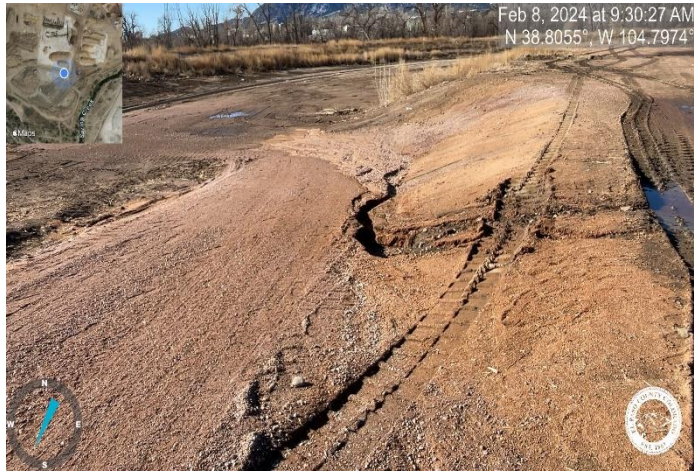
Photo 6: Repair rilling along maintenance access road. Rilling could worsen and will be required to be repaired at Final Acceptance.

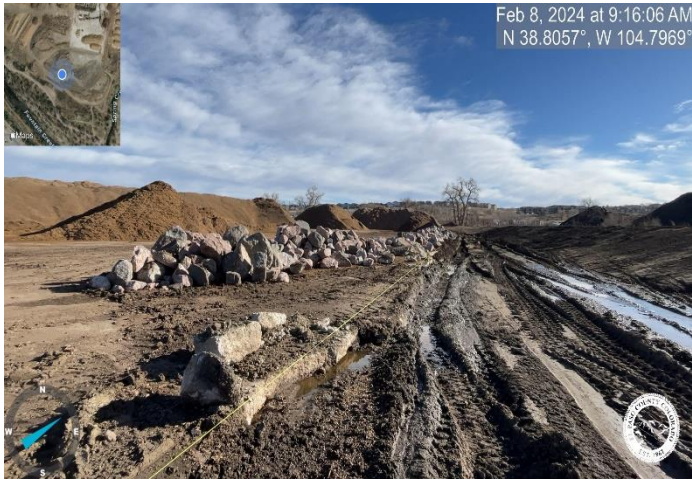
Photo 7: Complete installation of the 77 CY Riprap check (208'x10'x1' thick). Reference sheet 2 on the Extended Detention Basin and GEC Plans.

- Complete installation of the 77 CY Riprap check (208'x10'x1' thick). Reference photo 7.
- East of Pond: Fine grade drainage to pond to promote positive drainage (remove ruts). Reference photo 8.

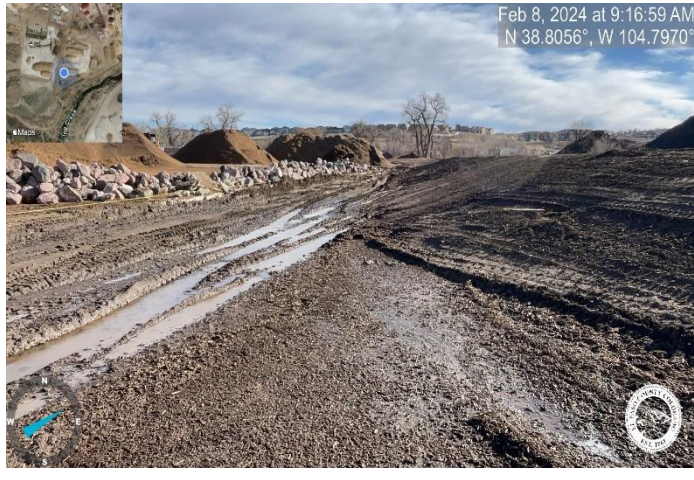
Photo 8: East of Pond: Fine grade drainage to pond to promote positive drainage (remove ruts).
