GRANDVIEW RESERVE (DRAINAGE A & B)
DR HORTON
FALCON, COLORADO

CONSTRUCTION DOCUMENTS
DETAILS

SHEET
DT2

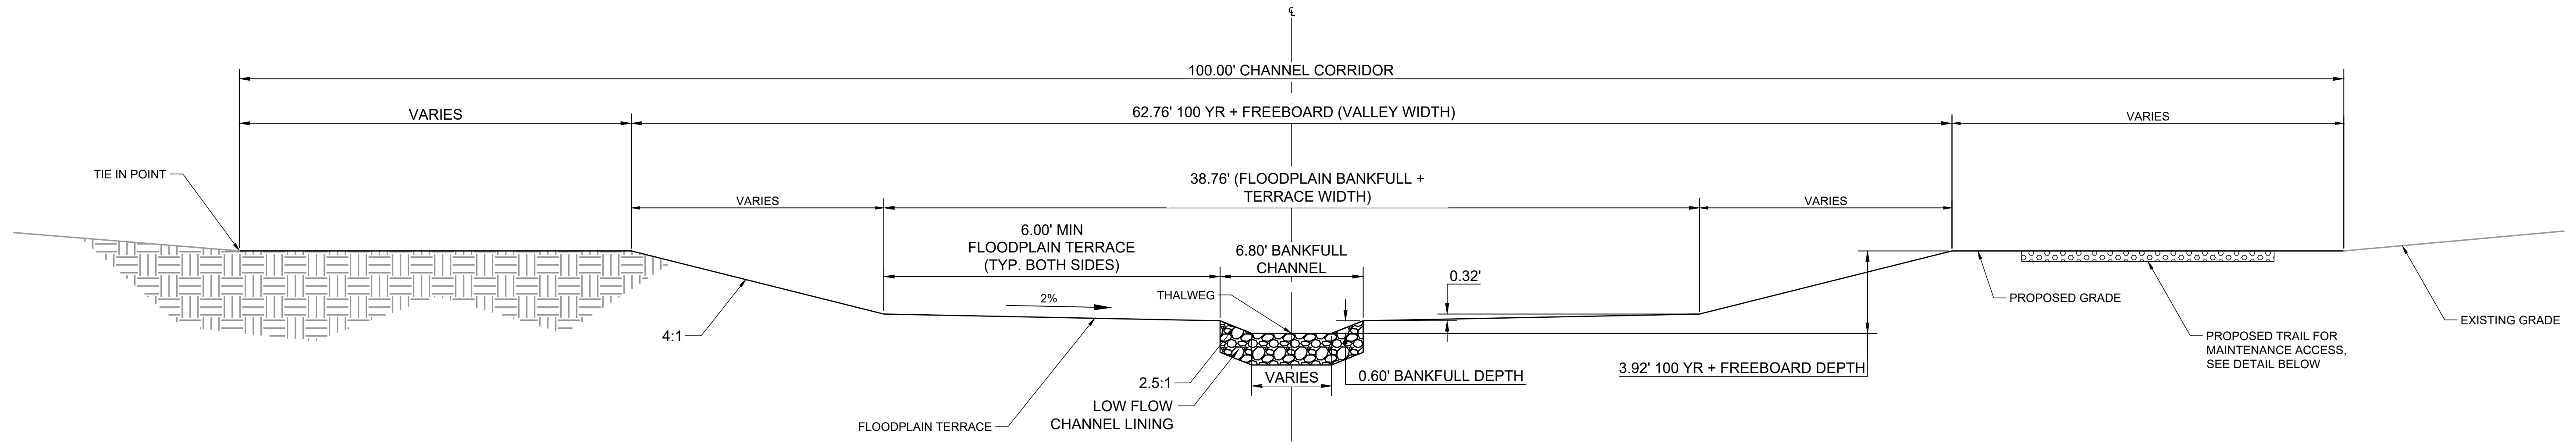
1 TYPICAL CROSS SECTION CHANNEL A
SCALE: N.T.S.

- NOTES:
1. BANKFULL CHANNEL MAY SHIFT LEFT OR RIGHT WITHIN THE BANKFULL + TERRACE WIDTH SO LONG AS THE MINIMUM FLOOD PLAIN TERRACE WIDTH OF 6' IS MAINTAINED ON BOTH SIDES.
 2. VALLEY WIDTH MAY SHIFT WITHIN THE 100' CHANNEL CORRIDOR.
 3. SEE PROFILES FOR ELEVATION AT THALWEG.

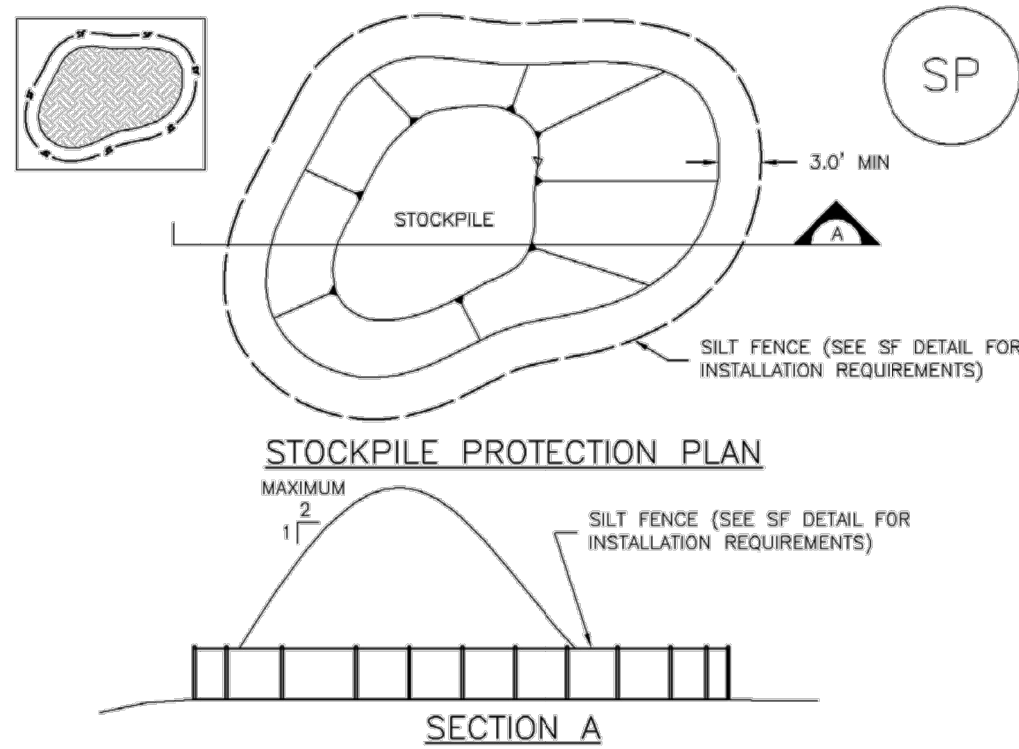
SP-1. STOCKPILE PROTECTION

4. IF PERIMETER PROTECTION MUST BE MOVED TO ACCESS SOIL STOCKPILE, REPLACE PERIMETER CONTROLS BY THE END OF THE WORKDAY.
5. STOCKPILE PERIMETER CONTROLS CAN BE REMOVED ONCE ALL THE MATERIAL FROM THE STOCKPILE HAS BEEN USED.

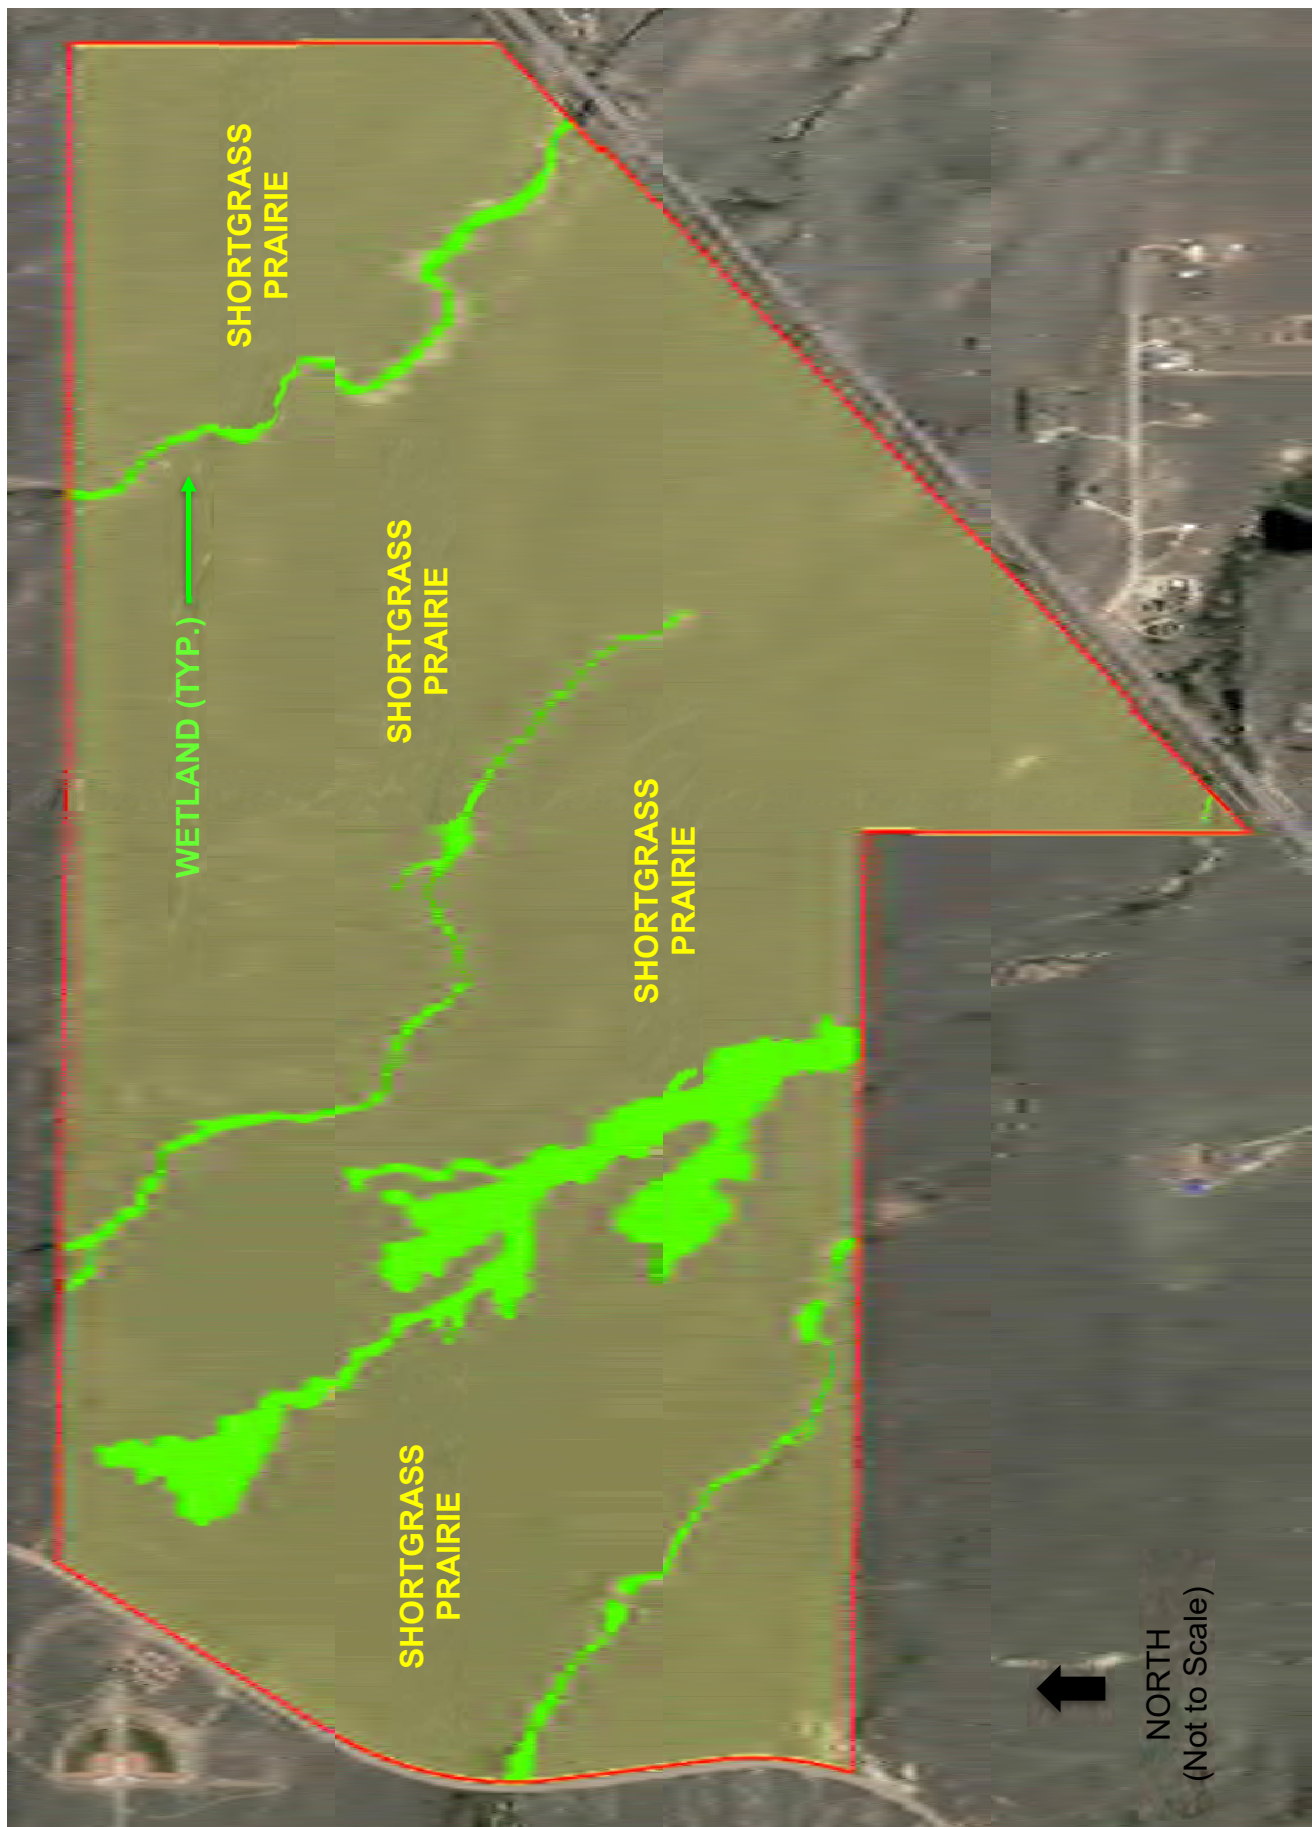
Figure 5

The vegetation within the Site is primarily comprised of shortgrass prairie with wetland vegetation in the swales and sloughs (Figure 5). The shortgrass prairie is dominated by little bluestem (*Schizachyrium scoparium*), blue grama (*Bouteloua gracilis*), and buffalograss (*Bouteloua dactyloides*) with occasional associative grass and forb species including western wheatgrass (*Pascopyrum smithii*), yellow Indiagrass (*Sorghastrum nutans*), Canada wildrye (*Elymus canadensis*), needle and thread (*Hesperostipa comata*), switchgrass (*Panicum virgatum*), Western yarrow (*Achillea millefolium*), broom snakeweed (*Gutierrezia sarothrae*), fringed sage (*Artemisia frigida*), Prickly pear (*Opuntia* spp.), and prairie aster spp. (*Symphotrichum* spp.). Occasional patches of snowberry (*Symphoricarpos albus*) and Wood's rose (*Rosa woodsii*) occupy the transitional areas between uplands and wetlands. A few, single plains cottonwood (*Populus deltoides*) occur along the drainages. The Site is heavily impacted by historic and ongoing grazing and there are weeds scattered throughout, including Canada thistle (*Cirsium arvense*), Scotch thistle (*Onopordum acanthium*),
