Job No. 193940

Re: Wastewater Study  
Triple H Ranch, North and East of Jones Rd and Murr Rd  
EPC Schedule No. 3300000168 and 3300000388  
El Paso County, Colorado

### **Project Description**

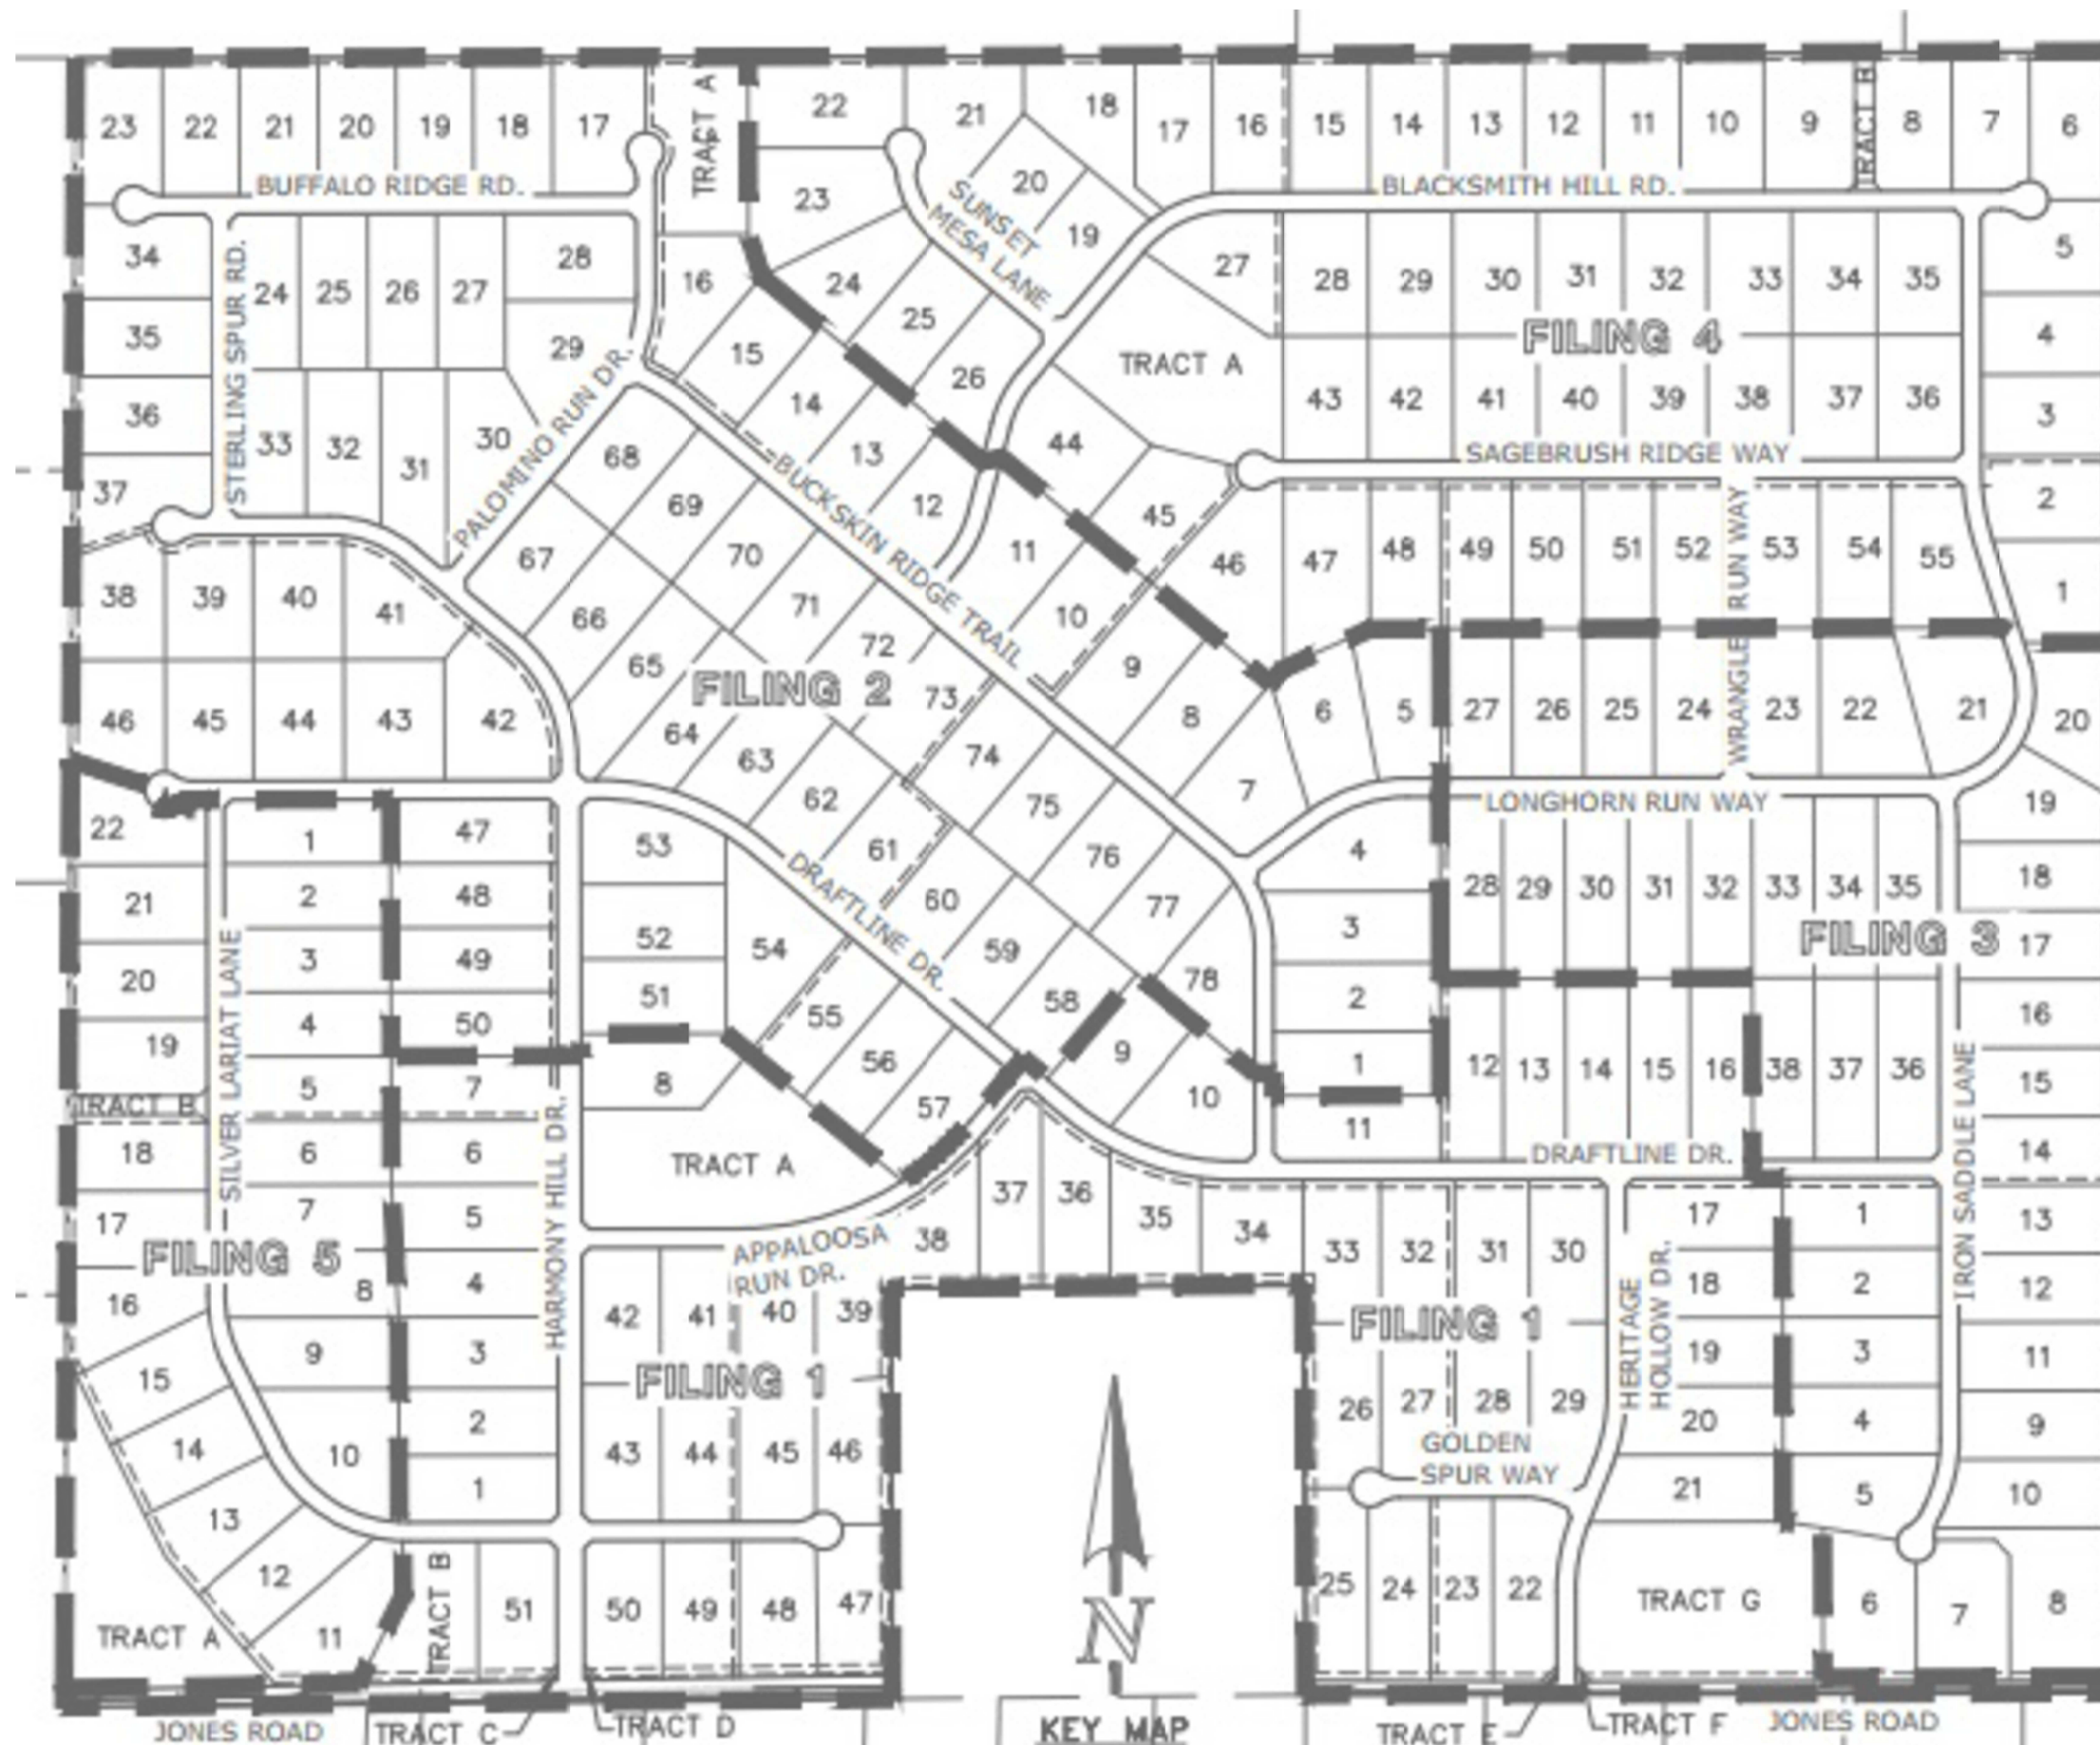
The proposed lots are to be accessed from two new residential roads, each extending north from Jones Road. The lots are to utilize a centralized water system and individual On-Site Wastewater Treatment Systems (OWTS). The Proposed Lot Layout is presented in Figure 2.

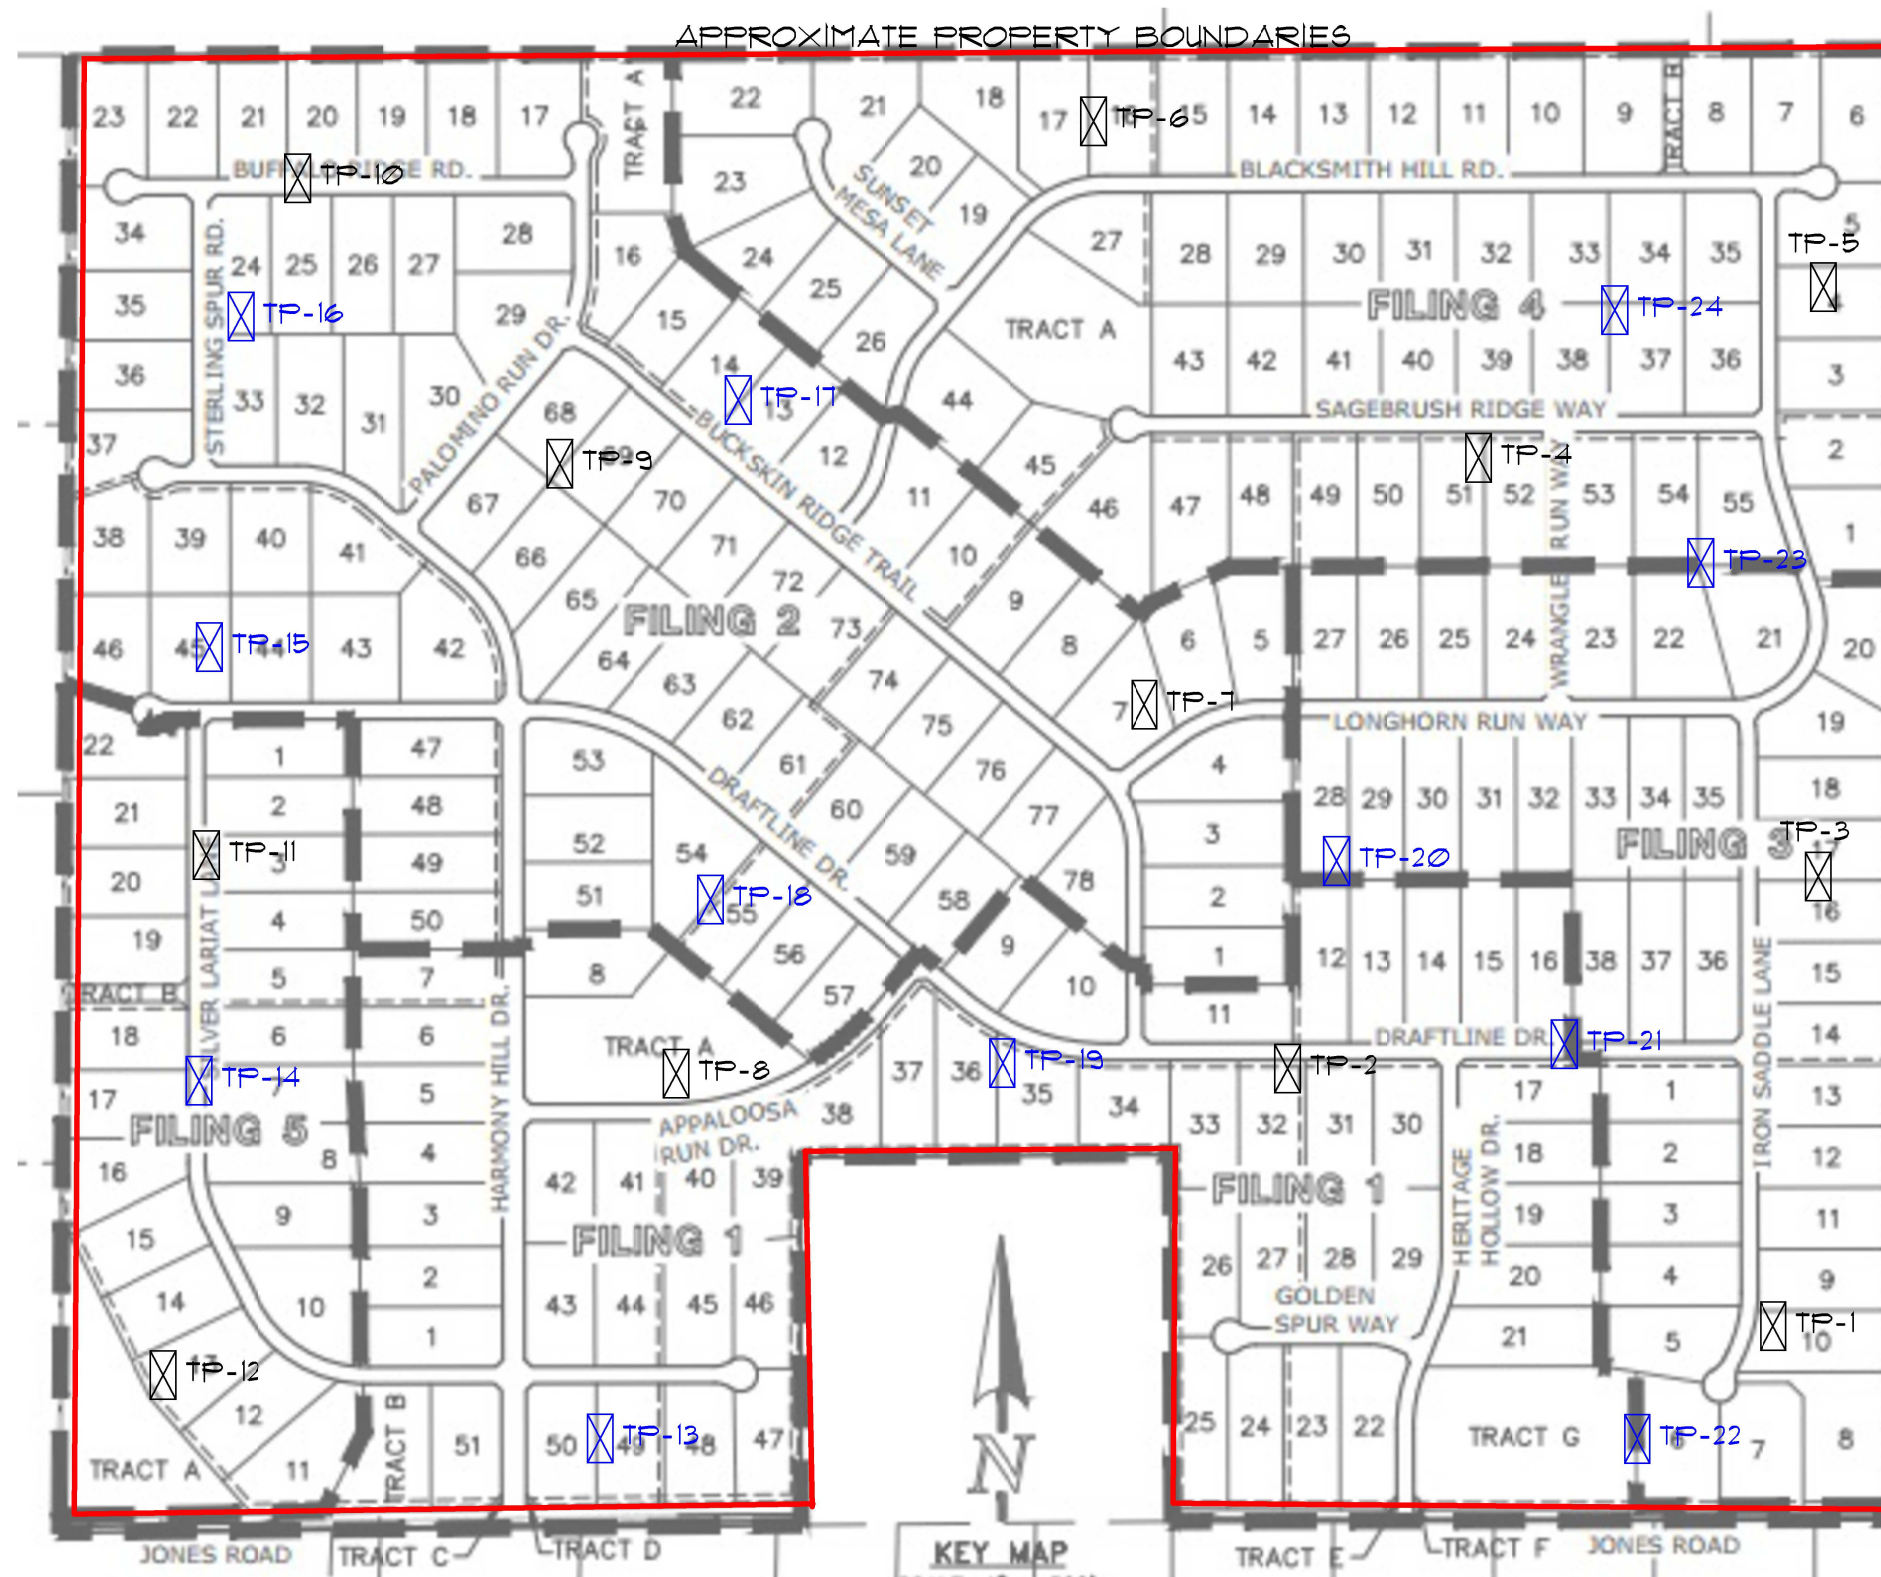
TEST PIT  
 LOCATION PLAN

Personnel of RMG performed our original reconnaissance visit on August 22, 2023, and a follow-up visit on April 13, 2026. The purpose of the reconnaissance visits was to evaluate the site surface characteristics including landscape position, topography, vegetation, natural and cultural features, and current and historic land uses. Twelve 8-foot deep test pits were performed across the site during each reconnaissance visit. A Test Pit Location Plan is presented in Figure 3.

DENOTES APPROXIMATE LOCATIONS  
 OF TEST PITS PERFORMED IN 2023

DENOTES APPROXIMATE LOCATIONS  
 OF TEST PITS PERFORMED IN 2026

Personnel of RMG performed a soil evaluation to include twelve 8-foot deep test pits, on August 22, 2023 (Test Pit TP-1 through TP-12), utilizing the visual and tactile method for the evaluation of the site soils. The test pits were excavated in areas that appeared most likely to be used for residential construction. The 2023 Test Pit Logs are presented in Figures 4 through 9 and the 2026 Test Pit Logs are presented in Figures 10 through 15.

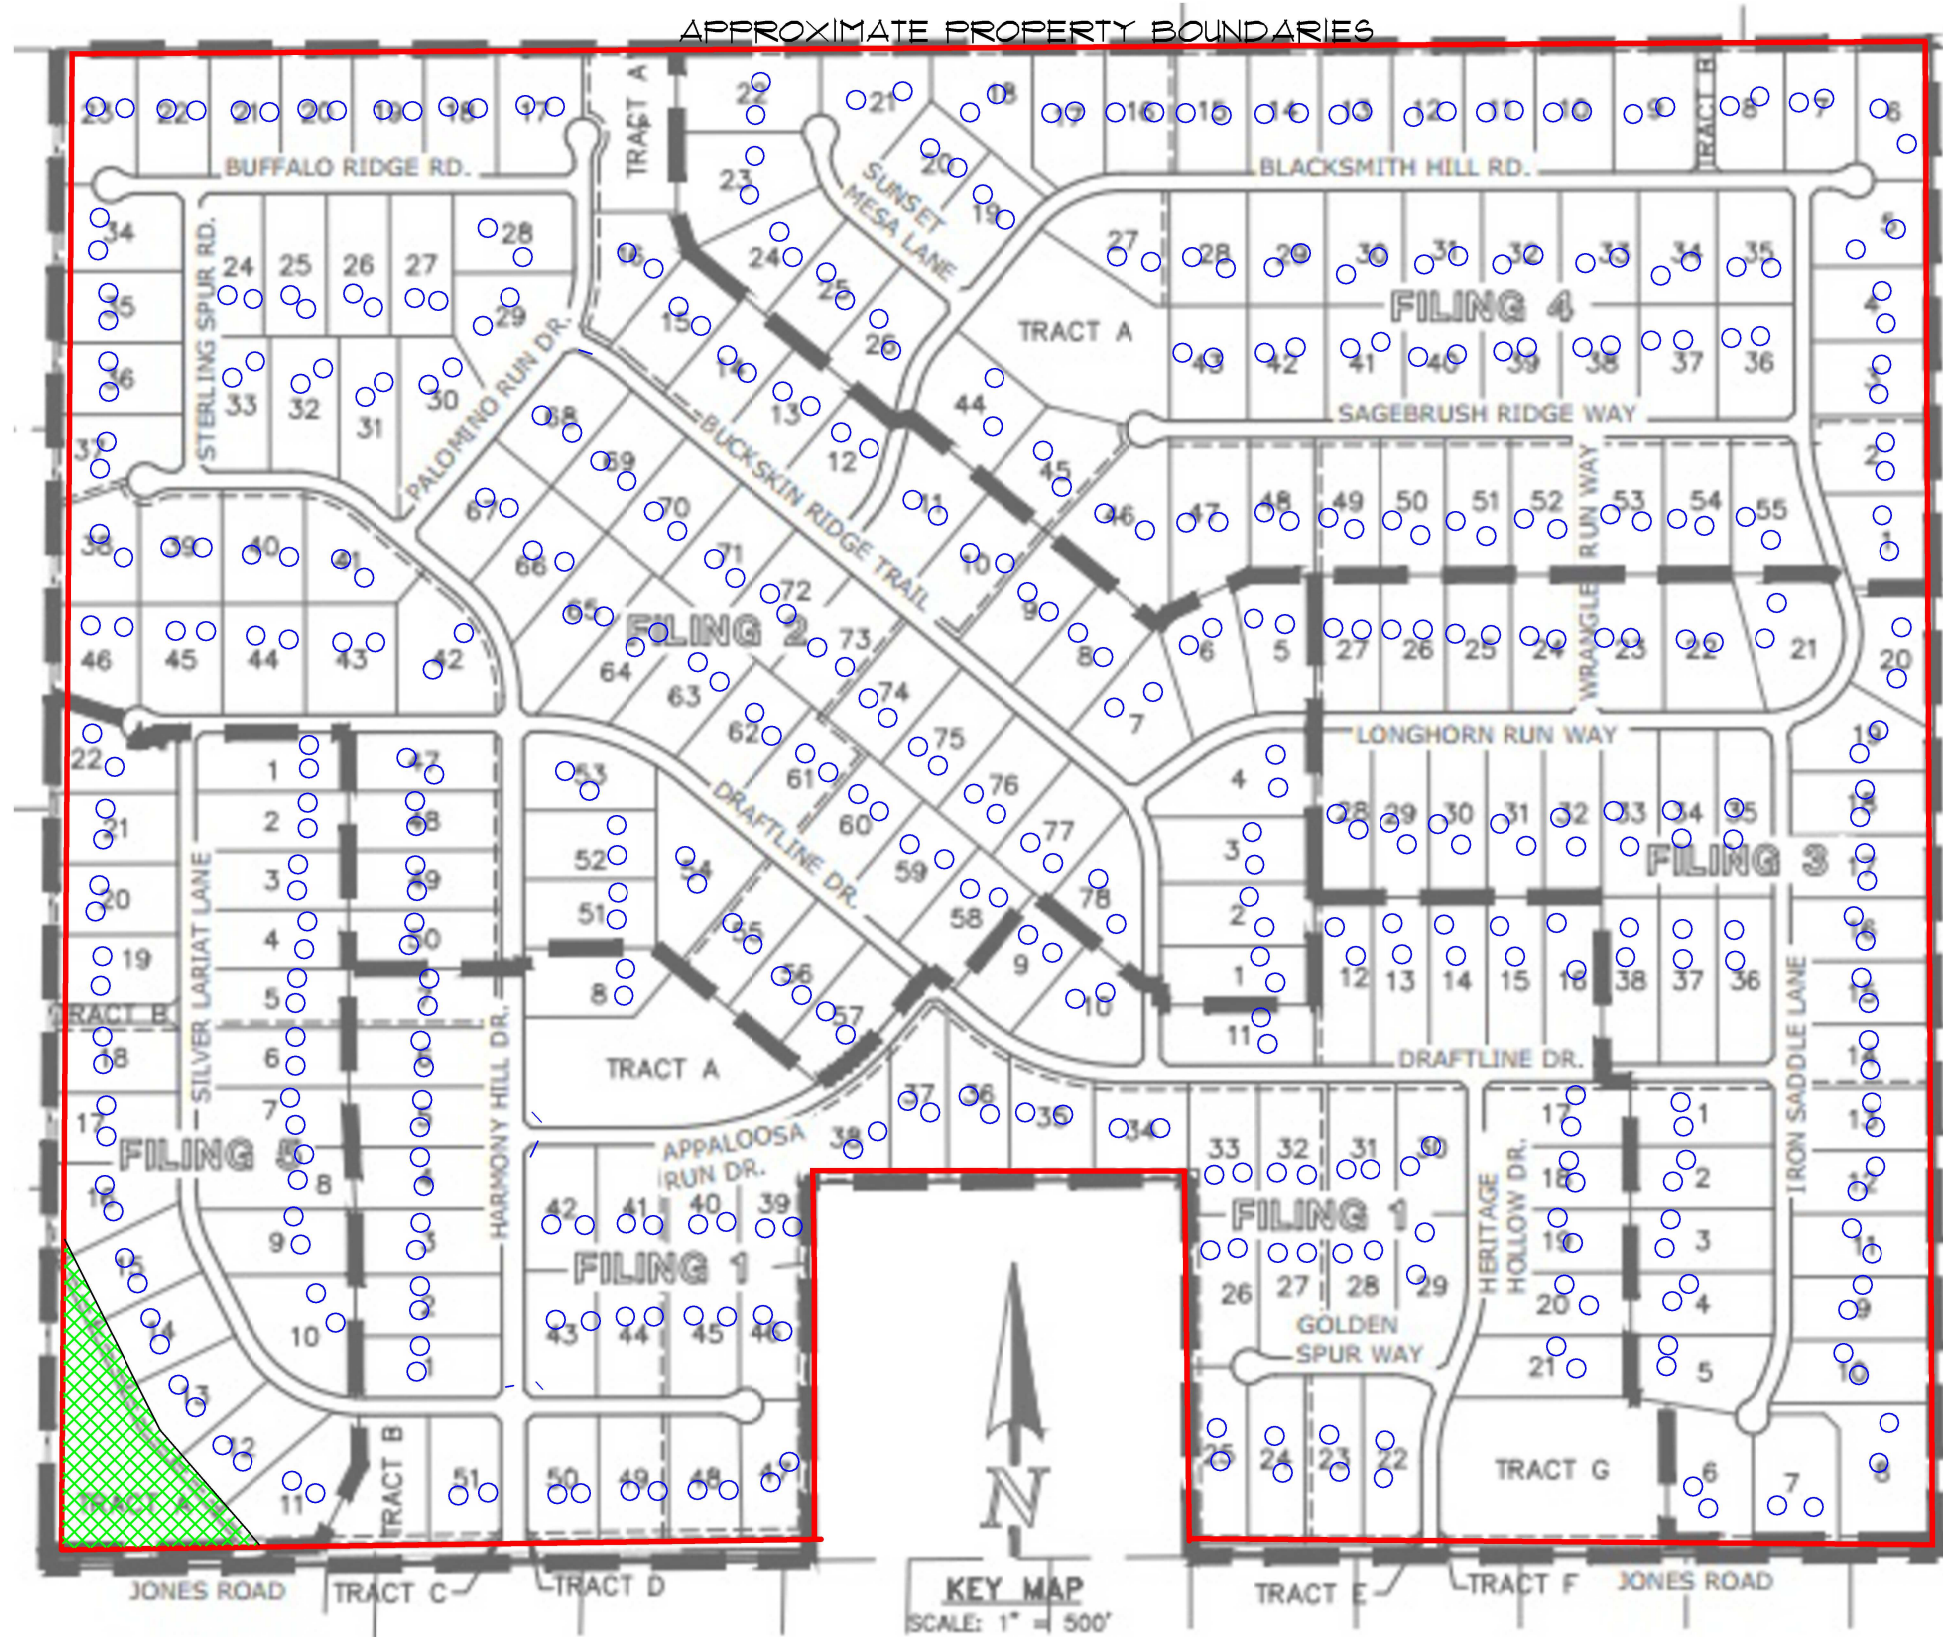
With the exception of the 5 lots partially located within the floodway, it is our opinion that if the EPCDHE physical setback requirements (both horizontal and vertical) are met for each lot, there are no restrictions on the placement of the individual On-site Wastewater Treatment Systems. The OWTS Suitability Map, showing two locations for the OWTS for each lot, is presented in Figure 16.

NO BUILD ZONE

It is our opinion that if the EPCDHE physical setback requirements (both horizontal and vertical) are met for each lot. Other than the designated No Build/Floodway area that encroaches upon the western half of the 5 lots boarding Black Squirrel Creek, there are no restrictions on the placement of the individual On-site Wastewater Treatment Systems.
