## SOIL AND GEOLOGY STUDY

**Triple H Ranch  
North and East of Jones Road and Murr Road  
EPC Schedule No. 3300000168 and 3300000388  
El Paso County, Colorado**

**JOB NO. 193940**

**September 15, 2023  
Amended July 24, 2026  
PCD File SP254**

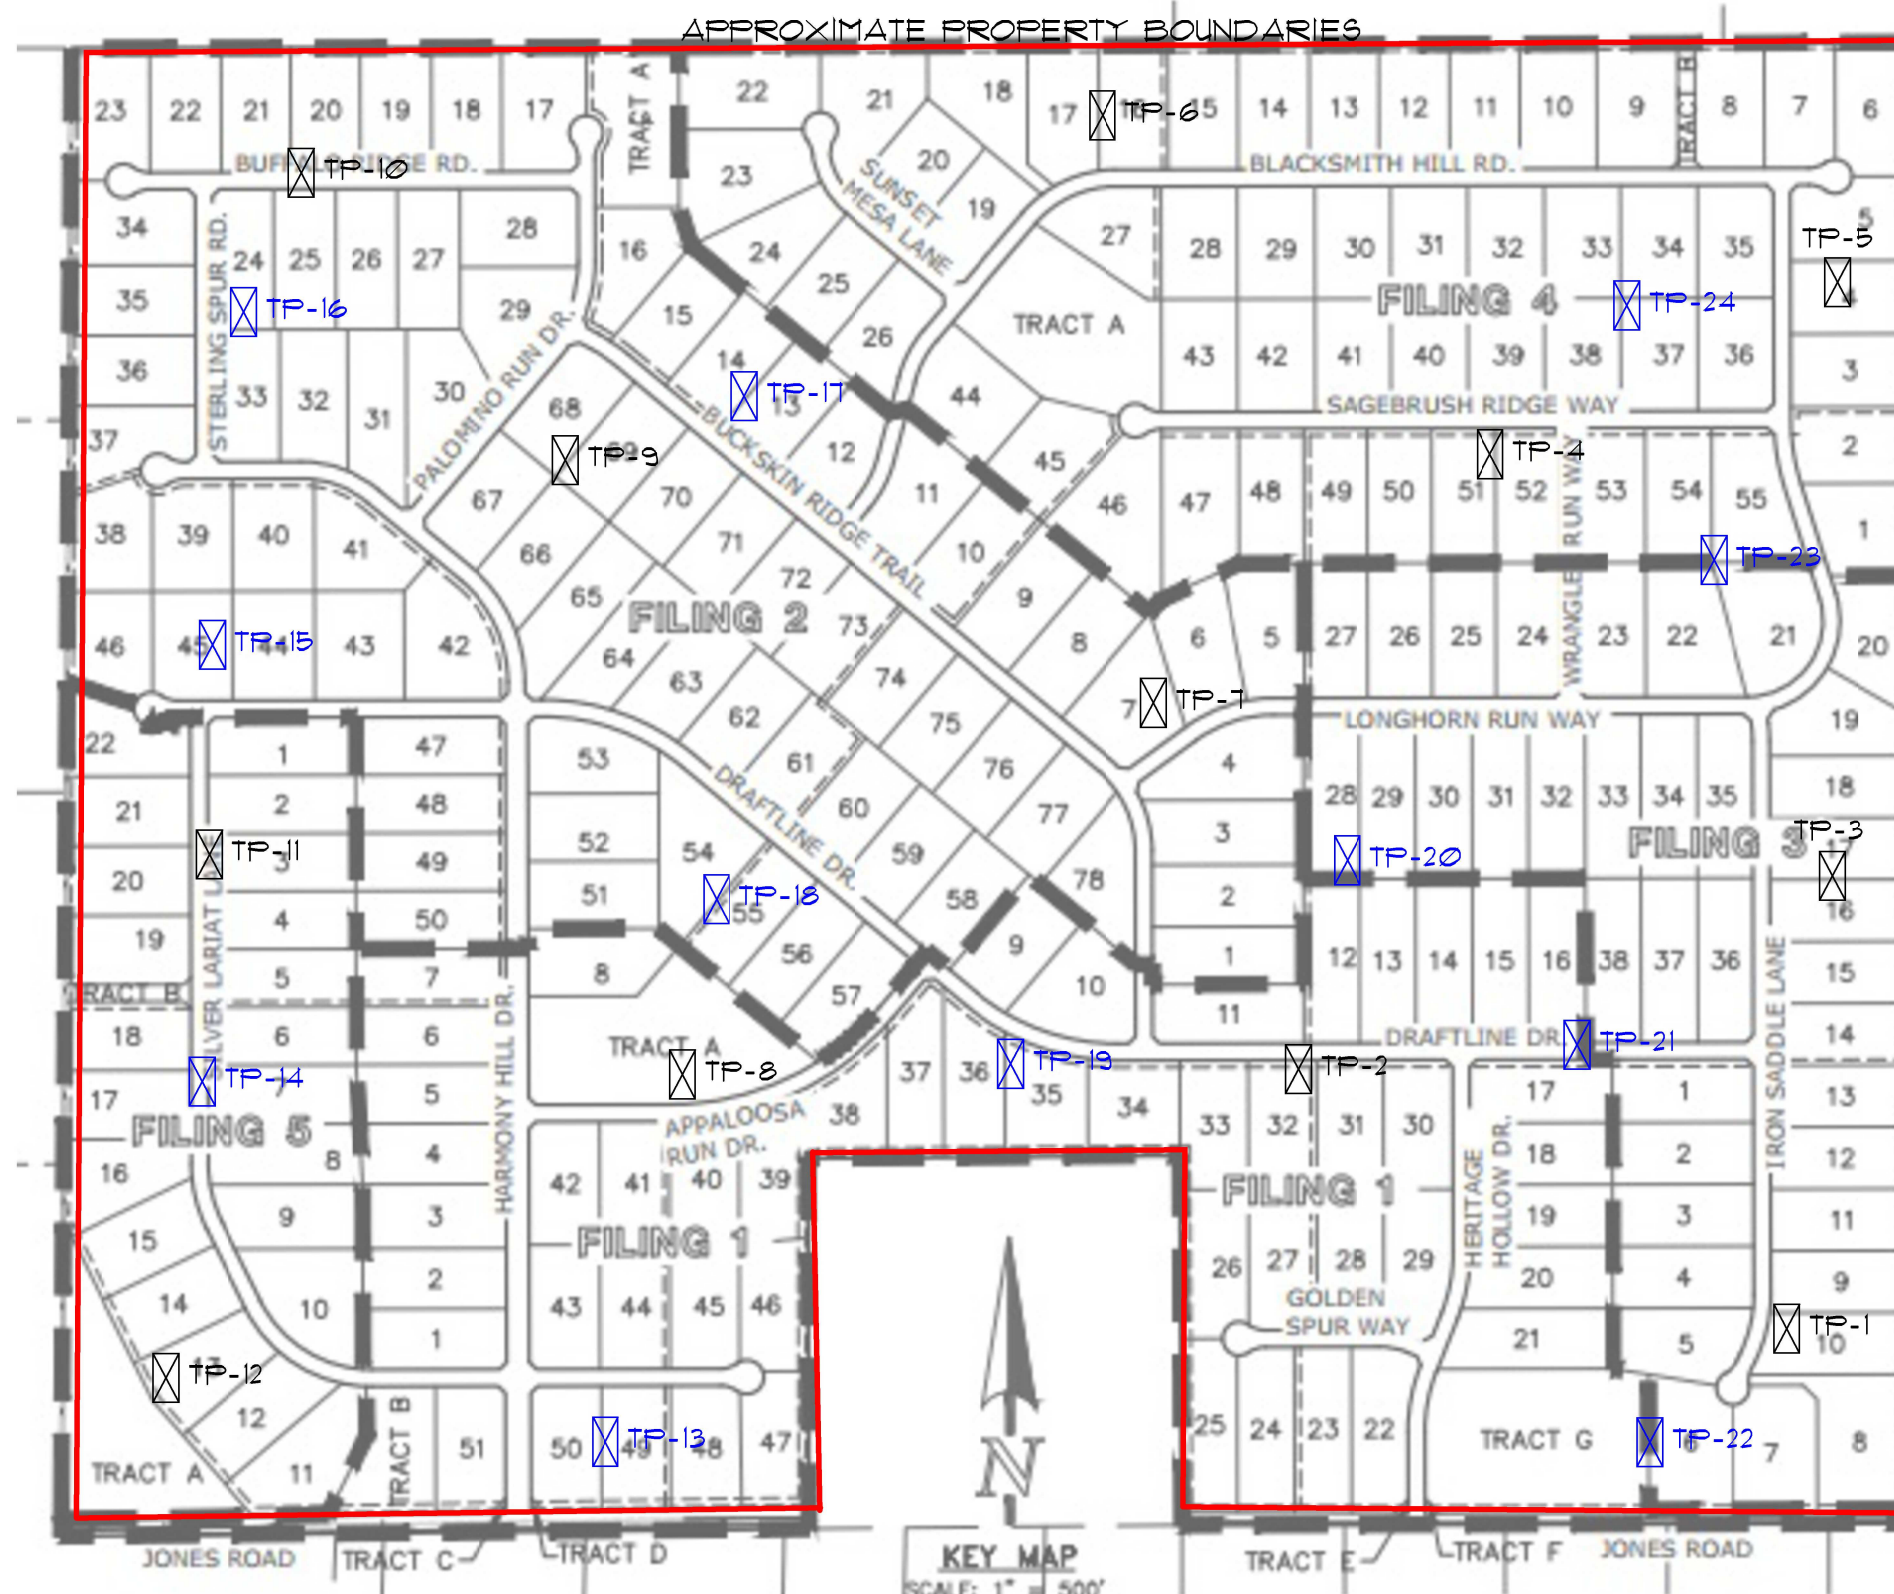
FIG-3

The test borings and test pits were spaced to provide preliminary soil information across the site for future residential foundations and on-site wastewater treatment systems. The Test Boring/Test Pit Layout Plan is presented in Figure 3.

✕ DENOTES APPROXIMATE LOCATIONS  
 OF TEST PITS PERFORMED FOR THE  
 INVESTIGATION COMPLETED 2023

✕ DENOTES APPROXIMATE LOCATIONS  
 OF TEST PITS PERFORMED FOR THE  
 INVESTIGATION COMPLETED 2026

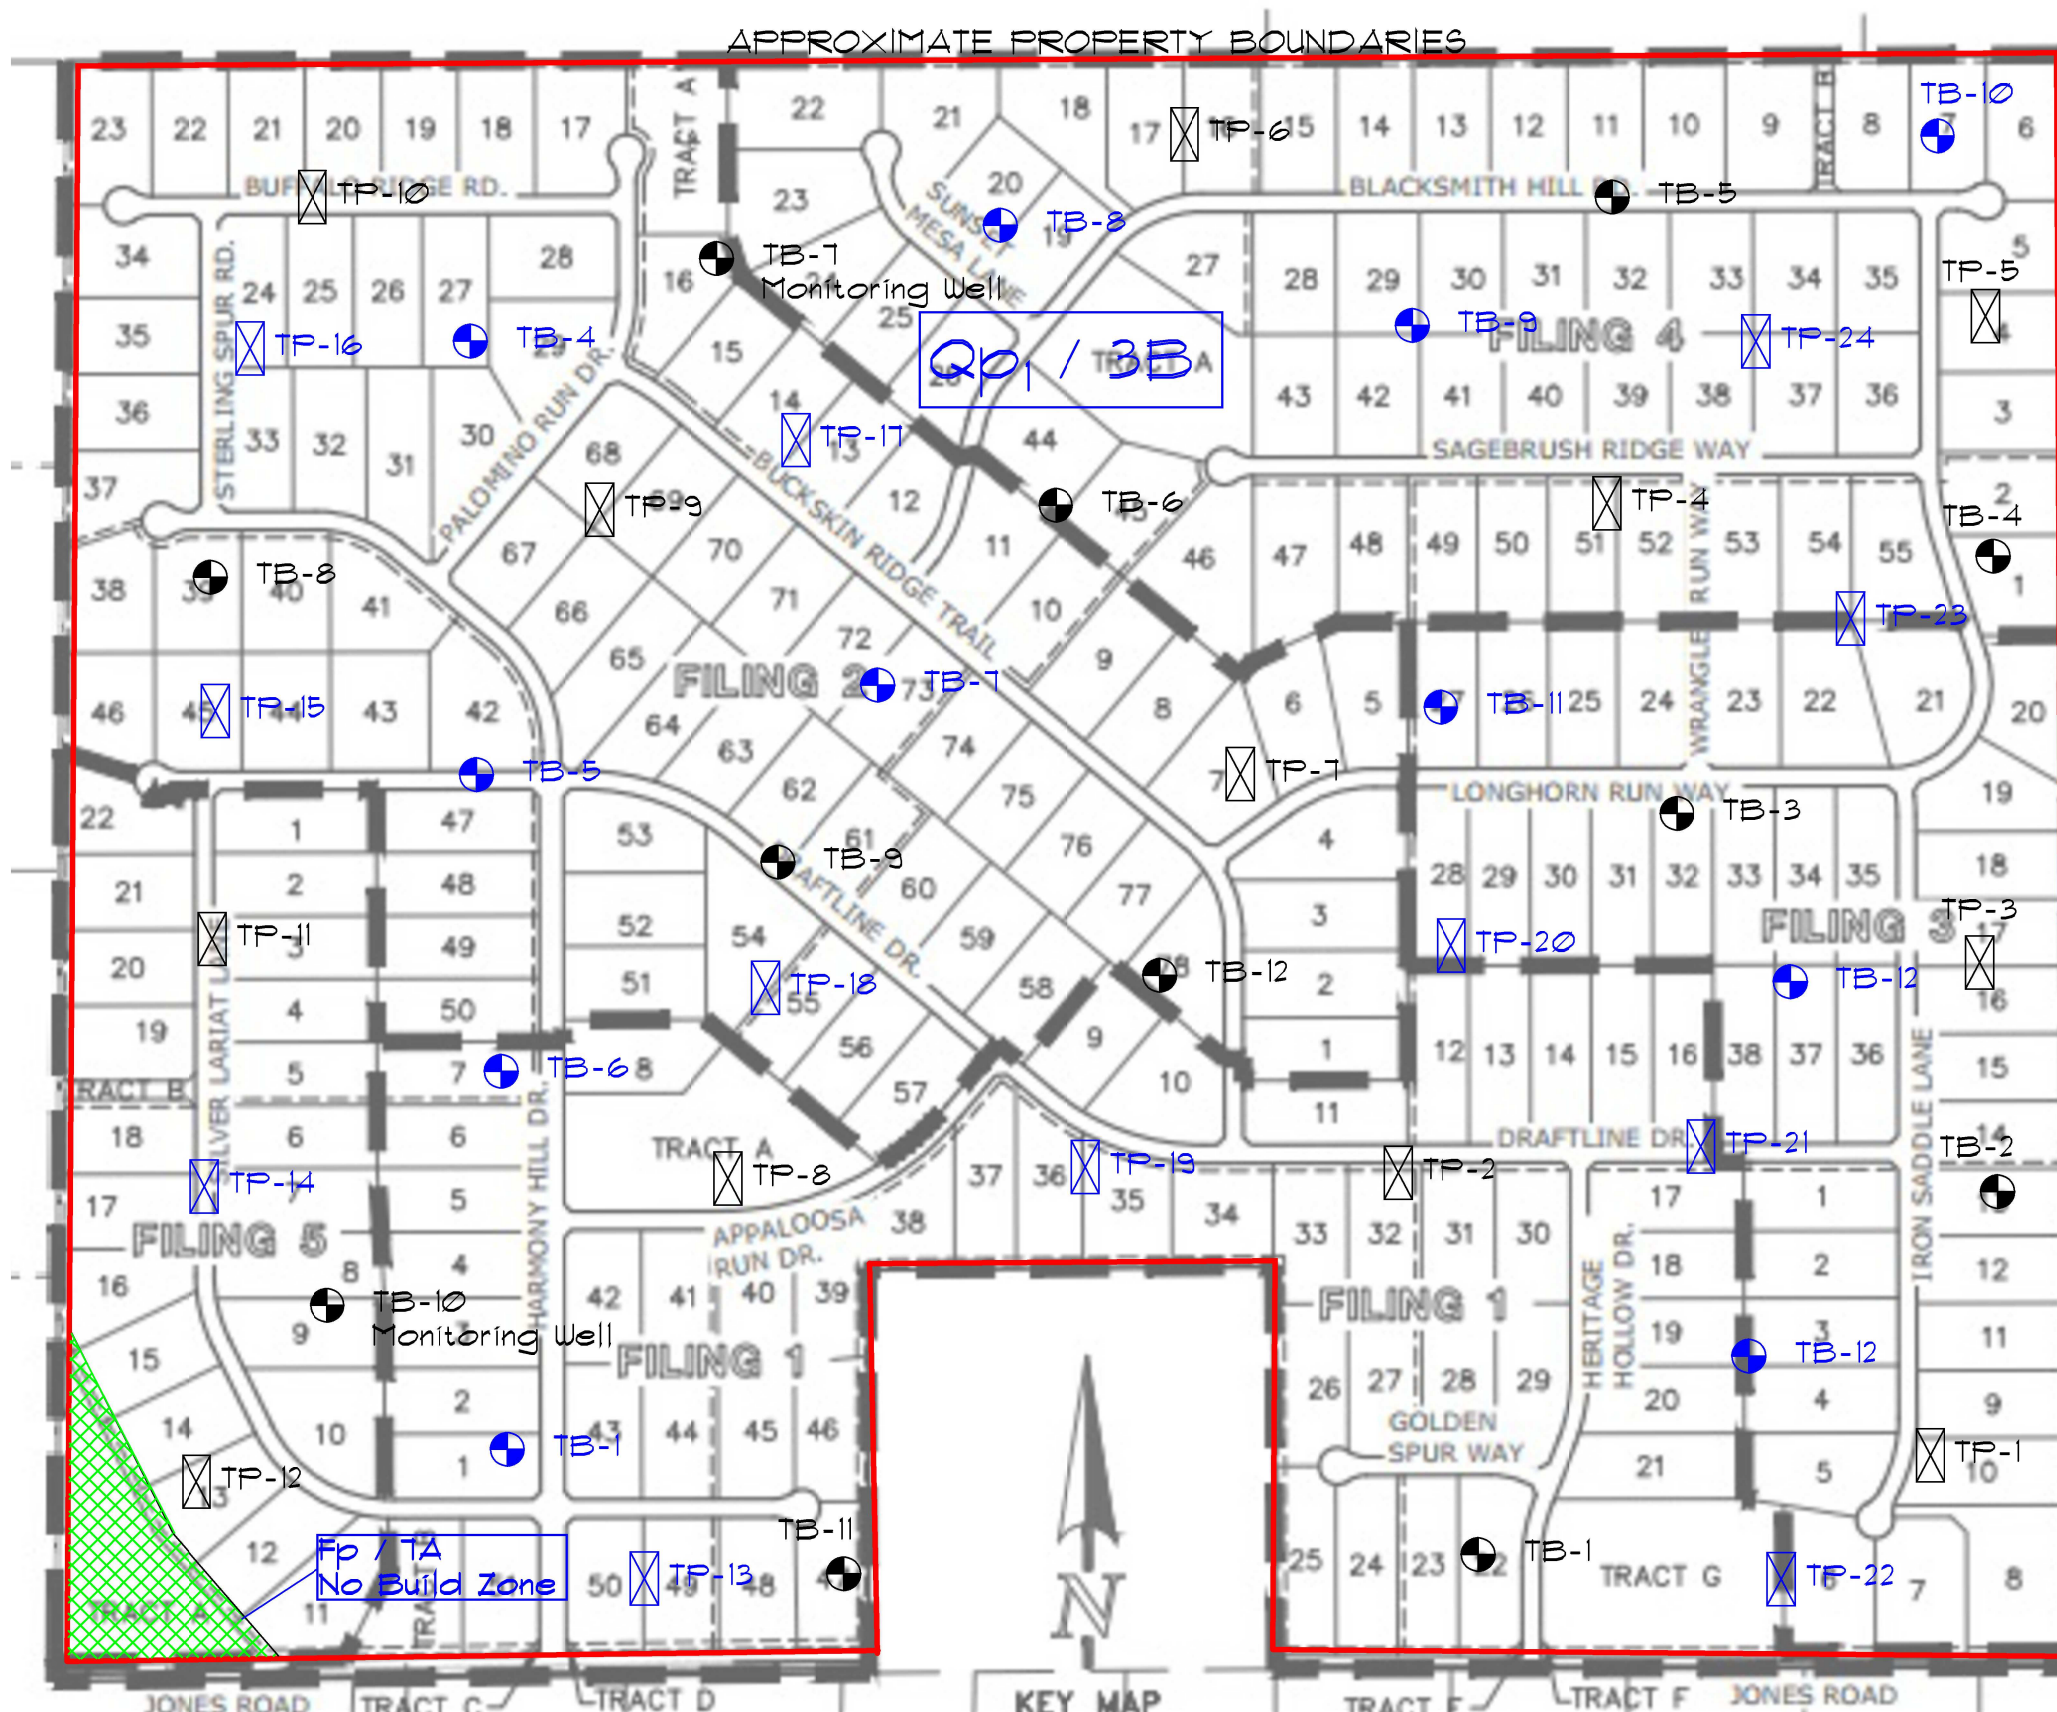
Based on our field observations and review of relevant geologic maps, we identified the geologic conditions (listed below) affecting the development, as shown on the Engineering and Geology Map, Figure 40.

⊗ DENOTES APPROXIMATE LOCATIONS OF TEST BORINGS/PITS PERFORMED FOR THE INVESTIGATION COMPLETED 2023

⊕ DENOTES APPROXIMATE LOCATIONS OF TEST BORINGS/PITS PERFORMED FOR THE INVESTIGATION COMPLETED 2026
