## SOIL AND GEOLOGY STUDY

North and East of Jones Road and Murr Road  
EPC Schedule No. 3300000168 and 3300000388  
El Paso County, Colorado

**JOB NO. 193940**

**September 15, 2023**  
**Amended May 29, 2026**

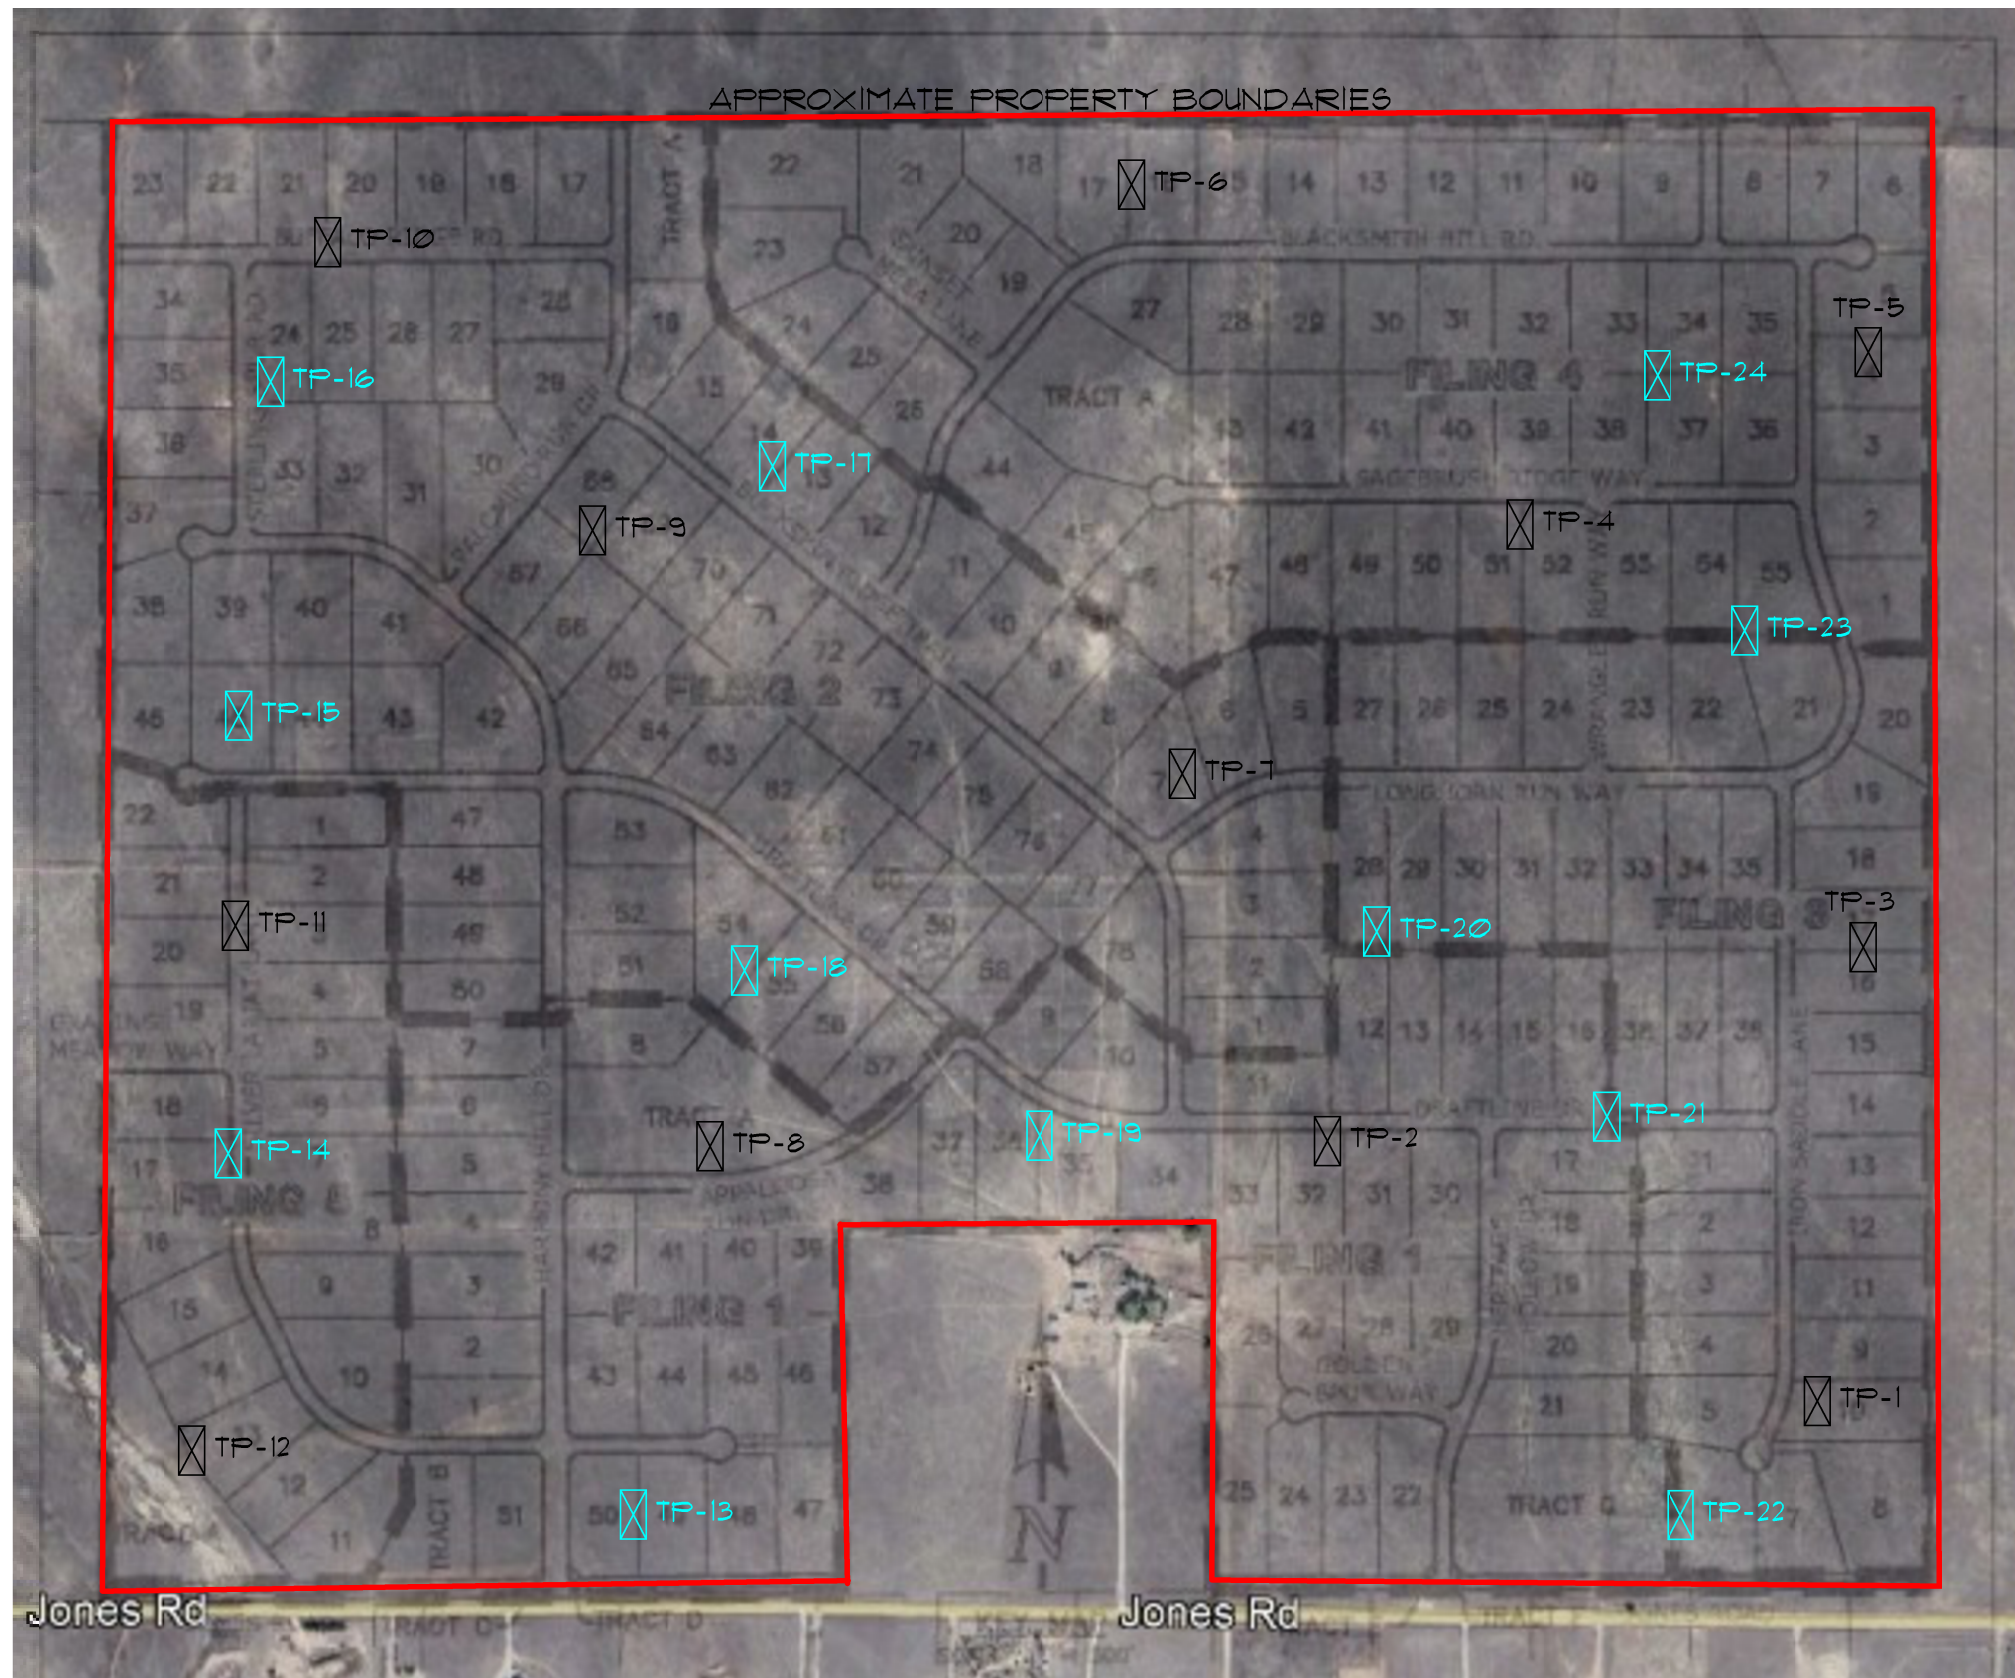
The test borings and test pits were spaced to provide preliminary soil information across the site for future residential foundations and on-site wastewater treatment systems. The Test Boring/Test Pit Layout Plan is presented in Figure 3.

DENOTES APPROXIMATE LOCATIONS  
OF TEST PITS PERFORMED FOR THE  
INVESTIGATION COMPLETED 2023
