Stormwater Management Facility Operation and Maintenance (O&M) Manual Underground Detention & Water Quality

**Lot 2, Pedrick-Eckerd Filing No. 3
Subdivision
304 Main Street
Kum & Go #2232**

2232 - EL PASO, COLORADO
 SECURITY BLVD. AND MAIN ST.
STORM SEWER PLAN

MC-3500 STORMTECH CHAMBER SPECIFICATIONS

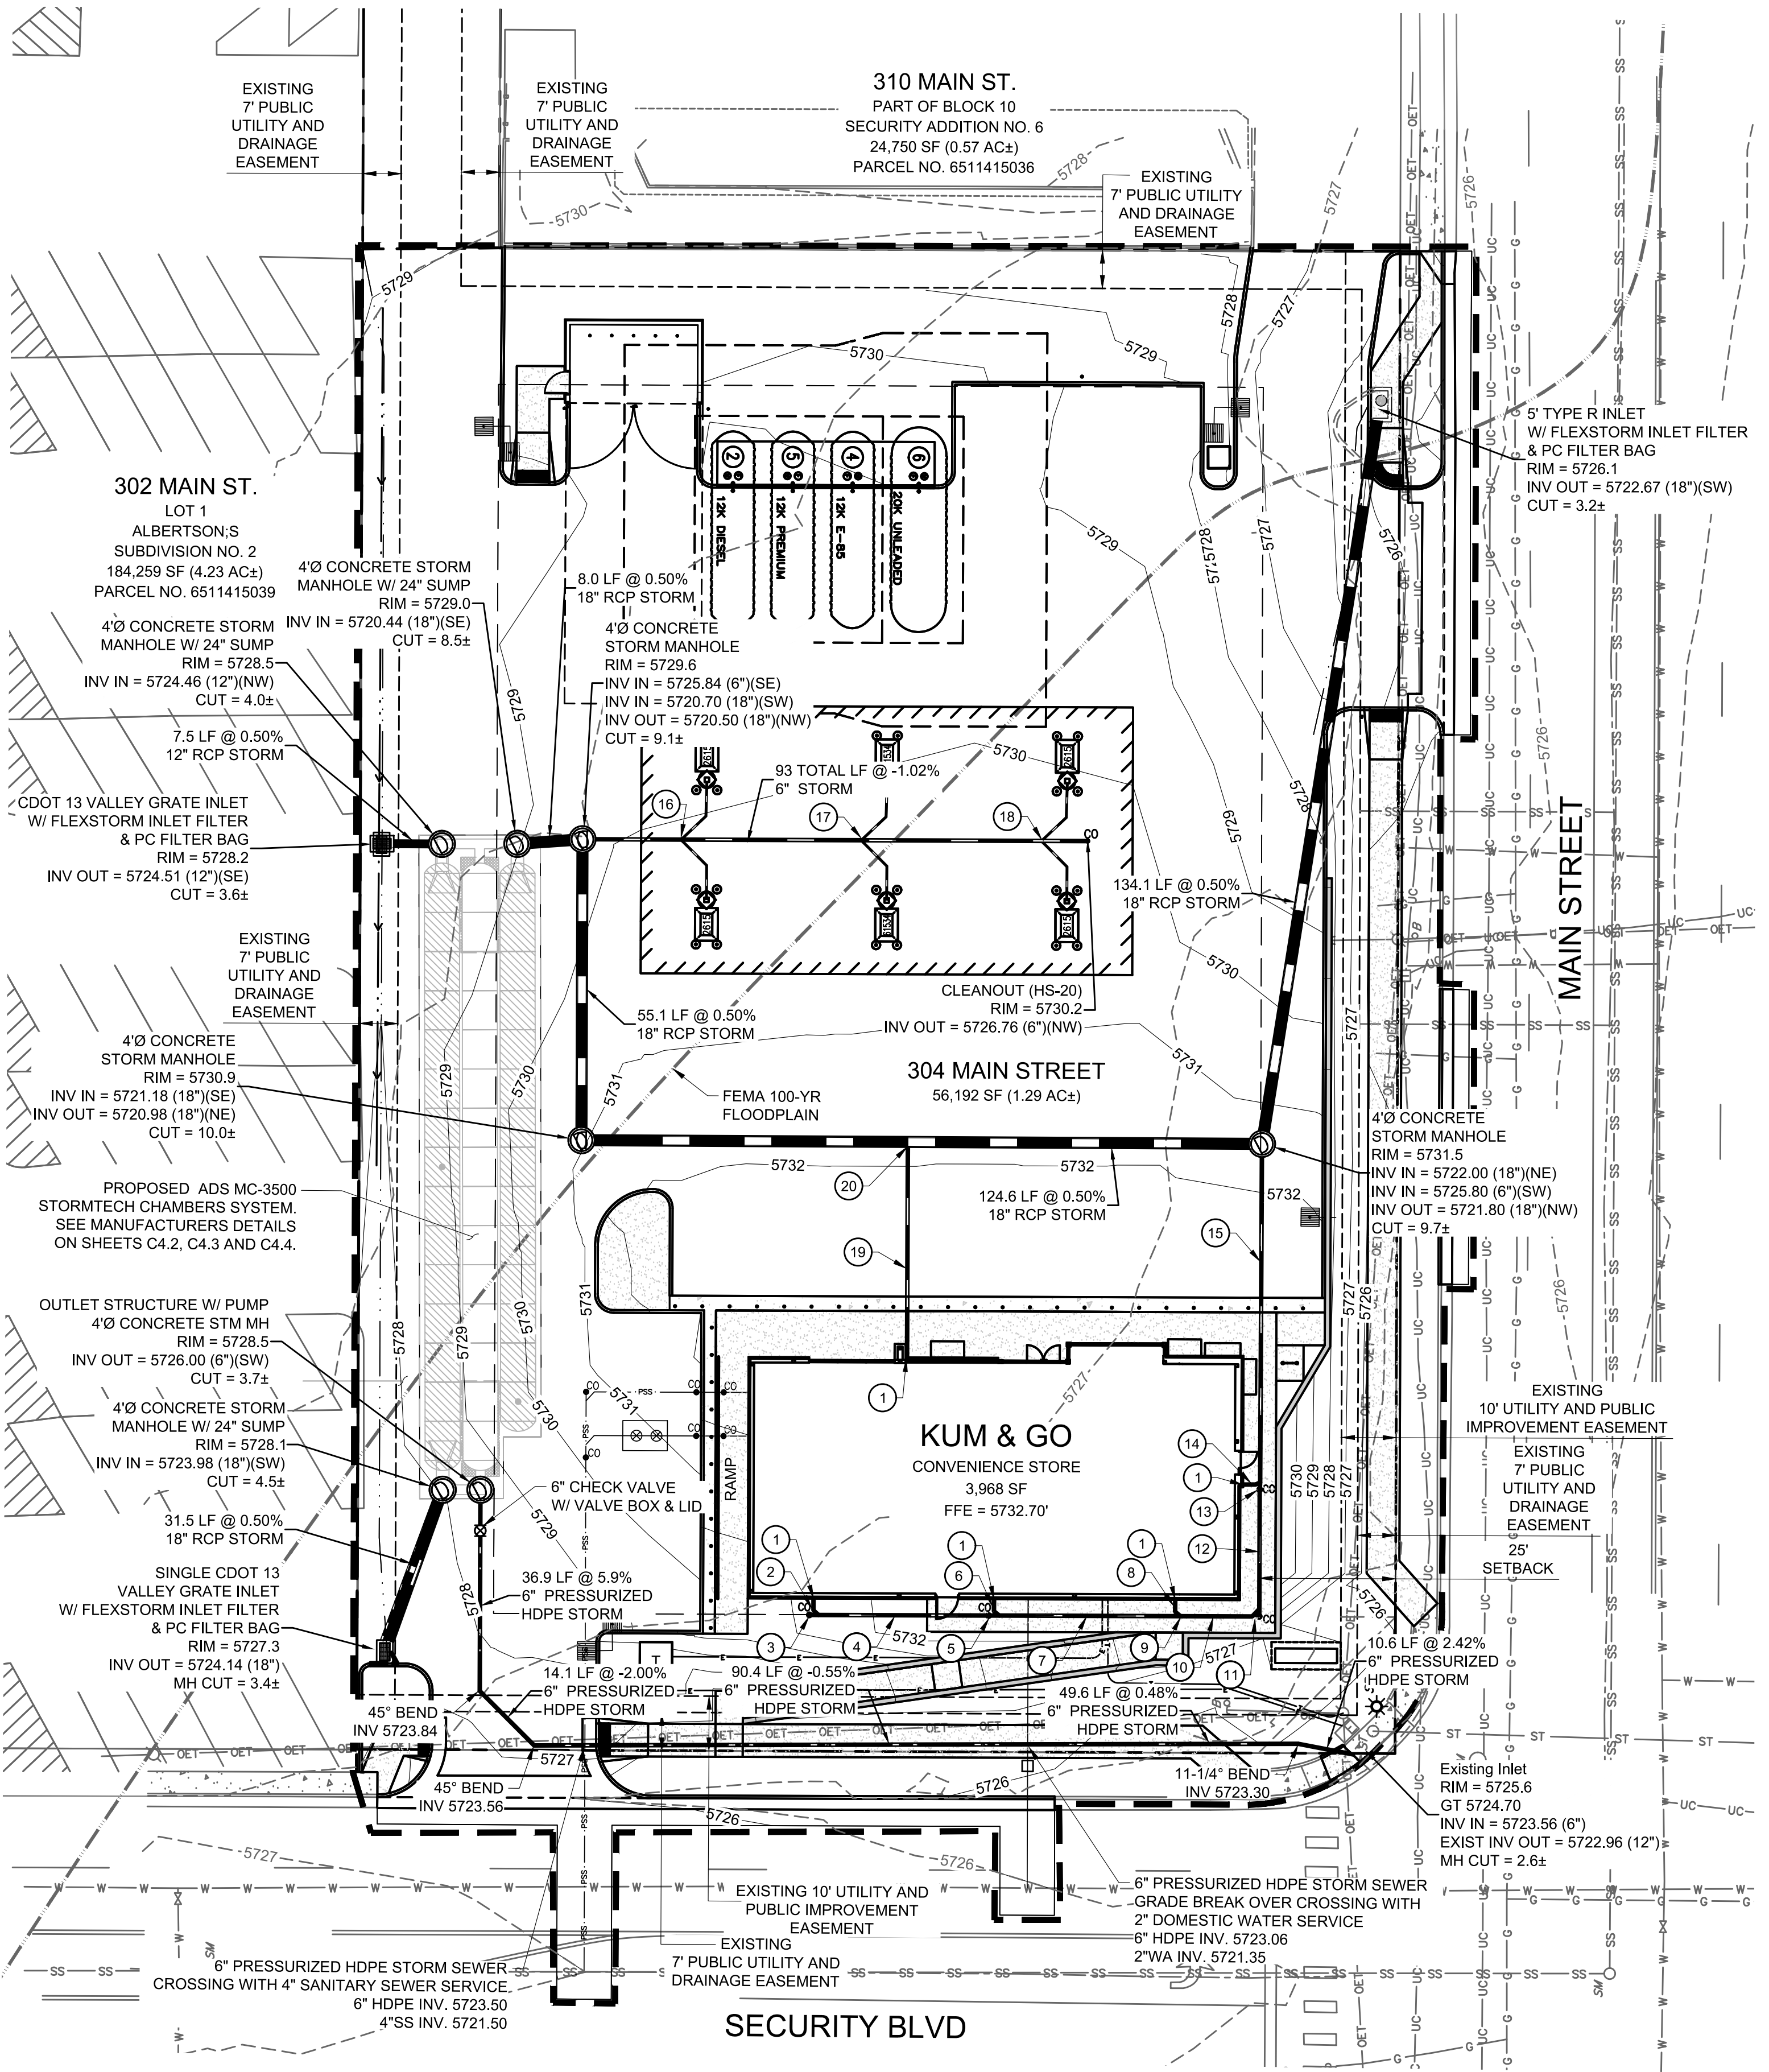
Due to existing condition constraints, the pond release will be conveyed to an existing inlet located at the north corner of the intersection of Main Street and Security Boulevard by a pump system. In the event of runoff overtopping, the emergency spillway will be at the proposed site access onto Security Boulevard as the site currently drains today in the existing condition.

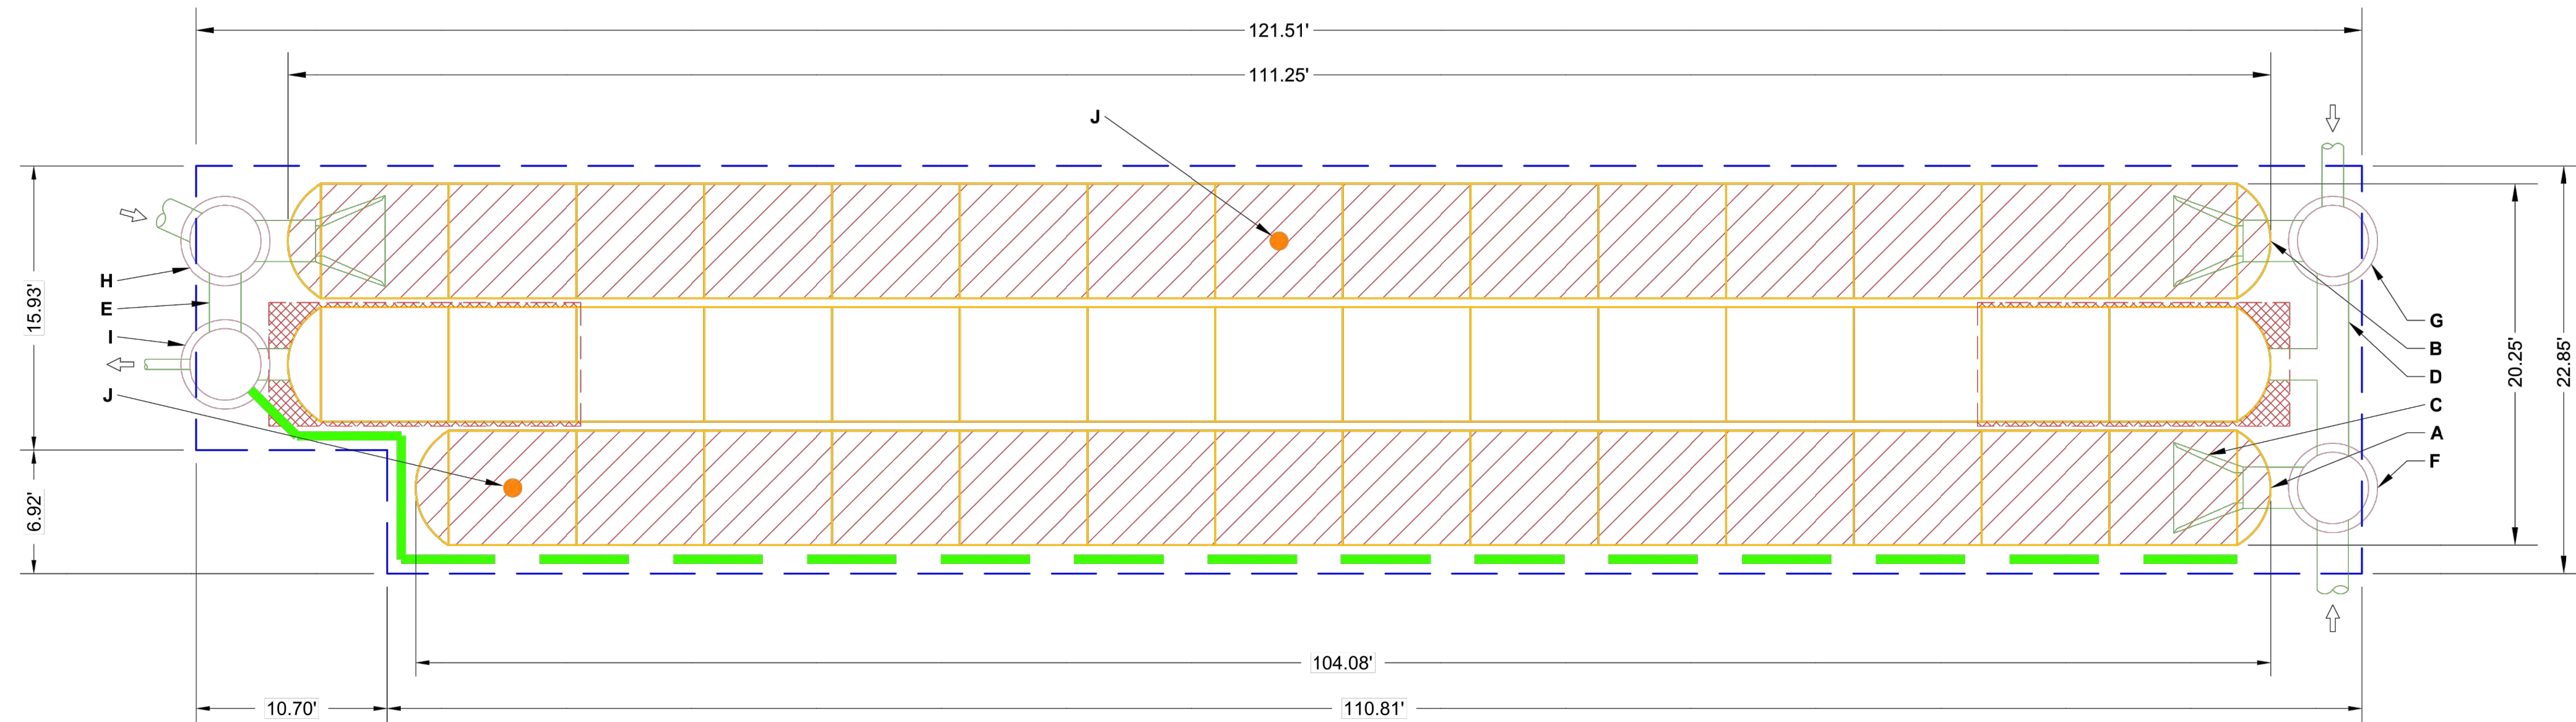
ISOLATOR ROW PLUS
(SEE DETAIL/TYP 2 PLACES)

PLACE MINIMUM 17.50' OF ADSPLUS175 WOVEN GEOTEXTILE OVER BEDDING STONE AND UNDERNEATH CHAMBER FEET FOR SCOUR PROTECTION AT ALL CHAMBER INLET ROWS

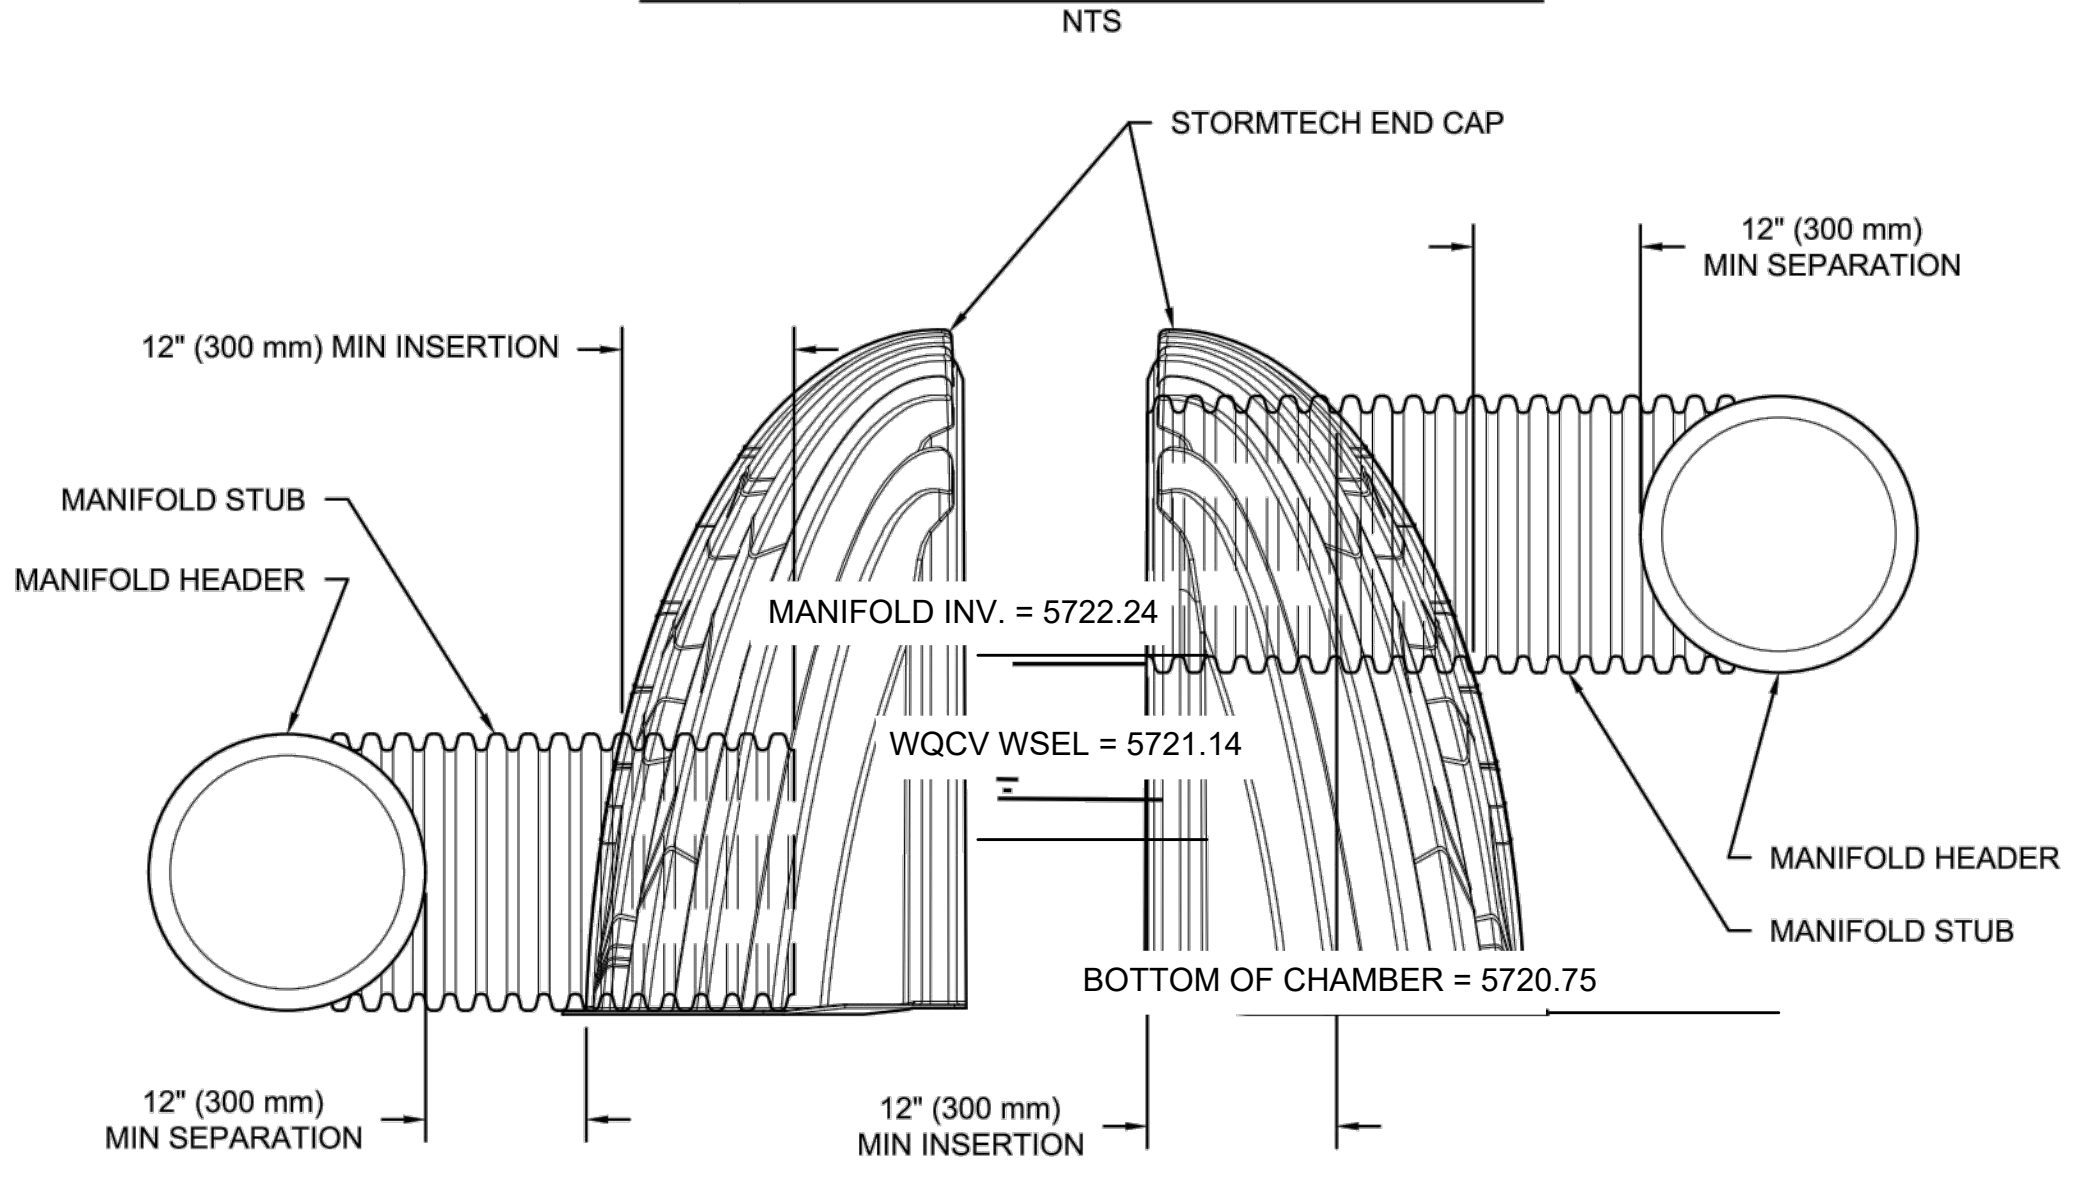
MC-SERIES END CAP INSERTION DETAIL

NOTE: MANIFOLD STUB MUST BE LAID HORIZONTAL FOR A PROPER FIT IN END CAP OPENING.

NOTE: ALL DIMENSIONS ARE NOMINAL
