Stormwater Management Facility Operation and Maintenance (O&M) Plan

Solace Apartments

SOLACE APARTMENTS –
FILING NO. 1
POND A I&M PLANS

SOLACE APARTMENTS – FILING NO. 1		POND A DETAILS	
SHEET	19	OF	32
JOB NO.	25174.00

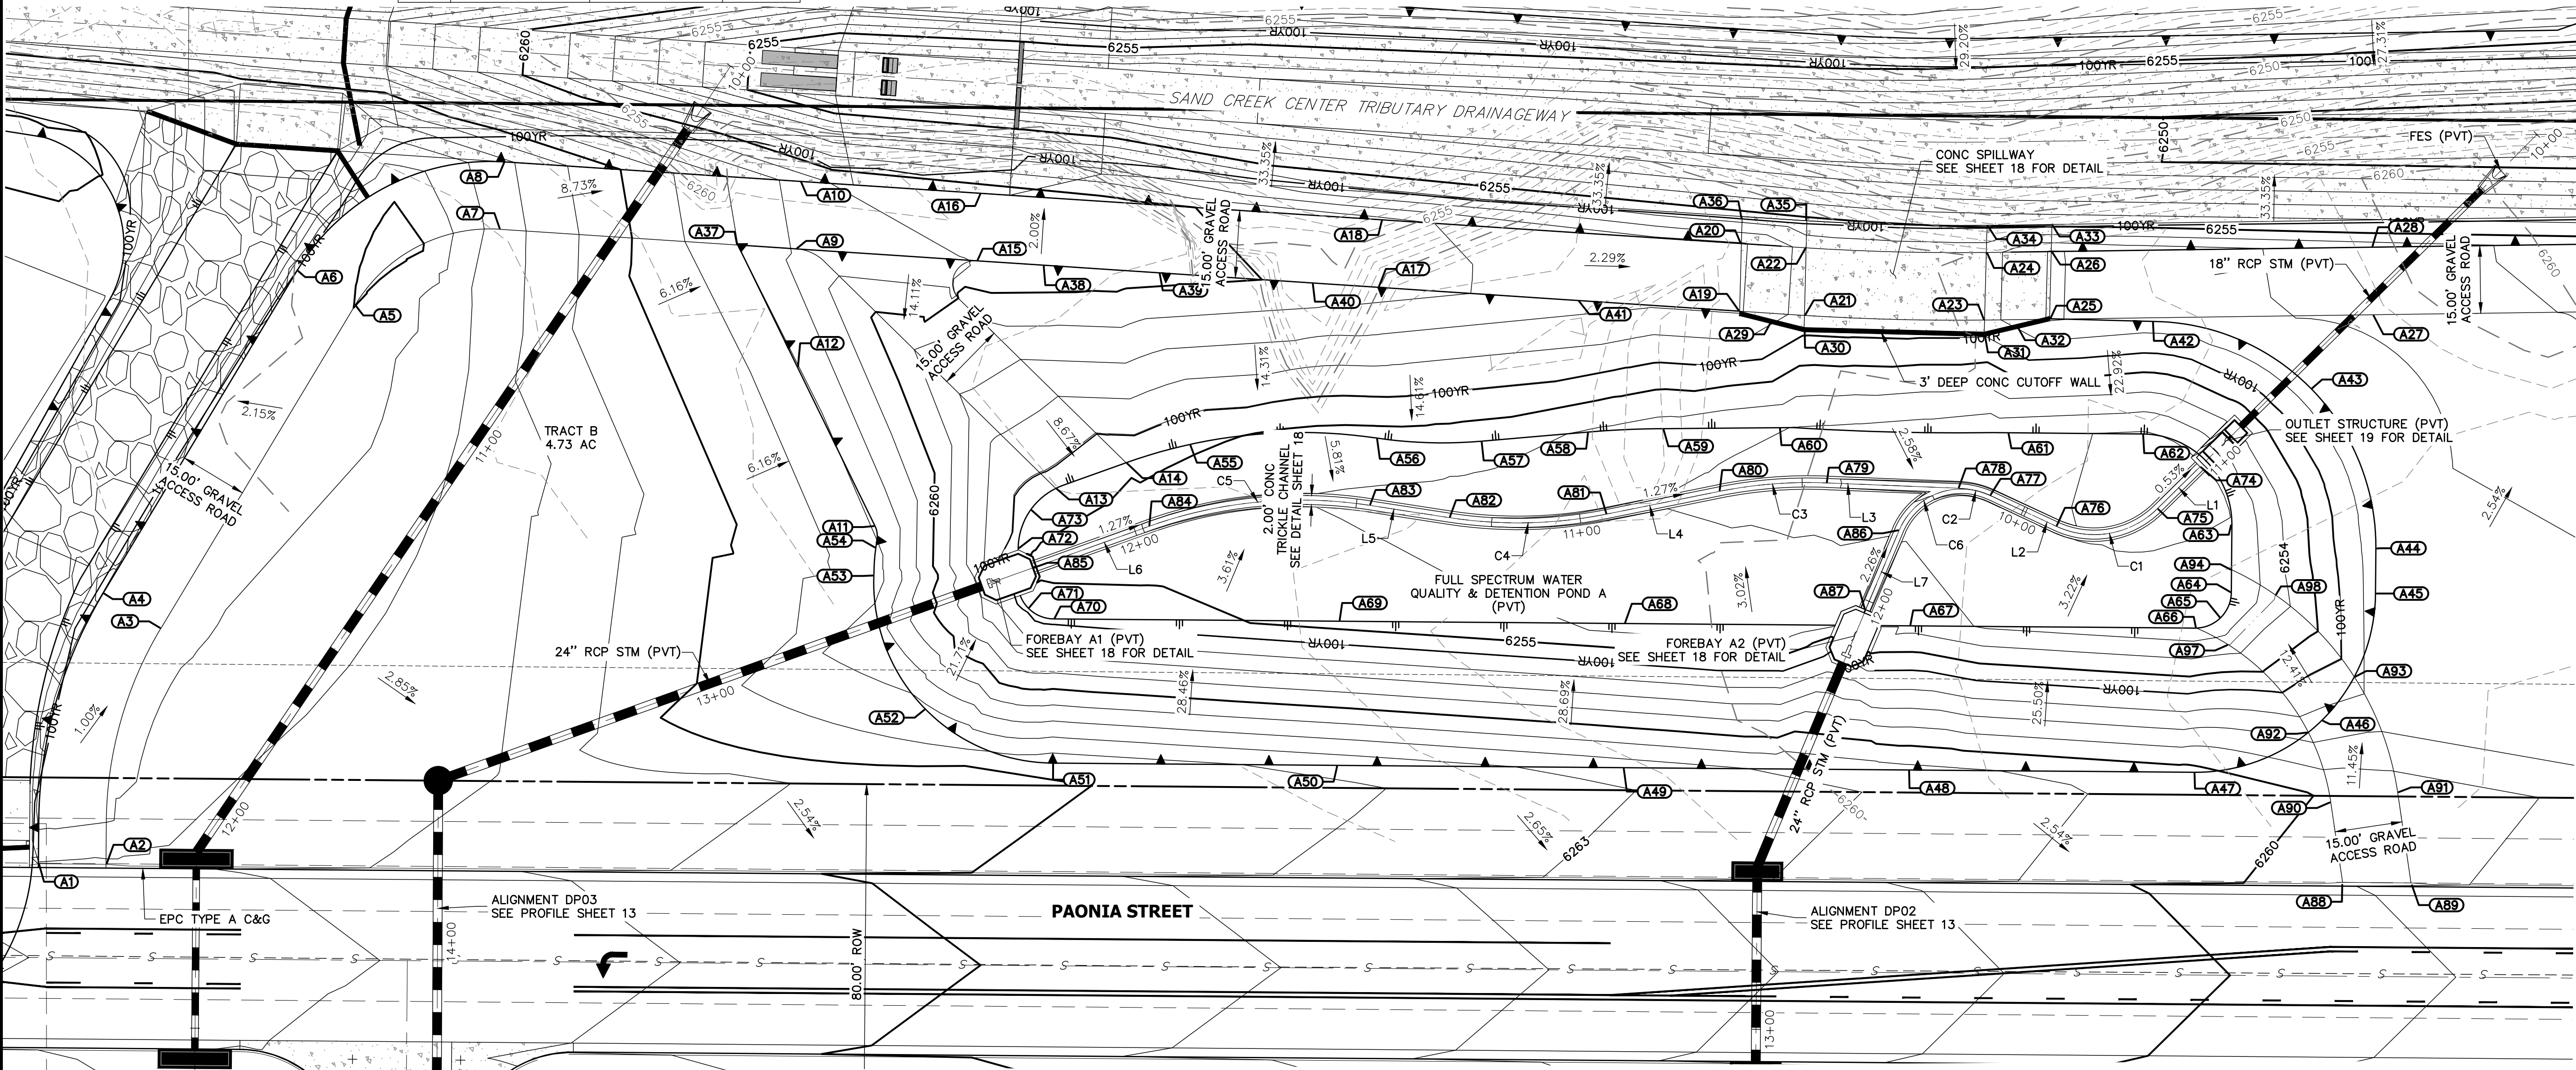
A17	ACCESS ROAD	N: 6012.06 E: 6374.21	6259.48	A37	ACCESS ROAD/TOP	N: 6154.20 E: 6383.60	6263.00	A57	TOE	N: 5989.23 E: 6340.05	6254.33	A77	TRICKLE CHANNEL INTERSECTION	N: 5876.29 E: 6328.05	6251.61				
A18	ACCESS ROAD	N: 6011.07 E: 6389.18	6259.22	A38	ACCESS ROAD/TOP	N: 6086.43 E: 6379.13	6260.82	A58	TOE	N: 5965.33 E: 6342.10	6253.91	A78	TRICKLE CHANNEL	N: 5883.34 E: 6329.62	6251.67				
A19	ACCESS ROAD/ SPILLWAY TOP/ CUTOFF WALL	N: 5931.83 E: 6368.92	6258.08	A39	ACCESS ROAD/TOP	N: 6060.71 E: 6377.43	6260.43	A59	TOE	N: 5948.88 E: 6342.83	6253.57	A79	TRICKLE CHANNEL	N: 5912.62 E: 6330.80	6252.04				
A20	ACCESS ROAD/ SPILLWAY TOP	N: 5931.44 E: 6383.92	6258.08	A40	ACCESS ROAD/TOP	N: 6026.71 E: 6375.18	6259.79	A60	TOE	N: 5923.02 E: 6343.05	6253.04	A80	TRICKLE CHANNEL	N: 5936.39 E: 6328.91	6252.35

POND A (7.89 TRIBUTARY ACRES, 49.43% COMP. IMPERVIOUSNESS)		
DESIGN STORM	STORAGE	STAGE
WQCV(AC-FT)	0.135	6253.49
EURV(AC-FT)	0.417	6254.77
100-YEAR(ACR-FT)	0.732	6255.7

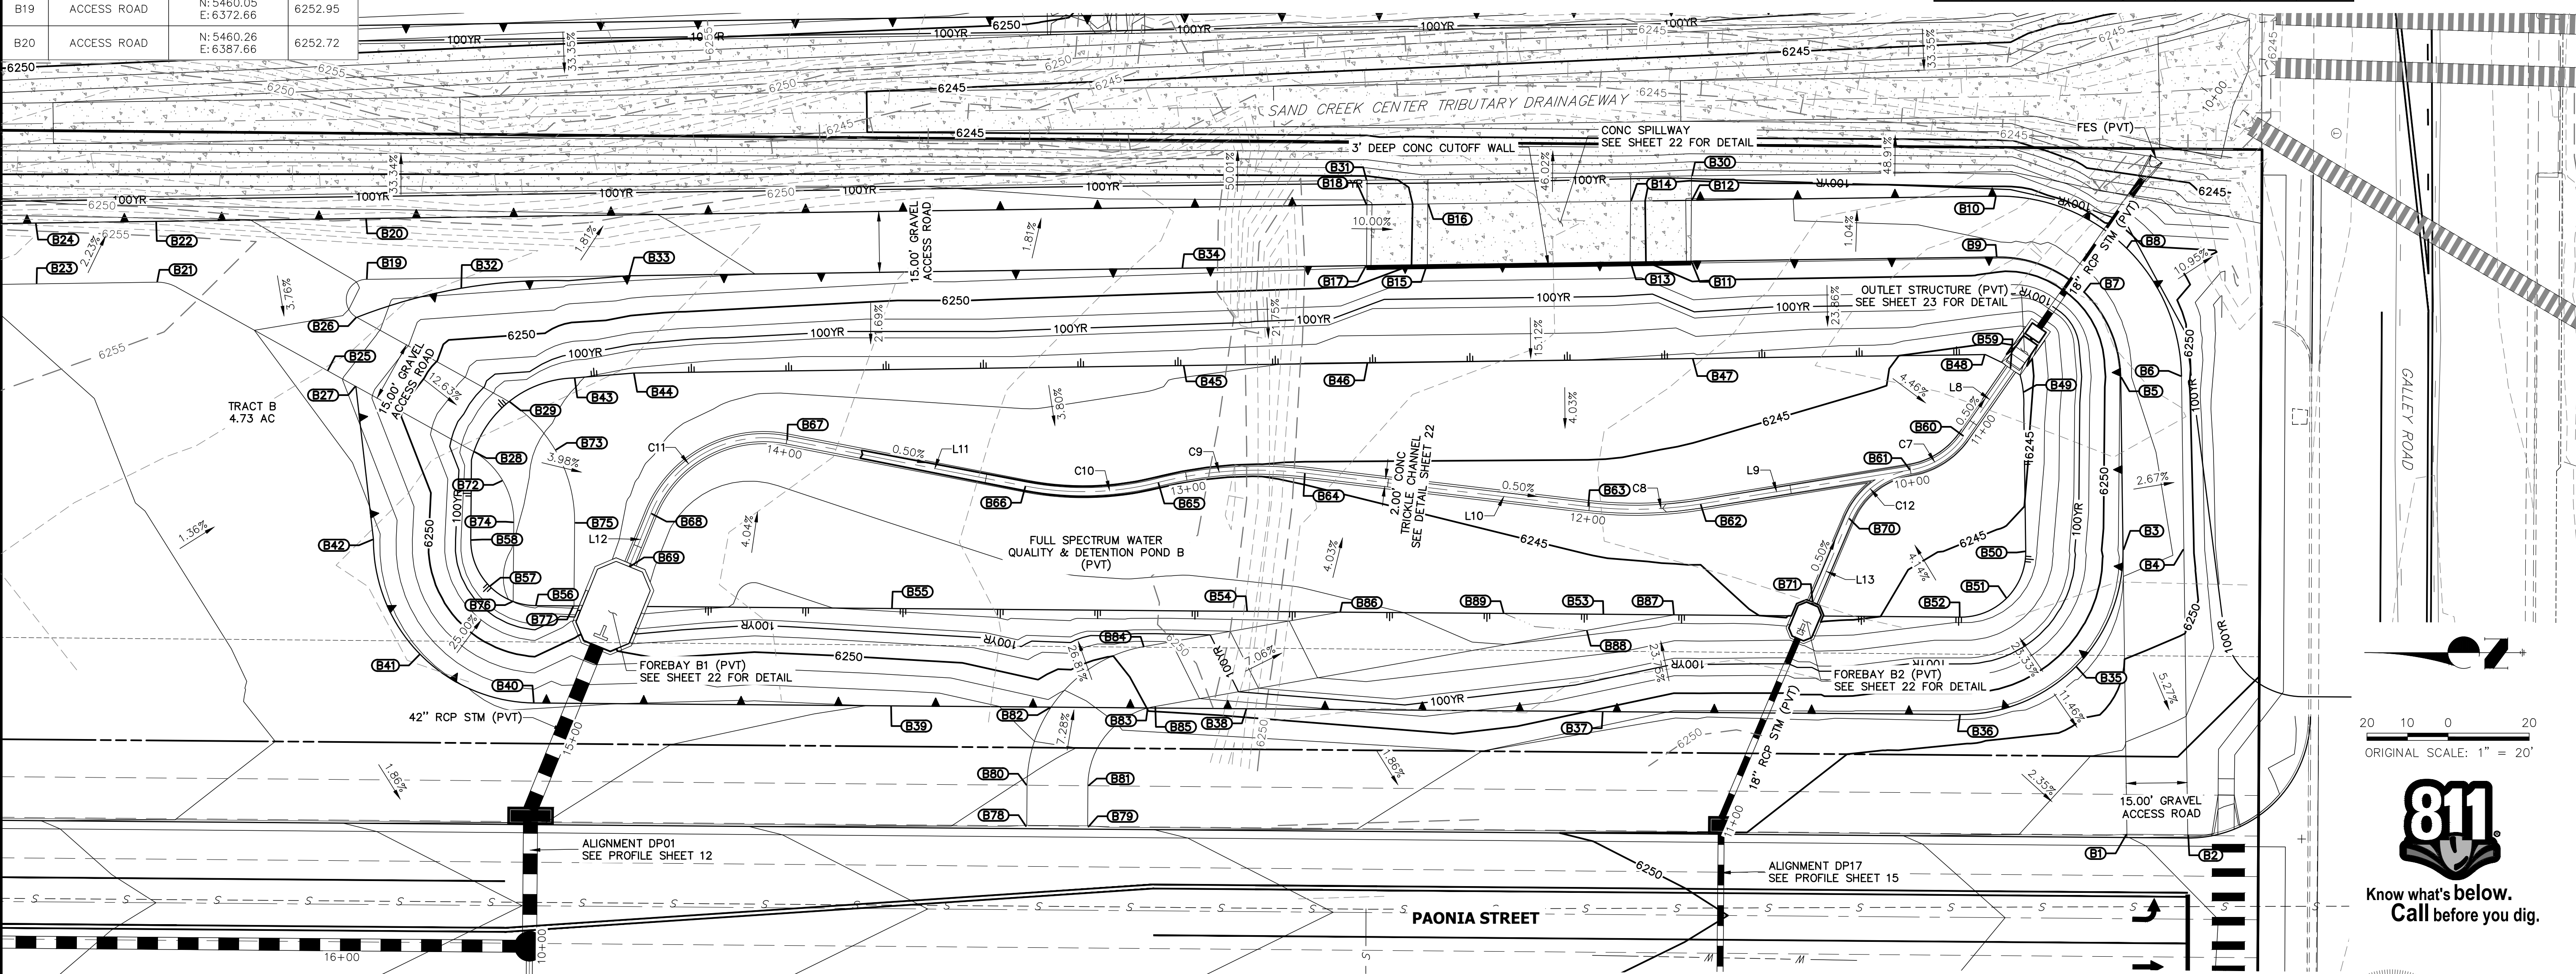
B17	ACCESS ROAD/ SPILLWAY TOP/ CUTOFF WALL	N: 5213.42 E: 6376.04	6251.11	B37	TOP	N: 5155.05 E: 6266.10	6250.20	B57	TOE	N: 5429.67 E: 6297.05	6247.13	B77	ACCESS ROAD/TOE	N: 5408.86 E: 6292.16	6246.63				
B18	ACCESS ROAD/ SPILLWAY TOP	N: 5213.31 E: 6391.04	6251.11	B38	TOP	N: 5242.91 E: 6266.81	6249.42	B58	TOE	N: 5434.30 E: 6308.41	6247.40	B78	ACCESS ROAD/TBC	N: 5297.21 E: 6237.75	6251.81				
B19	ACCESS ROAD	N: 5460.05 E: 6372.66	6252.95	B39	TOP	N: 5330.77 E: 6267.52	6252.95	B59	OUTLET STRUCTURE	N: 5054.56 E: 6350.61	6243.51	B79	ACCESS ROAD/TBC	N: 5282.21 E: 6237.63	6251.66				
B20	ACCESS ROAD	N: 5460.26 E: 6387.66	6252.72	B40	TOP	N: 5418.63 E: 6268.23	6252.85	B60	TRICKLE CHANNEL	N: 5066.08 E: 6334.01	6243.61	B80	ACCESS ROAD	N: 5297.13 E: 6247.96	6251.97

POND B (17.50 TRIBUTARY ACRES, 40.55% COMP. IMPERVIOUSNESS)		
DESIGN STORM	STORAGE	STAGE
WQCV (AC-FT)	0.264	6245.77
EURV (AC-FT)	0.746	6246.8
100-YEAR (ACR-FT)	1.412	6247.85
