**Stormwater Management Facility
Operation and Maintenance (O&M) Plan**

Solace Apartments Filing No. 1

PCD File Number: SF-20-032

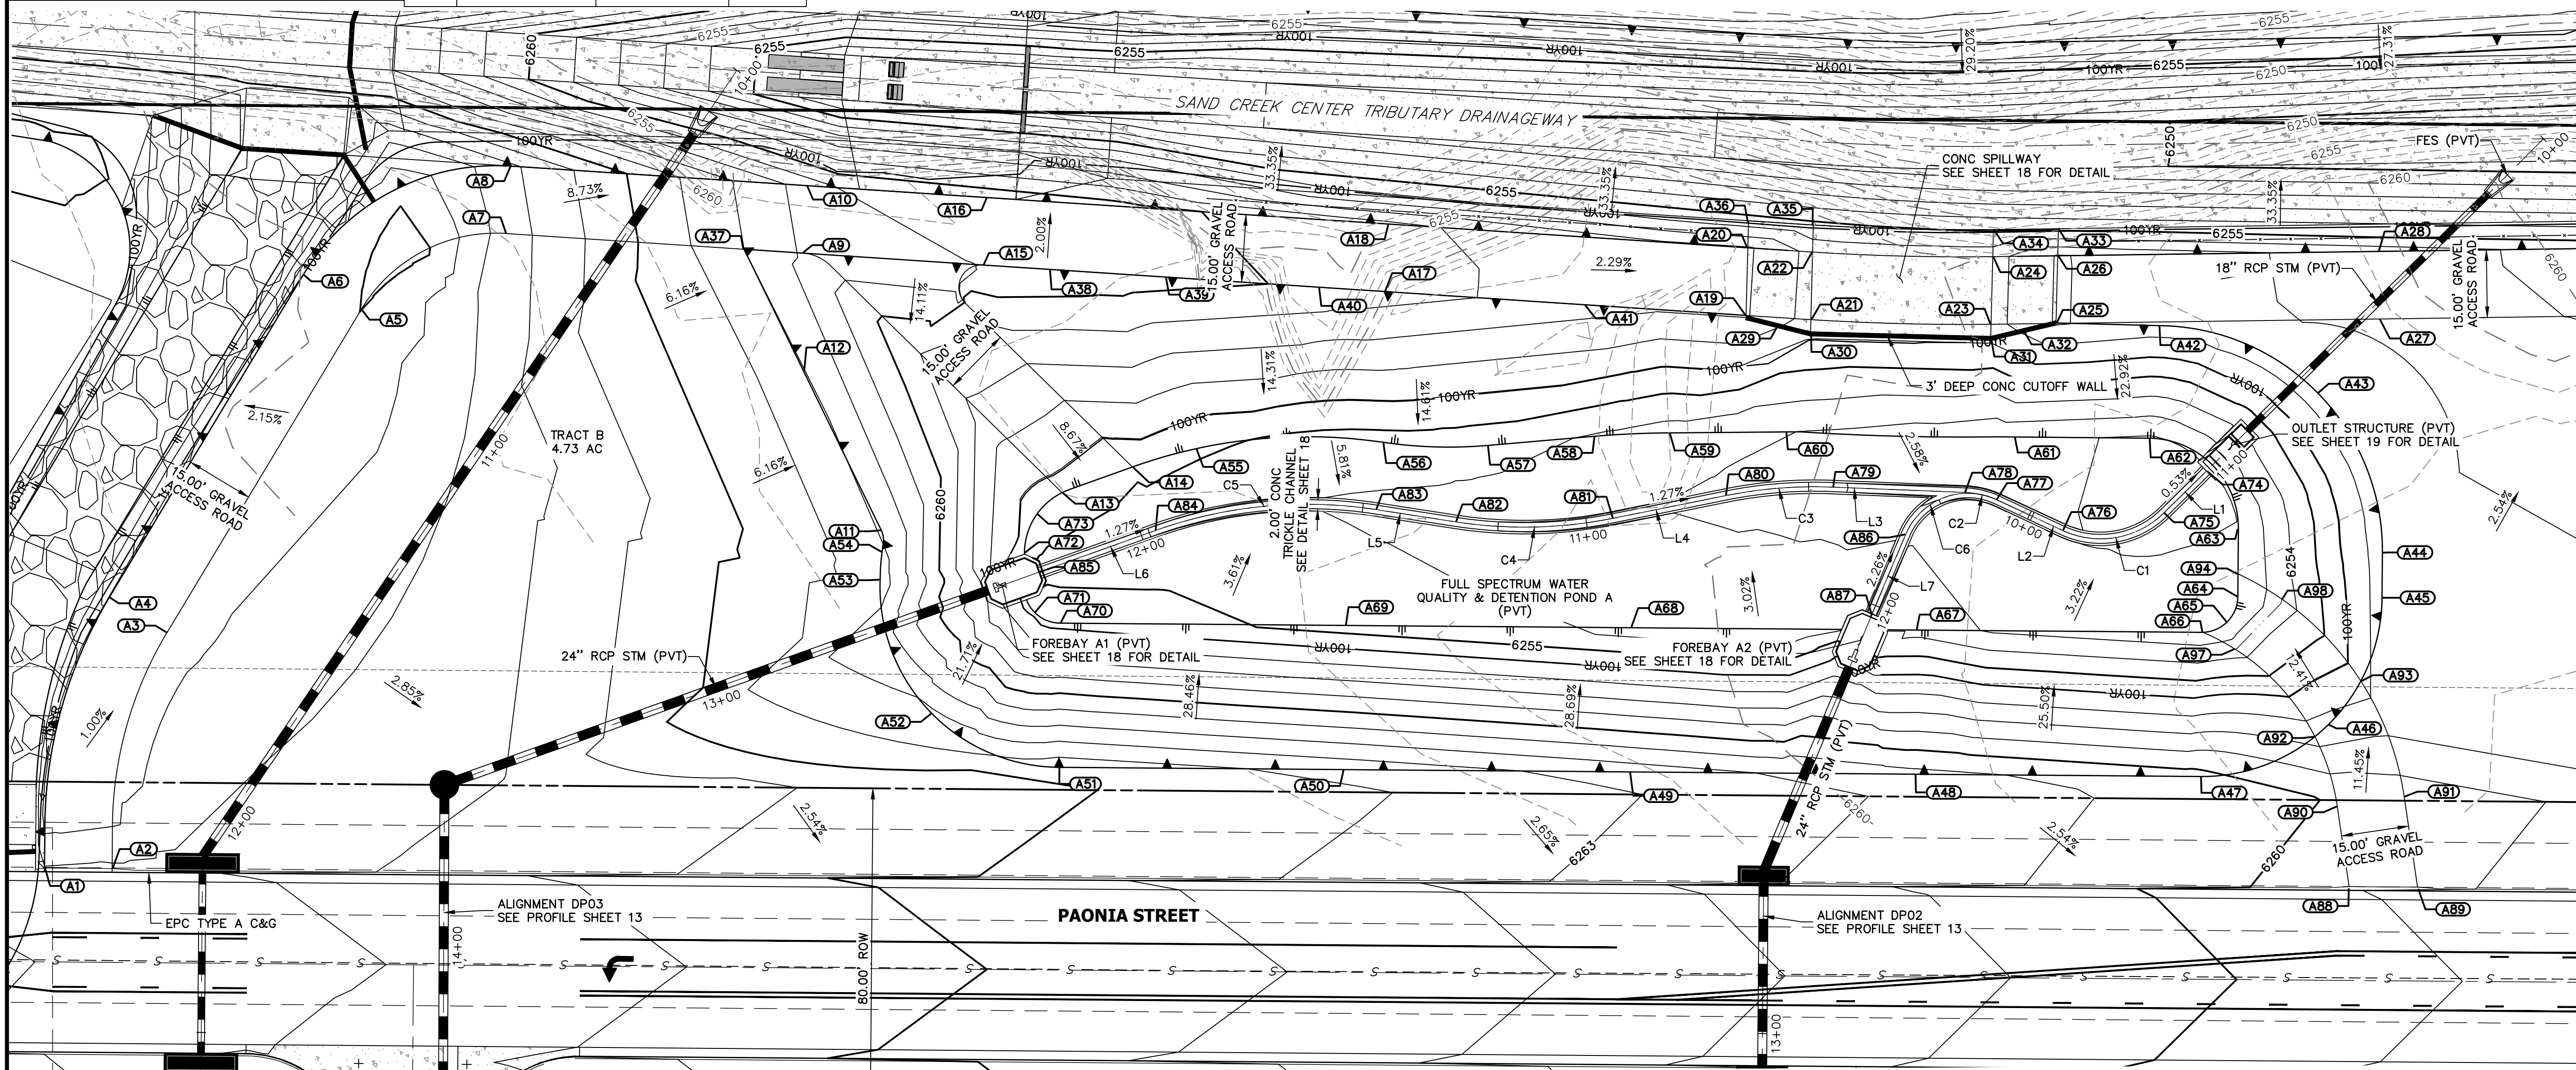
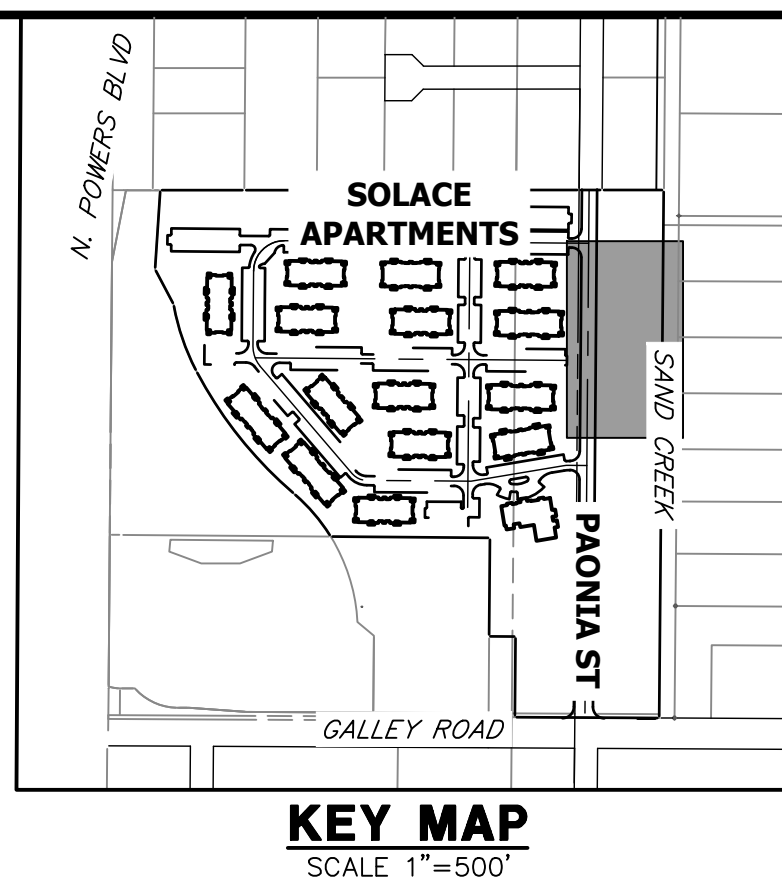
POND A
(7.89 TRIBUTARY ACRES,
49.43% COMP. IMPERVIOUSNESS)

DESIGN STORM	STORAGE	STAGE
WQCV (AC-FT)	0.135	6253.49
EURV (AC-FT)	0.417	6254.77
100-YEAR (ACR-FT)	0.732	6255.7

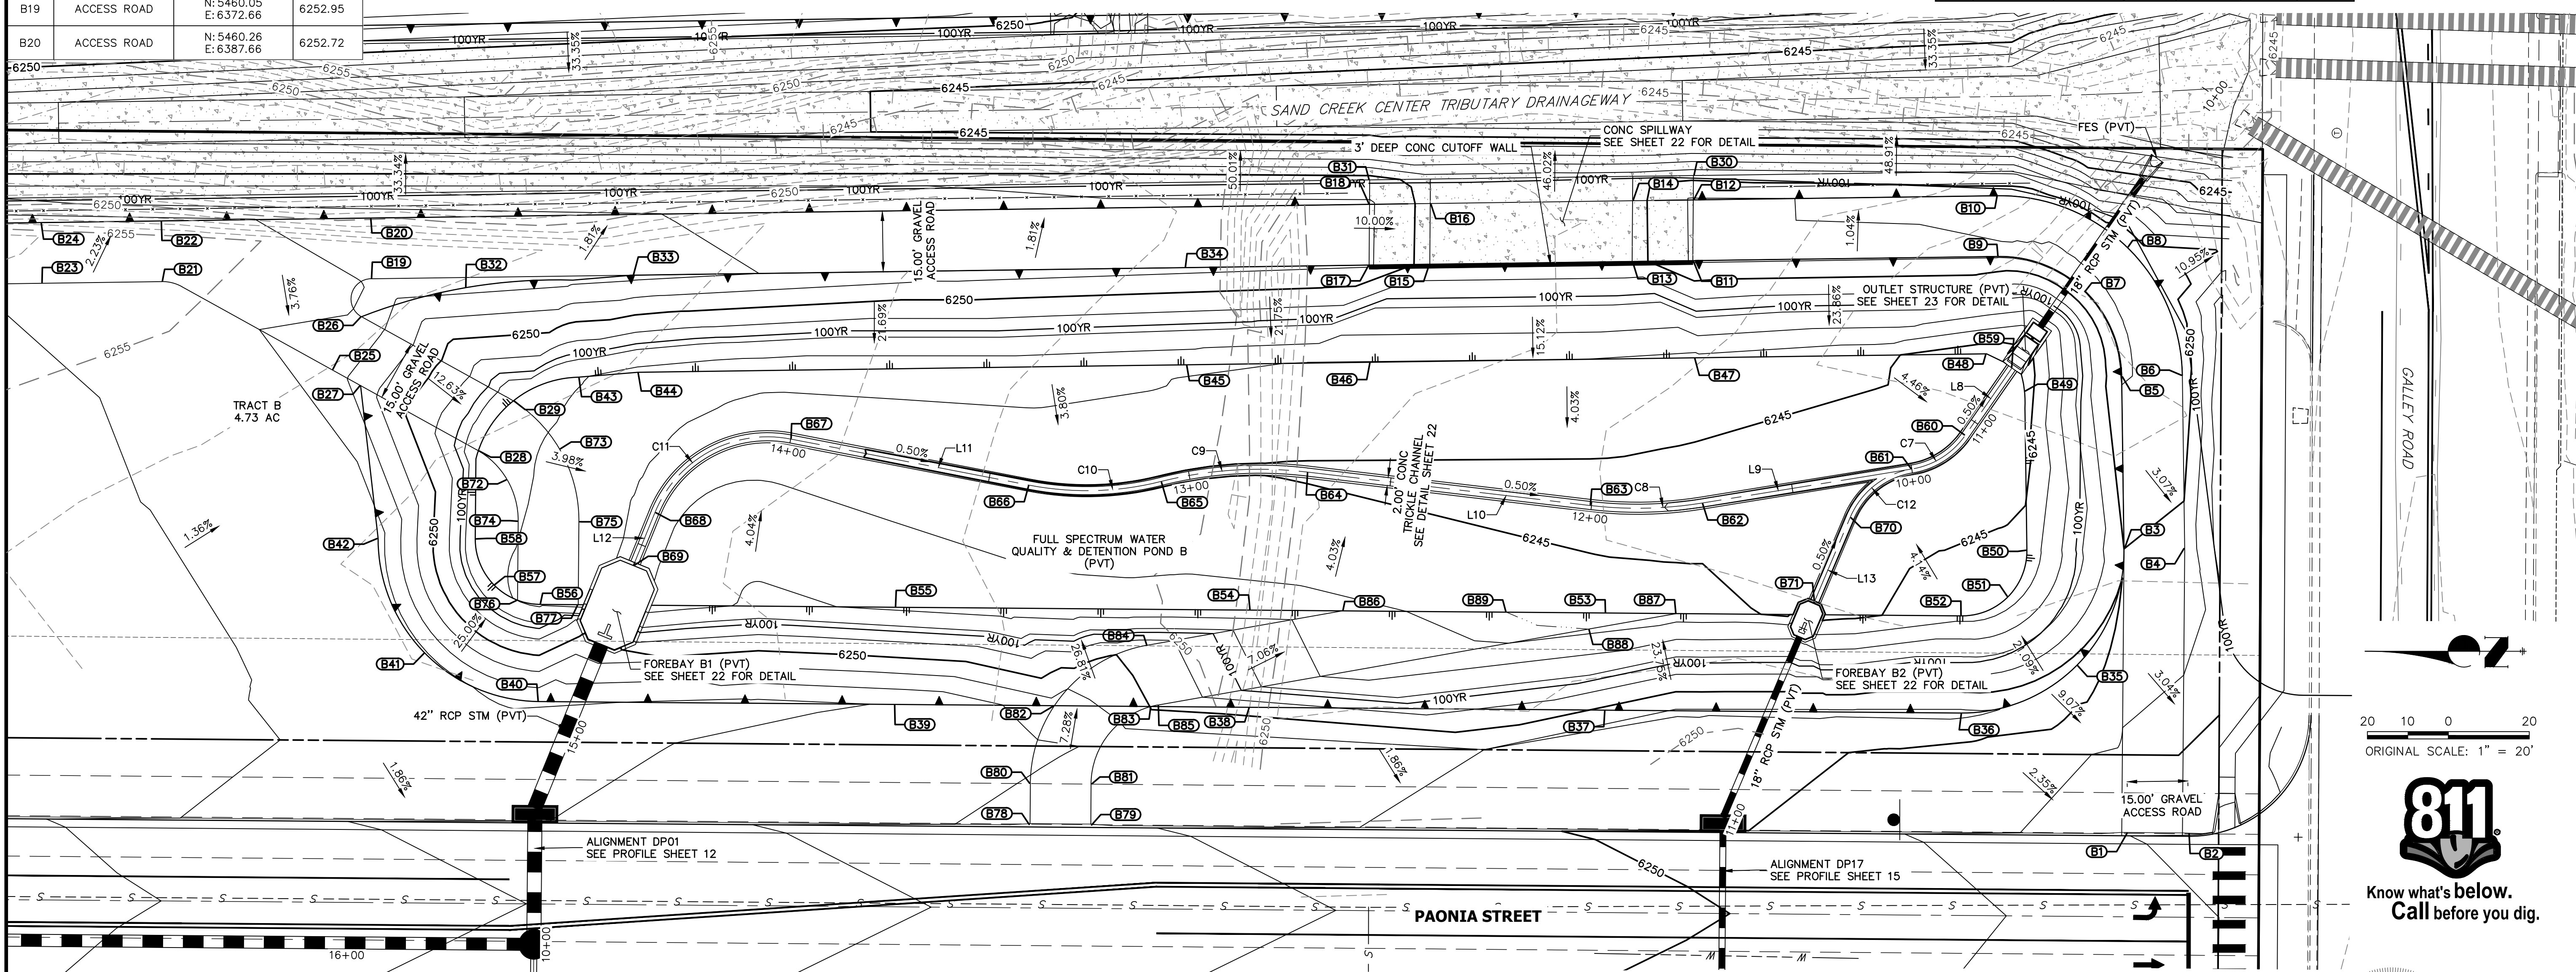
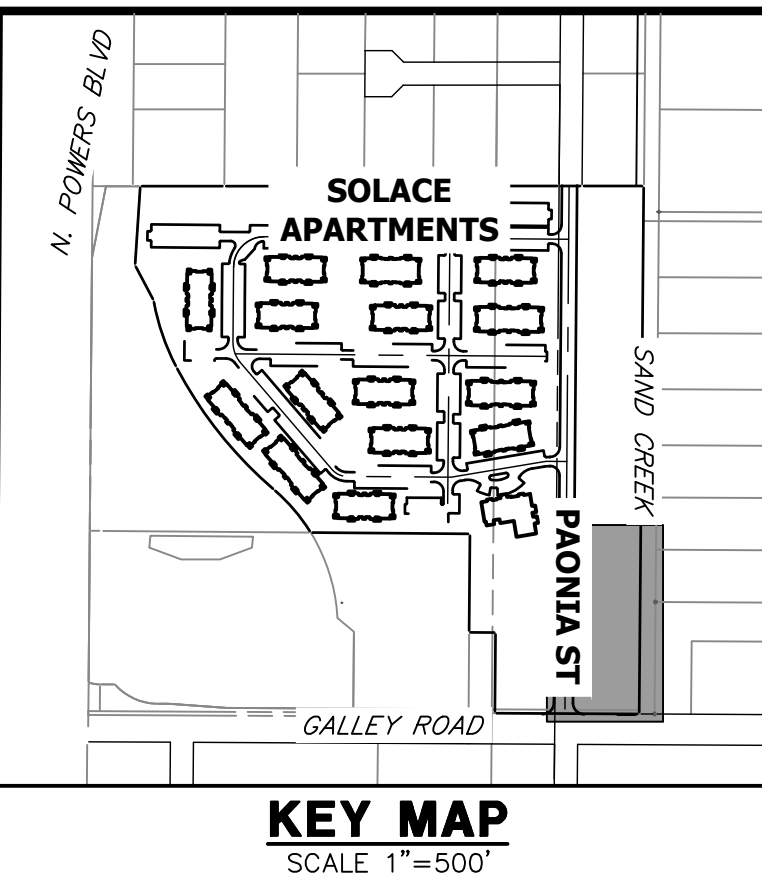
SOLACE APARTMENTS - FILING NO. 1
POND B I&M PLANS

POND B
(17.50 TRIBUTARY ACRES,
40.55% COMP. IMPERVIOUSNESS)

DESIGN STORM	STORAGE	STAGE
WQCV (AC-FT)	0.264	6245.77
EURV (AC-FT)	0.746	6246.88
100-YEAR (ACR-FT)	1.412	6247.85
