SOLACE OF COLORADO SPRINGS

NATURAL FEATURES AND HAZARD REPORT

DECEMBER 2020

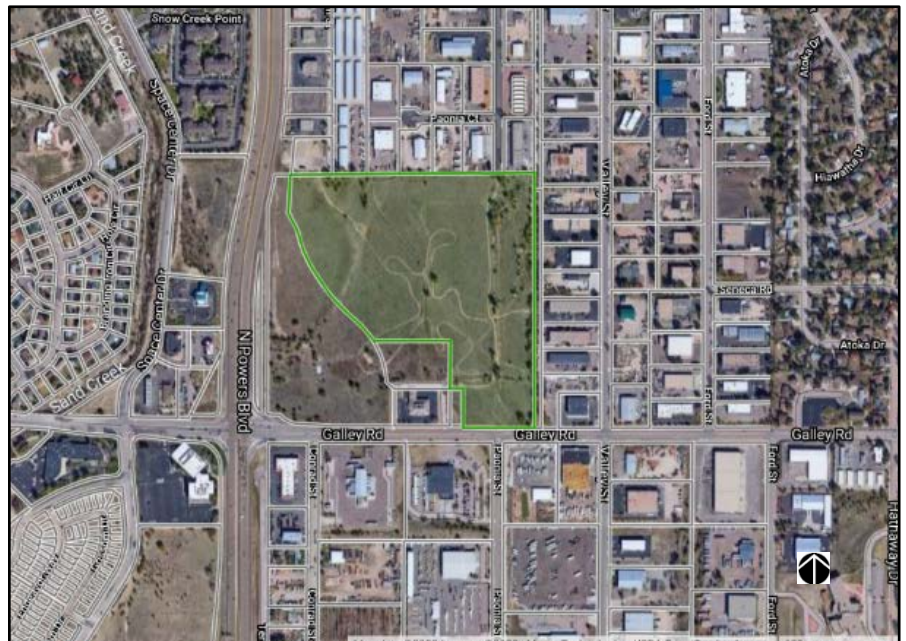
Provided with the submittal is a Sand Creek Tributary Channel Improvement letter and plans prepared by JR Engineering. The purpose of the letter is to provide design information for the existing conditions of the Sand Creek Center Tributary Drainageway. The letter also discusses the proposed improvements for the channel, design methodology, and the modeling results.

In summary, analysis of the proposed improvements of the Sand Creek Center Tributary Drainageway and its secondary drainageway located in Paonia Street show significant reduction of the floodplain extents, with it now being contained within the channel and no longer extensively flooding properties adjacent the proposed project. The proposed diversion channel also redirects flow that would otherwise flood the proposed extension of Paonia Street back into the channel, thus alleviating the risk of the roadway flooding in a 100 year event.
