PONDEROSA PINE ESTATES

WATER RESOURCES REPORT

December 12, 2023

Memorandum

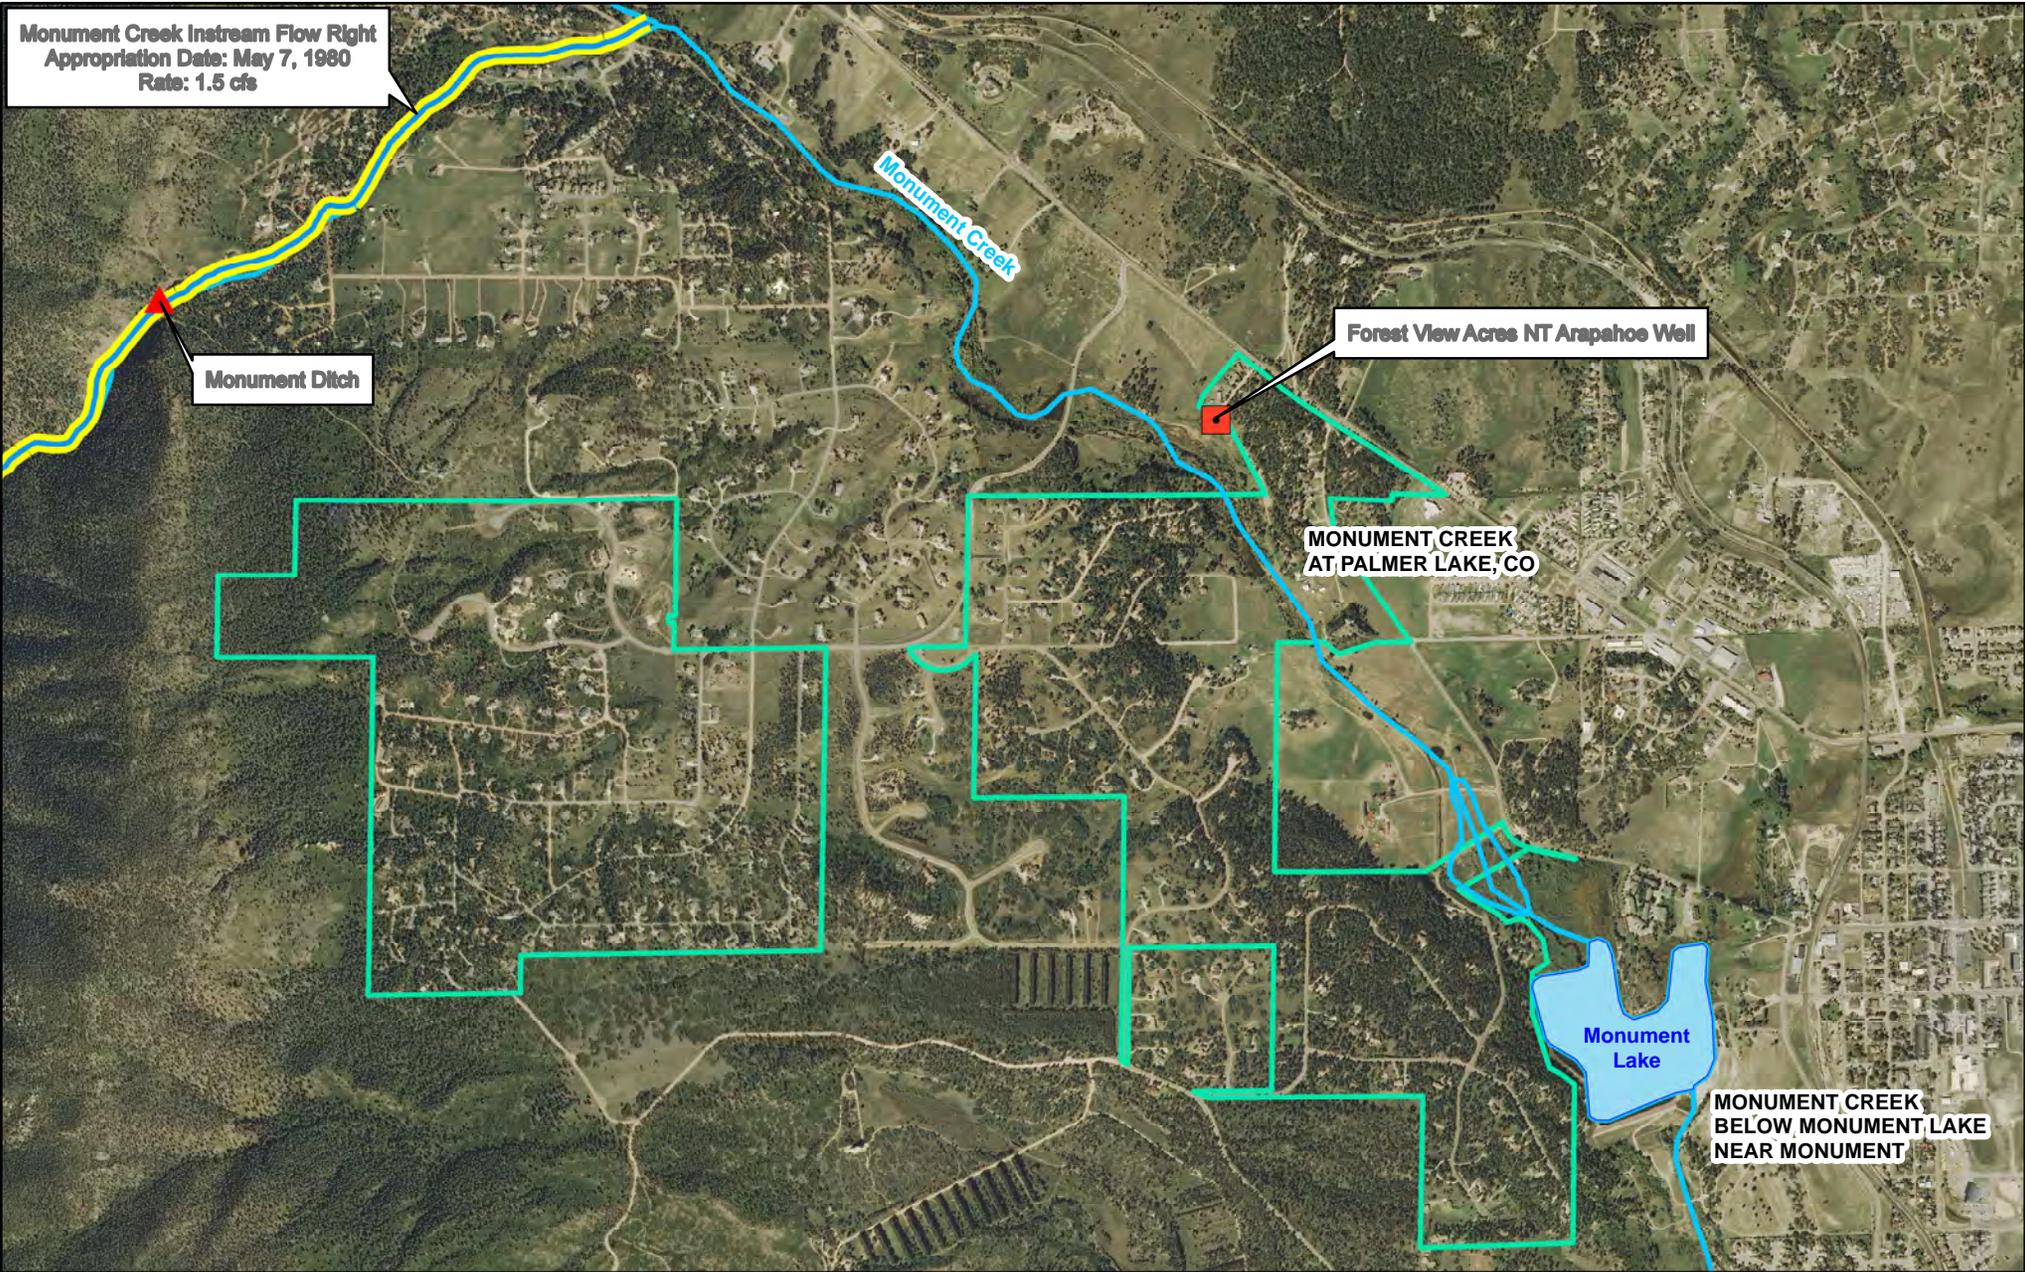
FIGURE 1
FOREST VIEW ACRES
WATER DISTRICT
GENERAL LOCATION MAP

FVAWD provides water service for residents within its District using a combination of surface water and groundwater supplies. Currently, the District serves approximately 342 homes (single-family equivalents, or SFEs), and may serve as many as 358 SFEs in the future. Figure 1, attached, is a general location map illustrating the extent of the FVAWD boundaries, the location of water supply sources and infrastructure supporting FVAWD water service.
