**WASTEWATER STUDY
FLYING HORSE NORTH
SKETCH PLAN
EL PASO COUNTY, COLORADO**

January 23, 2024

PCD File No. SKP223

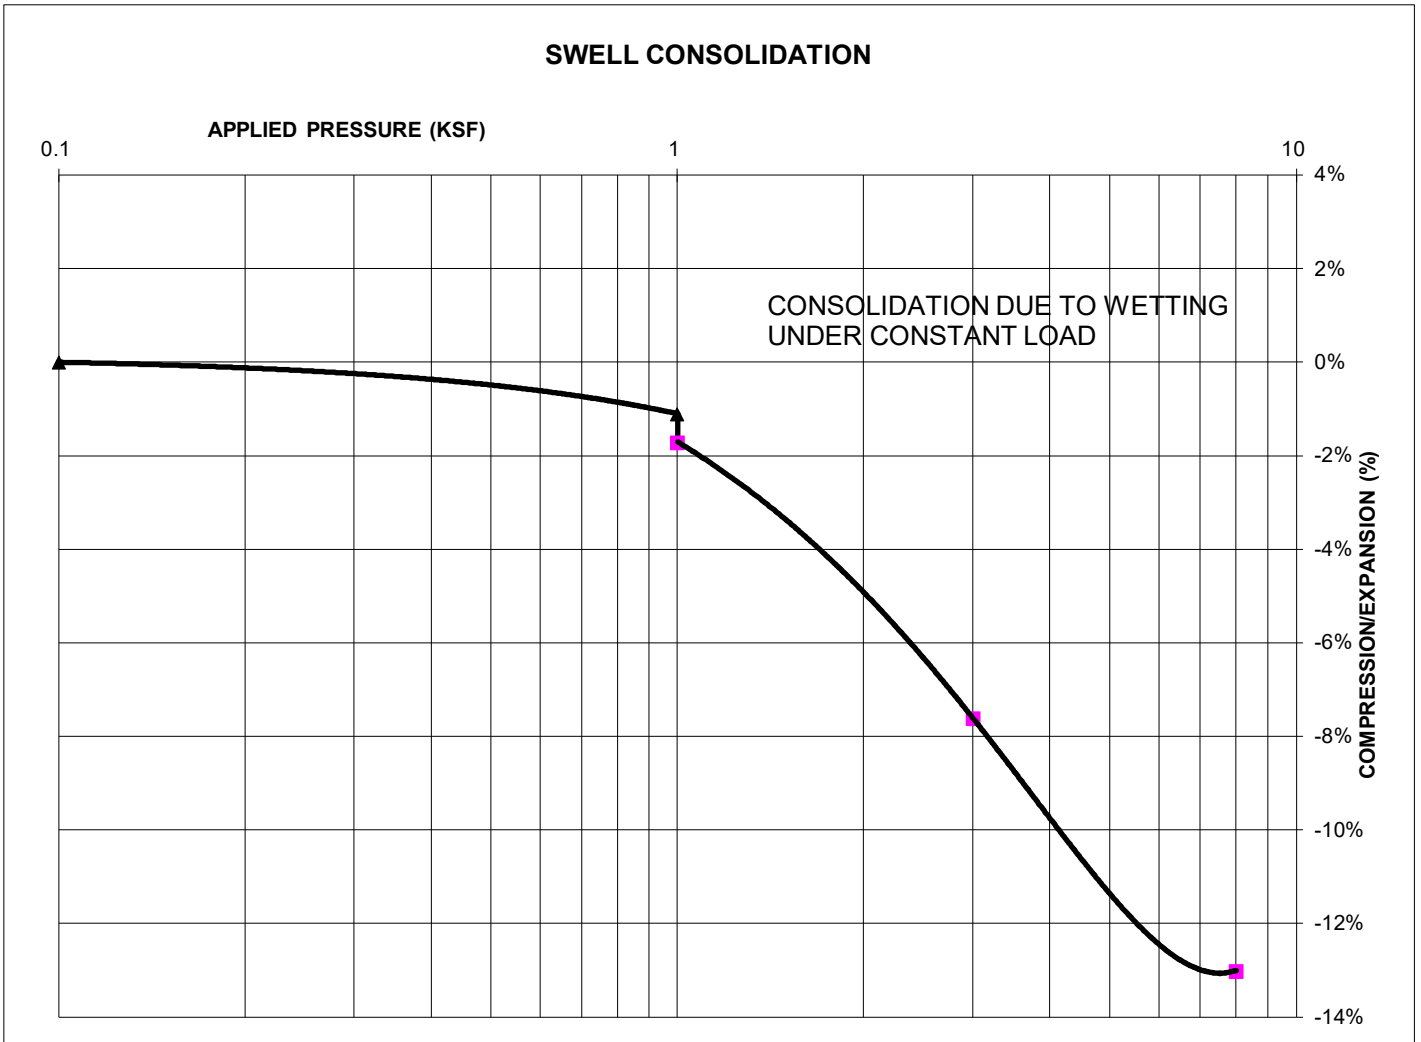
SWELL/CONSOLIDATION TEST RESULTS

TEST BORING 9
DEPTH (FT) 5

SOIL DESCRIPTION CLAY, SANDY
SOIL TYPE 2

NATURAL UNIT DRY WEIGHT (PCF): 95
NATURAL MOISTURE CONTENT: 11.8%
SWELL/CONSOLIDATION (%): -0.6%
