**PRIVATE DETENTION BASIN /
STORMWATER QUALITY BEST MANAGEMENT PRACTICE
MAINTENANCE AGREEMENT AND EASEMENT**

B. WHEREAS, Developer desires to plat and develop on the Property a subdivision to be known as **Hay Creek Valley Subdivision**, and

Exhibit C – Operation & Maintenance Manual

Standard Operation Procedures
for
Inspection and Maintenance
of
Extended Detention Basin(s)

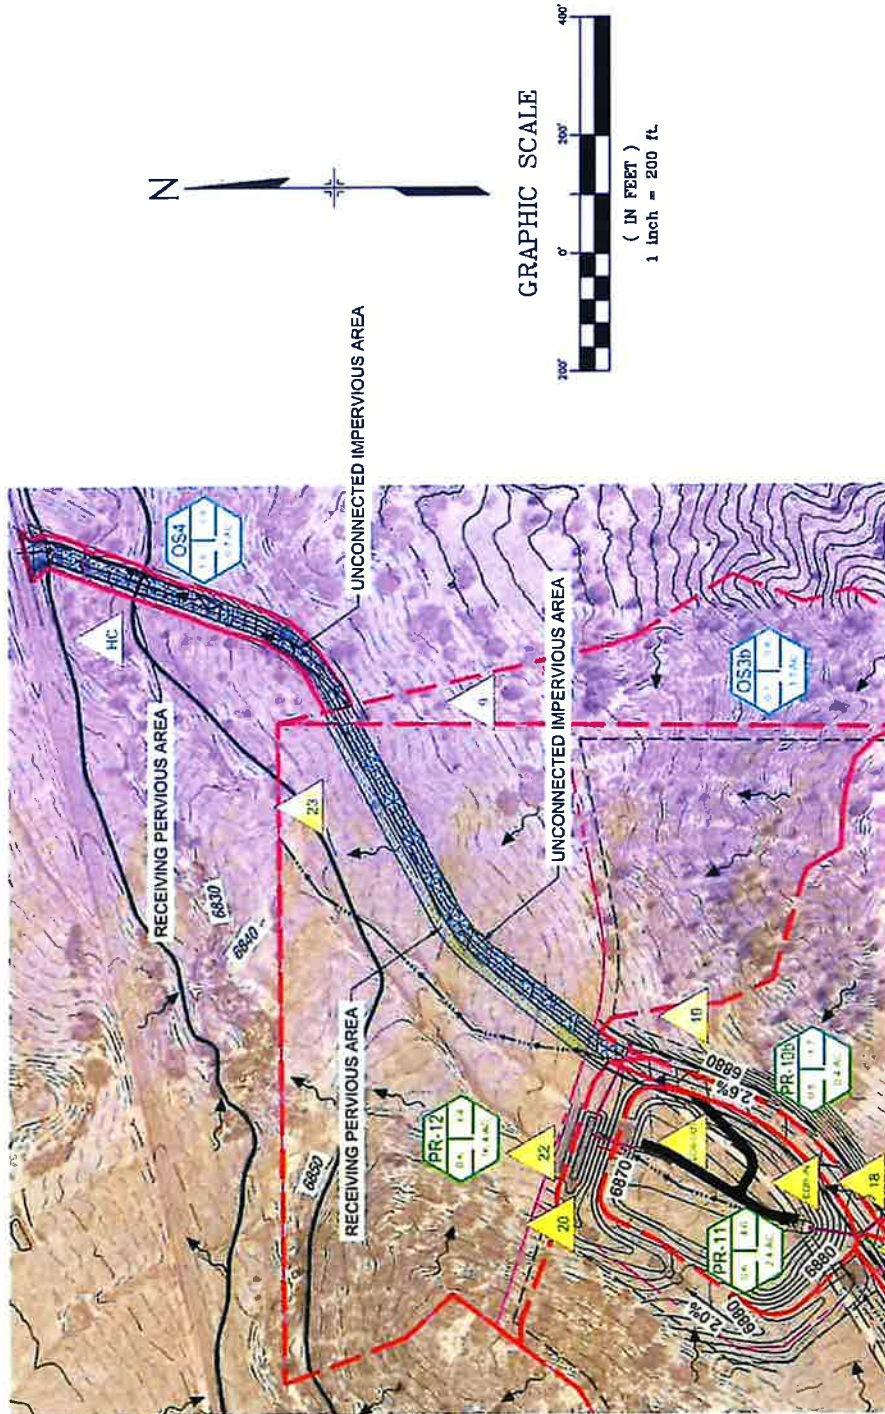
Exhibit B – Pond Location Exhibit

Legal Description: Tract B, Hay Creek Valley

(Image is an excerpt from the Hay Creek Valley Final Drainage Report Dated Jan. 2024)

- 1) Located in Tract B in the central-eastern region of the site.
- 2) Access is provided to the pond from a private access road directly off of White Bear Point, a private roadway.
- 3) The spillway is located on the east side of the pond. In the event of structure clogging and/or failure, overflows will be routed east into an existing ditch that ultimately ties in to Hay Creek.
- 4) An armored swale & spillway, concrete forebay, concrete outlet structure, concrete trickle channel, & access road are proposed as typically constructed with full spectrum detention ponds. A proposed 18" RCP storm outlet discharges onto a proposed rip rap pad in an existing ditch directly downstream. In the event of structure clogging and/or failure, overflows will be routed east into the existing ditch that ultimately ties in to Hay Creek.
