Stormwater Management Facility Operation and Maintenance (O&M) Plan

Cornerstone Estates

JR Engineering; 5475 Tech Center Drive, Colorado Springs, CO 80919

10/05/2021

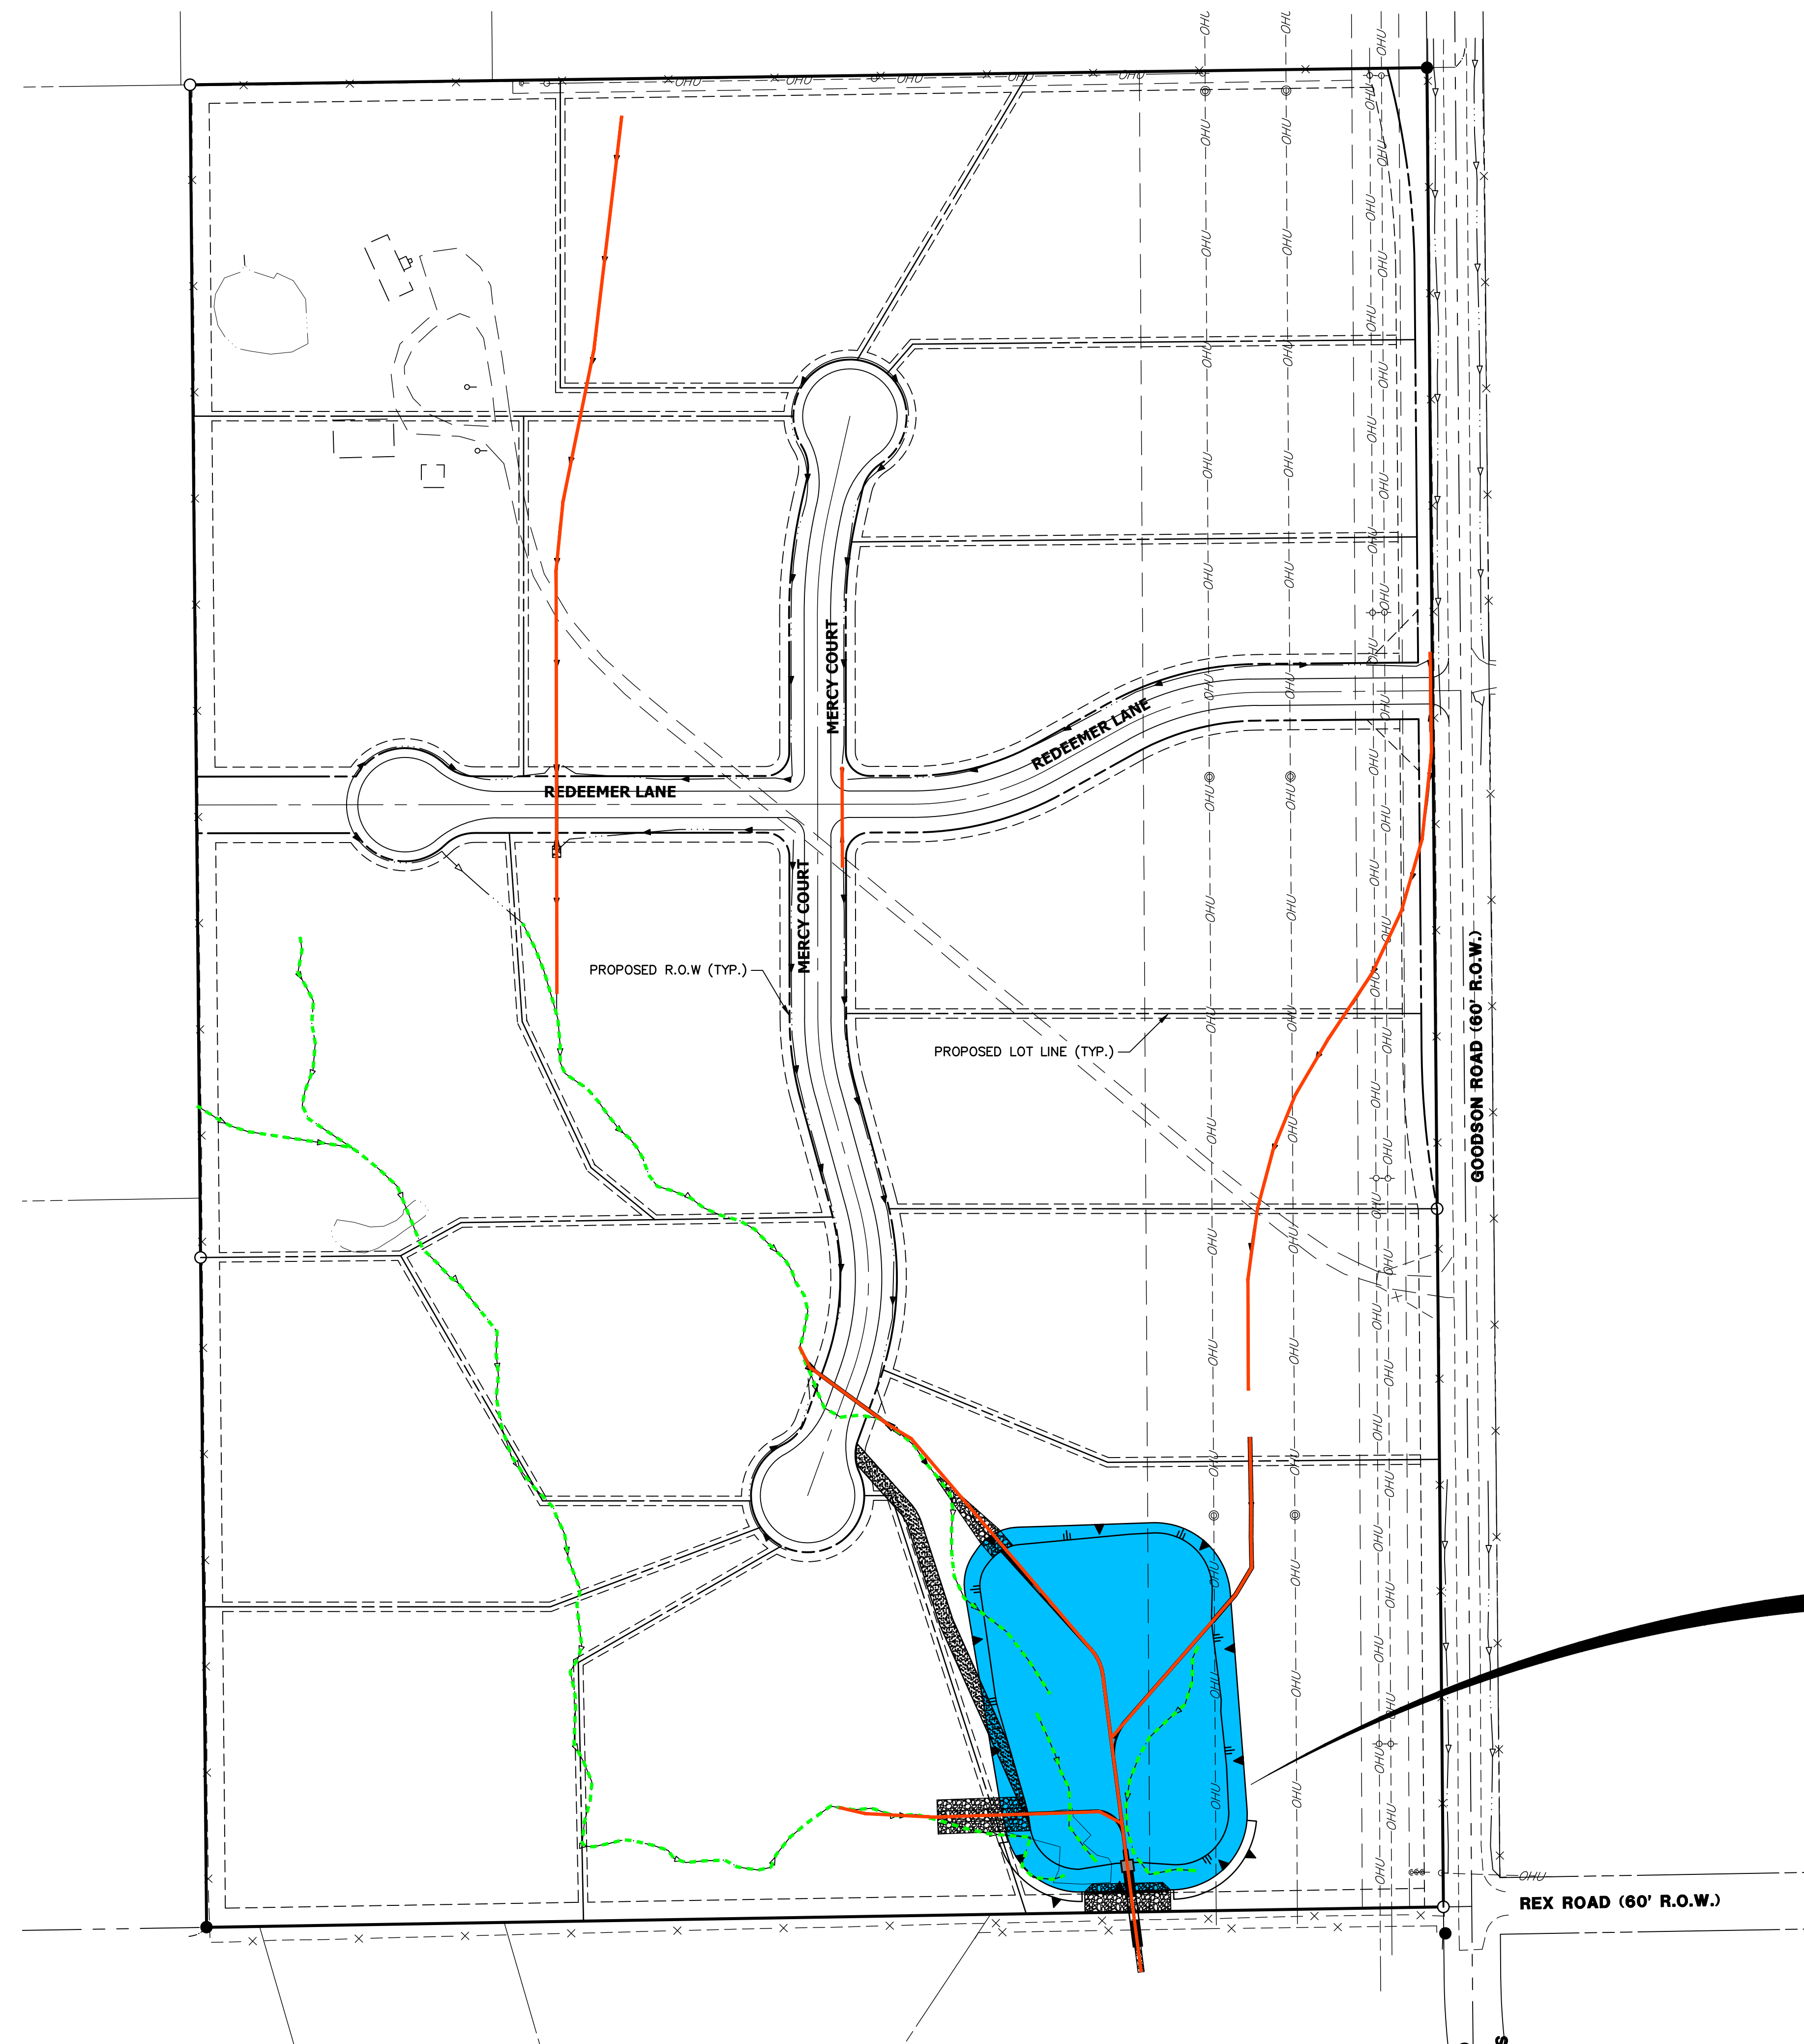
CORNERSTONE ESTATES
STORMWATER FACILITIES MAP
JOB NO. 25229.00
10-05-21
SHEET 1 OF 1

CORNERSTONE
ESTATES POND
