**WASTEWATER STUDY
JAYNES PROPERTY – PRELIMINARY PLAN
POCO ROAD AND VOLLMER ROAD
EL PASO COUNTY, COLORADO**

Prepared for:
**Elite Properties of America, LLC
2138 Flying Horse Club Drive
Colorado Springs, CO 80921**

November 21, 2023

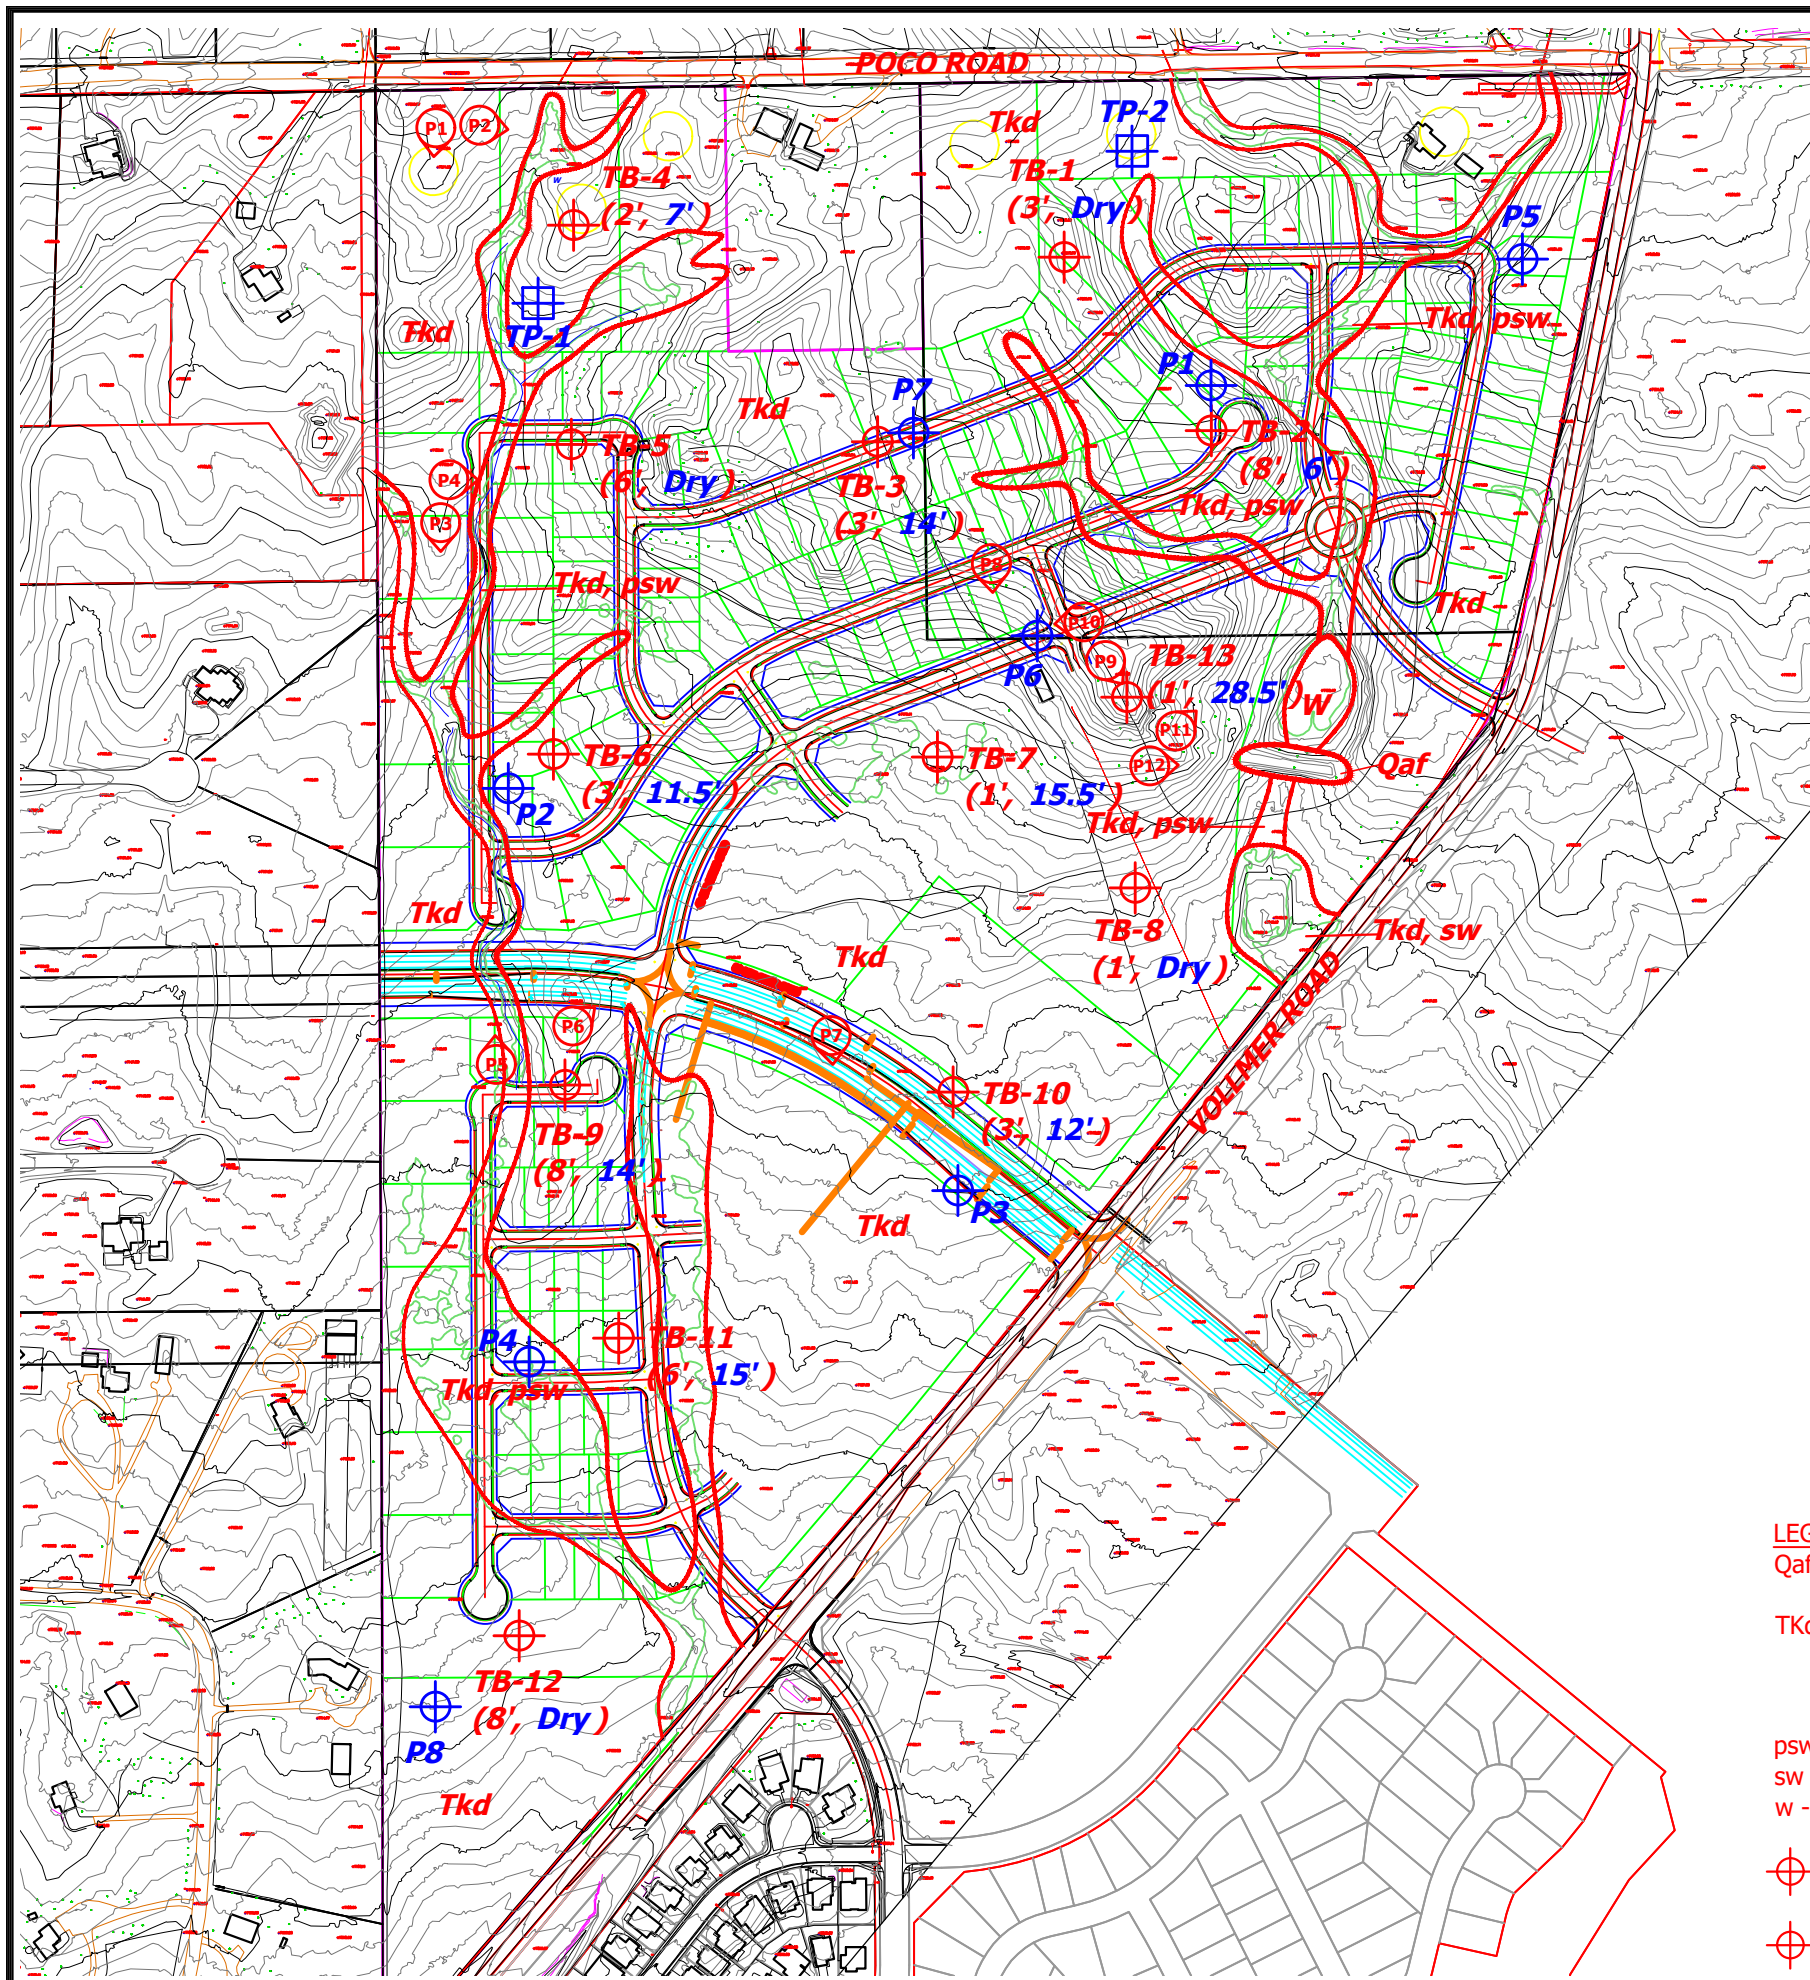
JOB NO.
212381
FIG. 6

- Qaf - Artificial Fill of Quaternary Age:
man-made fill deposits
- Tkd - Dawson Formation of Tertiary to Cretaceous Age:
variable layer of sheetwash and residual soil deposits overlying
arkosic sandstone with siltstone and claystone lenses
- psw - potential seasonally shallow groundwater area
- sw - seasonally wet area
- w - areas of ponded/flowing water
- ⊕ - TB- APPROXIMATE TEST BORING LOCATION AND NUMBER
(depth of bedrock in feet, depth of groundwater in feet)
- ⊕ - P- APPROXIMATE PIEZOMETER LOCATION AND NUMBER

GEOLOGY/ENGINEERING MAP
 JAYNES SITE
 POCO ROAD & VOLLMER ROAD
 EL PASO COUNTY, CO
 ELITE PROPERTIES OF AMERICA, INC.

The Falcon NW Quadrangle Geology Map showing the site is presented in Figure 5 (Reference 4). The Geology Map prepared for the site is presented in Figure 6. Three mappable units were identified on this site which are described as follows:

- Qaf Artificial Fill of Quaternary Age:** These recent man-made deposits associated with a fill berm located in the southern portion of the site. The berm is currently located in the proposed pond area and will likely be removed during site grading.
- Tkd Dawson Formation of Tertiary to Cretaceous Age:** The Dawson formation typically consists of arkosic sandstone with interbedded fine-grained sandstone, siltstone and claystone. Overlying this formation is a variable layer of residual and/or colluvial soils. The residual soils were derived from the in-situ weathering of the bedrock materials on-site. The colluvial soils have been transported by the action of sheetwash and gravity. These soils consisted of silty to clayey sands and sandy clays.

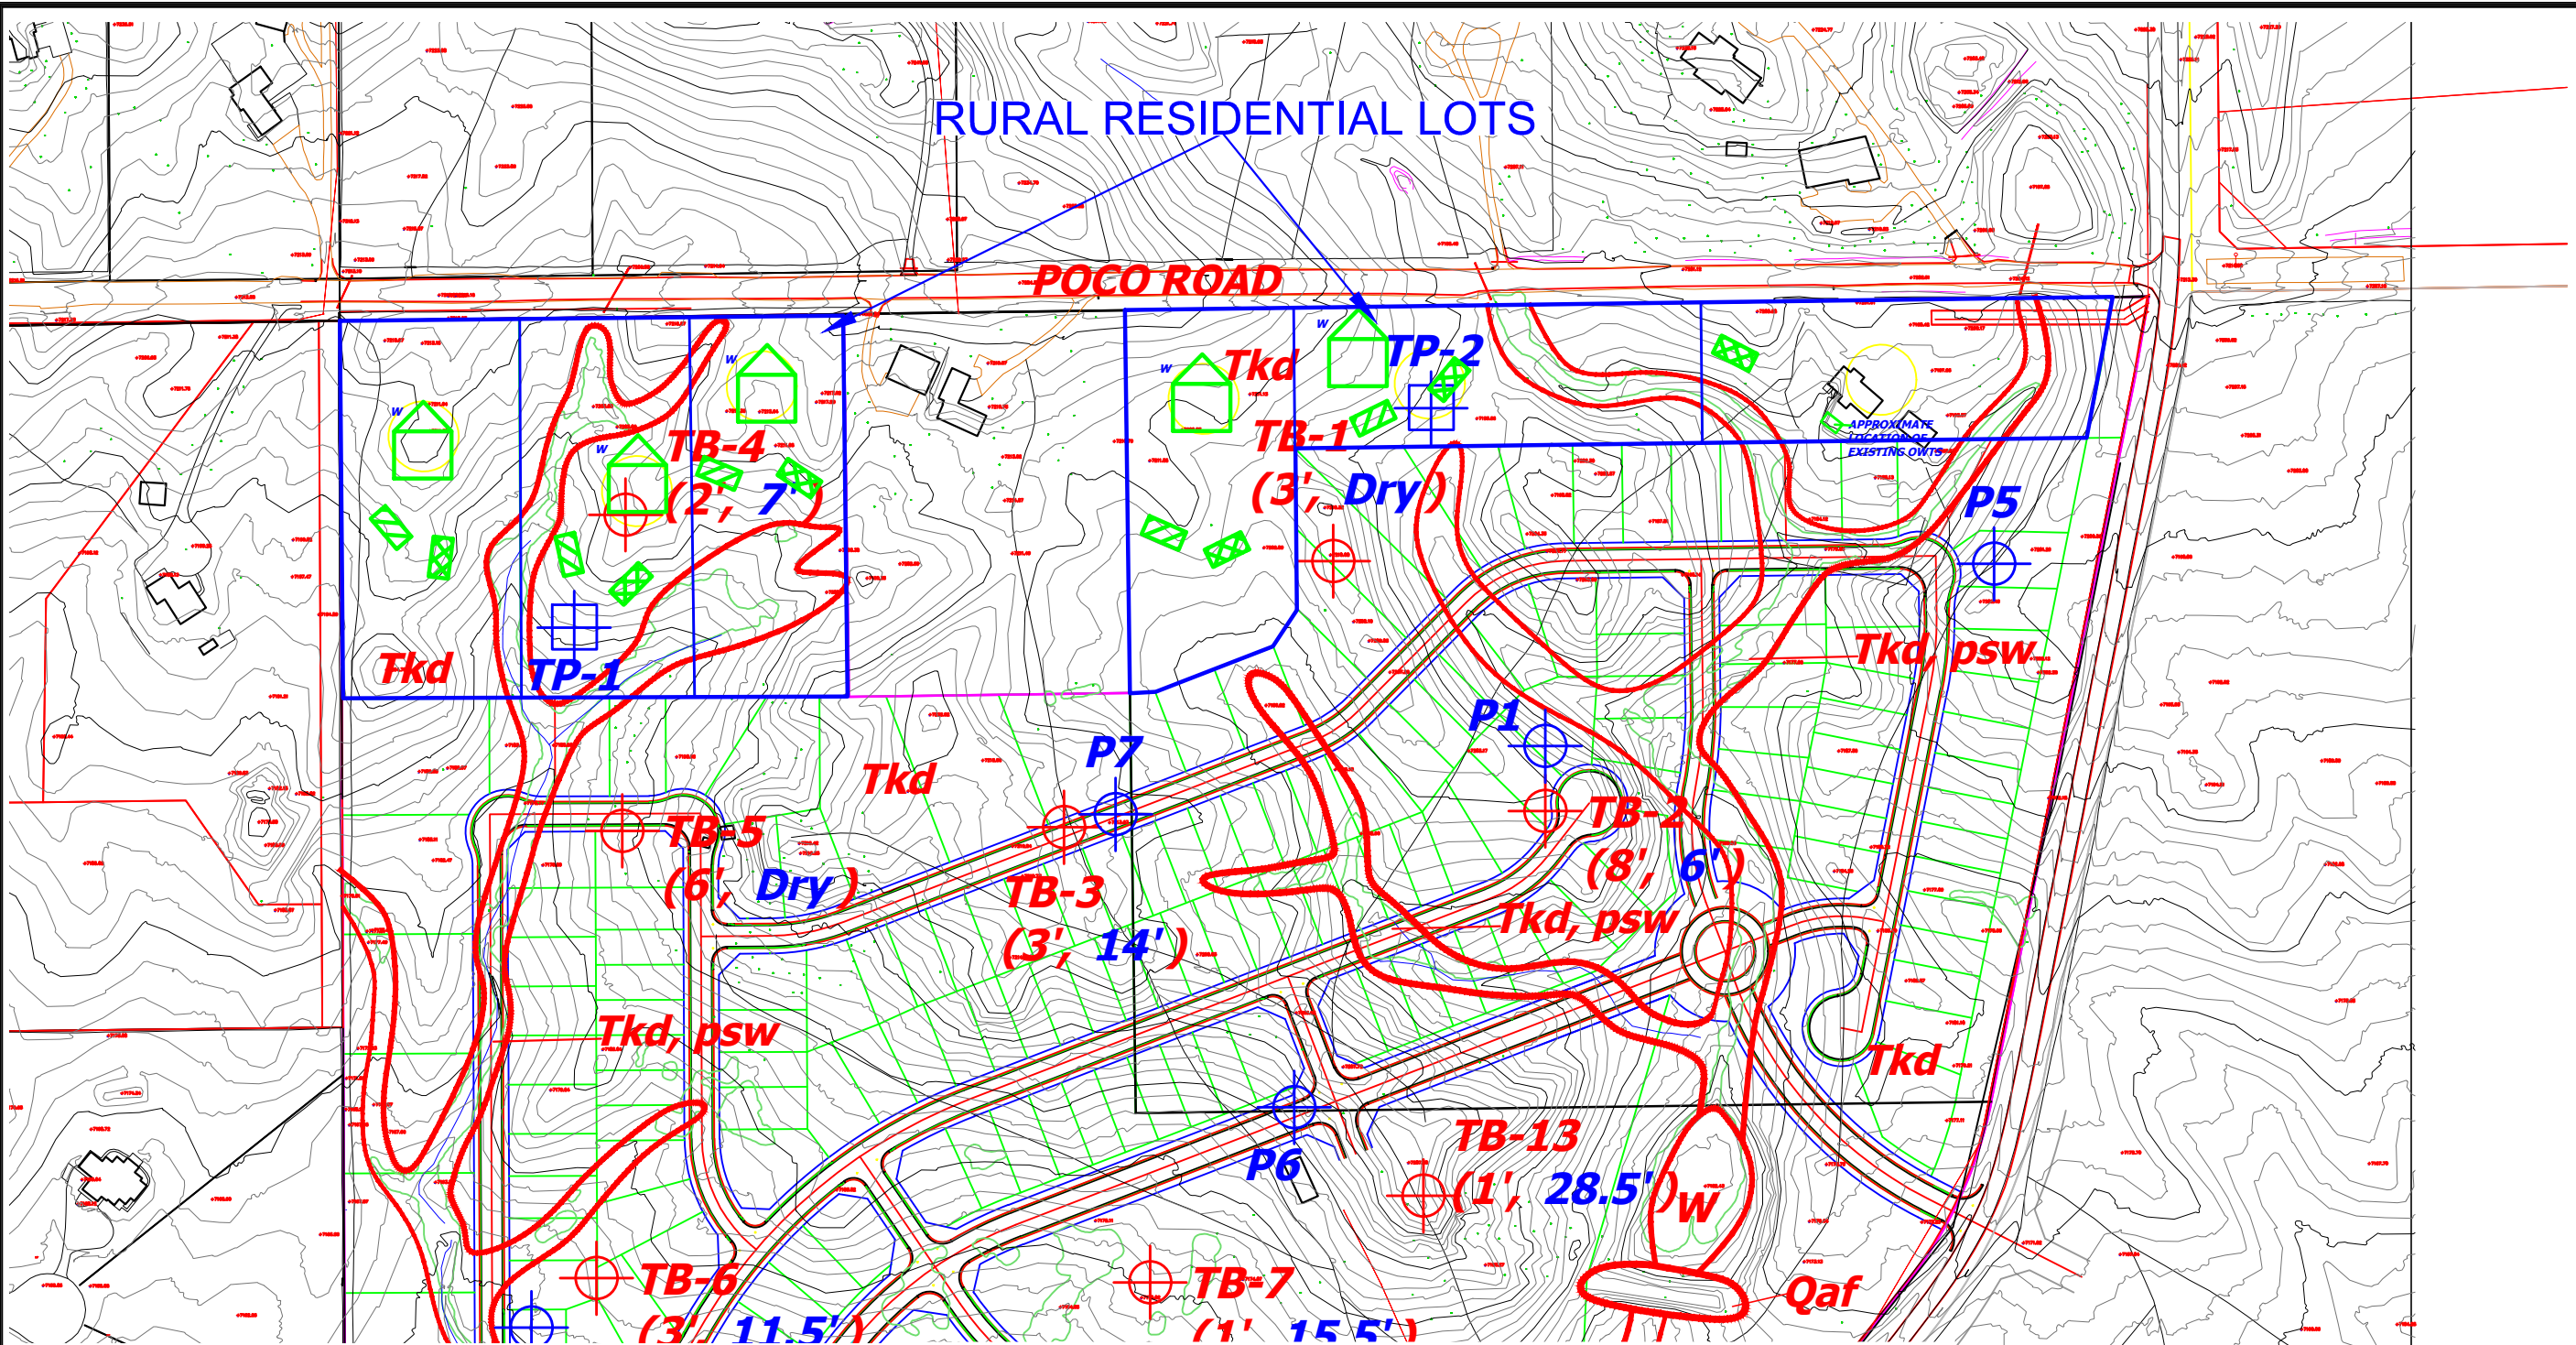
JOB NO.
212381
FIG. 8

- Qaf - Artificial Fill of Quaternary Age: man-made fill deposits
- Tkd - Dawson Formation of Tertiary to Cretaceous Age: variable layer of sheetwash and residual soil deposits overlying arkosic sandstone with siltstone and claystone lenses
- psw - potential seasonally shallow groundwater area
- sw - seasonally wet area
- w - areas of ponded/flowing water
- ⊕ - TB- APPROXIMATE TEST BORING LOCATION AND NUMBER (depth of bedrock in feet, depth of groundwater in feet)
- ⊕ - P- APPROXIMATE PIEZOMETER LOCATION AND NUMBER

- ⊕ - APPROXIMATE TEST PIT LOCATION AND NUMBER
- ▧ - OWTS LOCATION
- ▨ - ALTERNATE OWTS LOCATION
- ⊕_w - HOUSE LOCATION AND WATER WELL

GEOLOGY/ENGINEERING MAP
JAYNES SITE
POCO ROAD & VOLLMER ROAD
EL PASO COUNTY, CO
ELITE PROPERTIES OF AMERICA, INC.

OWTS. Signs of seasonally occurring groundwater were observed in the test pits at 4 to 6 feet. Weathered bedrock was encountered at approximately 3 to 5 feet in the test pits.
