PAVEMENT DESIGN REPORT

The Hills at Lorson Ranch - Area "C"

El Paso County, Colorado

JOB NO. 181479

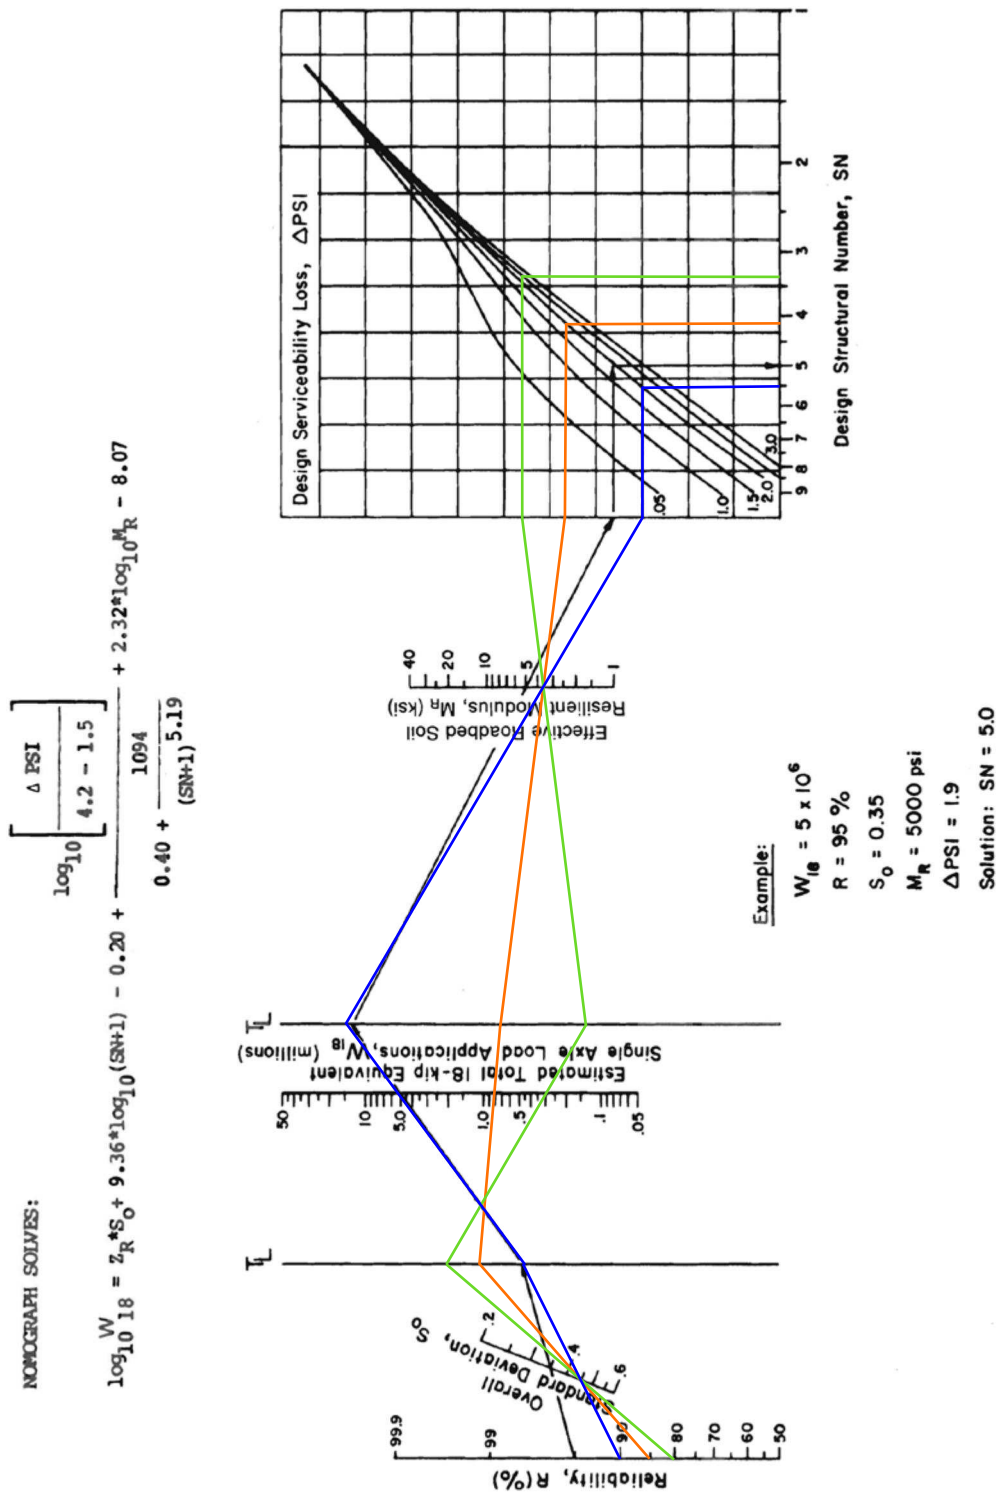
Figure D-1. Flexible Pavement Nomograph

Figure D-1 Flexible Pavement Nomograph - Urban Residential Local and Collector

4) Structural number (SN) = 5.5 (Flexible Pvm't Nomograph, Appendix A)

- 1) Scrub Jay Trail, Wigeon Way, Godwit Lane, Sanderling Street, Big Bird Drive, Whistling Duck Way, and Piping Plover Place
ESAL = 292,000 (Table D-2)
Serviceability Index = 2.0 (Table D-1)
Reliability = 80% (Table D-1)
- 2) Strength coefficients (Table D-3)
Asphalt (HMA): $a_1 = 0.44$
Cement Stabilized Subgrade (CTS): $a_2 = 0.11$
- 3) Subgrade
 $M_r = \text{CBR} \times 1500 = 2.4 \times 1500 = 3,600 \text{ psi}$
- 4) Structural number (SN) = 3.4 (Flexible Pvm't Nomograph, Appendix A)
