**PRIVATE DETENTION BASIN /
STORMWATER QUALITY BEST MANAGEMENT PRACTICE
MAINTENANCE AGREEMENT AND EASEMENT**

B. WHEREAS, Developer desires to plat and develop on the Property a subdivision to be known as THE ESTATES AT CATHEDRAL PINES SUBDIVISION FILING NO. 1; and

STORMWATER FACILITIES AREAS—POND A
PORTIONS OF LOT 6 AND 7 SHOWN AS DRAINAGE EASEMENTS AS INDICATED ON THE
ESTATES AT CATHEDRAL PINES SUBDIVISION FILING NO. 1 PLAT

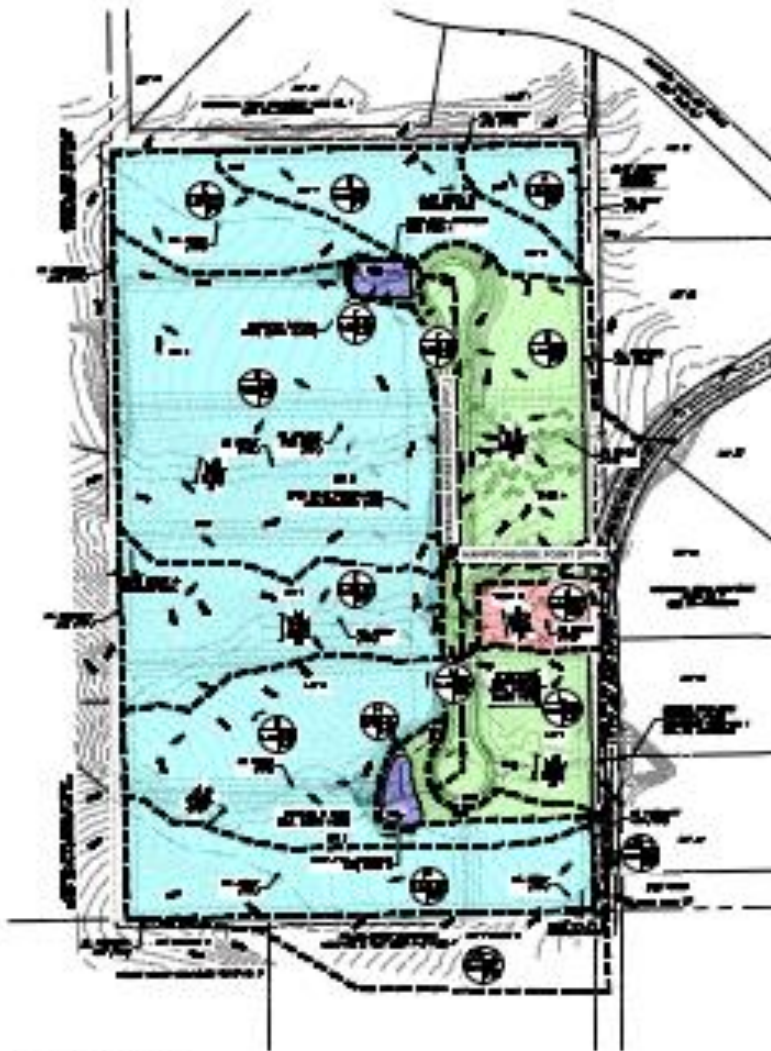
ESTATES AT CATHEDRAL PINES PROPOSED WATER QUALITY MAP

PROPOSED WATER QUALITY MAP
FOR THE ESTATES AT CATHEDRAL PINES
REVISED 1/2011
