**Stormwater Management Facility
Inspection and Maintenance (I&M) Plan
Template**

Saddlehorn Ranch

*Southeast Corner of the intersection of
Judge Orr Road and Curtis Road*

**Stormwater Management Facility
Inspection and Maintenance (I&M) Plan**

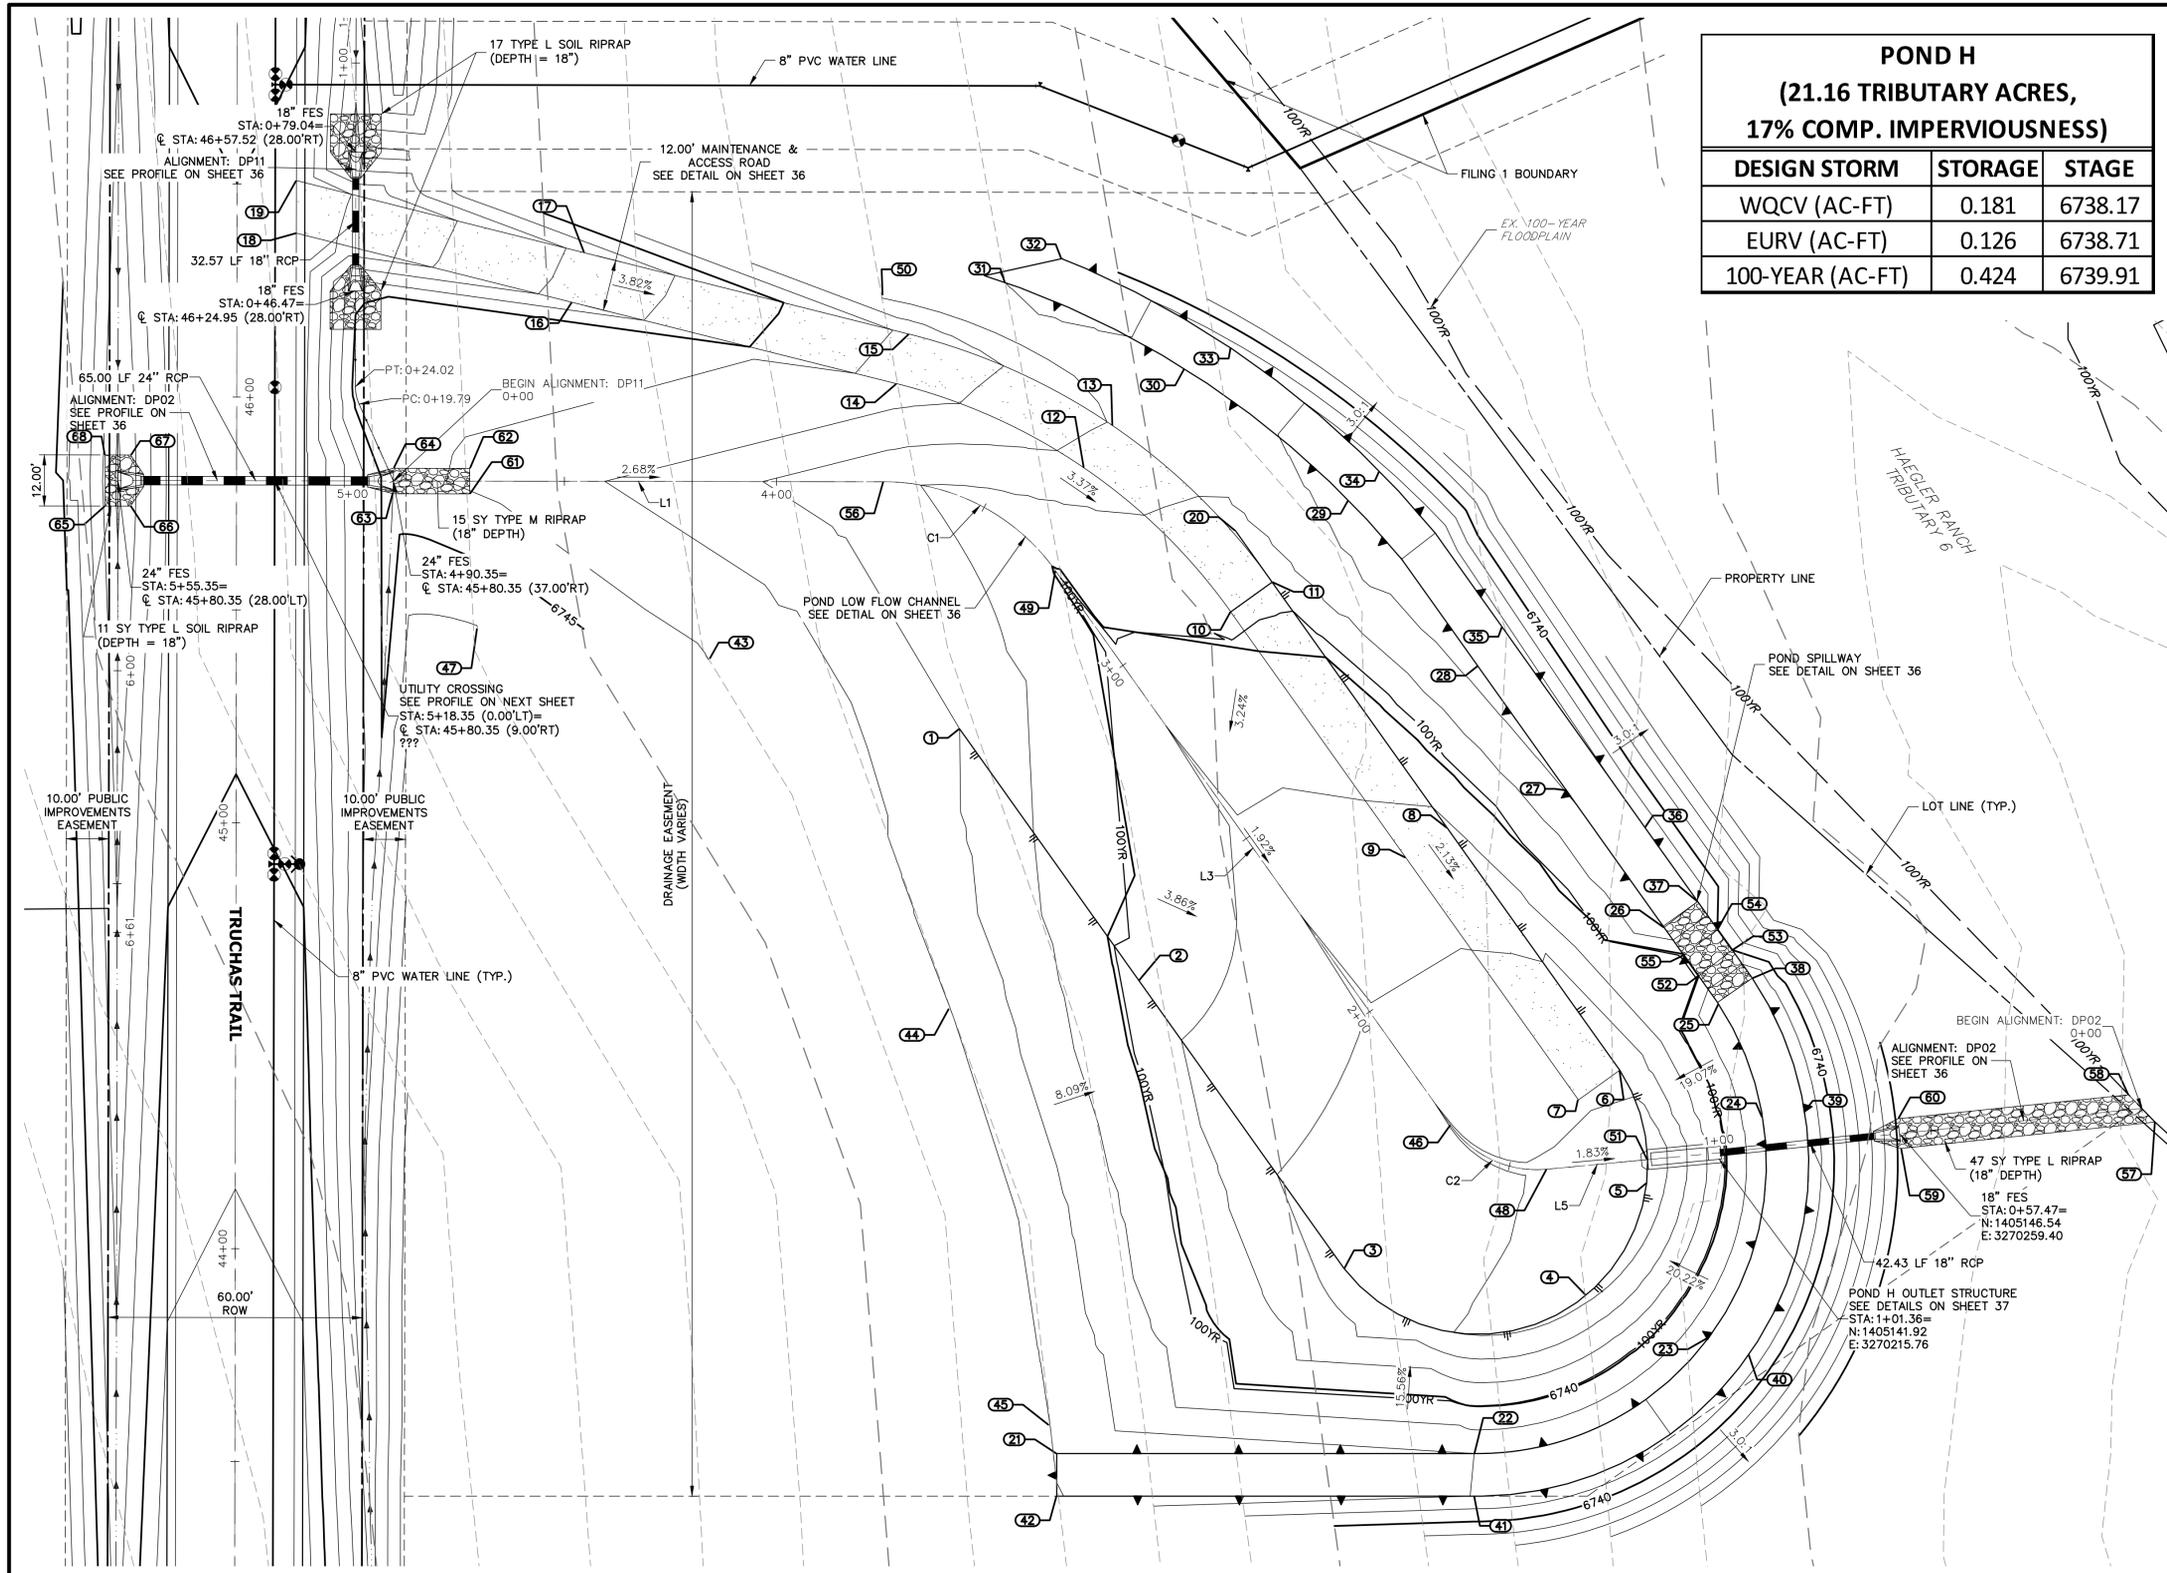
**SADDLEHORN RANCH –
FILING 1**
POND H I&M TABLES

POND H (21.16 TRIBUTARY ACRES, 17% COMP. IMPERVIOUSNESS)		
DESIGN STORM	STORAGE	STAGE
WQCV (AC-FT)	0.181	6738.17
EURV (AC-FT)	0.126	6738.71
100-YEAR (AC-FT)	0.424	6739.91

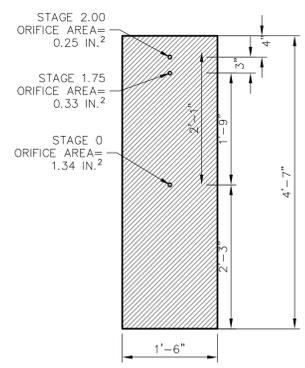
WQCV/EURV ORIFICE PLATE DETAIL
SCALE: 3/4"=1'

EURV/WQCV ORIFICE PLATE:
4'-7" x 1'-6" x 1/2" THICK FLOW GALVANIZED STEEL FLOW CONTROL PLATE. PROVIDE CONTINUOUS NEOPRENE GASKET MATERIAL BETWEEN THE ORIFICE PLATE AND CONCRETE. BOLT PLATE TO CONCRETE @ 12" MAX O.C., 1/2" FROM PLATE EDGE.
