Final Channel Design Report
East Fork Jimmy Camp Creek
Creekside at Lorson Ranch Filing No. 1
CDR 192
El Paso County, Colorado

Prepared by:
Kiowa
Engineering Corporation

Kiowa Project No. 18020
May 14, 2020

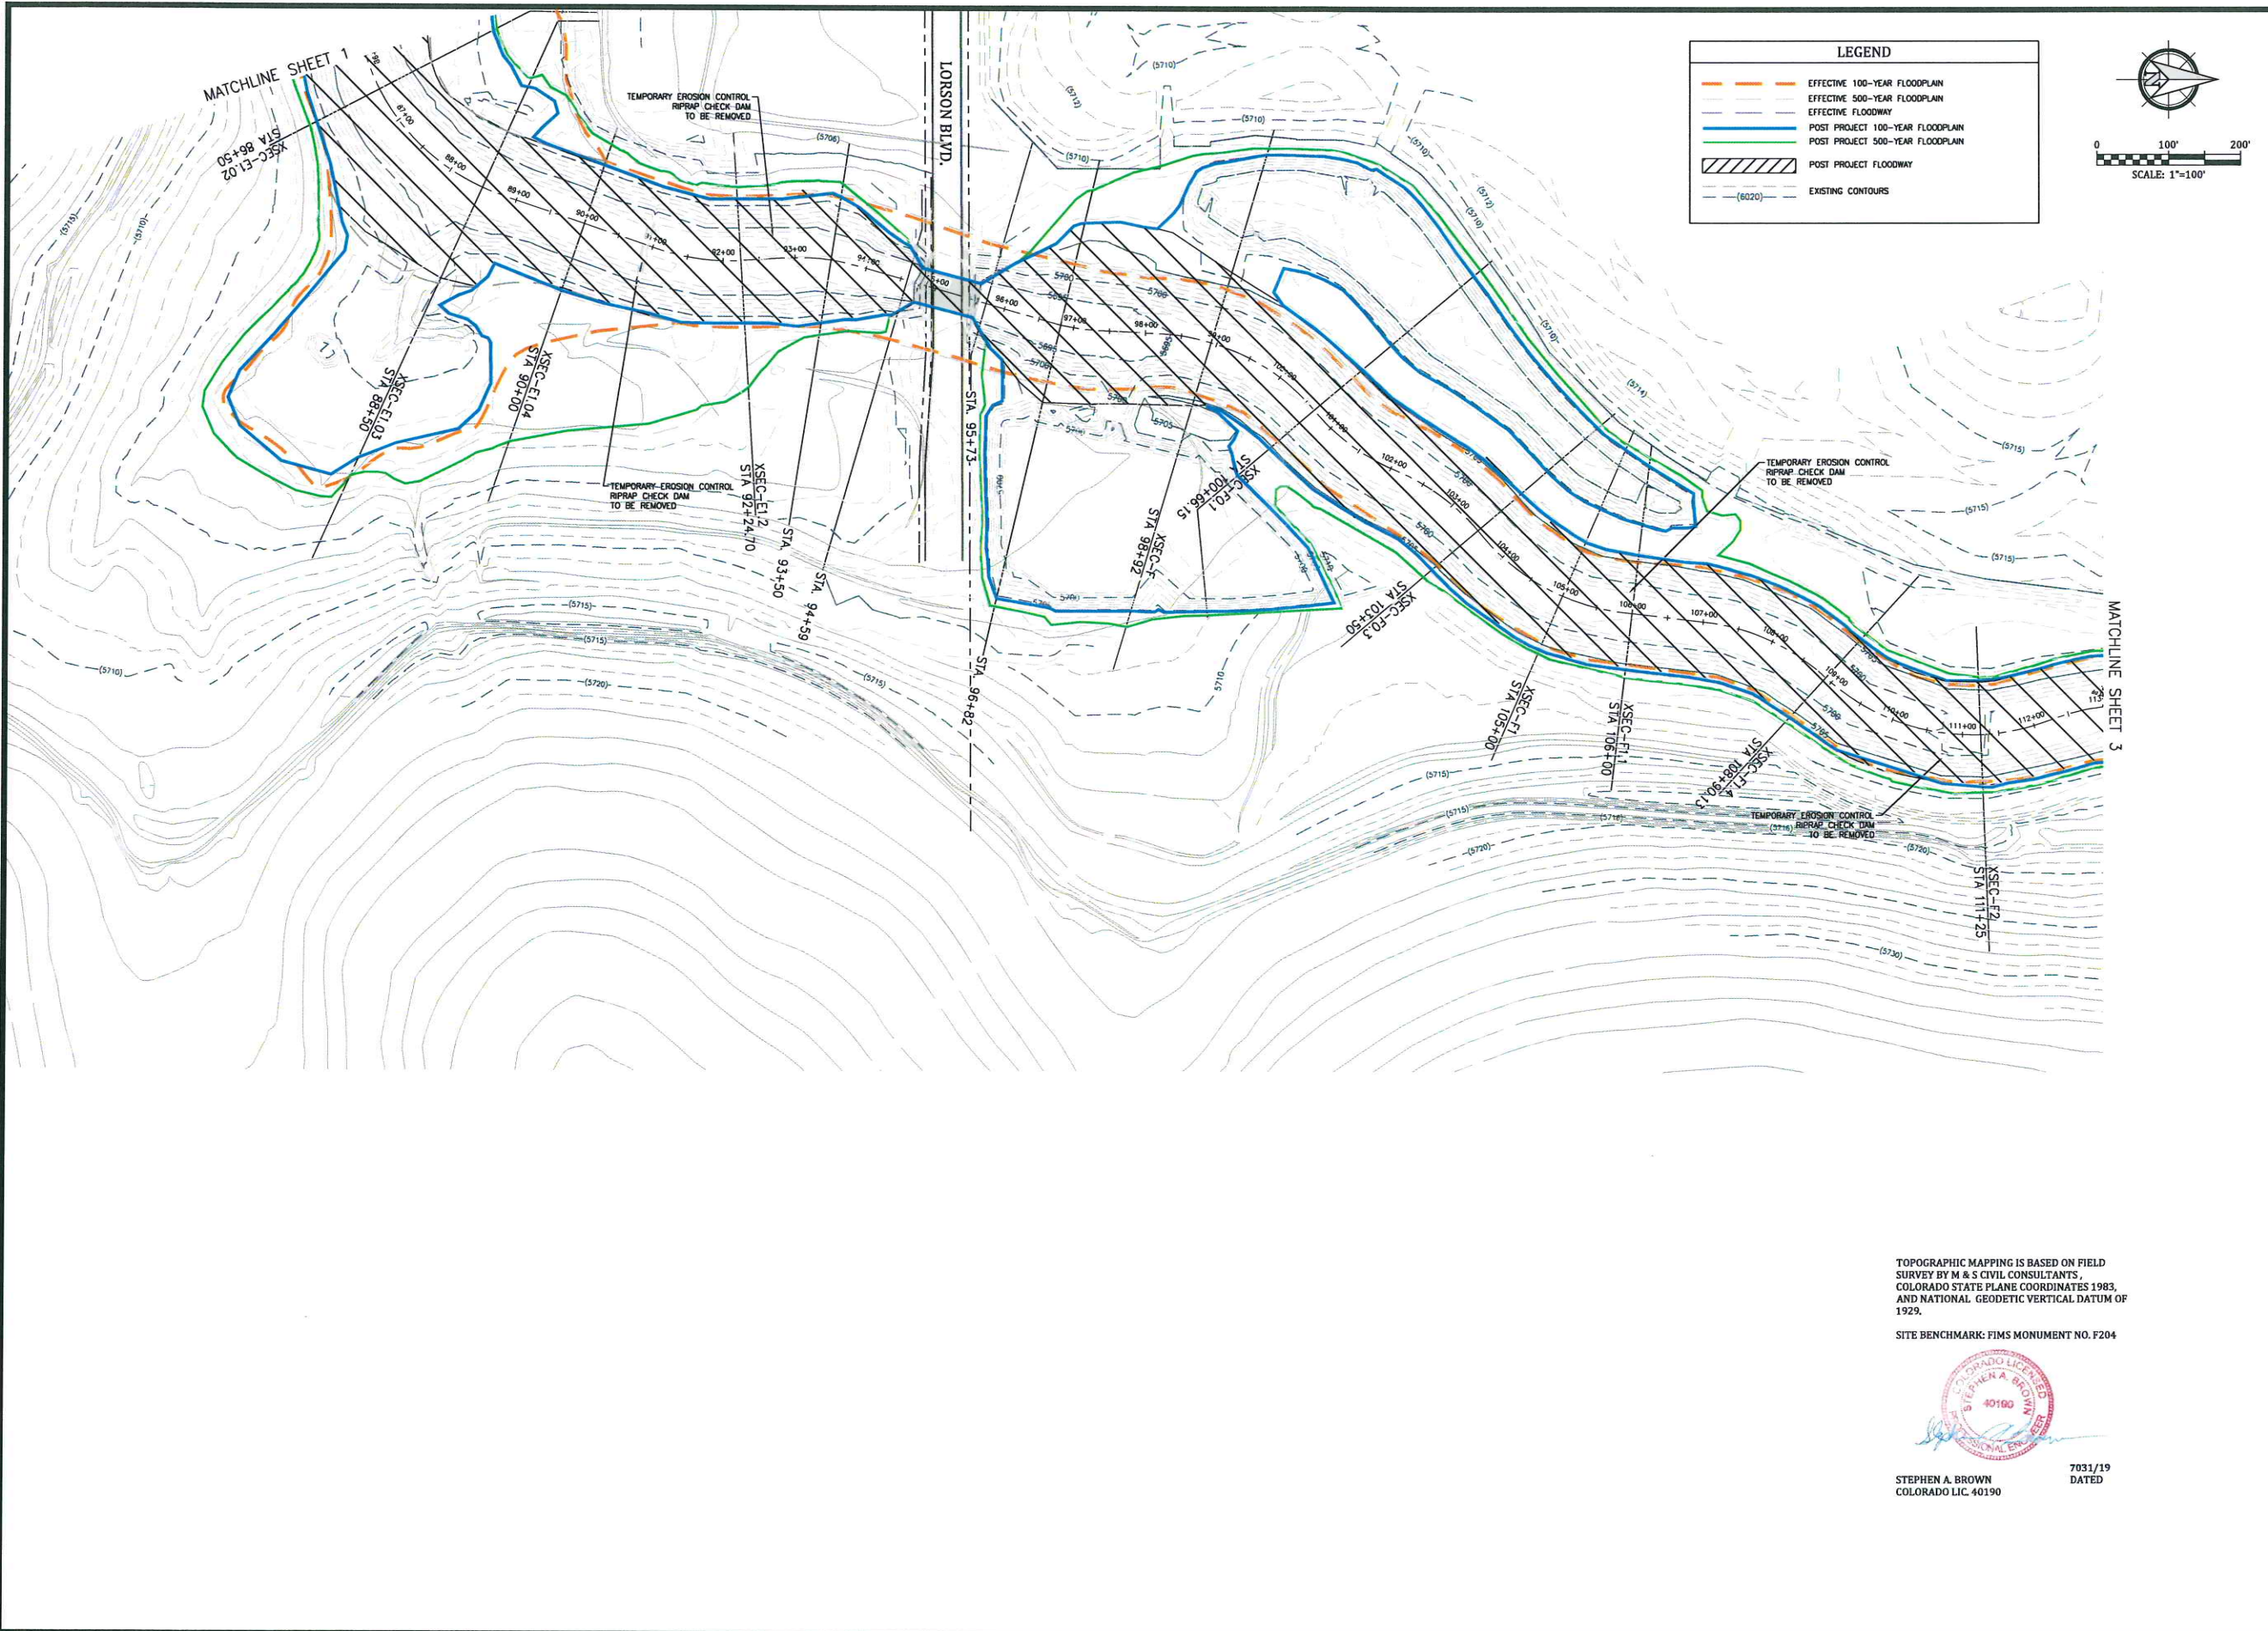
EAST TRIBUTARY JIMMY CAMP CREEK LOMR
LORSON RANCH
POST PROJECT CONDITIONS FLOODPLAIN MAP
EL PASO COUNTY, COLORADO

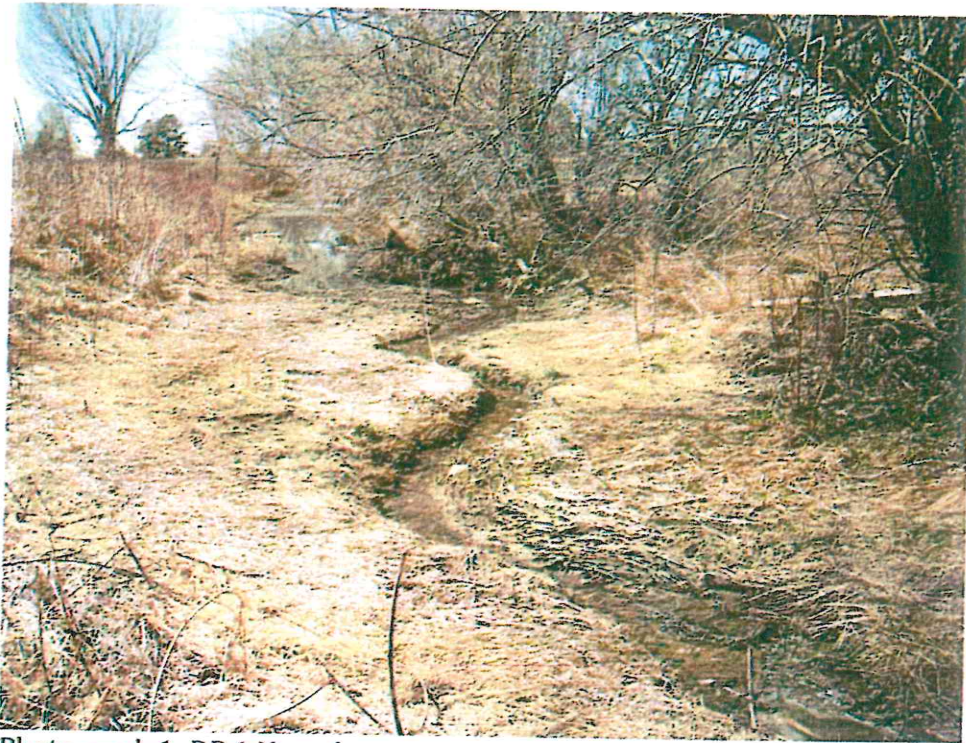
Photograph 1: DP 1 Near downstream property line near FMIC siphon.

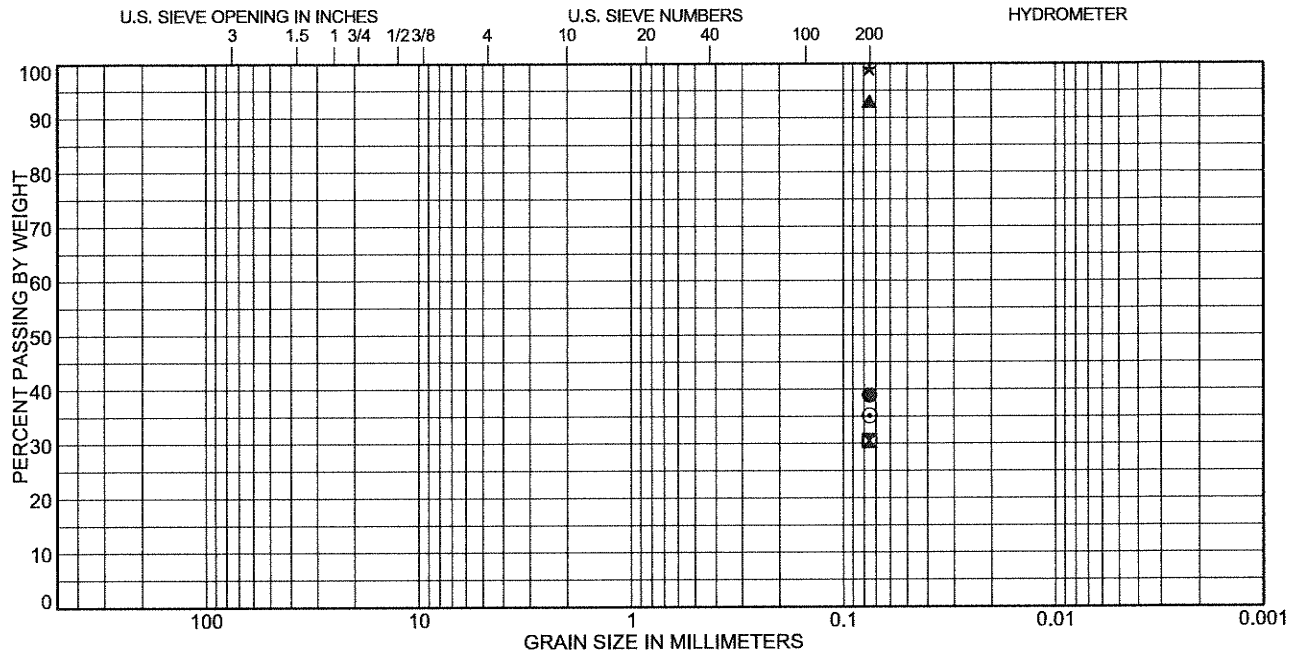
Test Boring	Depth (ft)	Classification	LL	PL	PI
● 1	9.0	CLAYEY SAND(SC)	42	25	17
☒ 2	14.0	SILTY SAND(SM)	NP	NP	NP
▲ 3	4.0	SILT(ML)	39	27	12
★ 4	9.0	FAT CLAY(CH)	59	30	29
⊙ 5	14.0	SILTY SAND(SM)	NP	NP	NP

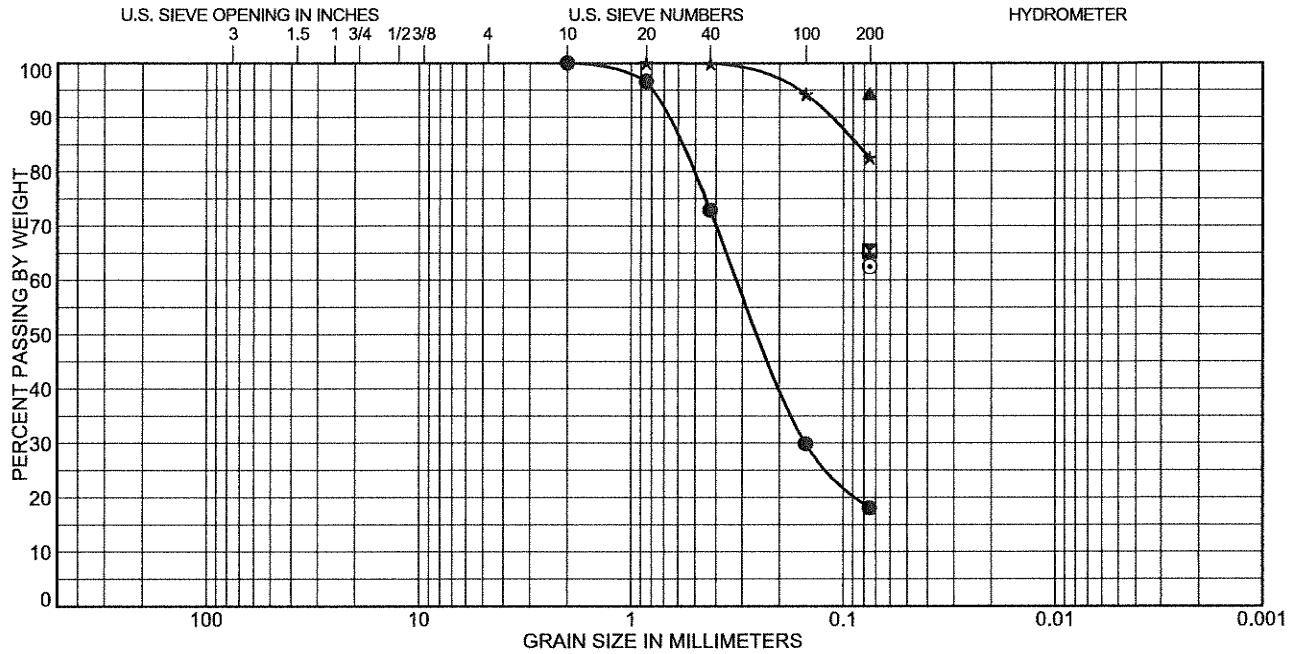
Test Boring	Depth (ft)	Classification	LL	PL	PI
● 6	9.0	SILTY SAND(SM)	NP	NP	NP
⊗ 7	9.0	SANDY LEAN CLAY(CL)	32	19	13
▲ 8	19.0	LEAN CLAY(CL)	35	16	19
★ 9	4.0	SILT with SAND(ML)	NP	NP	NP
⊙ 10	14.0	SANDY LEAN CLAY(CL)	46	22	24

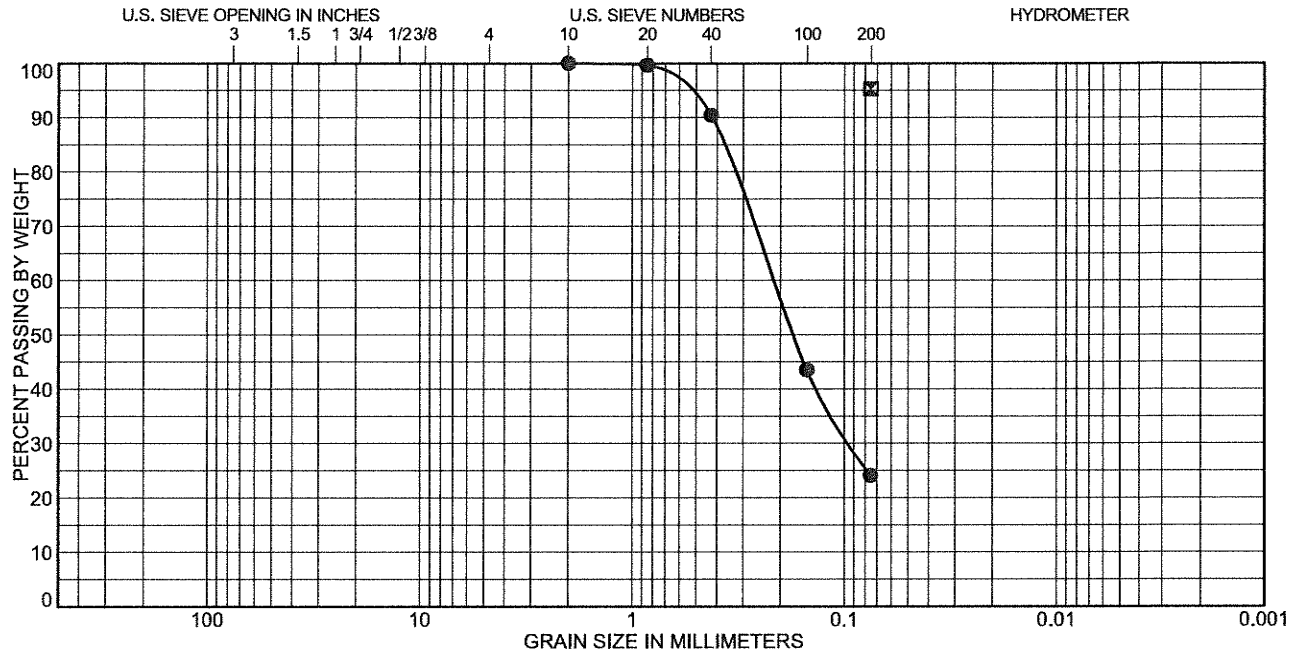
Test Boring	Depth (ft)	Classification	LL	PL	PI
● 11	9.0	SILTY SAND(SM)	NP	NP	NP
☒ 12	9.0	SILT(ML)	NP	NP	NP

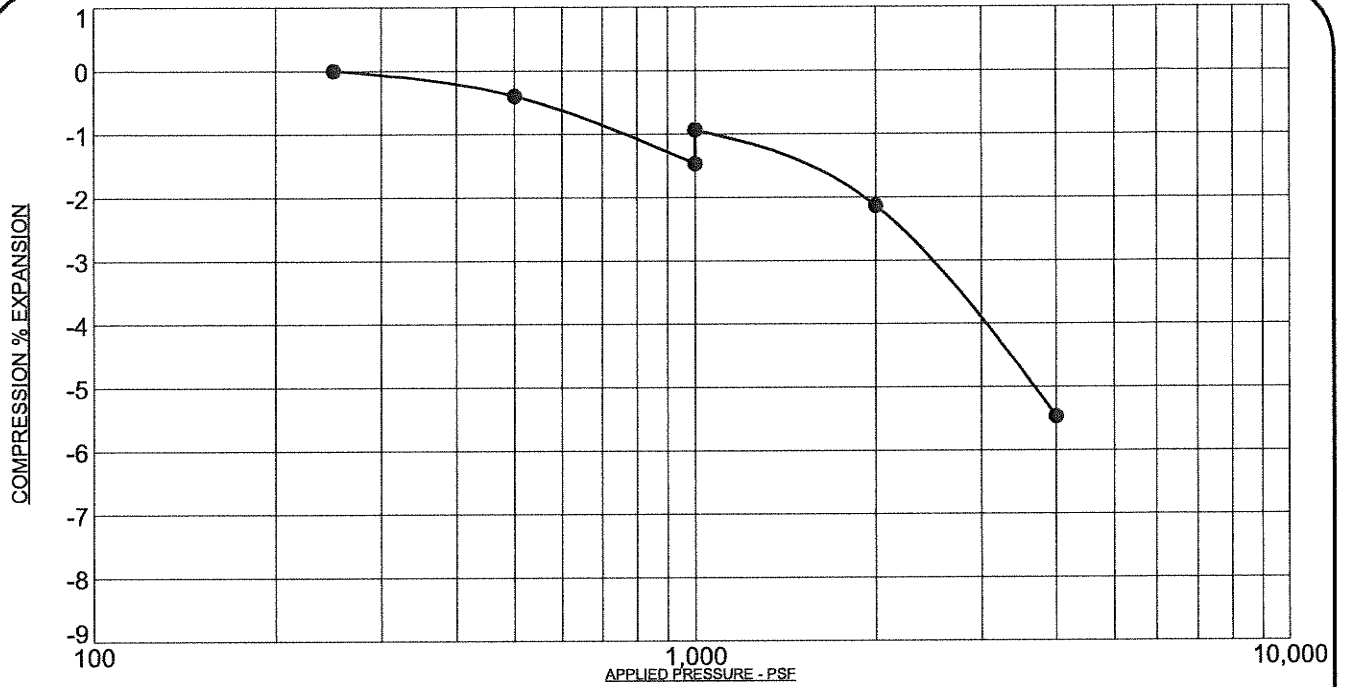
PROJECT: Creekside at Lorson Ranch, Filing No. 1 El Paso County, Colorado
 SAMPLE DESCRIPTION: SAND, CLAYEY
 NOTE: SAMPLE WAS INUNDATED WITH WATER AT 1,000 PSF

SAMPLE LOCATION: 1 @ 9 FT
 NATURAL DRY UNIT WEIGHT: 90.3 PCF
 NATURAL MOISTURE CONTENT: 16.8%
 PERCENT SWELL/COMPRESSION: 0.5

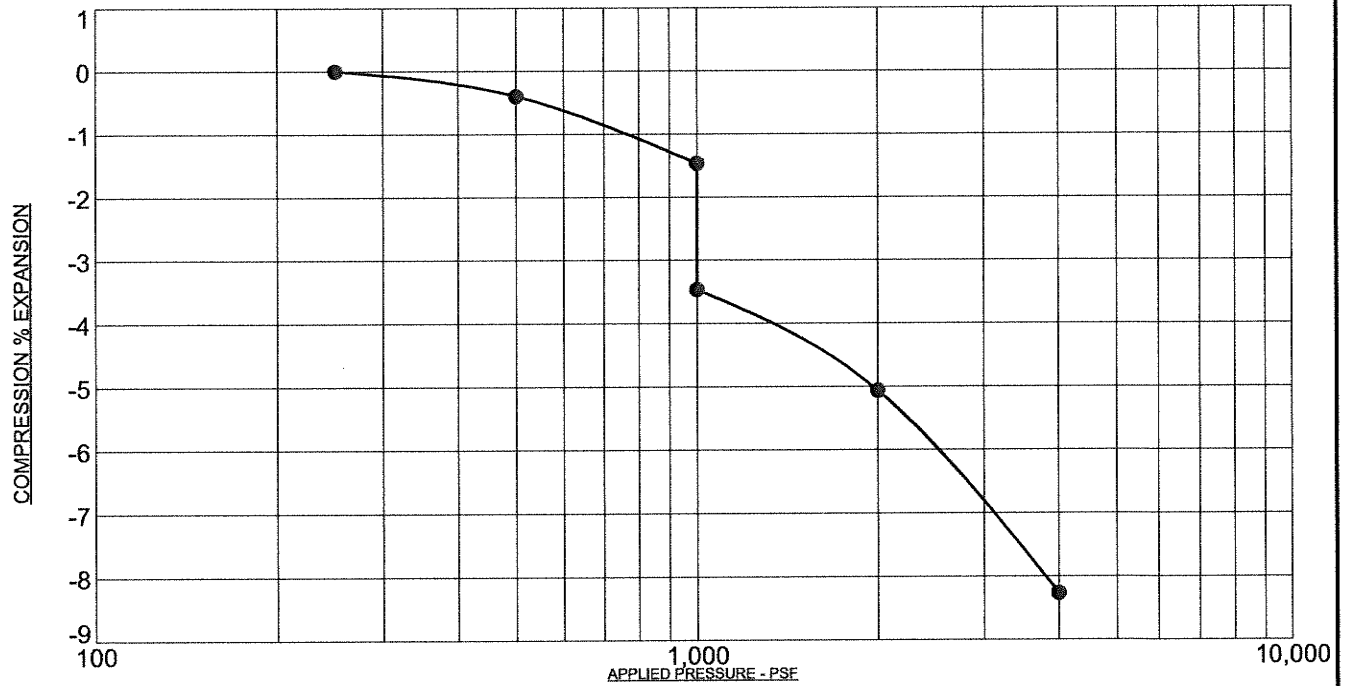
PROJECT: Creekside at Lorson Ranch, Filing No. 1 El Paso County, Colorado
 SAMPLE DESCRIPTION: SAND, SILTY
 NOTE: SAMPLE WAS INUNDATED WITH WATER AT 1,000 PSF

SAMPLE LOCATION: 2 @ 14 FT
 NATURAL DRY UNIT WEIGHT: 106.7 PCF
 NATURAL MOISTURE CONTENT: 4.3%
 PERCENT SWELL/COMPRESSION: -2.0

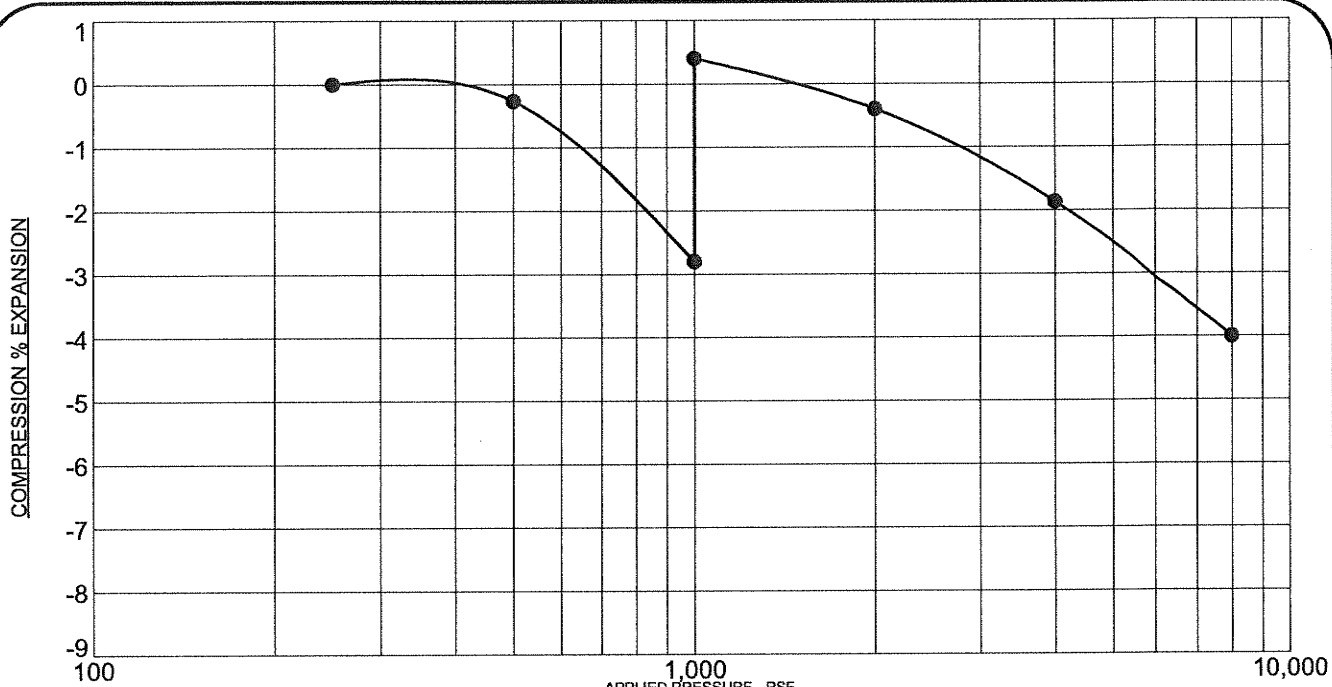
PROJECT: Creekside at Lorson Ranch, Filing No. 1 El Paso County, Colorado
 SAMPLE DESCRIPTION: CLAY, SANDY
 NOTE: SAMPLE WAS INUNDATED WITH WATER AT 1,000 PSF

SAMPLE LOCATION: 3 @ 14 FT
 NATURAL DRY UNIT WEIGHT: 108.4 PCF
 NATURAL MOISTURE CONTENT: 15.3%
 PERCENT SWELL/COMPRESSION: 3.2

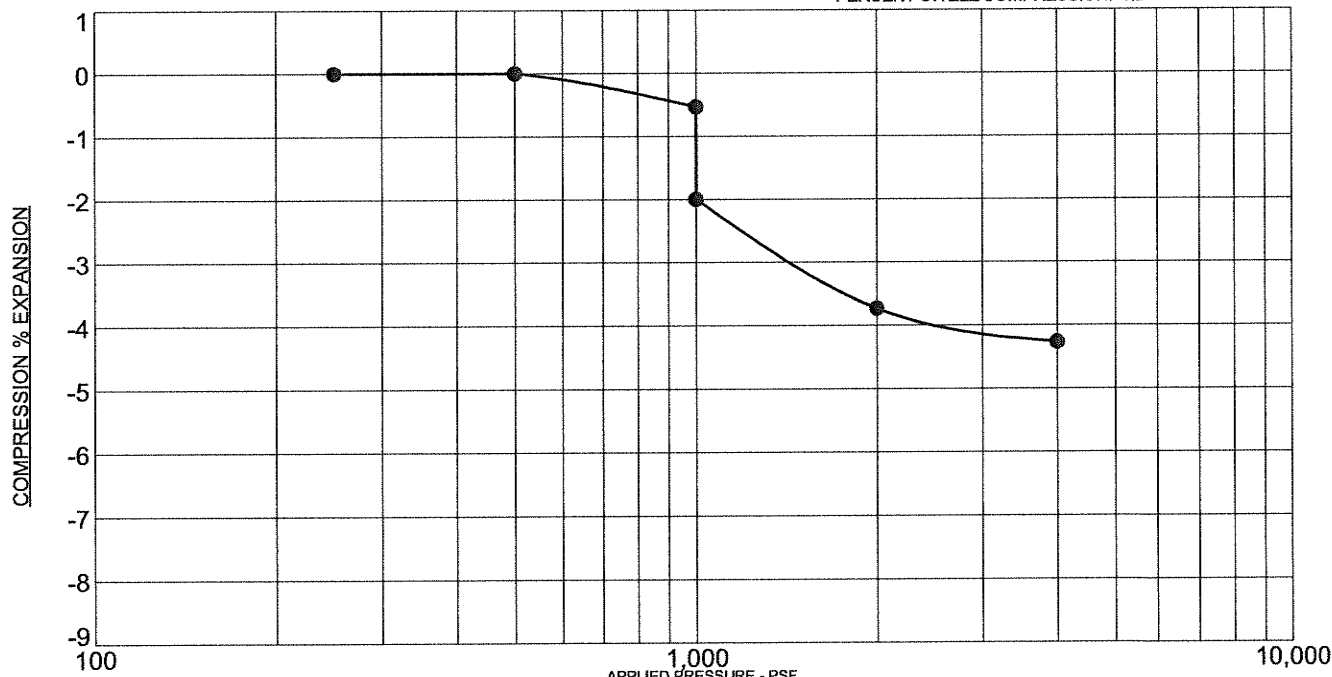
PROJECT: Creekside at Lorson Ranch, Filing No. 1 El Paso County, Colorado
 SAMPLE DESCRIPTION: SAND, SILTY
 NOTE: SAMPLE WAS INUNDATED WITH WATER AT 1,000 PSF

SAMPLE LOCATION: 5 @ 14 FT
 NATURAL DRY UNIT WEIGHT: 93.9 PCF
 NATURAL MOISTURE CONTENT: 11.4%
 PERCENT SWELL/COMPRESSION: -1.5

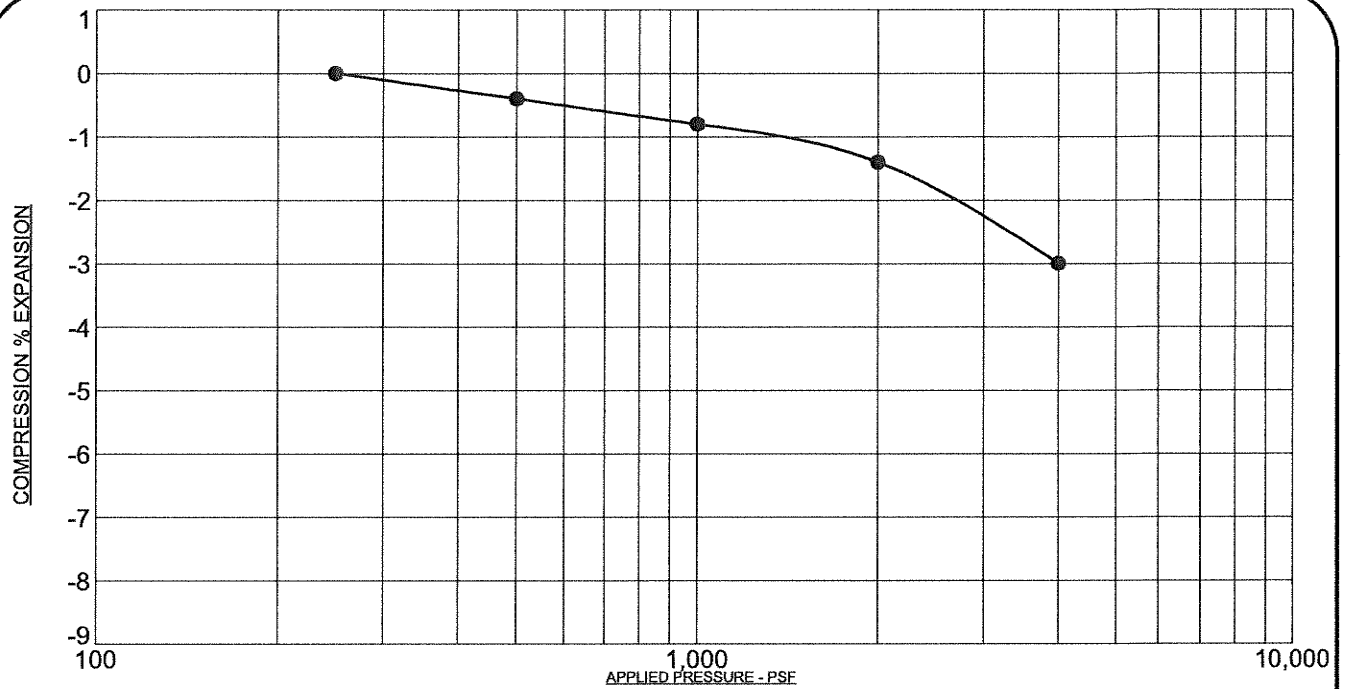
PROJECT: Creekside at Lorson Ranch, Filing No. 1 El Paso County, Colorado
 SAMPLE DESCRIPTION: CLAY, SANDY
 NOTE: SAMPLE WAS INUNDATED WITH WATER AT 1,000 PSF

SAMPLE LOCATION: 10 @ 14 FT
 NATURAL DRY UNIT WEIGHT: 77.4 PCF
 NATURAL MOISTURE CONTENT: 20.9%
 PERCENT SWELL/COMPRESSION: 0.0

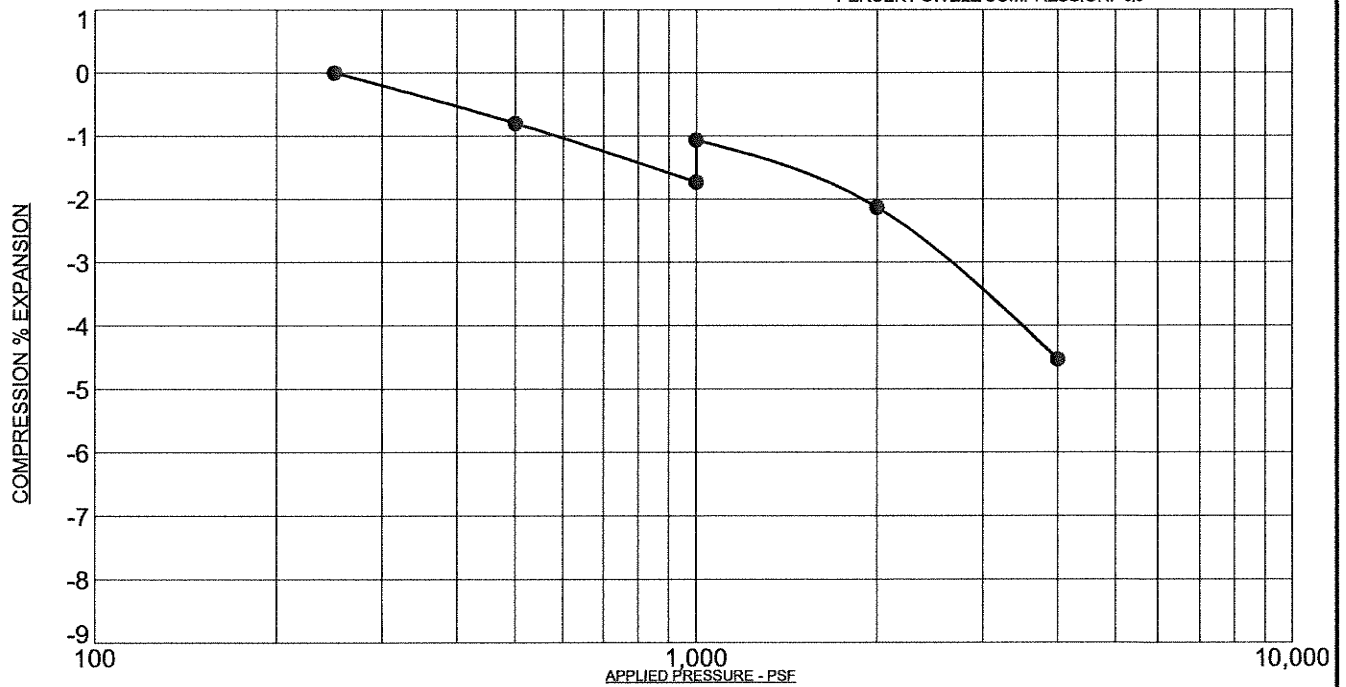
PROJECT: Creekside at Lorson Ranch, Filing No. 1 El Paso County, Colorado
 SAMPLE DESCRIPTION: CLAY, SANDY
 NOTE: SAMPLE WAS INUNDATED WITH WATER AT 1,000 PSF

SAMPLE LOCATION: 12 @ 9 FT
 NATURAL DRY UNIT WEIGHT: 85.0 PCF
 NATURAL MOISTURE CONTENT: 34.8%
 PERCENT SWELL/COMPRESSION: 0.7

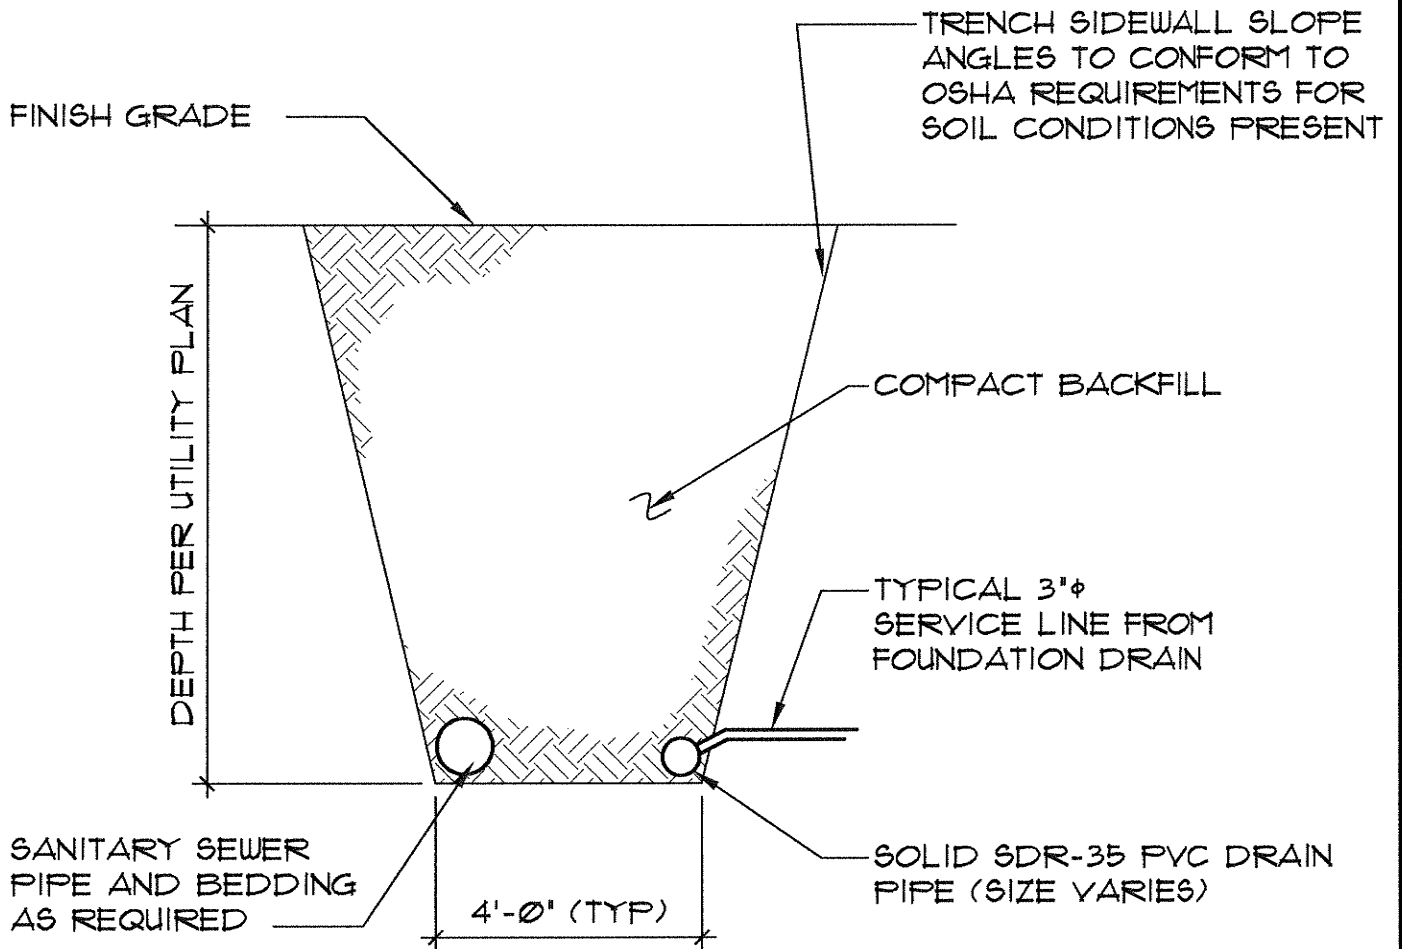
NOTE: TO BE USED WHERE NO SHALLOW GROUNDWATER IS KNOWN TO EXIST
