**WASTEWATER STUDY  
THE RESERVE AT CORRAL BLUFFS  
EL PASO COUNTY, COLORADO**

December 12, 2019  
Revised June 18, 2020

Entech Job No. 192142 (previously 83691)  
AAProjects/2019/192142 county soil geo-revised

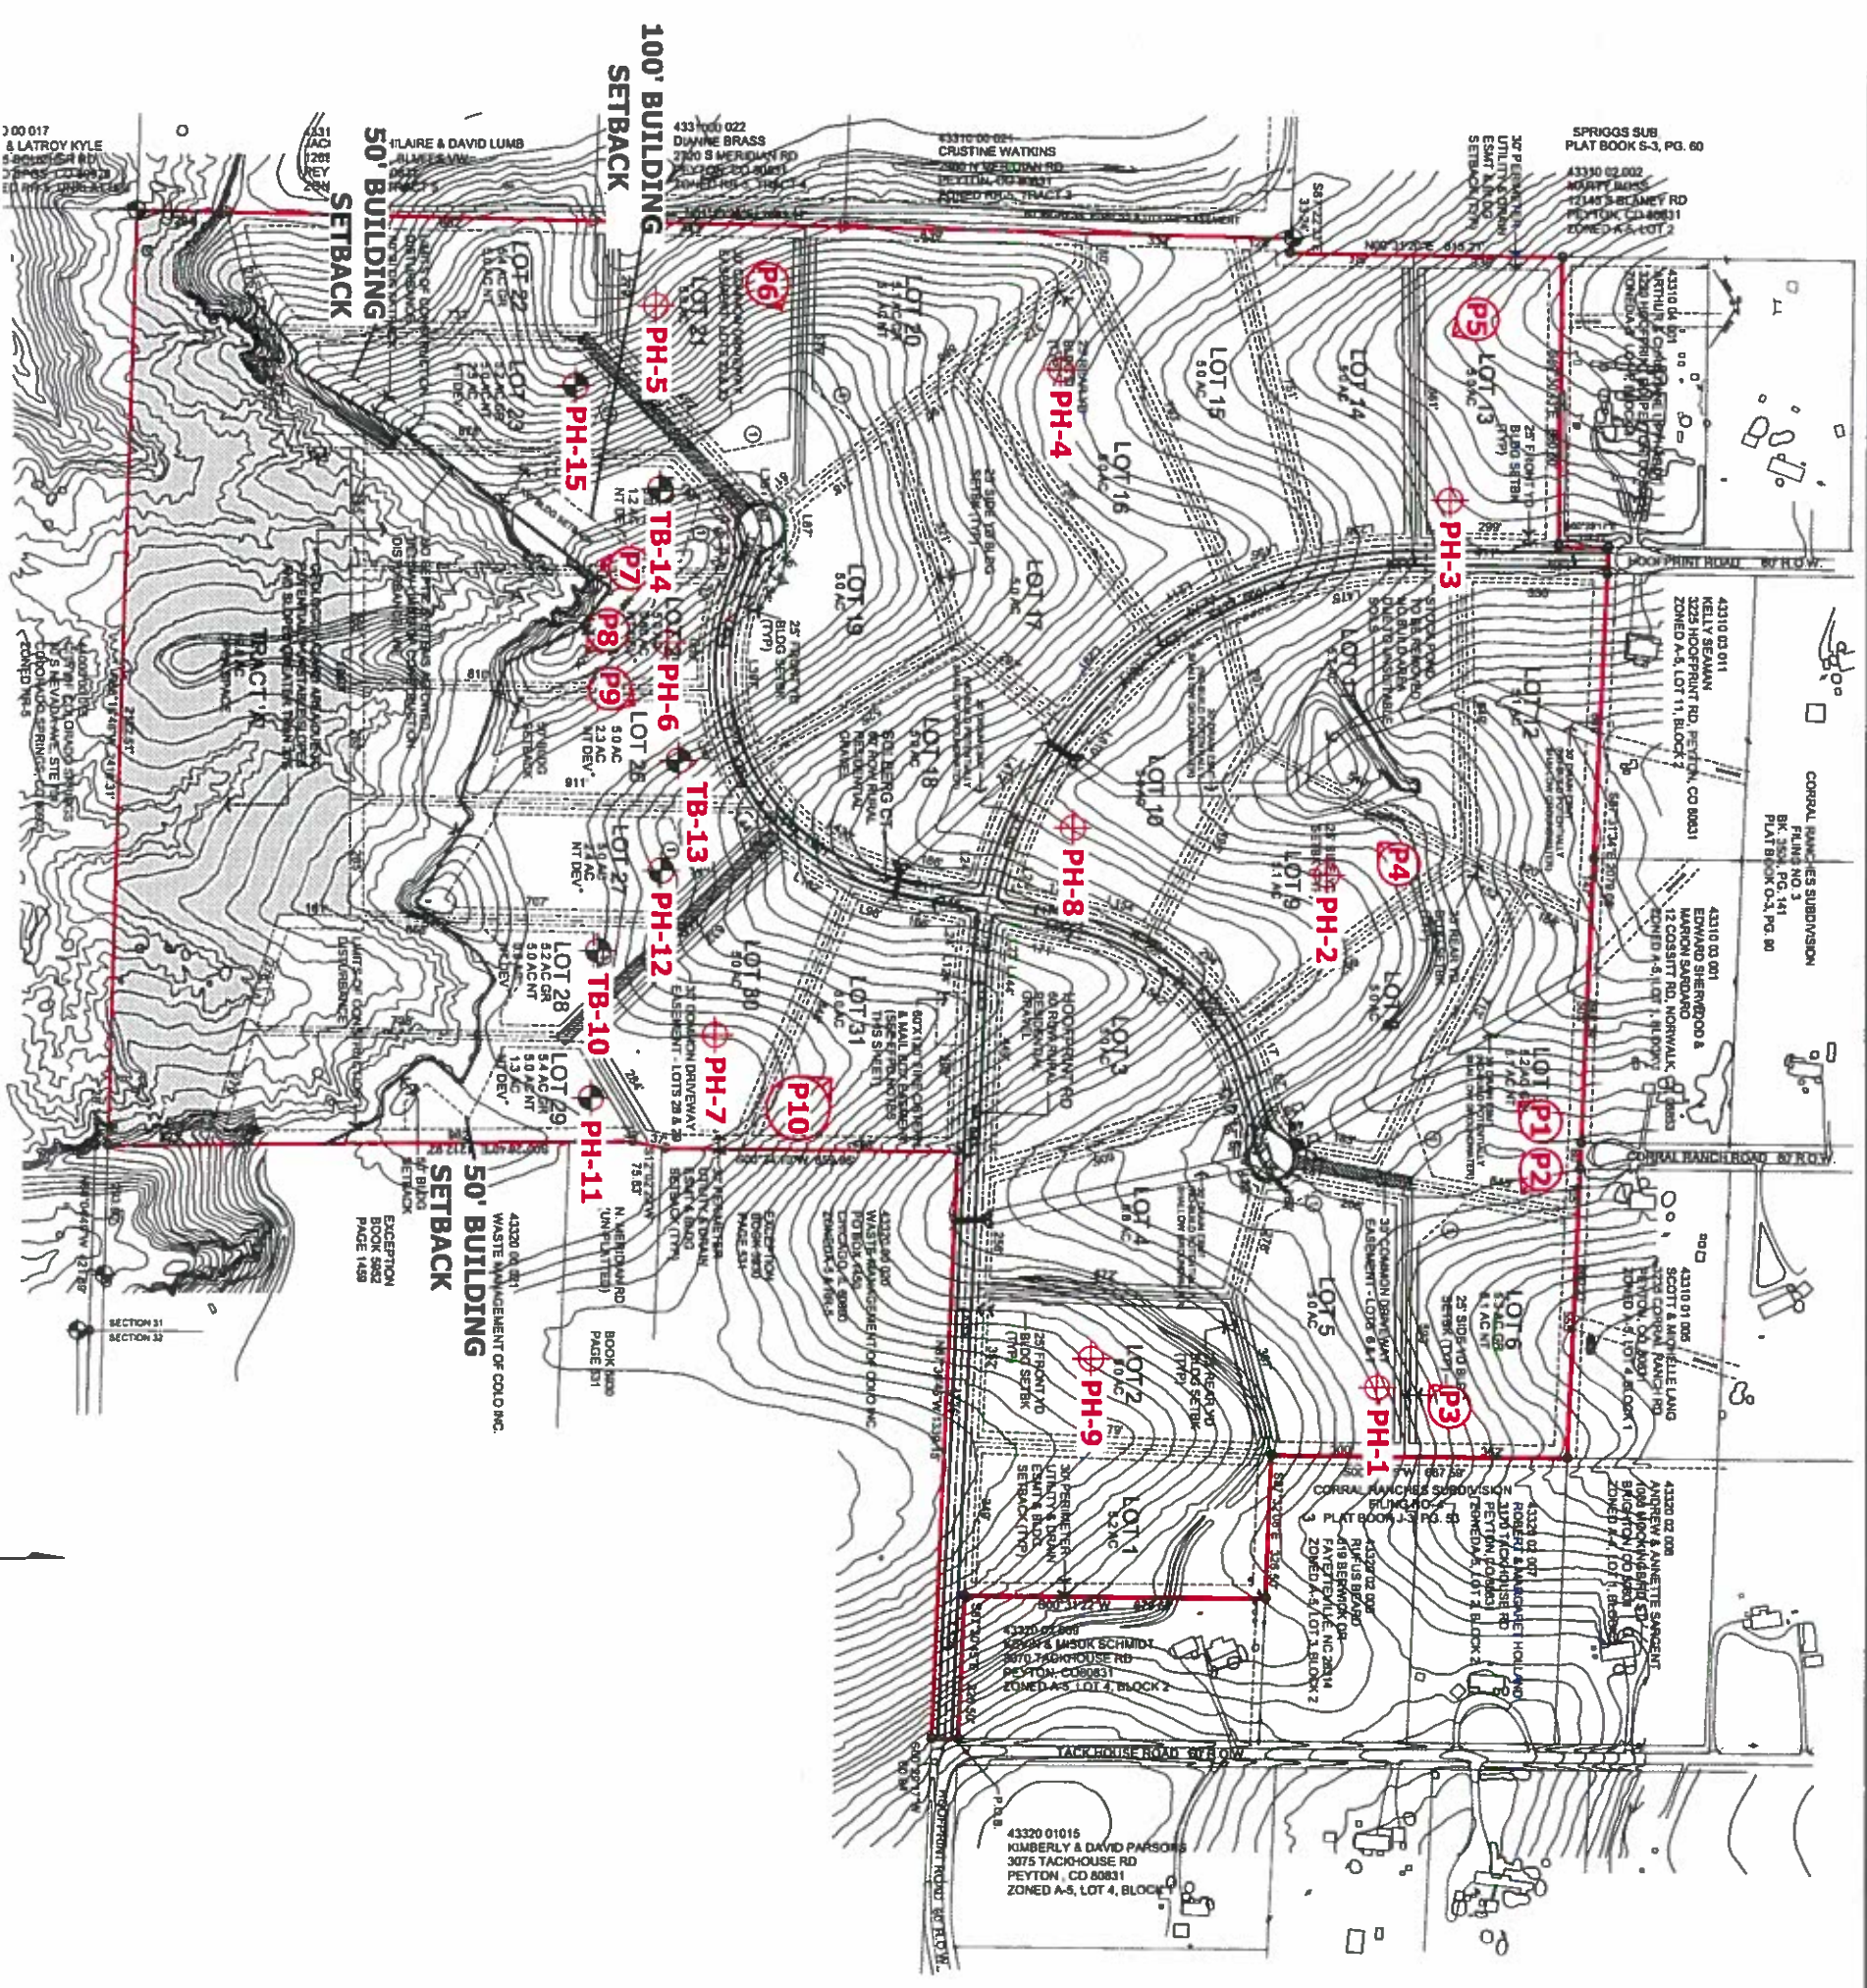
| FIGURE NO: 4 |

- ② - APPROXIMATE LOCATION AND DIRECTION OF PHOTOS
- ⊕ PH-2 - APPROXIMATE LOCATION AND NUMBER OF PERCOLATION TEST FROM ORIGINAL REPORT
- ⊕ PH-15 - APPROXIMATE LOCATION AND NUMBER OF ADDITIONAL PERCOLATION TEST
- ⊕ TB-14 - APPROXIMATE LOCATION AND NUMBER OF ADDITIONAL TEST BORING

DEVELOPMENT PLAN / PERCOLATION  
TEST LOCATION MAP  
THE RESERVE AT CORRAL BLUFFS  
EL PASO COUNTY, CO  
FOR: CORRAL RANCH DEVELOPMENT

Pg 28 - Figure No. 10 has been updated to show correct setbacks, but no longer shows possible well and septic locations.

The percolation rates in nine of the locations are suitable for conventional systems. (References 1 and 2). Three tests had rates of slower than 60 minutes per inch. Additional drilling may reveal other areas where more suitable rates can be found. El Paso County guidelines require designed systems for percolation rates exceeding 60 minutes per inch. Bedrock was not encountered in any of the profile holes at a depth that would affect conventional systems, however, some areas may contain shallow bedrock. Where bedrock is encountered less than 6 feet, designed systems may be required. A Septic Suitability Map is presented in Figure 10. A possible house location, two potential on site wastewater treatment system (OWTS) locations and a possible well site for each lot are indicated on Figure 10. Due to the size of the building lots, it is anticipated that suitable areas will be available where conventional systems may be utilized on most lots. In areas where suitable percolation rates cannot be found, shallow groundwater exists or shallow bedrock exists, designed systems will be required.

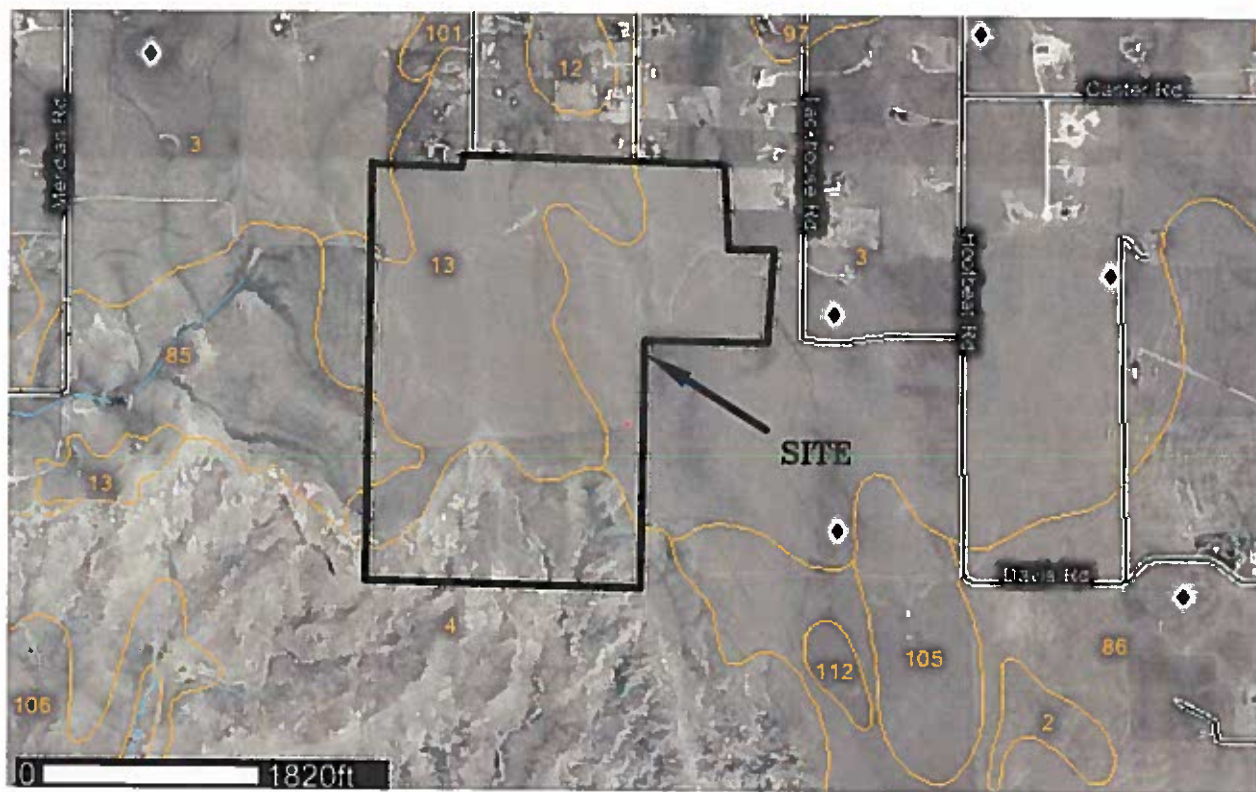
FIG NO.:  
5

Soil Survey Map  
The Reserve at Corral Bluffs  
El Paso County, CO.  
For: Corral Ranch Development Co.

Complete descriptions of each soil type are presented in Appendix E. The soils have generally been described to have rapid to moderate permeabilities. Soil Type 4 (Badland) exists on the steeper slopes in the southern portion of the site where no development is proposed. Soil Types 3 and 13 have been described as having good potential for home sites. Limitations on soil Type 85 include steep slopes, and depth to bedrock. Possible hazards with soil erosion are present on the site. The erosion potential can be controlled with vegetation. The majority of the soils have been described to have moderate erosion hazards with high erosion hazards on Soil Type 4 (Badland) due to the potential for gullying.

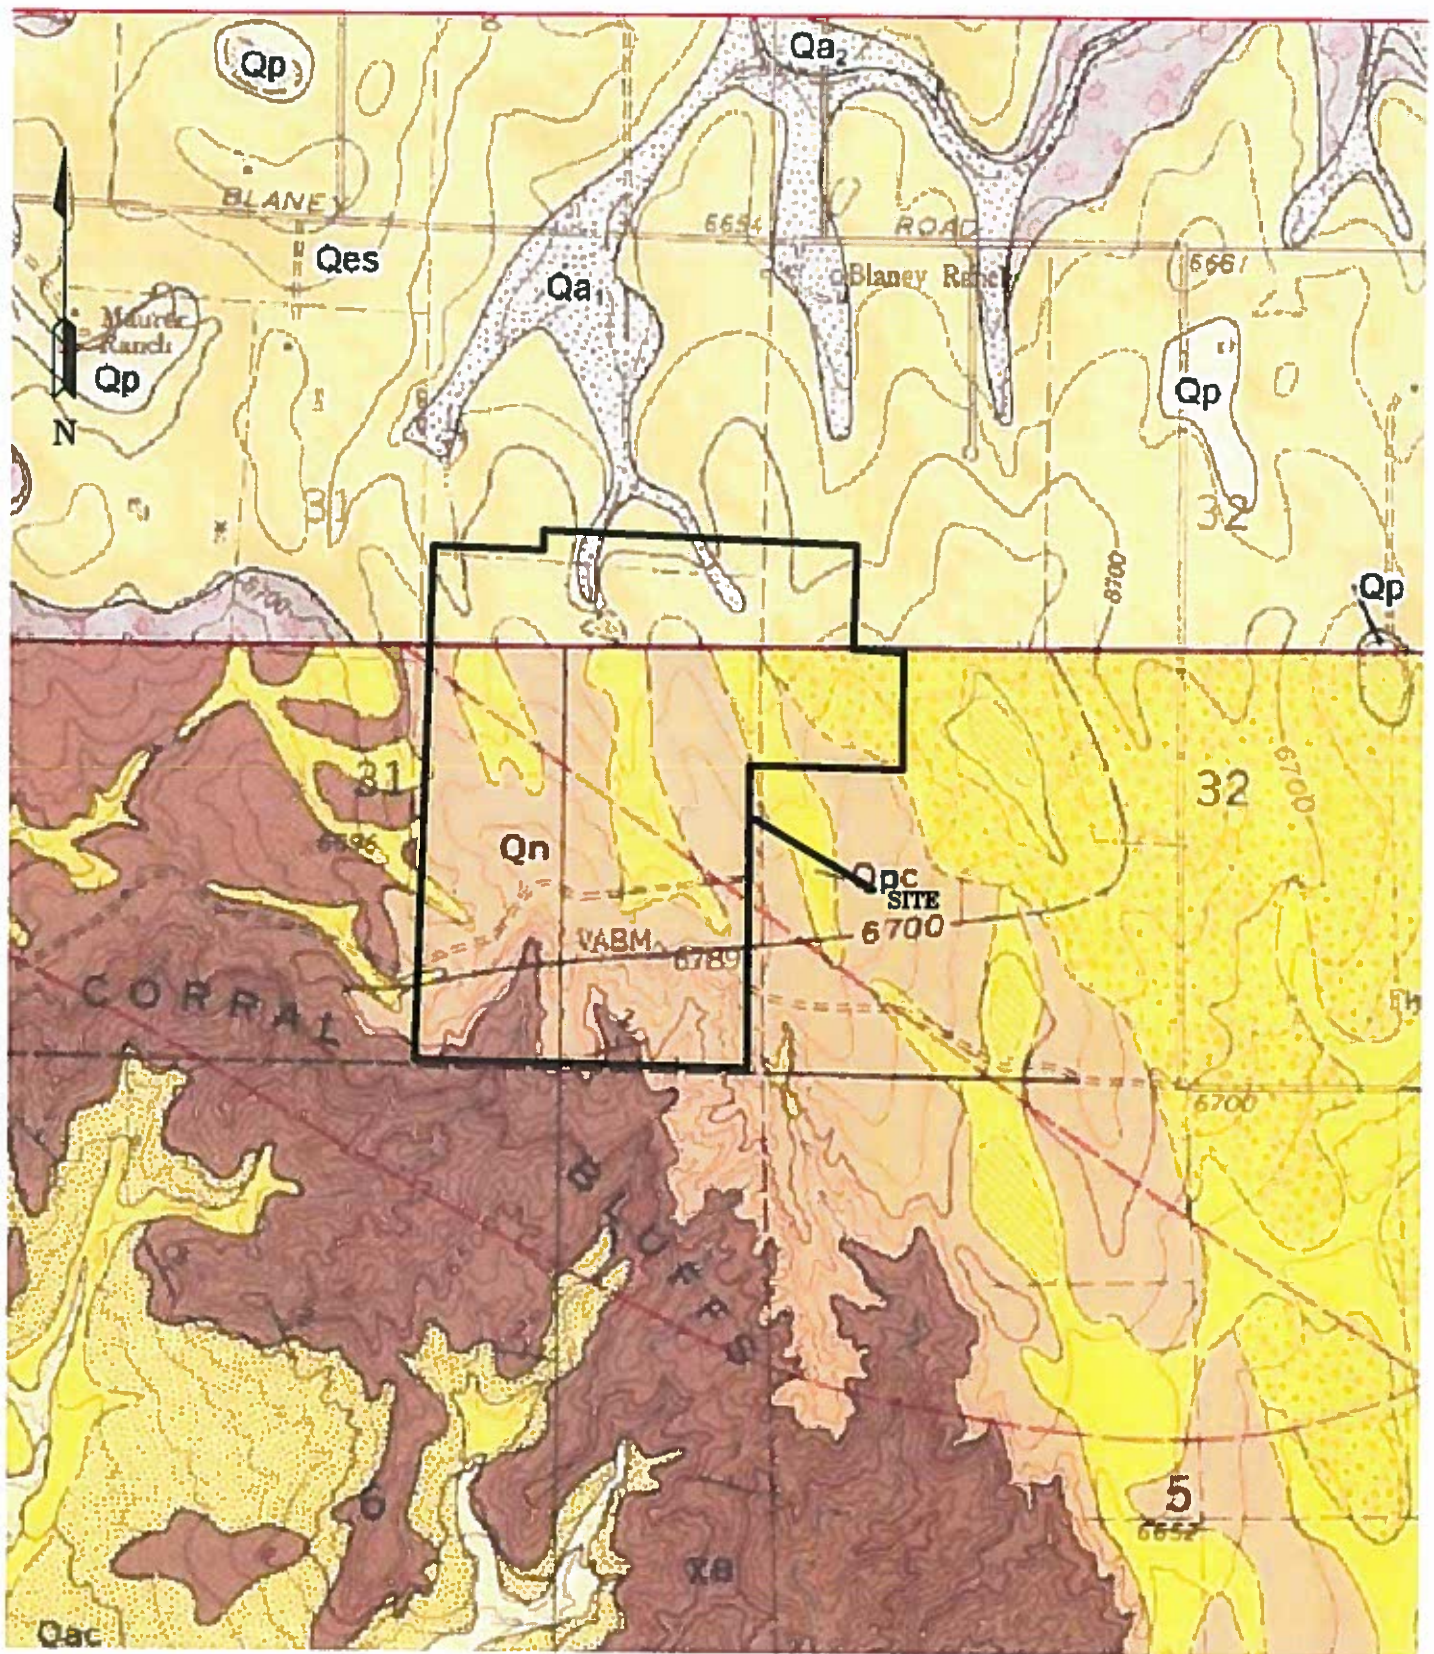
Corral Bluffs/Falcon Geology Map  
The Reserve at Corral Bluffs  
El Paso County, CO.  
For: Corral Ranch Development Co.

- Qaf - Artificial Fill of Holocene Age:  
Man-made fill deposits.
- Qal - Recent Alluvium of Holocene Age:  
Recent water deposited materials
- Qp - Piney Creek Alluvium of Holocene Age:  
Water deposited sands and clays
- Qes - Eolian Sand of Quaternary Age:  
Wind blown sand deposits
- Qc/Tkd - Colluvium of Quaternary Age Overlying  
the Dawson Formation of Tertiary to  
Cretaceous Age:  
Sheetwash and residual soil deposits  
overlying arkosic sandstone with  
interbedded siltstone and claystone.
- w - areas of ponded water
- psw - potentially seasonal shallow groundwater
- h - hydrocompaction
- pu - potentially unstable slope

Potentially unstable slopes have been mapped on the southern portions of the site. Development is not proposed in this area. A 50-foot building setback is recommended from the crest of the potentially unstable slopes. A 100-foot setback is recommended for Lots 24 and 25. These setbacks also apply to individual wastewater treatment systems. The recommended 50-foot and 100-foot setbacks are indicated on the Geology Map, Figure 8 and the Septic Suitability Map, Figure 10. It is anticipated the lots are of sufficient size to avoid the potentially unstable slopes and maintain the minimum setbacks.

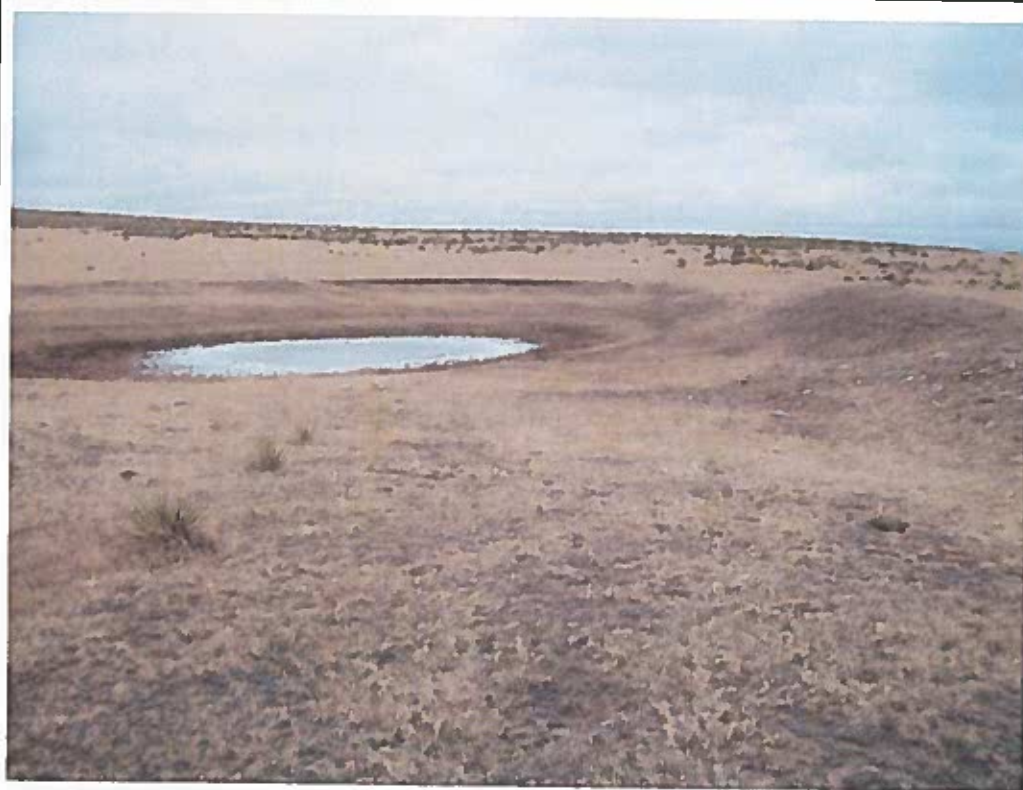
**Looking at dam and  
pond in central portion  
of the site.**

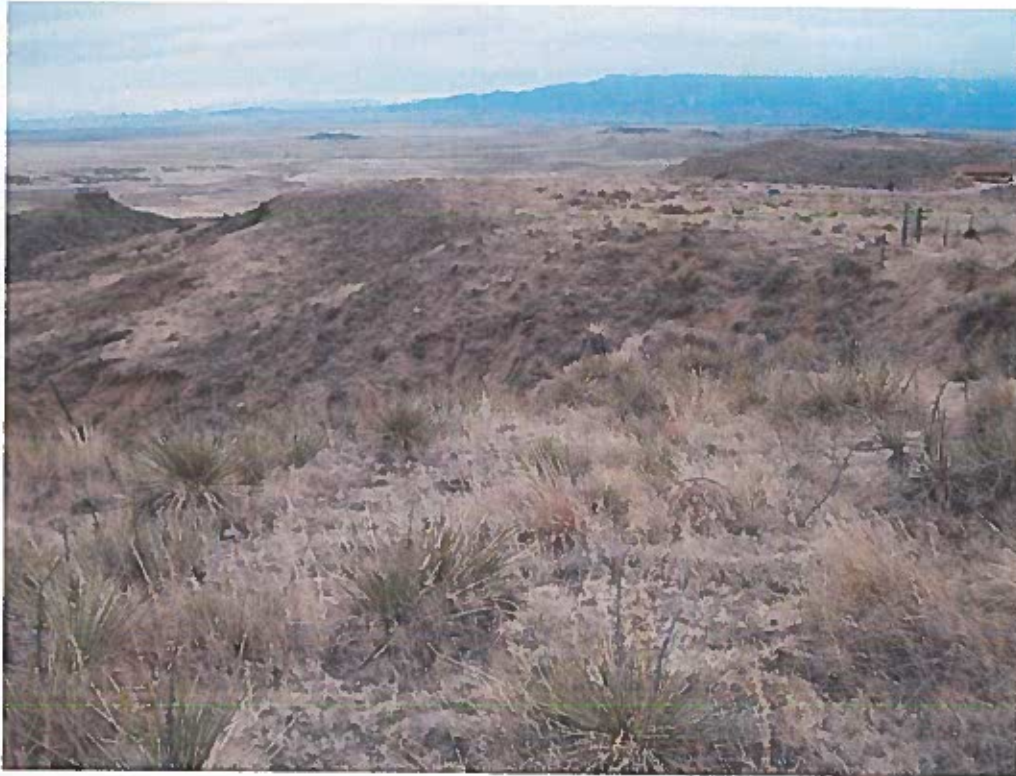
**Looking south at  
potentially unstable  
slopes in south central  
portion of the site.**

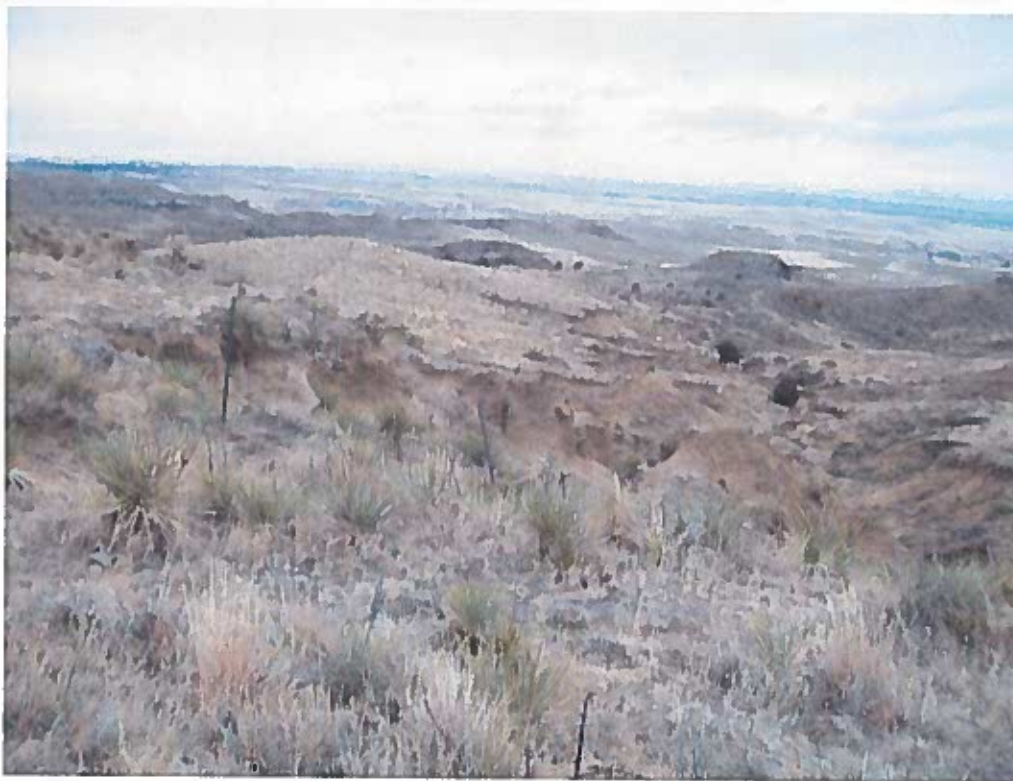
**Looking southeast at  
potentially unstable  
slopes in south central  
portion of the site.**
