**WASTEWATER STUDY  
THE RESERVE AT CORRAL BLUFFS  
EL PASO COUNTY, COLORADO**

**Corral Ranches Development Company**  
1830 Coyote Point Drive  
Colorado Springs, Colorado 80904

December 12, 2019  
Revised June 18, 2020

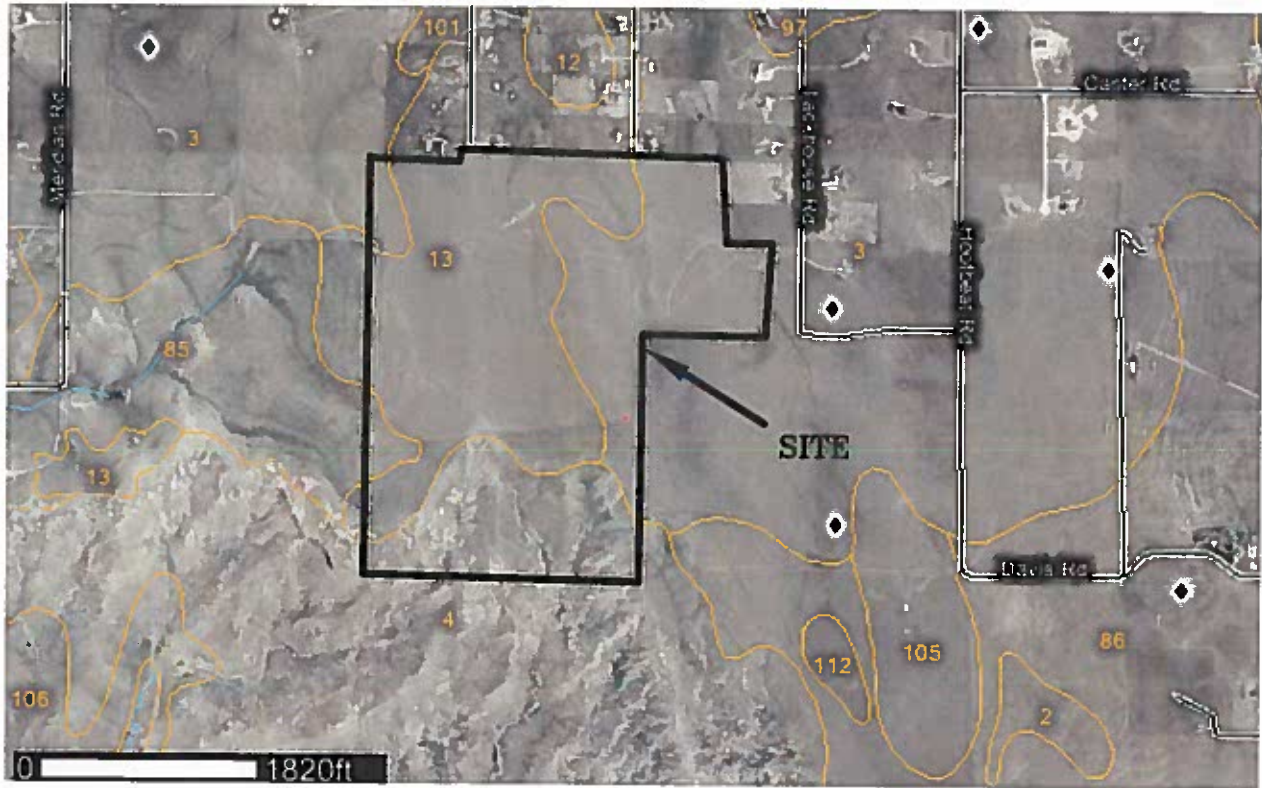
FIG NO.:  
5

Soil Survey Map  
The Reserve at Corral Bluffs  
El Paso County, CO.  
For: Corral Ranch Development Co.

Complete descriptions of each soil type are presented in Appendix E. The soils have generally been described to have rapid to moderate permeabilities. Soil Type 4 (Badland) exists on the steeper slopes in the southern portion of the site where no development is proposed. Soil Types 3 and 13 have been described as having good potential for home sites. Limitations on soil Type 85 include steep slopes, and depth to bedrock. Possible hazards with soil erosion are present on the site. The erosion potential can be controlled with vegetation. The majority of the soils have been described to have moderate erosion hazards with high erosion hazards on Soil Type 4 (Badland) due to the potential for gullying.

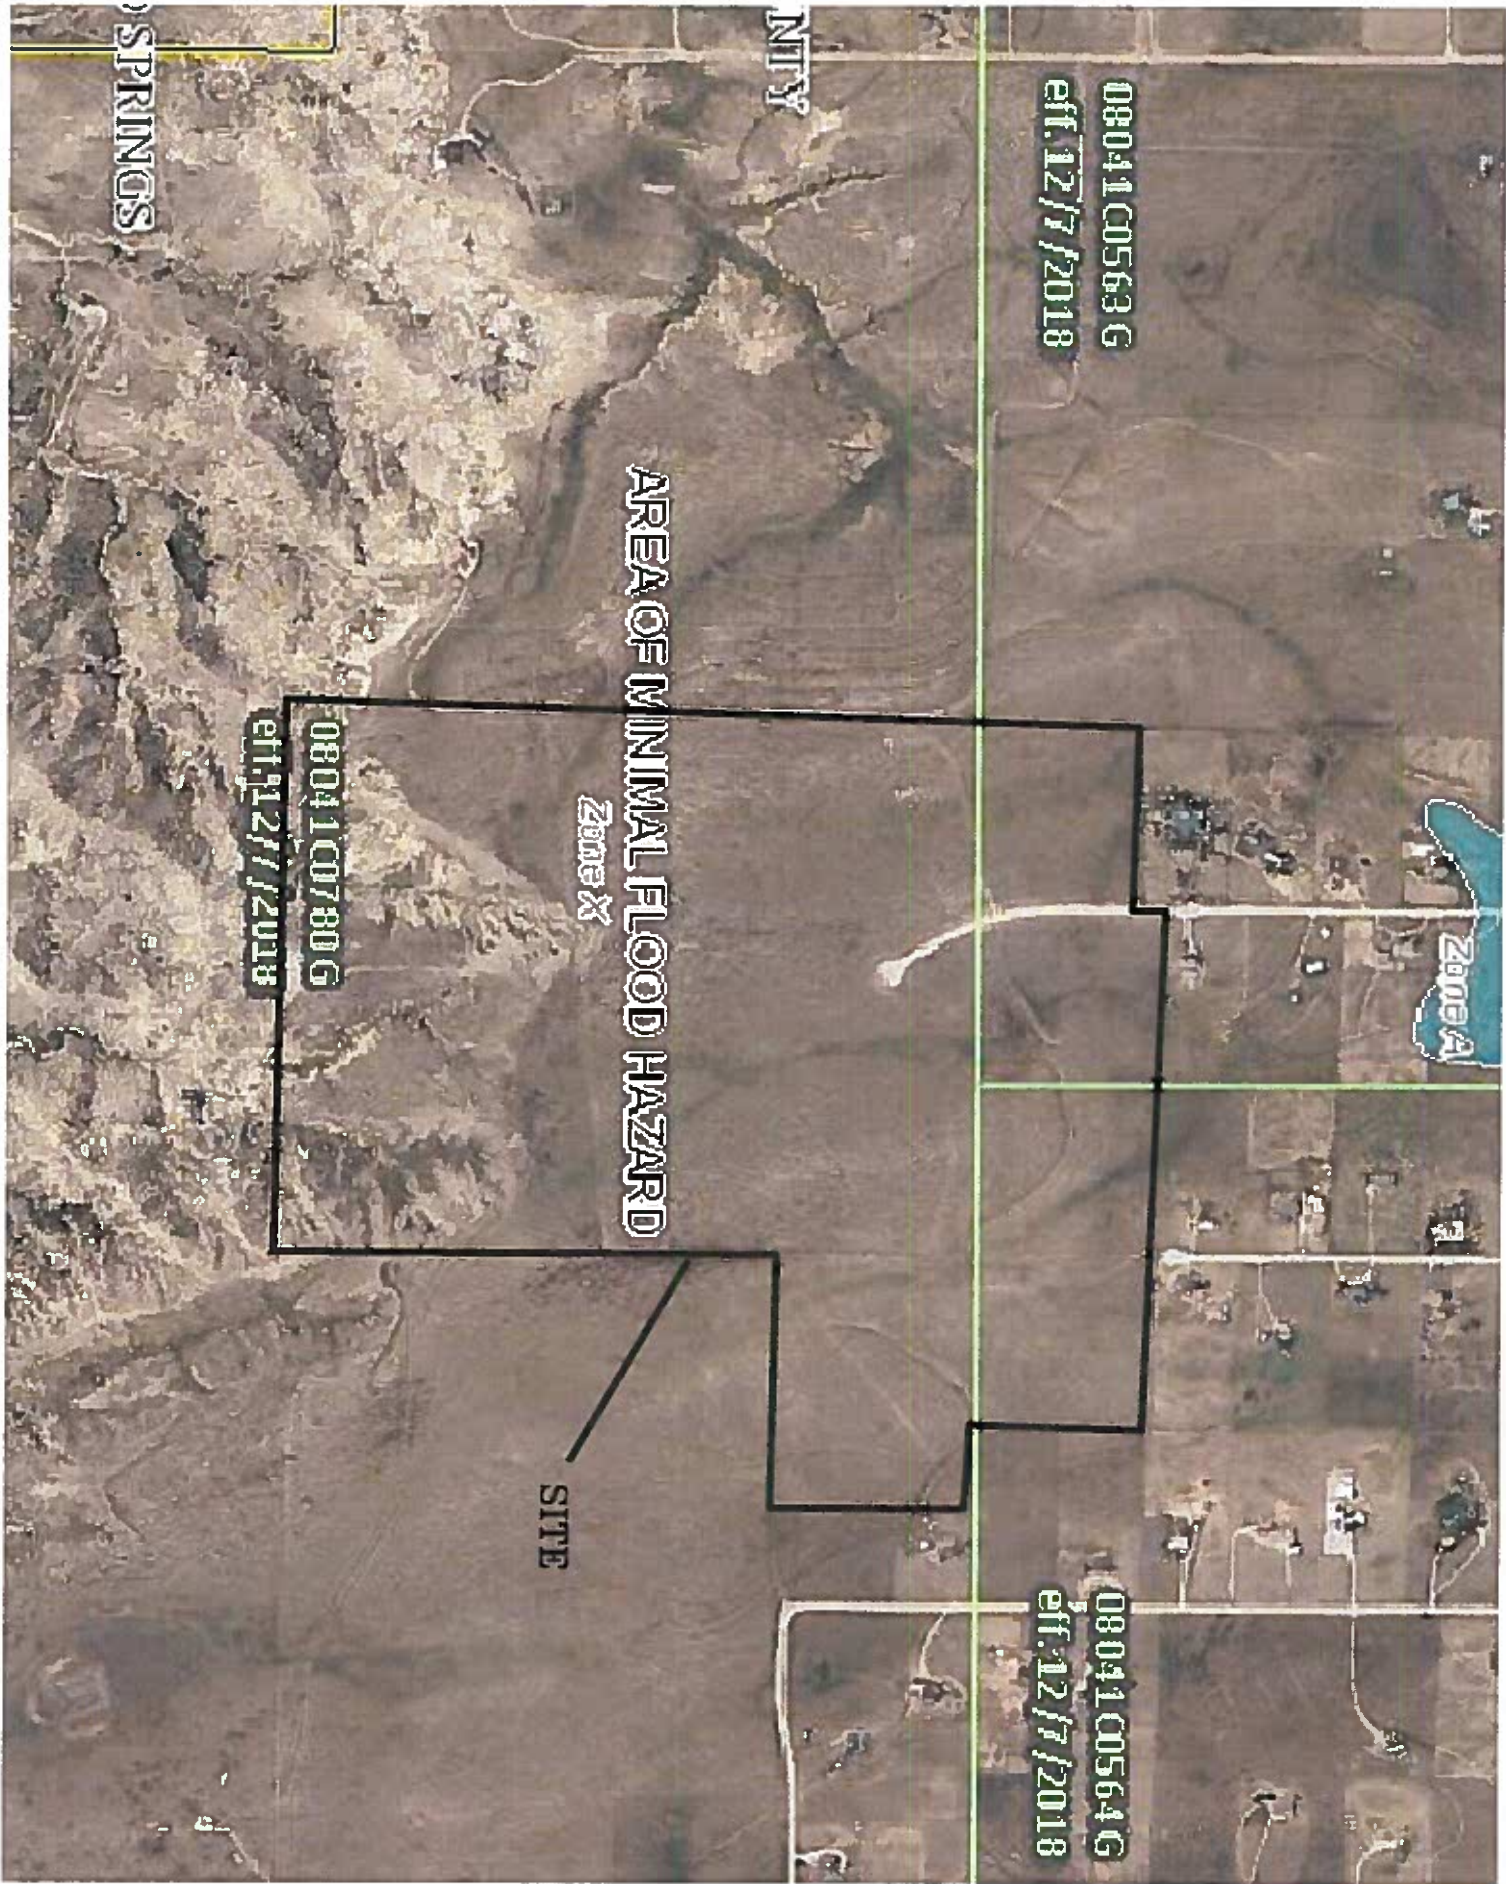
DATE  
12/2/19  
BY  
AS SHOWN  
JOB NO.  
102142  
PROJECT  
9

- LEGEND
- AREAS WHERE SEPTIC SYSTEMS ARE NOT RECOMMENDED DUE TO DRAINAGE AREA OR POTENTIALLY UNSTABLE SLOPES
  - AREAS WHERE DESIGNED SYSTEMS MAY BE REQUIRED DUE TO SLOW PERCOLATION RATES
  - AREAS WHERE CONVENTIONAL SYSTEMS MAY BE USED UNLESS SLOW PERCOLATION RATES, SHALLOW GROUNDWATER, OR SHALLOW BEDROCK IS ENCOUNTERED REQUIRING DESIGNED SYSTEMS
  - POSSIBLE HOUSE LOCATION
  - TWO POSSIBLE SEPTIC FIELD SITES
  - POSSIBLE WELL LOCATION

The percolation rates in nine of the locations are suitable for conventional systems. (References 1 and 2). Three tests had rates of slower than 60 minutes per inch. Additional drilling may reveal other areas where more suitable rates can be found. El Paso County guidelines require designed systems for percolation rates exceeding 60 minutes per inch. Bedrock was not encountered in any of the profile holes at a depth that would affect conventional systems, however, some areas may contain shallow bedrock. Where bedrock is encountered less than 6 feet, designed systems may be required. A Septic Suitability Map is presented in Figure 10. A possible house location, two potential on site wastewater treatment system (OWTS) locations and a possible well site for each lot are indicated on Figure 10. Due to the size of the building lots, it is anticipated that suitable areas will be available where conventional systems may be utilized on most lots. In areas where suitable percolation rates cannot be found, shallow groundwater exists or shallow bedrock exists, designed systems will be required.

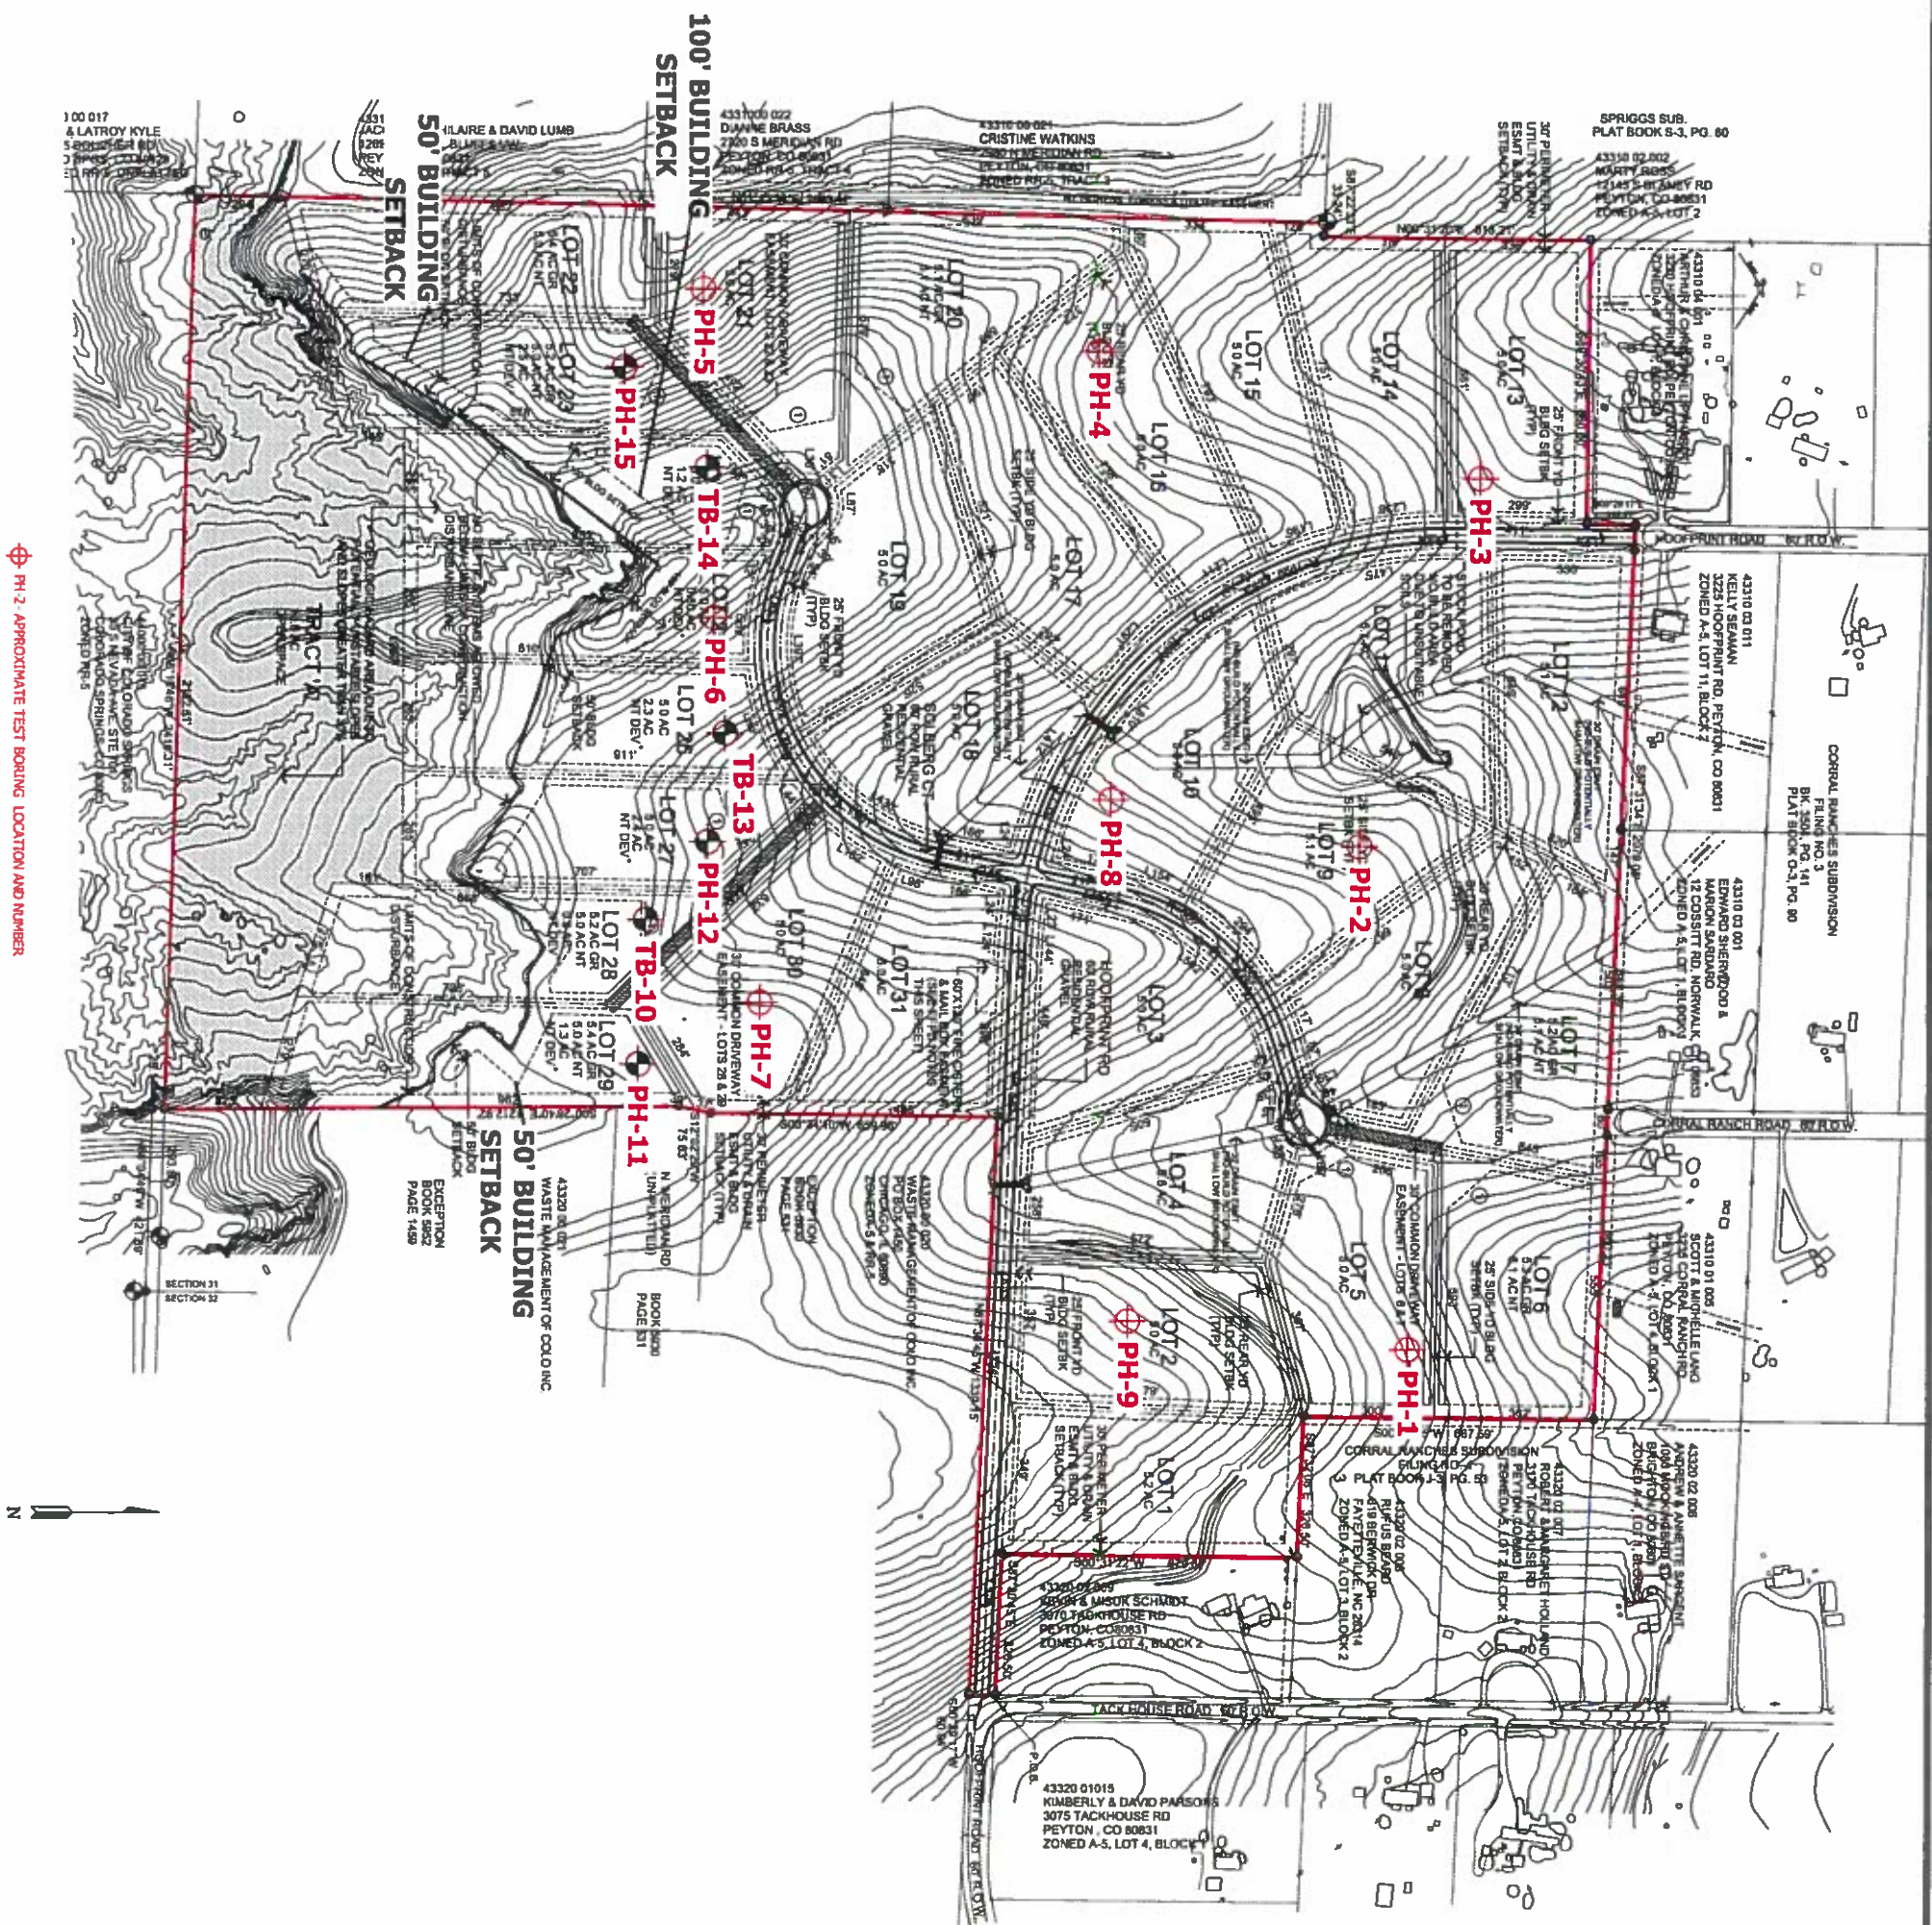
PH-2 APPROXIMATE TEST BORING LOCATION AND NUMBER

SEPTIC SUITABILITY MAP  
THE RESERVE AT CORRAL BLUFFS  
EL PASO COUNTY, CO  
FOR: CORRAL RANCH DEVELOPMENT

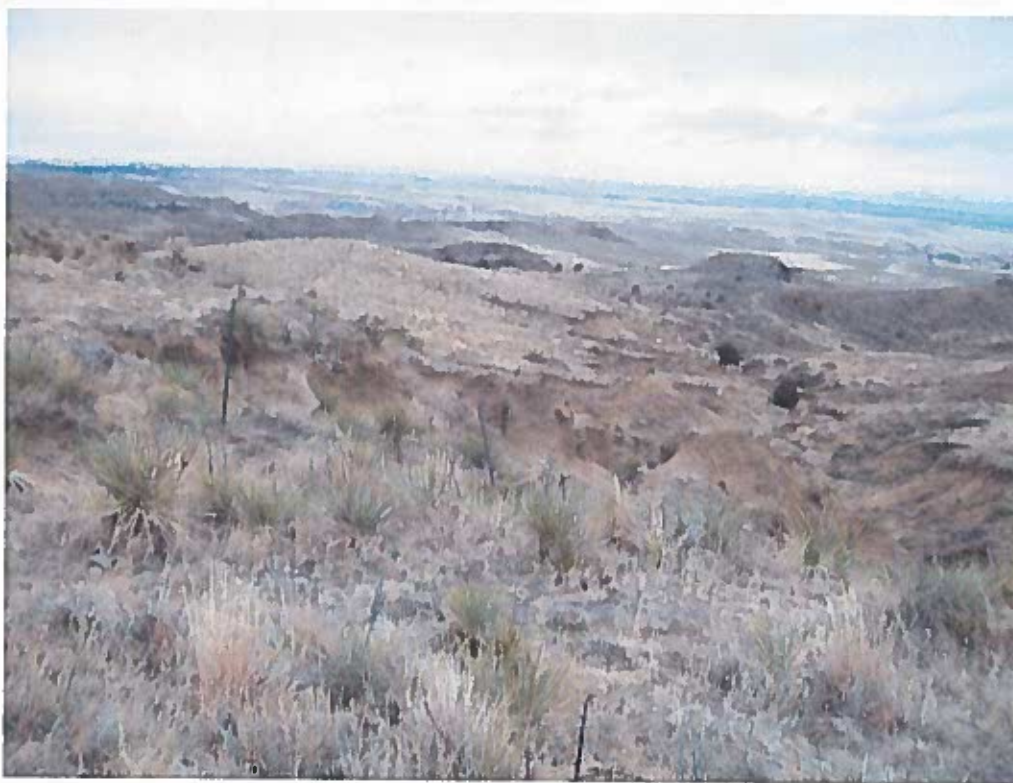
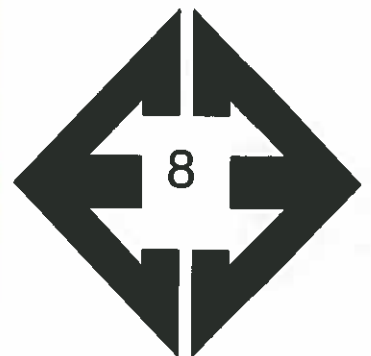
**Looking southeast at  
potentially unstable  
slopes in south central  
portion of the site.**

Potentially unstable slopes have been mapped on the southern portions of the site. Development is not proposed in this area. A 50-foot building setback is recommended from the crest of the potentially unstable slopes. A 100-foot setback is recommended for Lots 24 and 25. These setbacks also apply to individual wastewater treatment systems. The recommended 50-foot and 100-foot setbacks are indicated on the Geology Map, Figure 8 and the Septic Suitability Map, Figure 10. It is anticipated the lots are of sufficient size to avoid the potentially unstable slopes and maintain the minimum setbacks.

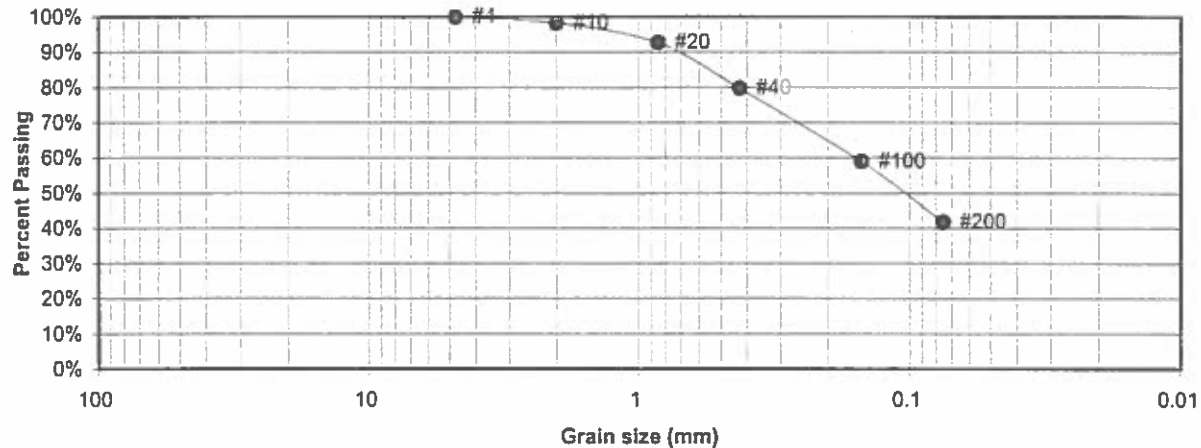
**Sieve Analysis**  
**Grain Size Distribution**

U.S. Sieve #	Percent Finer
3"	
1 1/2"	
3/4"	
1/2"	
3/8"	
4	100.0%
10	98.2%
20	92.7%
40	79.7%
100	58.9%
200	41.7%

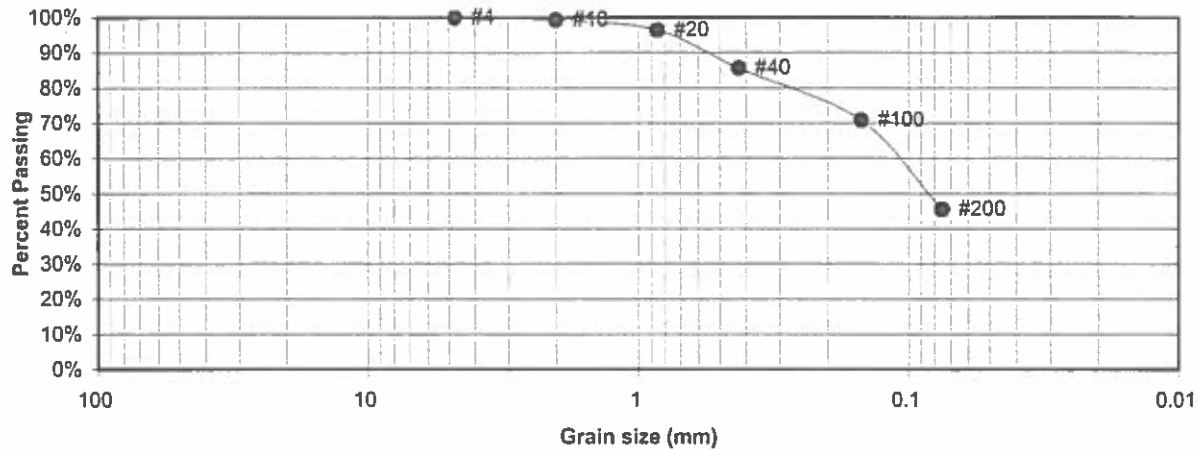
**Sieve Analysis  
Grain Size Distribution**

U.S. Sieve #	Percent Finer
3"	
1 1/2"	
3/4"	
1/2"	
3/8"	
4	100.0%
10	99.3%
20	96.4%
40	85.7%
100	70.8%
200	45.5%

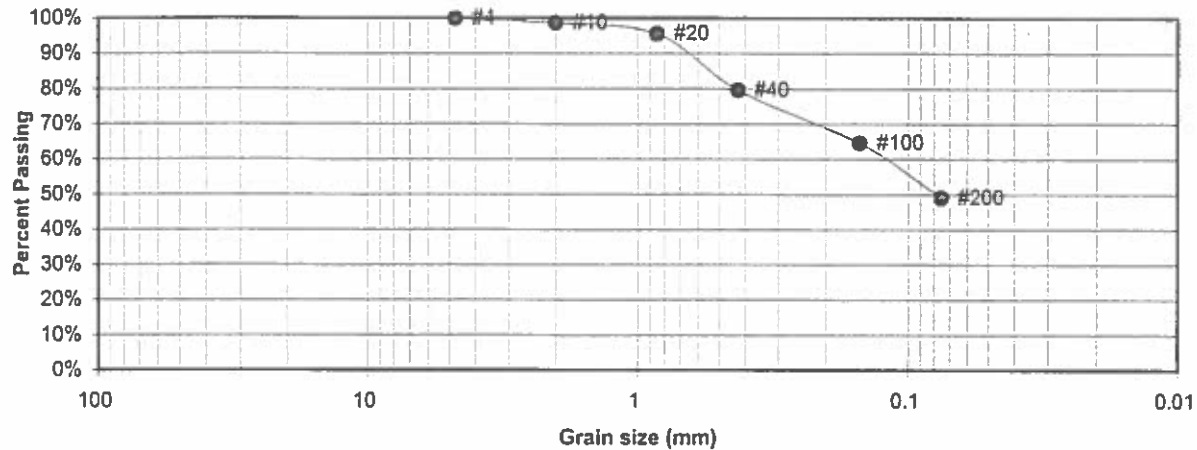
**Sieve Analysis  
Grain Size Distribution**

U.S. Sieve #	Percent Finer
3"	
1 1/2"	
3/4"	
1/2"	
3/8"	
4	100.0%
10	98.7%
20	95.6%
40	79.6%
100	64.6%
200	49.0%

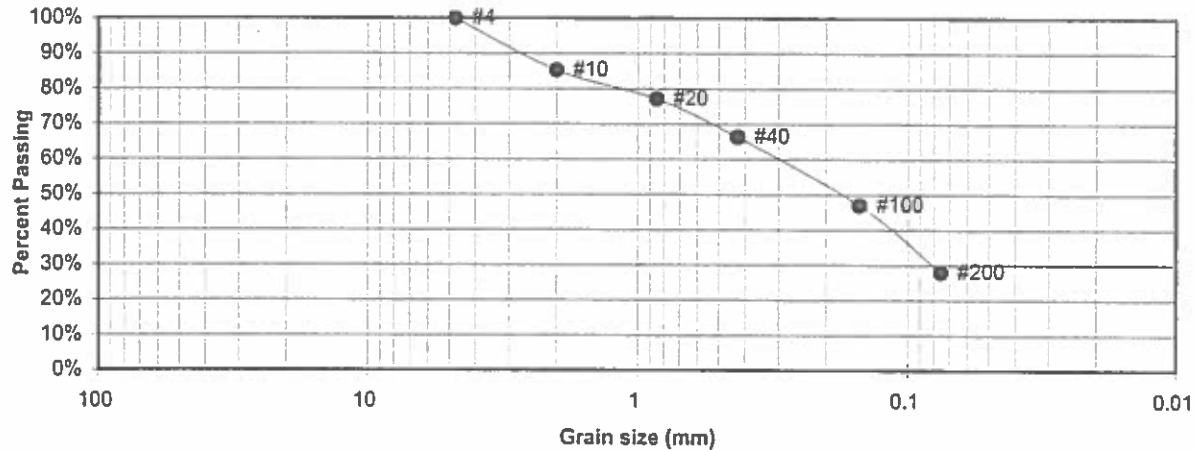
**Sieve Analysis  
Grain Size Distribution**

U.S. Sieve #	Percent Finer
3"	
1 1/2"	
3/4"	
1/2"	
3/8"	
4	100.0%
10	85.3%
20	77.1%
40	66.3%
100	47.0%
200	28.0%

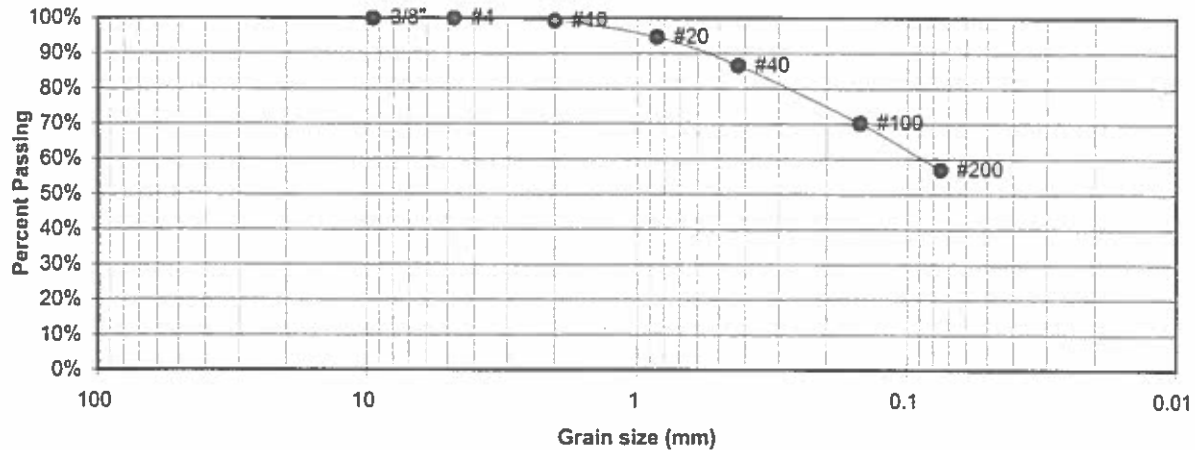
Sieve Analysis  
Grain Size Distribution

U.S. Sieve #	Percent Finer
3"	
1 1/2"	
3/4"	
1/2"	
3/8"	100.0%
4	100.0%
10	99.3%
20	94.6%
40	86.5%
100	70.2%
200	57.0%

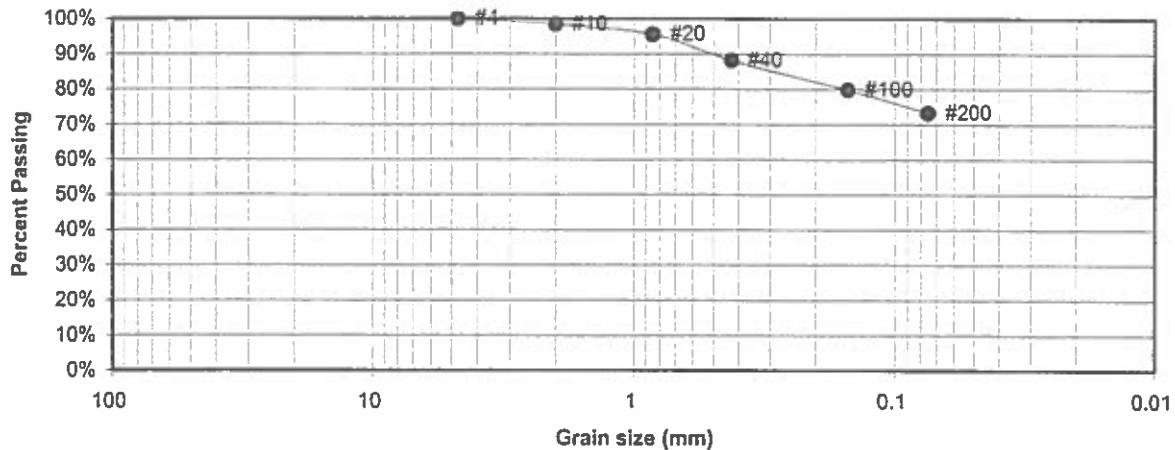
**Sieve Analysis  
Grain Size Distribution**

U.S. Sieve #	Percent Finer
3"	
1 1/2"	
3/4"	
1/2"	
3/8"	
4	100.0%
10	98.4%
20	95.6%
40	88.2%
100	79.9%
200	73.2%

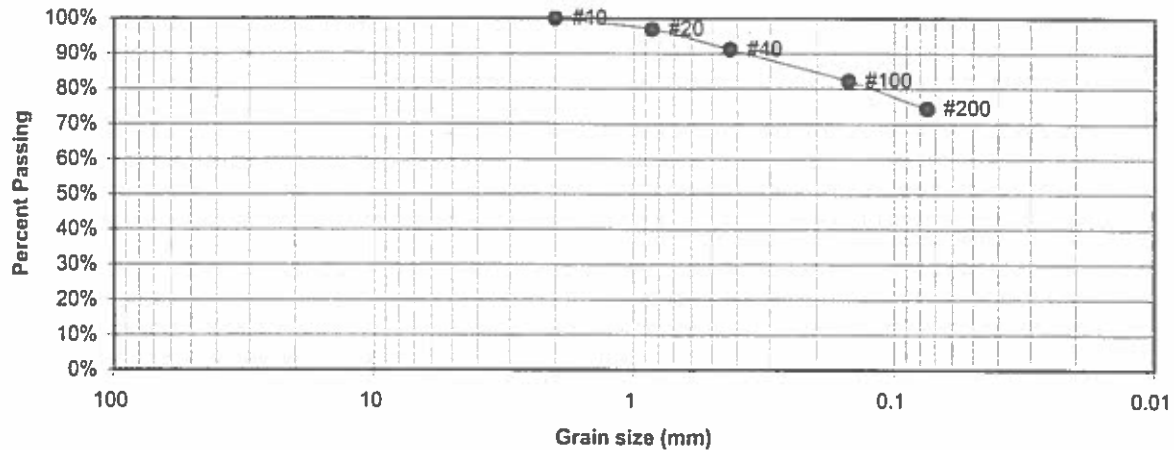
Sieve Analysis  
Grain Size Distribution

U.S. Sieve #	Percent Finer
3"	
1 1/2"	
3/4"	
1/2"	
3/8"	
4	
10	100.0%
20	97.0%
40	91.2%
100	82.2%
200	74.3%

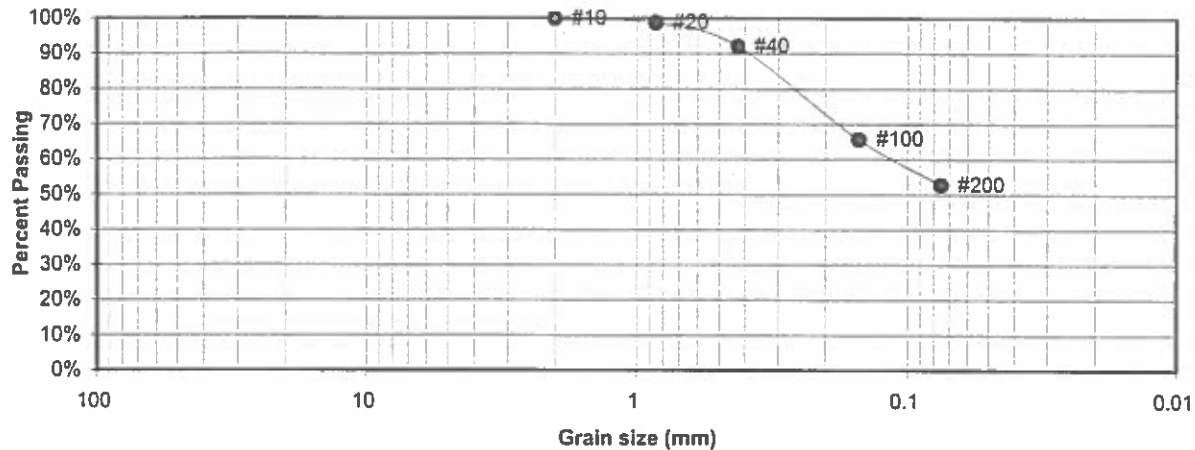
**Sieve Analysis**  
**Grain Size Distribution**

U.S. Sieve #	Percent Finer
3"	
1 1/2"	
3/4"	
1/2"	
3/8"	
4	
10	100.0%
20	98.8%
40	92.0%
100	65.7%
200	52.7%

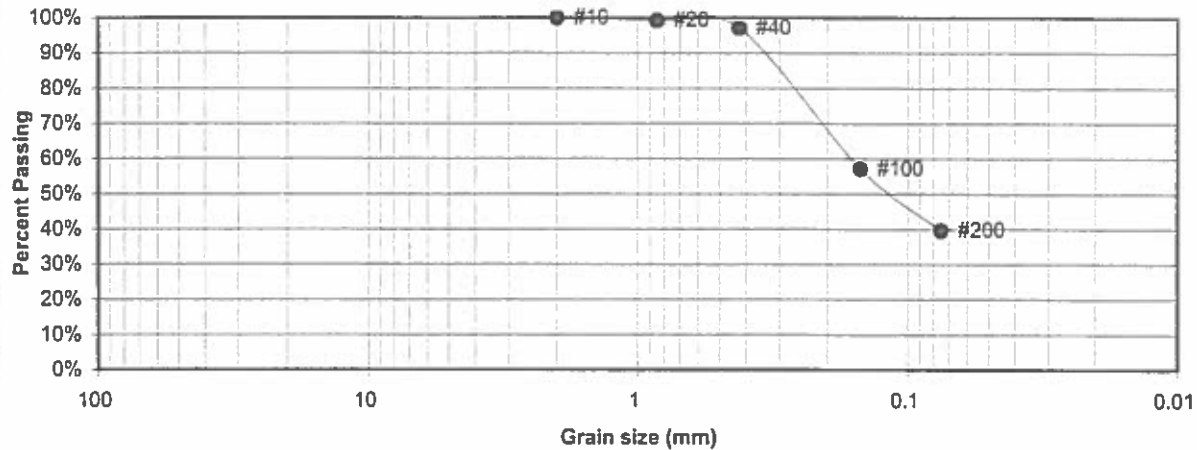
**Sieve Analysis  
Grain Size Distribution**

U.S. Sieve #	Percent Finer
3"	
1 1/2"	
3/4"	
1/2"	
3/8"	
4	
10	100.0%
20	99.3%
40	97.0%
100	57.1%
200	39.6%

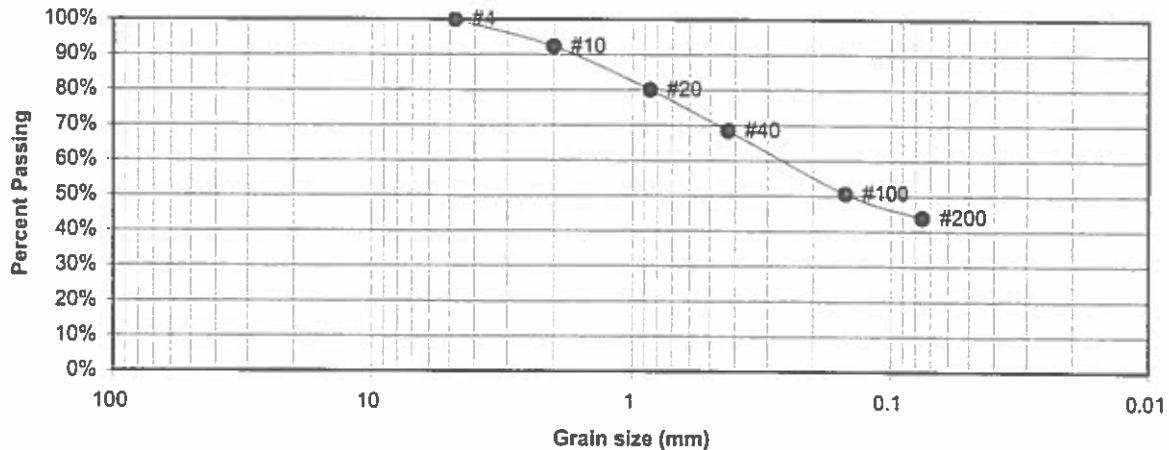
**Sieve Analysis  
Grain Size Distribution**

U.S. Sieve #	Percent Finer
3"	
1 1/2"	
3/4"	
1/2"	
3/8"	
4	100.0%
10	92.3%
20	80.0%
40	68.5%
100	50.6%
200	43.8%

Moisture at start	14.2%
Moisture at finish	23.6%
Moisture increase	9.4%
Initial dry density (pcf)	103
Swell (psf)	1330

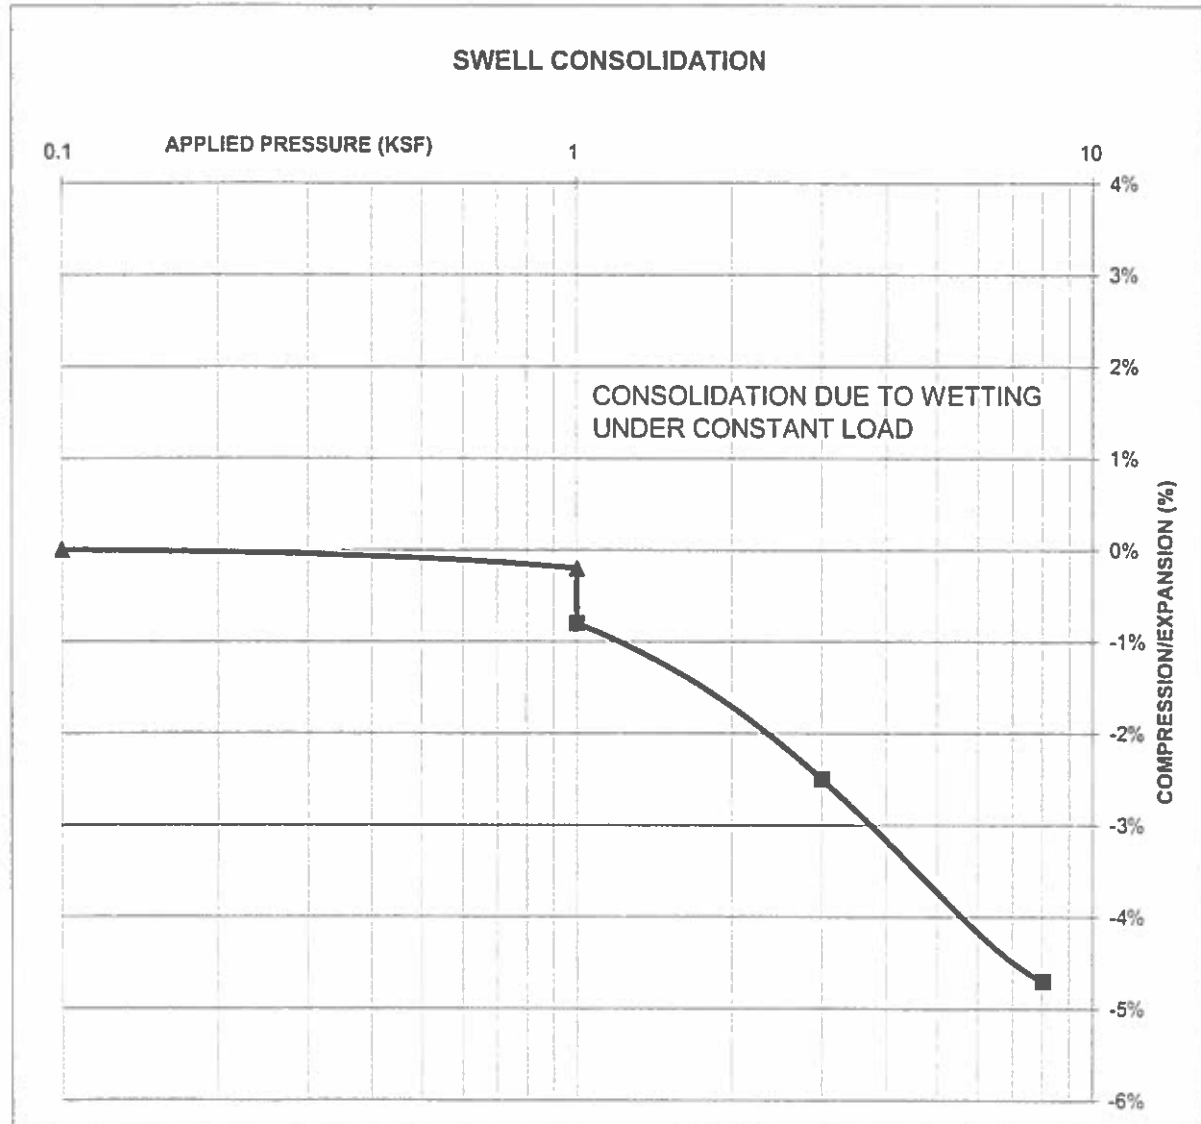
TEST BORING #	1	DEPTH(ft)	2-3
DESCRIPTION	SM	SOIL TYPE	1
NATURAL UNIT DRY WEIGHT (PCF)	107		
NATURAL MOISTURE CONTENT	6.3%		
SWELL/CONSOLIDATION (%)	-0.6%

Soil Type 1 is a silty to very silty sand (SM), encountered in the upper soil profile in all but one of the profile holes. These soils were encountered at medium dense to dense states and at moist conditions. Samples tested had 27 to 49 percent passing the No. 200 Sieve. A consolidation of 0.6% was measured in the Swell/Consolidation Test. This consolidation is in the low range.

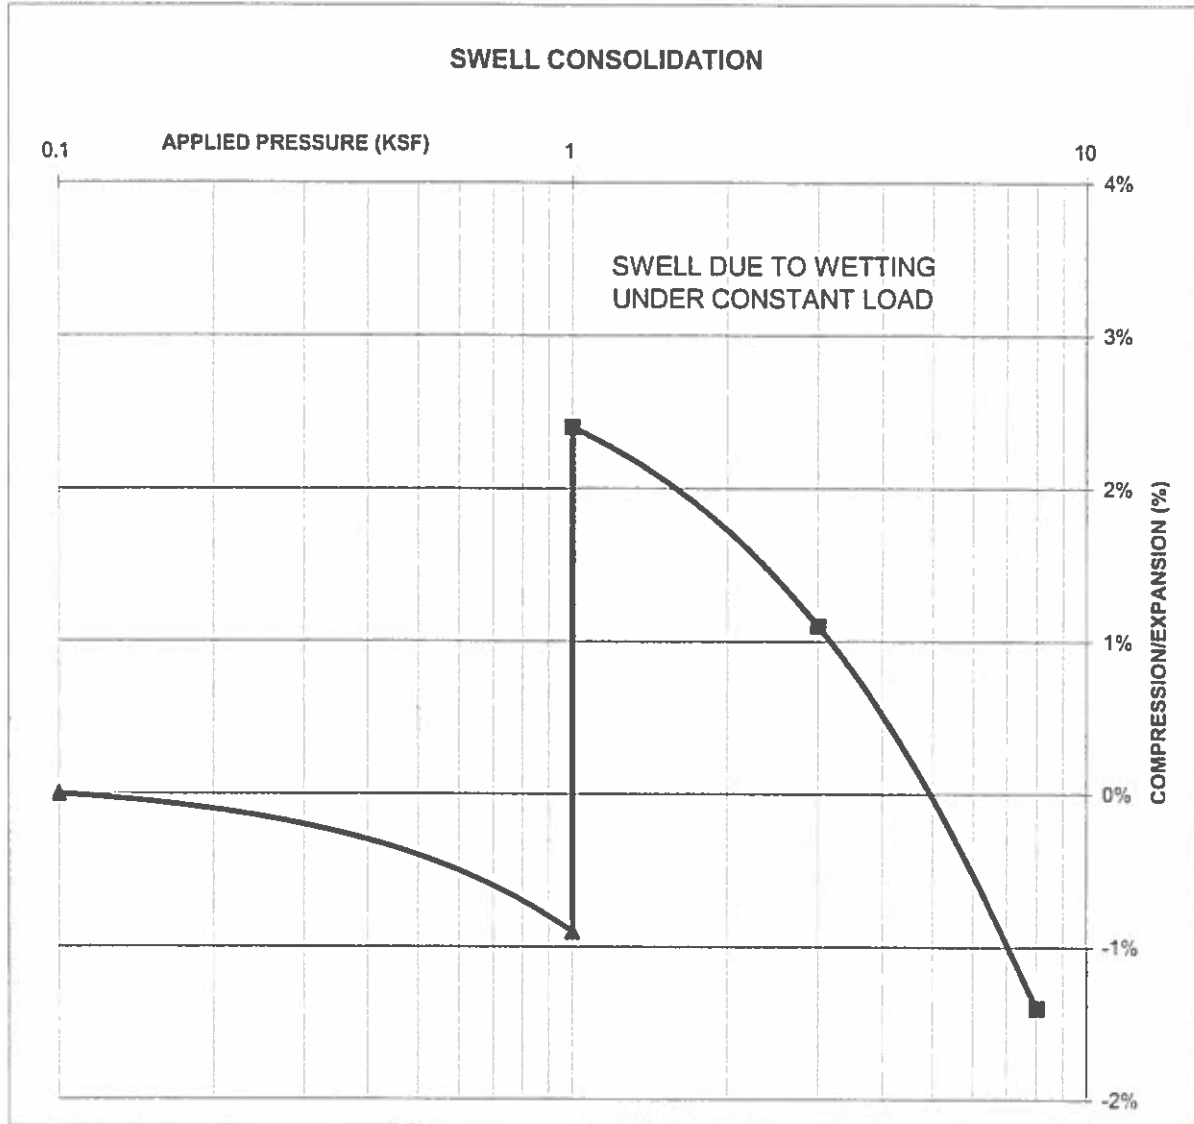
TEST BORING #	4	DEPTH(ft)	5
DESCRIPTION	CL-M	SOIL TYPE	2
NATURAL UNIT DRY WEIGHT (PCF)	110		
NATURAL MOISTURE CONTENT	11.0%		
SWELL/CONSOLIDATION (%)	3.3%

Soil Type 2 consists of sandy to very sandy clay and clay-silt (CL, CL-ML). The clays were encountered in two of the profile holes at depths ranging from the surface to 9 feet below the surface. These soils were encountered at stiff to very stiff consistencies and moist conditions. Samples tested had 57 to 74 percent passing the No. 200 sieve. A swell of 3.3 percent was measured on the clays in the Swell/Consolidation Test. This swell is in the moderate to high expansion range. A consolidation of 0.2 percent was measured on the soils in the Swell/Consolidation Test indicating low potential for consolidation.

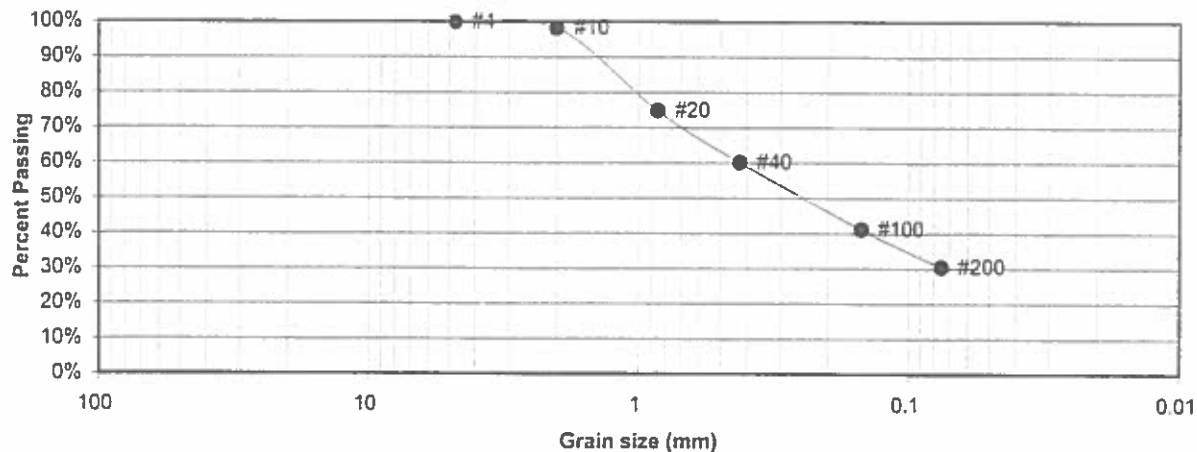
**Sieve Analysis  
Grain Size Distribution**

3"  
1 1/2"  
3/4"  
1/2"  
3/8"  
4 100.0%  
10 98.3%  
20 74.8%  
40 60.1%  
100 41.2%  
200 30.5%

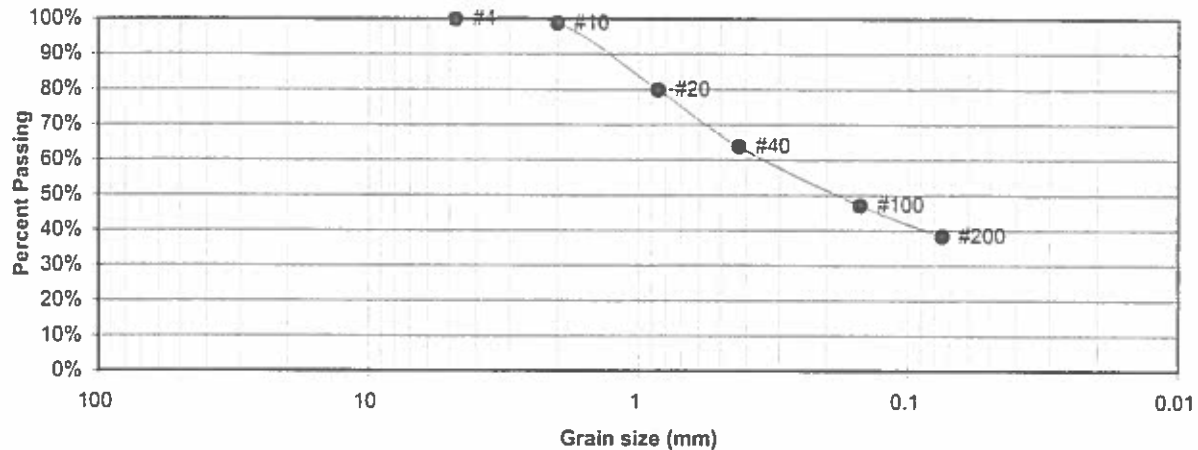
**Sieve Analysis**  
**Grain Size Distribution**

U.S. Sieve #	Percent Finer
3"	
1 1/2"	
3/4"	
1/2"	
3/8"	
4	100.0%
10	98.8%
20	79.9%
40	63.7%
100	47.2%
200	38.3%
