**WASTEWATER STUDY
THE RESERVE AT CORRAL BLUFFS
EL PASO COUNTY, COLORADO**

Corral Ranches Development Company
1830 Coyote Point Drive
Colorado Springs, Colorado 80904

December 11, 2019

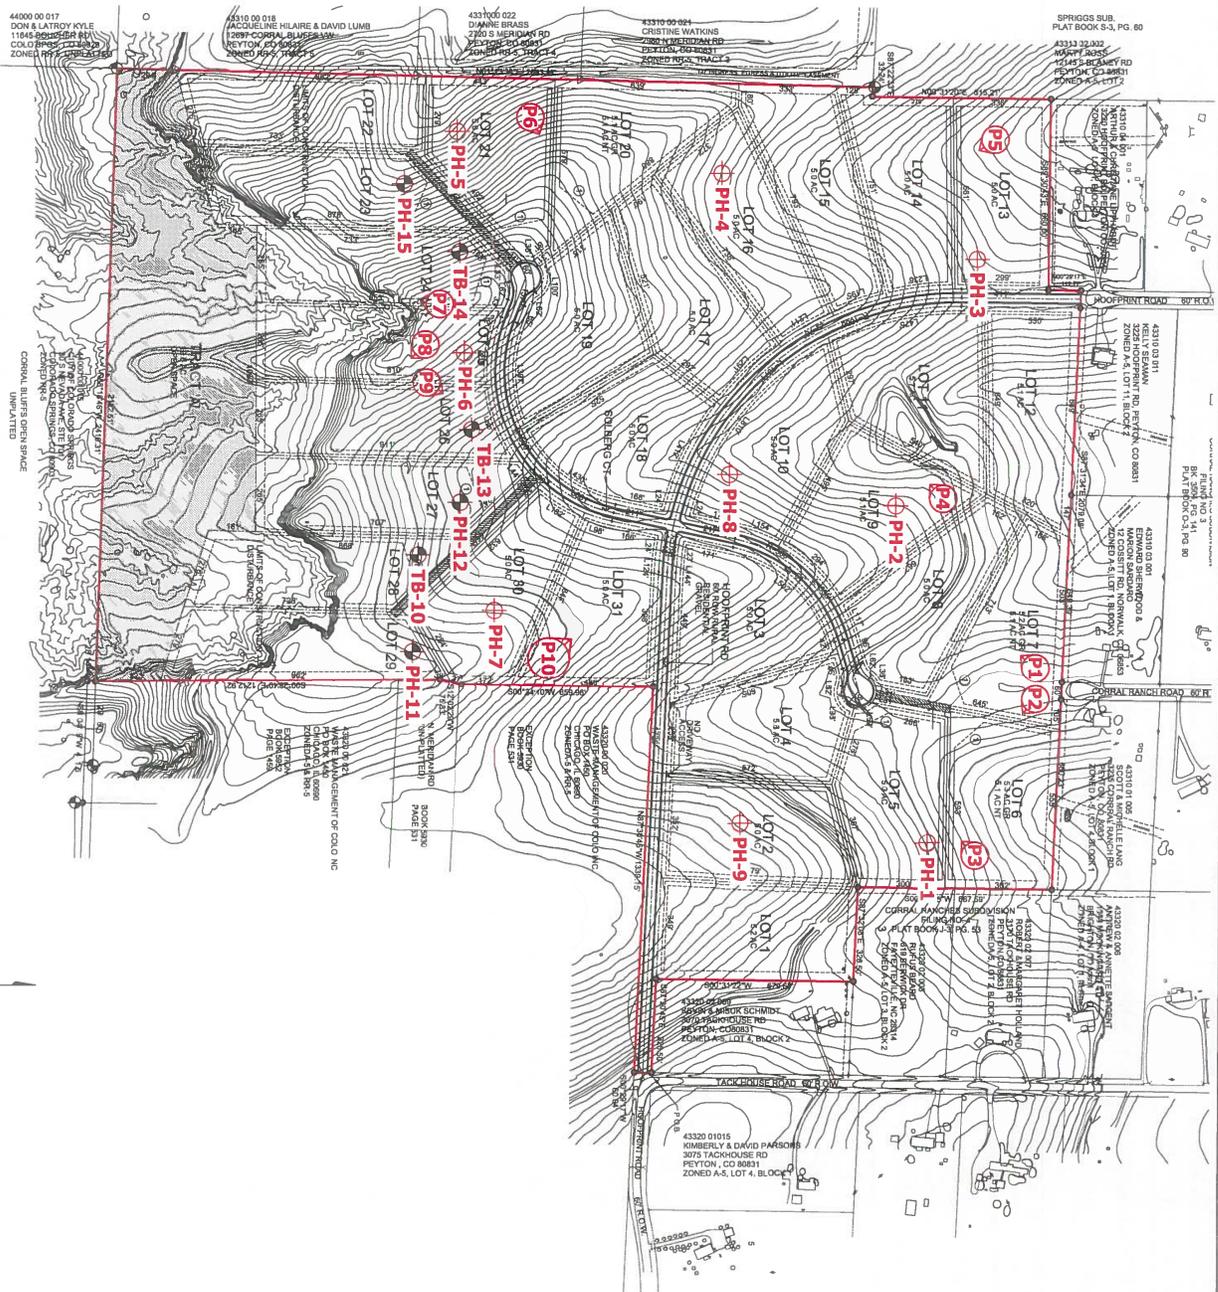
DRAWN BY: JAC
DESIGNED BY: KAH
CHECKED BY:
DATE: 12/04/19
SCALE: 1/200
JOB NO: 192142
FIGURE NO: 4

DEVELOPMENT PLAN / PERCOLATION
 TEST LOCATION MAP
 THE RESERVE AT CORRAL BLUFFS
 EL PASO COUNTY, CO
 FOR: CORRAL RANCH DEVELOPMENT

The percolation rates in nine of the locations are suitable for conventional systems. (References 1 and 2) Three tests had rates of slower than 60 minutes per inch. Additional drilling may reveal other areas where more suitable rates can be found. El Paso County guidelines require designed systems for percolation rates exceeding 60 minutes per inch. Bedrock was not encountered in any of the profile holes at a depth that would affect conventional systems, however, some areas may contain shallow bedrock. Where bedrock is encountered less than 6 feet, designed systems may be required. A Septic Suitability Map is presented in Figure 10. A possible house location, two potential on site wastewater treatment system (OWTS) locations and a possible well site for each lot are indicated on Figure 10. Due to the size of the building lots, it is anticipated that suitable areas will be available where conventional systems may be utilized on most lots. In areas where suitable percolation rates cannot be found, shallow groundwater exists or shallow bedrock exists, designed systems will be required.

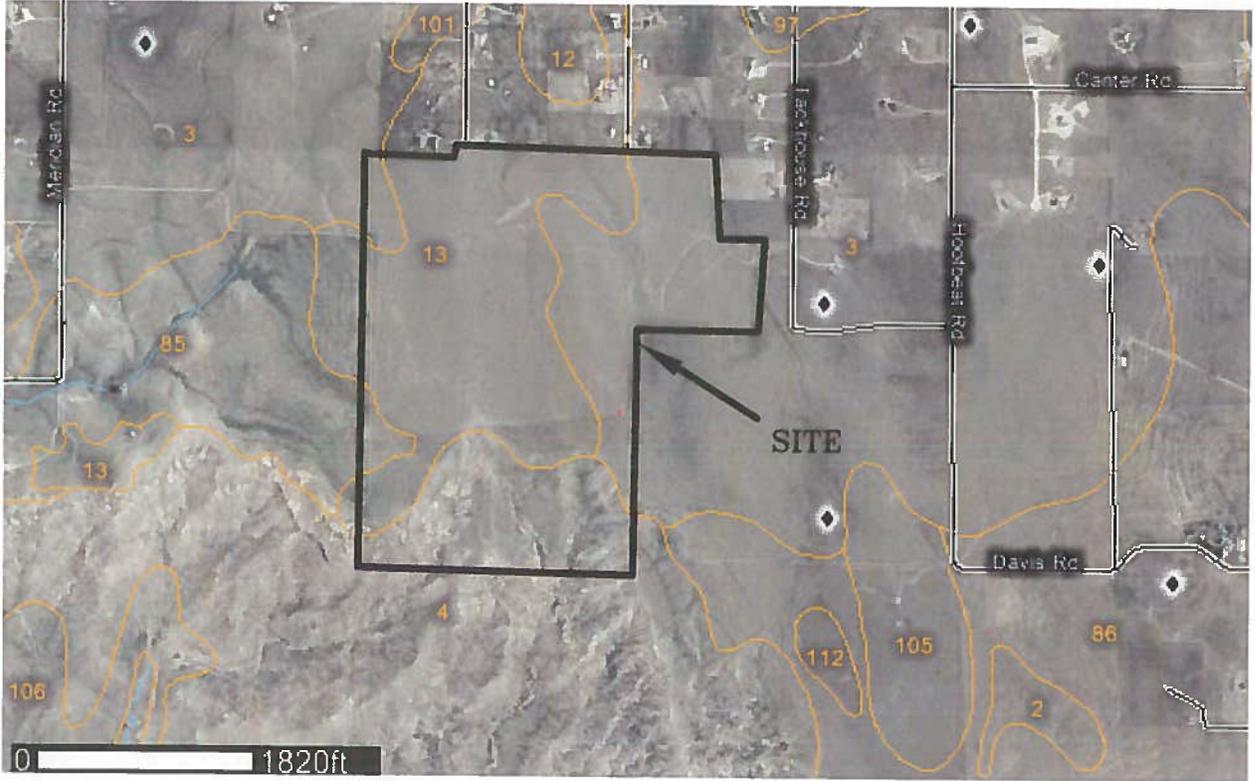
FIG NO.:
5

Soil Survey Map
The Reserve at Corral Bluffs
El Paso County, CO.
For: Corral Ranch Development Co.

Complete descriptions of each soil type are presented in Appendix E. The soils have generally been described to have rapid to moderate permeabilities. Soil Type 4 (Badland) exists on the steeper slopes in the southern portion of the site where no development is proposed. Soil Types 3 and 13 have been described as having good potential for home sites. Limitations on soil Type 85 include steep slopes, and depth to bedrock. Possible hazards with soil erosion are present on the site. The erosion potential can be controlled with vegetation. The majority of the soils have been described to have moderate erosion hazards with high erosion hazards on Soil Type 4 (Badland) due to the potential for gullying.

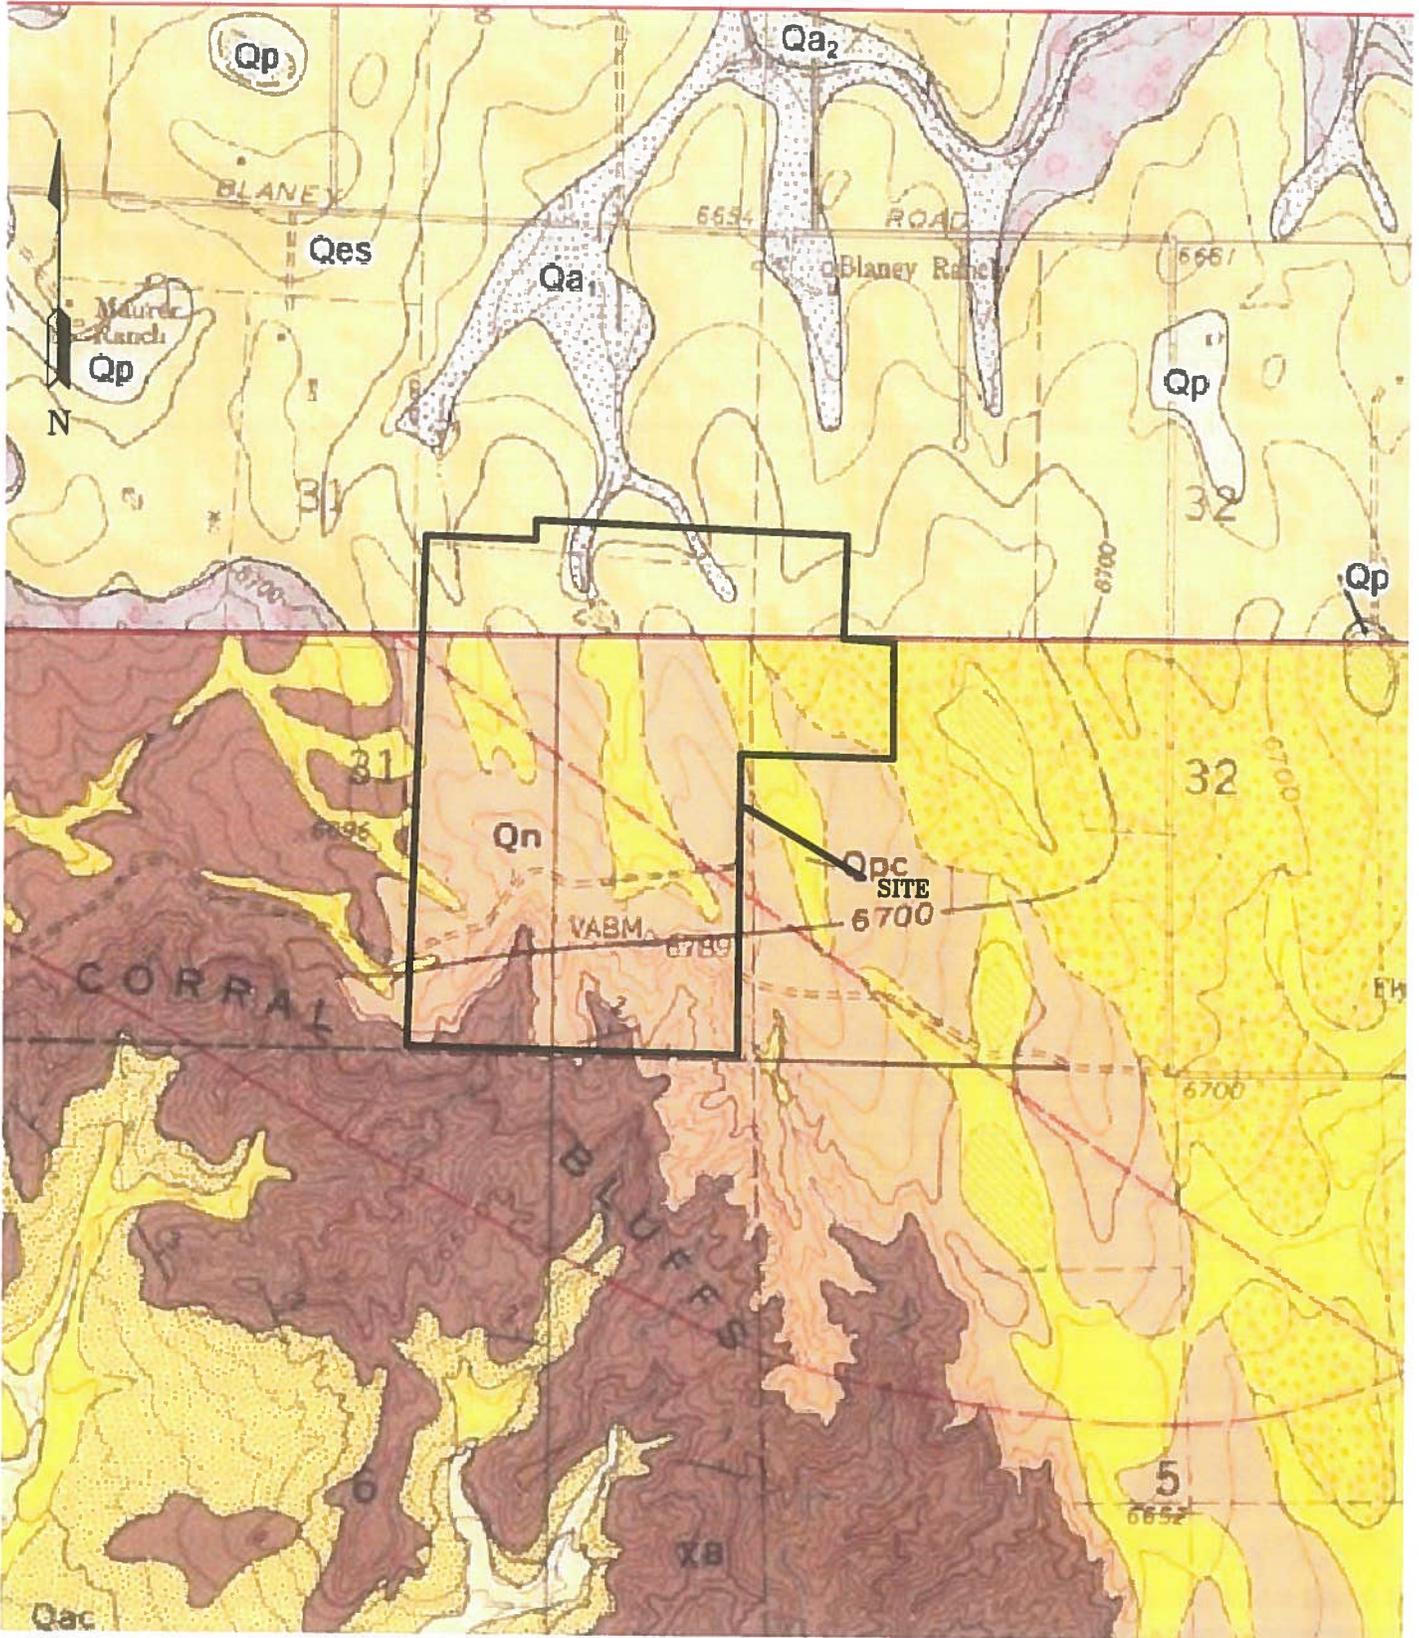
Corral Bluffs/Falcon Geology Map
 The Reserve at Corral Bluffs
 El Paso County, CO.
 For: Corral Ranch Development Co.

Potentially unstable slopes have been mapped on the southern portions of the site. Development is not proposed in this area. A 50-foot building setback is recommended from the crest of the potentially unstable slopes. This 50-foot building setback applies to individual wastewater treatment systems as well. The recommended 50-foot setback is indicated on the Geology Map, Figure 8 and the Septic Suitability Map, Figure 10. It is anticipated the lots are of sufficient size to avoid the potentially unstable slopes and maintain the minimum 50-foot setback.

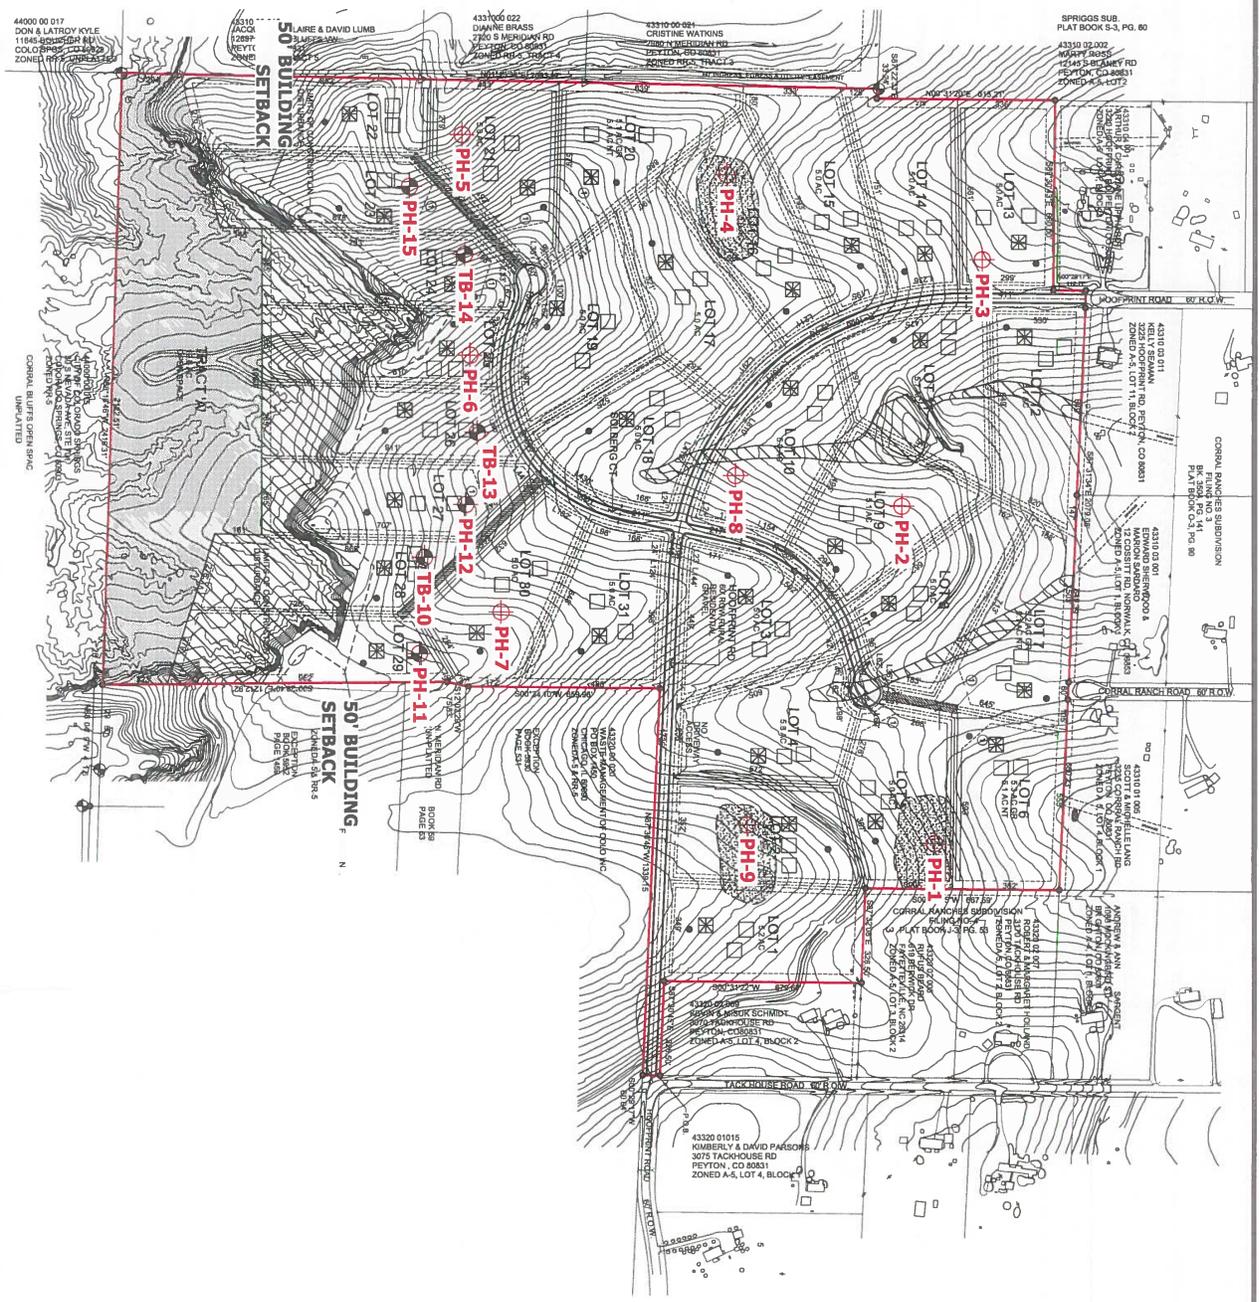
DRAWN BY: JAC
DESIGNED BY: KMH
CHECKED BY:
DATE: 12/04/19
SCALE: 1"=200'
JOB NO: 192142
FIGURING:
10

AREAS WHERE SEPTIC SYSTEMS ARE NOT RECOMMENDED DUE TO DRAINAGE AREA OR POTENTIALLY UNSUITABLE SLOPES
-

Leach fields must be maintained a minimum of 4 feet above groundwater. Groundwater was not encountered in any of the profile holes, which were drilled to depths of 10 to 15 feet. Should groundwater be encountered within 6 feet of the surface, shallow leaching fields would be recommended. In areas where groundwater is less than 4 feet, designed systems will be required.

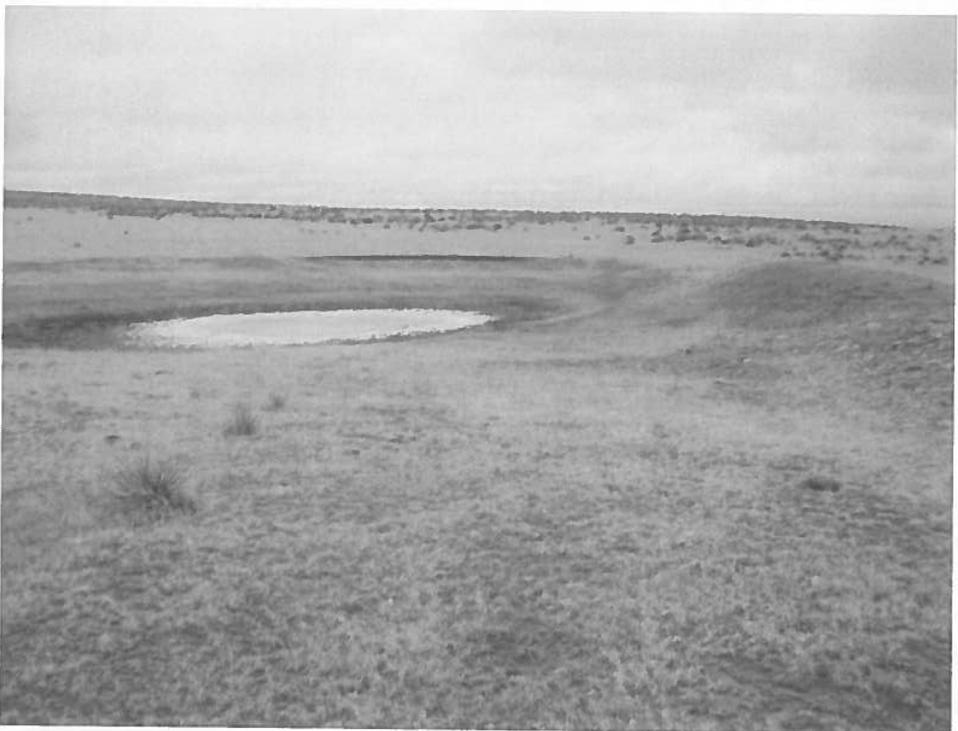
**Looking at dam and
pond in central portion
of the site.**

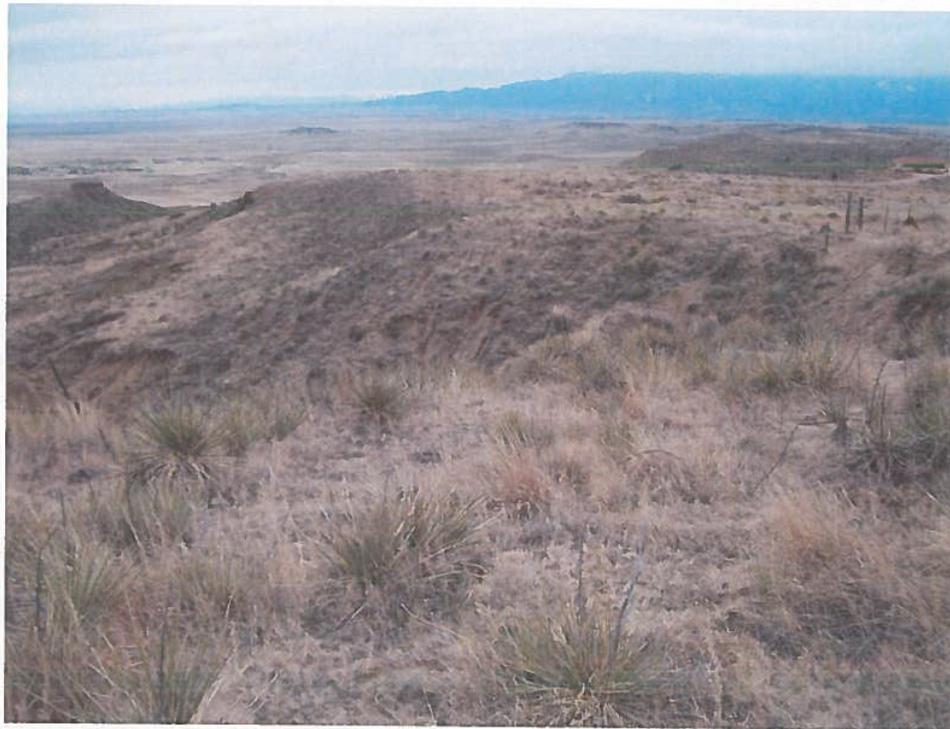
**Looking south at
potentially unstable
slopes in south central
portion of the site.**

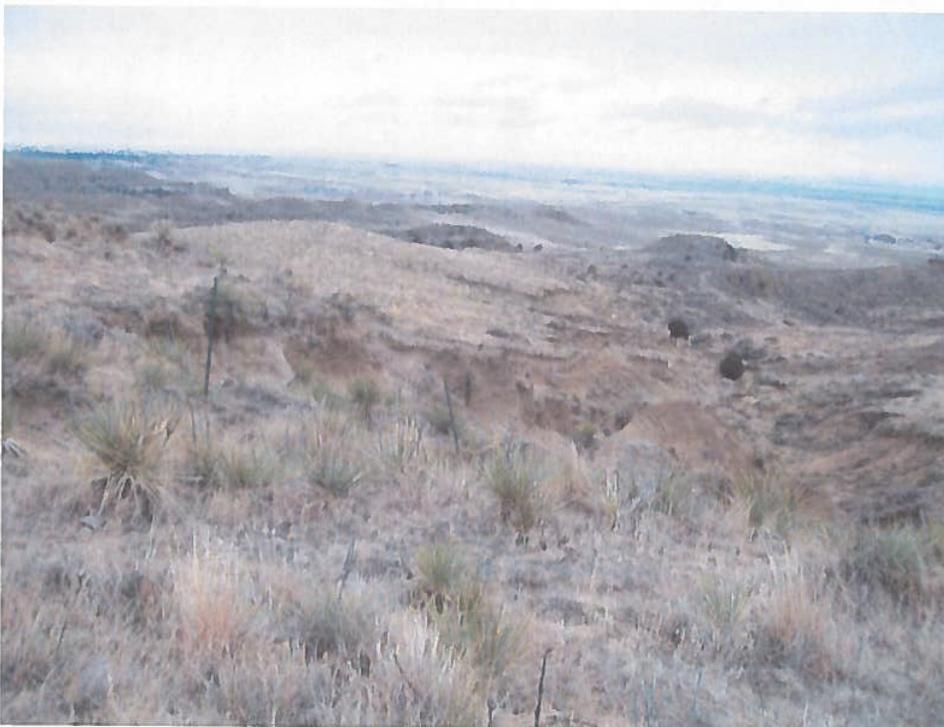
**Looking southeast at
potentially unstable
slopes in south central
portion of the site.**

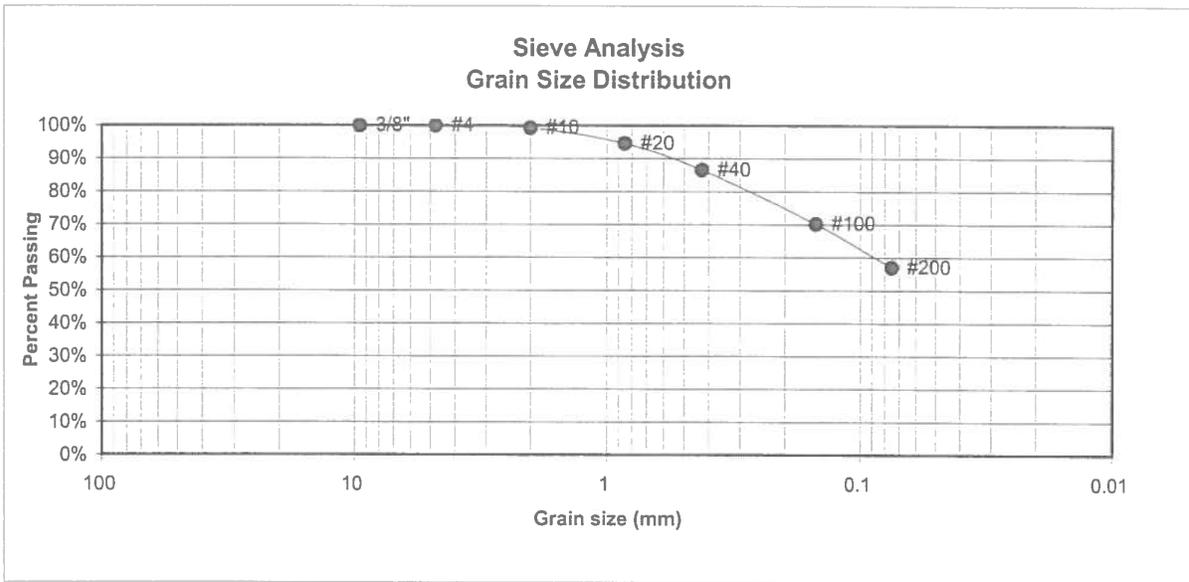
UNIFIED CLASSIFICATION CL-ML		CLIENT	CORRAL RANCH DEV.
SOIL TYPE #	2	PROJECT	RESERVE AT CORRAL BLUFFS
TEST BORING #	1	JOB NO.	83691
DEPTH (FT)	10	TEST BY	BL

U.S. Sieve #	Percent Finer
3"	
1 1/2"	
3/4"	
1/2"	
3/8"	100.0%
4	100.0%
10	99.3%
20	94.6%
40	86.5%
100	70.2%
200	57.0%

Atterberg Limits	
Plastic Limit	12
Liquid Limit	18
Plastic Index	7

Soil Type 2 consists of sandy to very sandy clay and clay-silt (CL, CL-ML). The clays were encountered in two of the profile holes at depths ranging from the surface to 9 feet below the surface. These soils were encountered at stiff to very stiff consistencies and moist conditions. Samples tested had 57 to 74 percent passing the No. 200 sieve. A swell of 3.3 percent was measured on the clays in the Swell/Consolidation Test. This swell is in the moderate to high expansion range. A consolidation of 0.2 percent was measured on the soils in the Swell/Consolidation Test indicating low potential for consolidation.

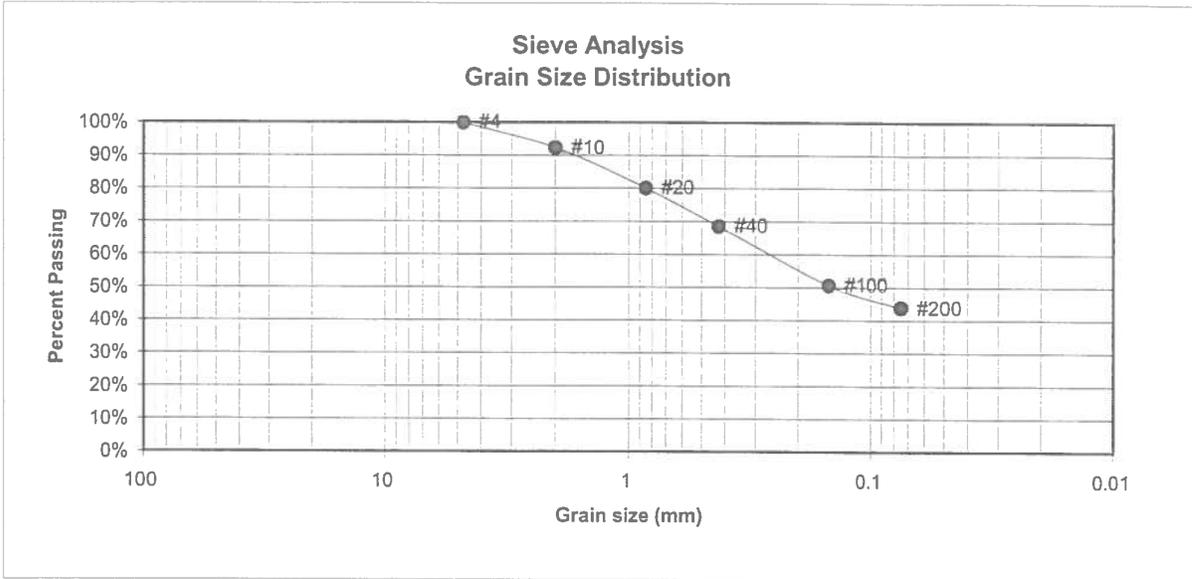
CLIENT CORRAL RANCH DEV.
 PROJECT RESERVE AT CORRAL BLUFFS
 JOB NO. 83691
 TEST BY BL

U.S. Sieve #	Percent Finer
3"	
1 1/2"	
3/4"	
1/2"	
3/8"	
4	100.0%
10	92.3%
20	80.0%
40	68.5%
100	50.6%
200	43.8%

Atterberg Limits	
Plastic Limit	12
Liquid Limit	28
Plastic Index	16

Swell	
Moisture at start	14.2%
Moisture at finish	23.6%
Moisture increase	9.4%
Initial dry density (pcf)	103
Swell (psf)	1330

Soil Type 4 consists of very clayey to silty sandstone bedrock (SM, SC, SC-SM). This material was encountered in 4 of the test borings at 7 to 13 feet below the surface. The sandstone was encountered at very dense states and moist conditions. The samples tested had 40 to 44 percent passing the No. 200 sieve. A FHA swell pressure of 1330 psf was measured on the very clayey sandstone. This swell is in the moderate expansion range.
