Job No. 173099

Re: Wastewater Study

Warner 4-lot Minor Subdivision

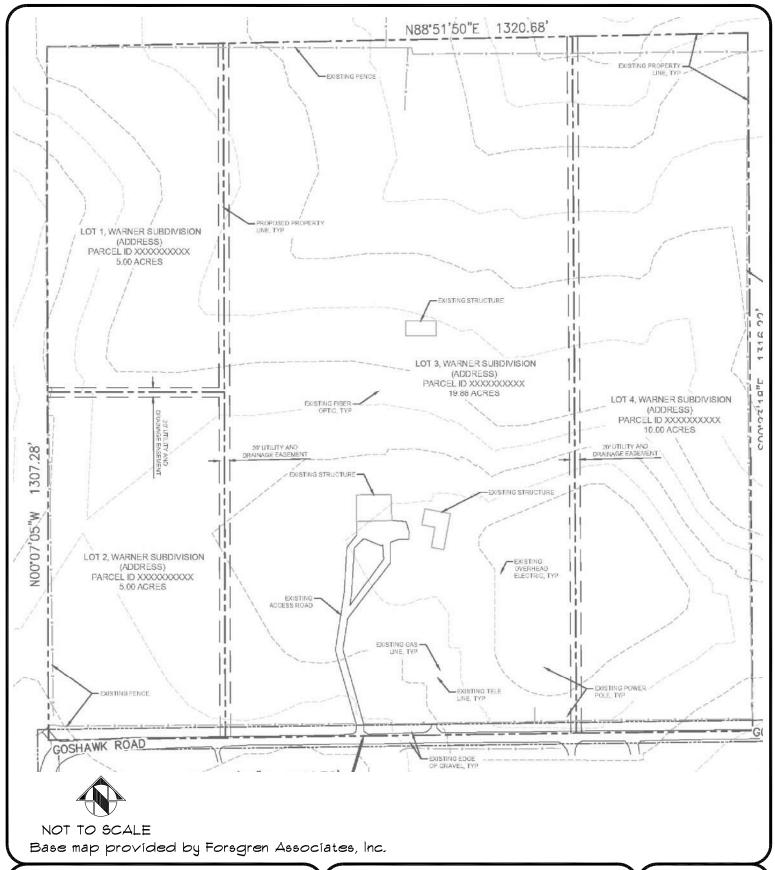
FIG No.

It is our understanding the 40-acre parcel is to be subdivided into four lots of approximately 5.00 to 19.86 acres each. An existing single-family residence with a septic and well are to remain on Lot 3. The proposed site development is to consist of one single family residence with a well and an on-site wastewater treatment system on the remaining three lots. The Proposed Lot Layout (Figure 1) presents the general boundaries of our investigation.

PROPOSED LOT LAYOUT

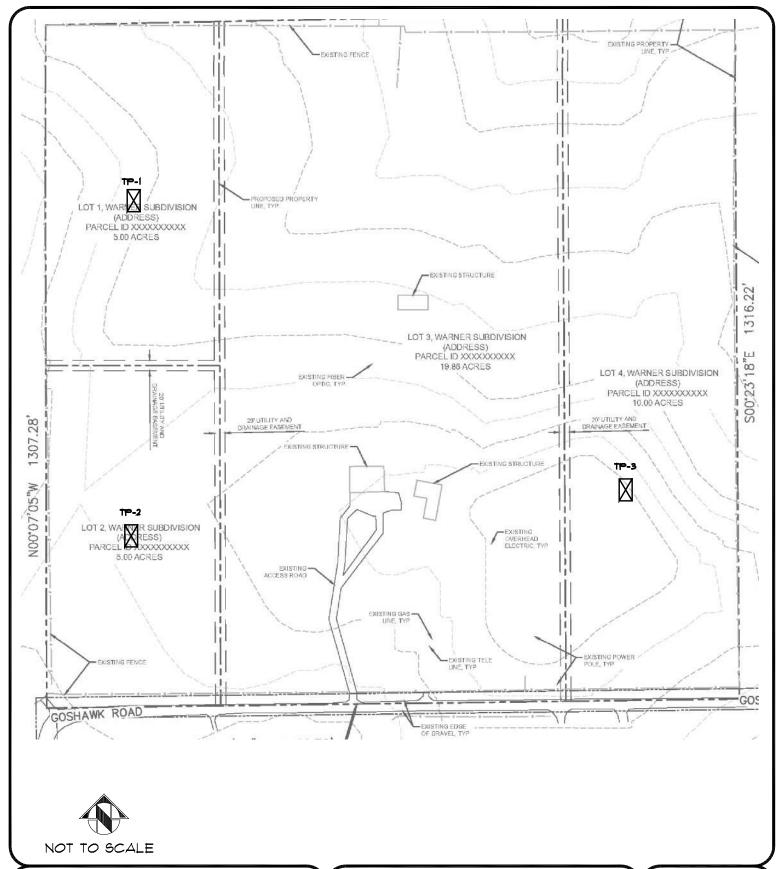
FIG No. 2

Personnel of RMG performed a reconnaissance visit on September 24, 2020. The purpose of the reconnaissance visit was to evaluate the site surface characteristics including topography, vegetation, natural and cultural features, and current and historic land uses. Three 8-foot deep test pits were performed across the site, during our reconnaissance visit. The Test Pit Locations are presented in Figure 2.

TEST PIT LOCATIONS

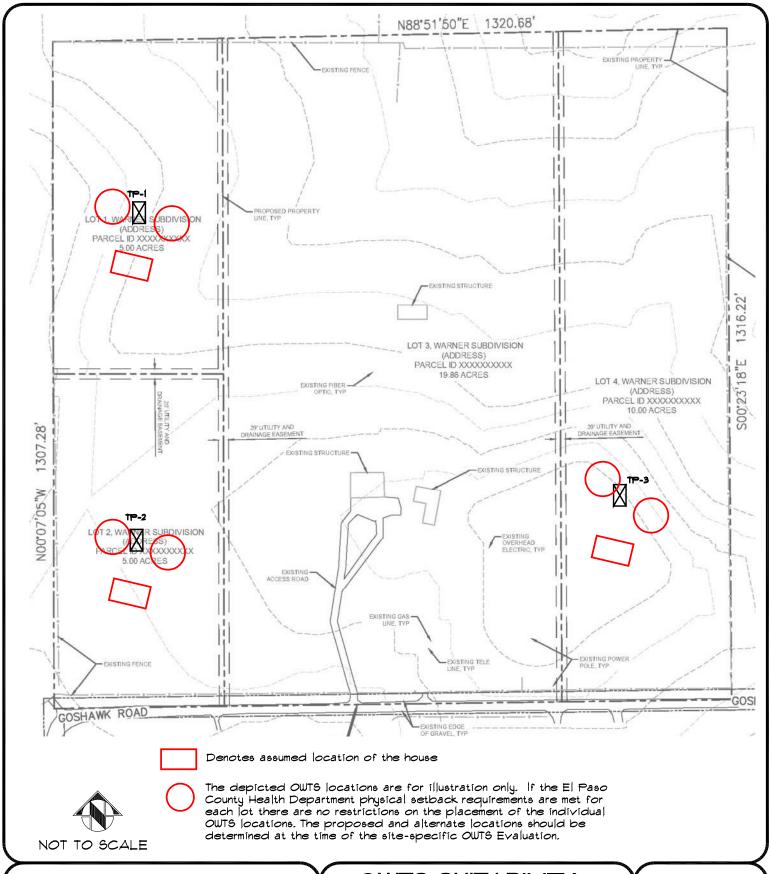
FIG No. 3

- Each new lot shall be laid out to insure that a minimum of 2 sites are appropriate for an OWTS and do not fall within any restricted areas, (e.g. utility easements, right of ways). Based on the test pit observations performed, each new lot has a minimum of two locations for the OWTS, as presented on the OWTS Suitability Map, Figure 3.

OWTS SUITABILITY MAP

An OWTS is proposed for each proposed new lot and should conform to the recommendations presented in an OWTS site evaluation, performed in accordance with the applicable health department codes prior to construction. This report may require additional test pits in the vicinity of the proposed treatment field. A minimum separation of 4 feet shall be maintained from groundwater and bedrock to the infiltrative surface.

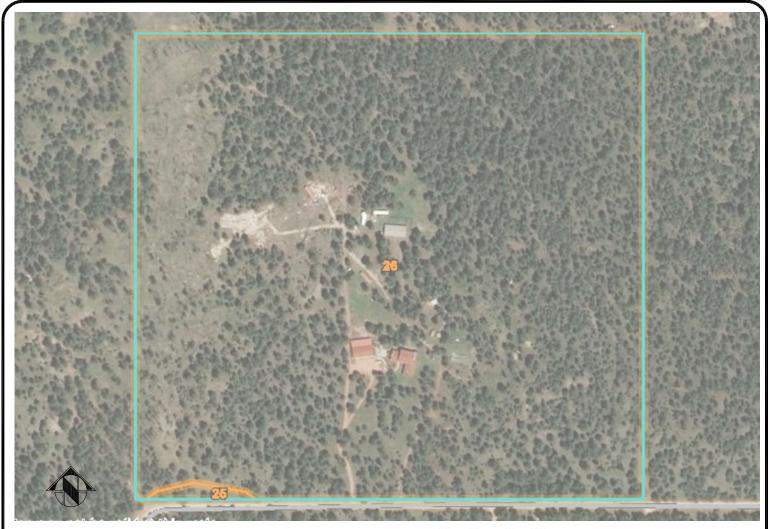
FIG No. 4

• 26 – Elbeth sandy loam, 8 to 15 percent slopes. Elbeth sandy loam was mapped by the USDA to encompass the majority of the site. Properties of the Elbeth sandy loam include, well-drained soil, depth of the water table is anticipated to be greater than 80 inches, runoff is anticipated to be low, frequency of flooding and ponding is none, and landforms are depressions. The hydrologic soil group of the unit is B. The USDA Soil Survey Map is presented in Figure 4.

USDA SOIL

SURVEY MAP

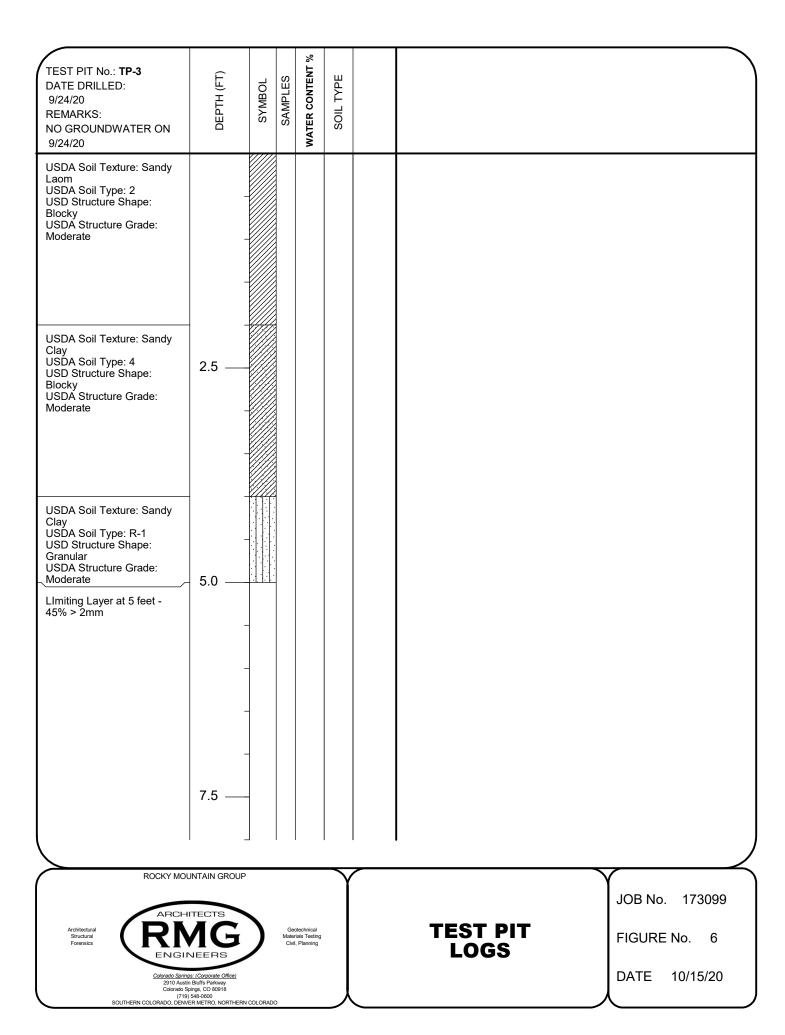
FIGURE No. 5

Groundwater was not encountered in the test pits observed by RMG. However, bedrock/ limiting layers were encountered in TP-2 at a depth of 7 feet and in TP-3 at a depth of 5 feet.

Redoximorphic features indicating the fluctuation of groundwater or higher ground water levels were not observed in the test pits observed by RMG. However, evidence of groundwater was observed by Geoquest, LLC as stated in their Profile Pit Evaluation letter, referenced above. Redoximorphic features were observed between 36 to 40 inches below the surface. The Test Pit Logs are presented in Figures 5 and 6.

TEST PIT No.: TP-1 DATE DRILLED: 9/24/20 REMARKS: NO GROUNDWATER ON 9/24/20	БЕРТН (FT)	SYMBOL	SAMPLES	WATER CONTENT %	SOIL TYPE	TEST PIT No.: TP-2 DATE DRILLED: 9/24/20 REMARKS: NO GROUNDWATER ON 9/24/20	ОЕРТН (FT)	SYMBOL	SAMPLES	WATER CONTENT %	SOIL TYPE	
USDA Soil Texture: Sandy Loam USDA Soil Type: 2 USD Structure Shape: Moderate USDA Structure Grade: Strong						USDA Soil Texture: Sandy Loam USDA Soil Type: 2 USD Structure Shape: Granulary USDA Structure Grade: Strong		-				
USDA Soil Texture: Sandy Clay USDA Soil Type: 4 USD Structure Shape: Blocky USDA Structure Grade: Moderate	2.5 —					USDA Soil Texture: Sandy Clay USDA Soil Type: 4 USD Structure Shape: Blocky USDA Structure Grade: Moderate	2.5 —

5.0 —	5.0				USDA Soil Texture: Sand USDA Soil Type: R-0 USD Structure Shape: Single-Grain USDA Structure Grade: Sructureless	5.0 —					
	7.5 —					Limiting Layer at 7 feet - 44% > 2mm	7.5 —

TEST PIT LOGS
