Soils and Geology  
Report  
For  
Warner Subdivision  
17350 W. Goshawk Road  
Colorado Springs, Colorado 80908  
April 16, 2021

# Warner Subdivision

**WARNER 4-LOT SUBDIVISION**  
 SITE DEVELOPMENT PLANS  
 17350 GOSHAWK RD, COLORADO SPRINGS, CO 80908

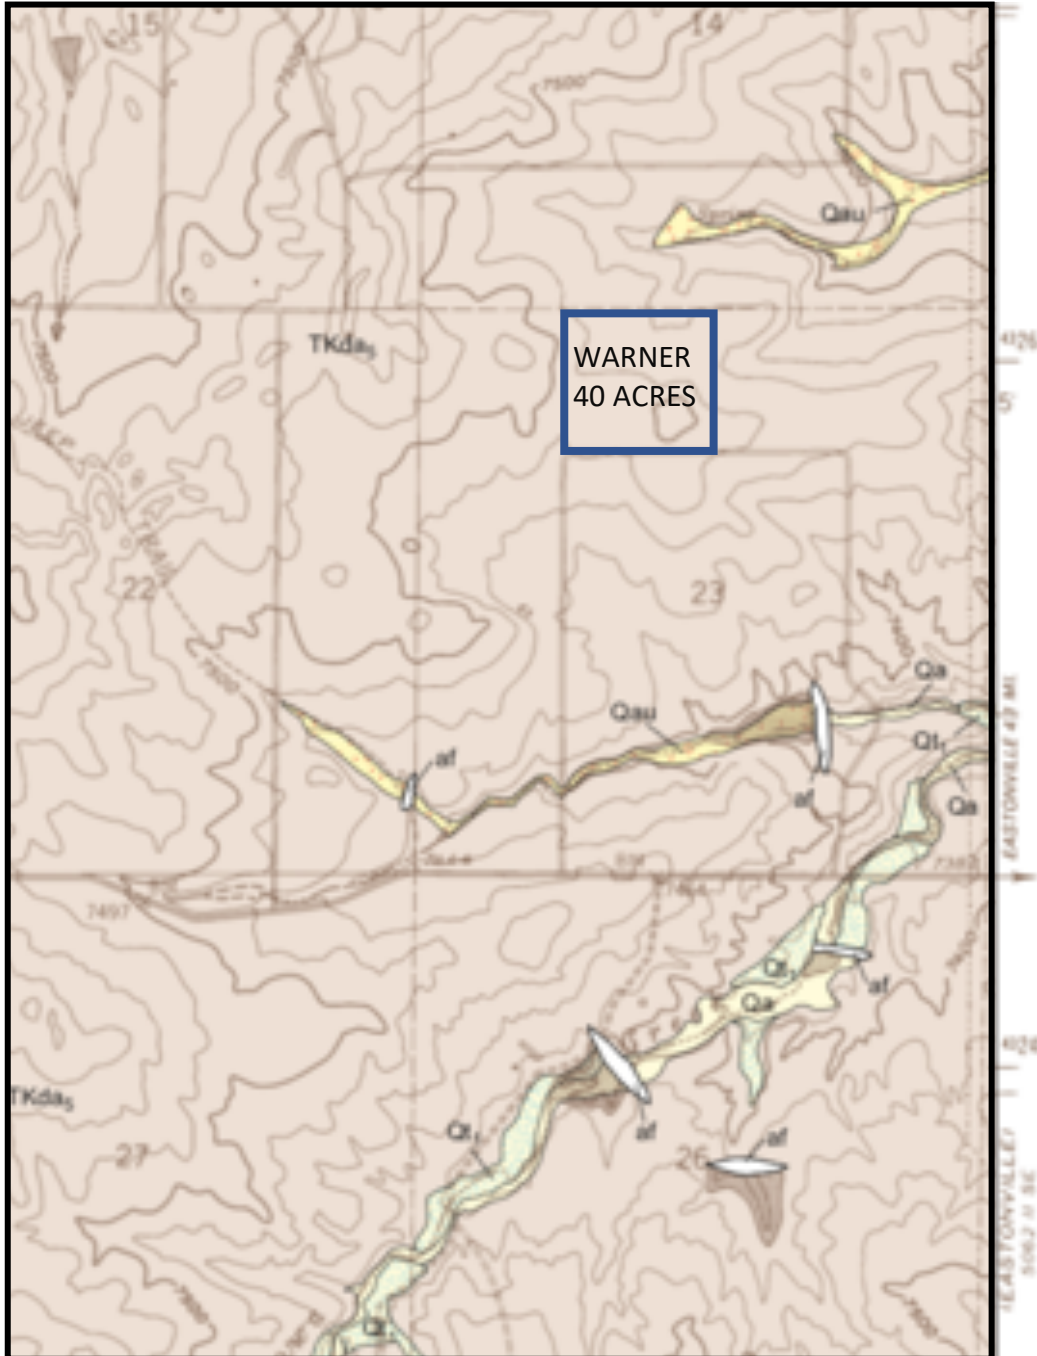
FIGURE 3  
 GEOLOGY MAP

Facies Unit 5 (TKda5) is the uppermost facies of the Dawson Formation and is mapped over the Project Site (Figure 3). Facies Unit 5 is described as generally permeable, well drained, with good foundation characteristics.

Black Forest Quadrangle -Thorson OF-30-6  
 NE1/4 NW1/4 T11S R65W

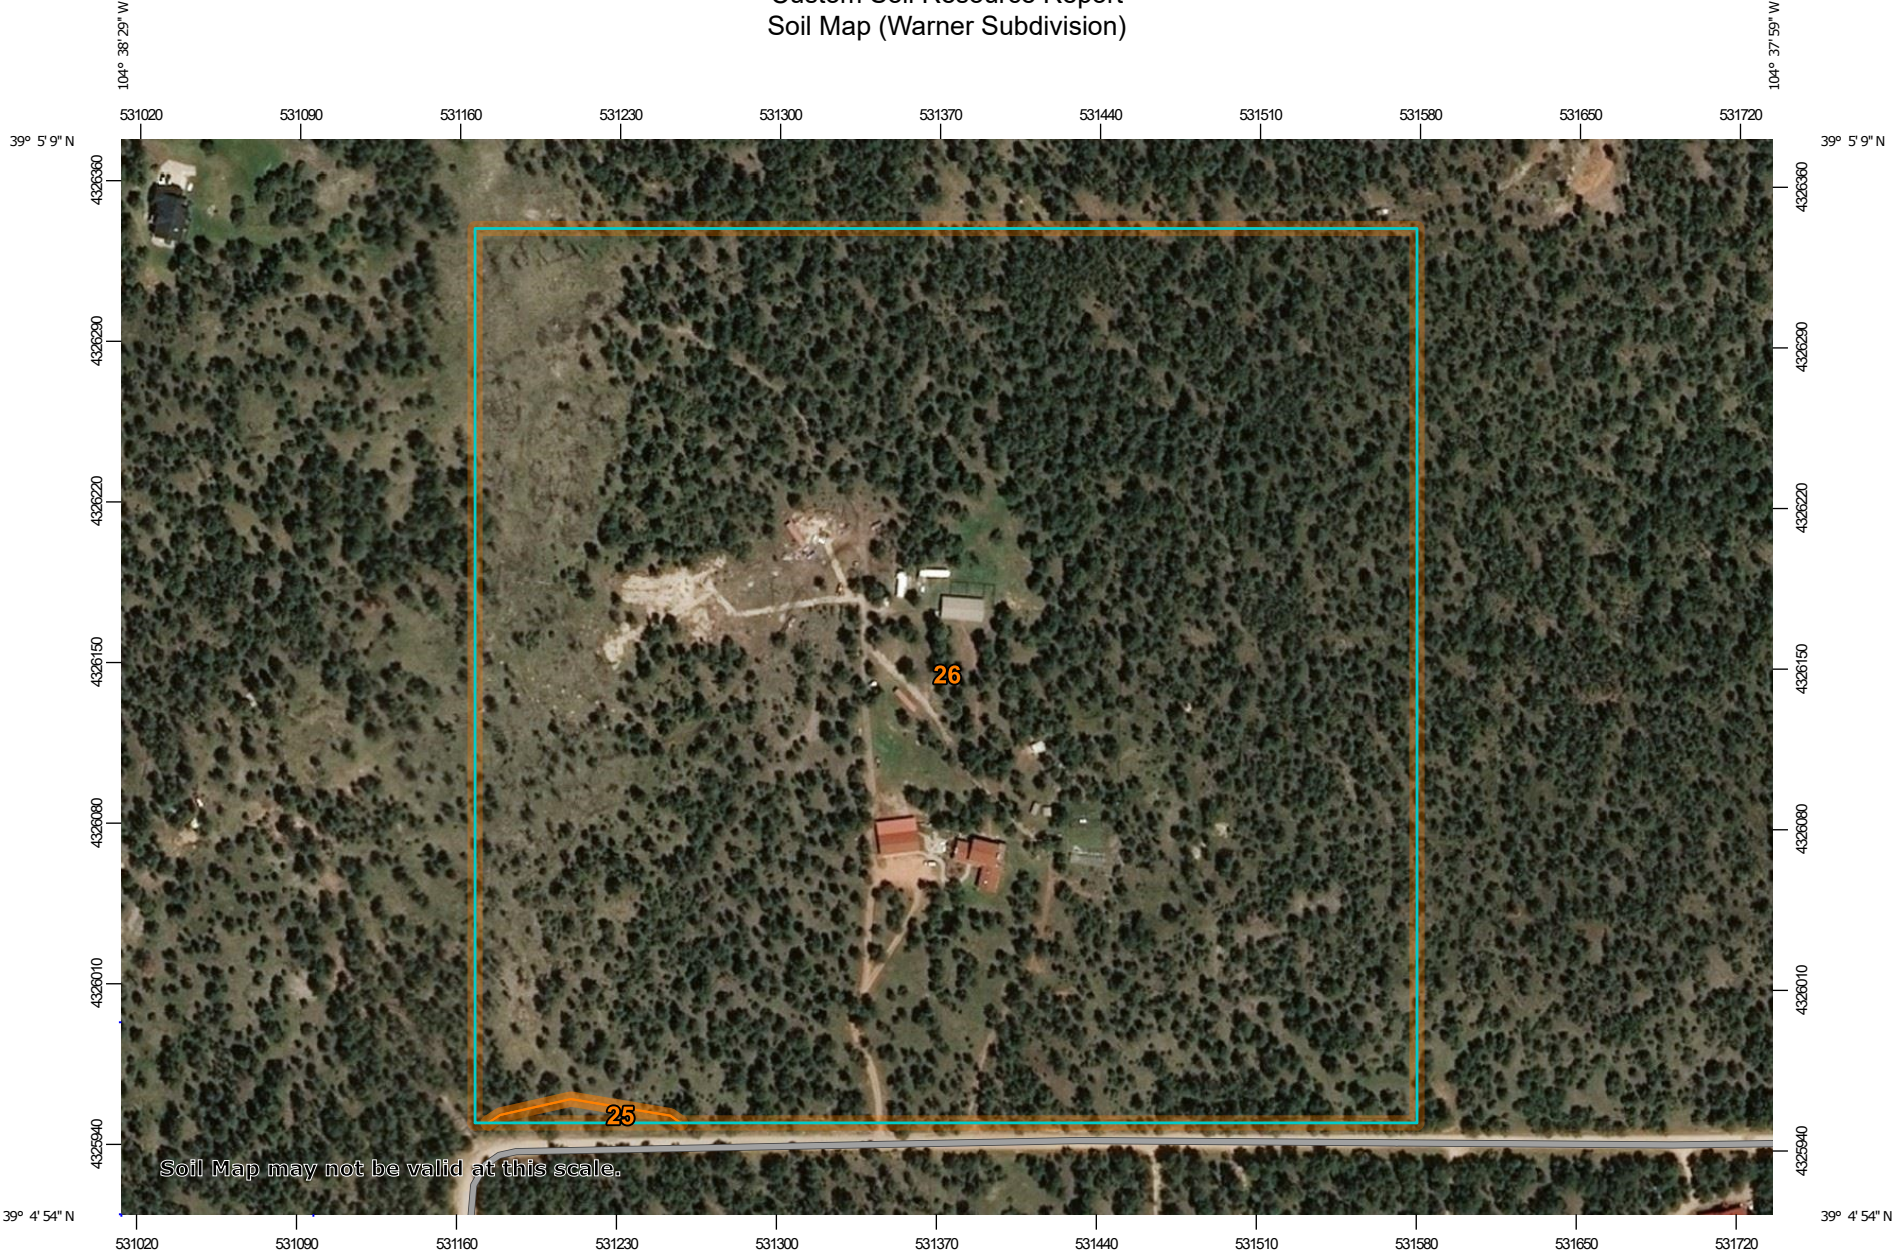
# Custom Soil Resource Report Soil Map (Warner Subdivision)

The soil map section includes the soil map for the defined area of interest, a list of soil map units on the map and extent of each map unit, and cartographic symbols displayed on the map. Also presented are various metadata about data used to produce the map, and a description of each soil map unit.

Map Unit Symbol	Map Unit Name	Acres in AOI	Percent of AOI
25	Elbeth sandy loam, 3 to 8 percent slopes	0.1	0.3%
26	Elbeth sandy loam, 8 to 15 percent slopes	39.7	99.7%
<b>Totals for Area of Interest</b>		<b>39.9</b>	<b>100.0%</b>

The National Resource Conservation Service (NRCS) identified one soil type, Elbeth Sandy Loam.

Type	Description	Percent Coverage
25	Elbeth Sandy Loam , 3 to 8 percent slopes	97
26	Elbeth Sandy Loam, 8 to 15 percent slopes	0.3

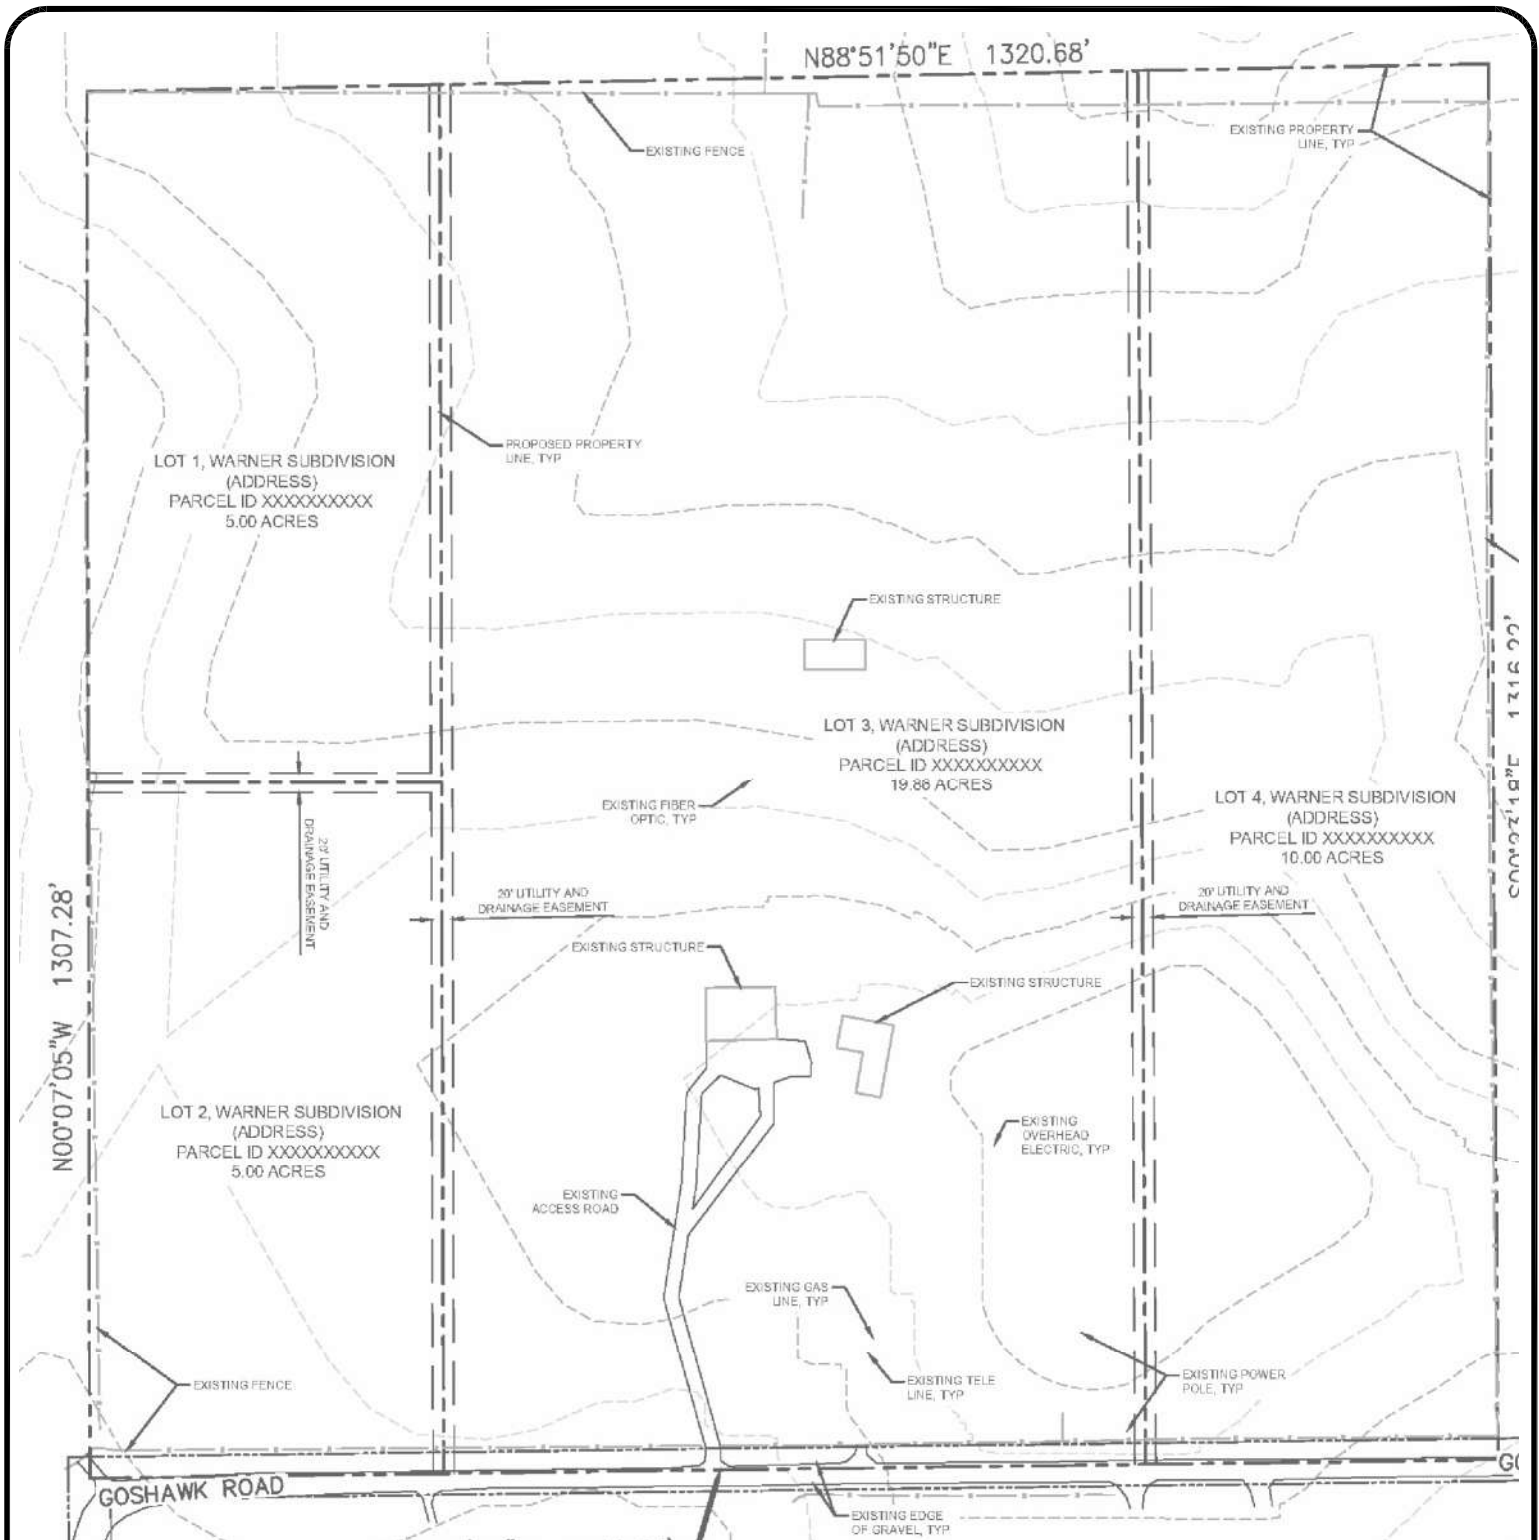
FIG No. 1

Base map provided by Forsgren Associates, Inc.

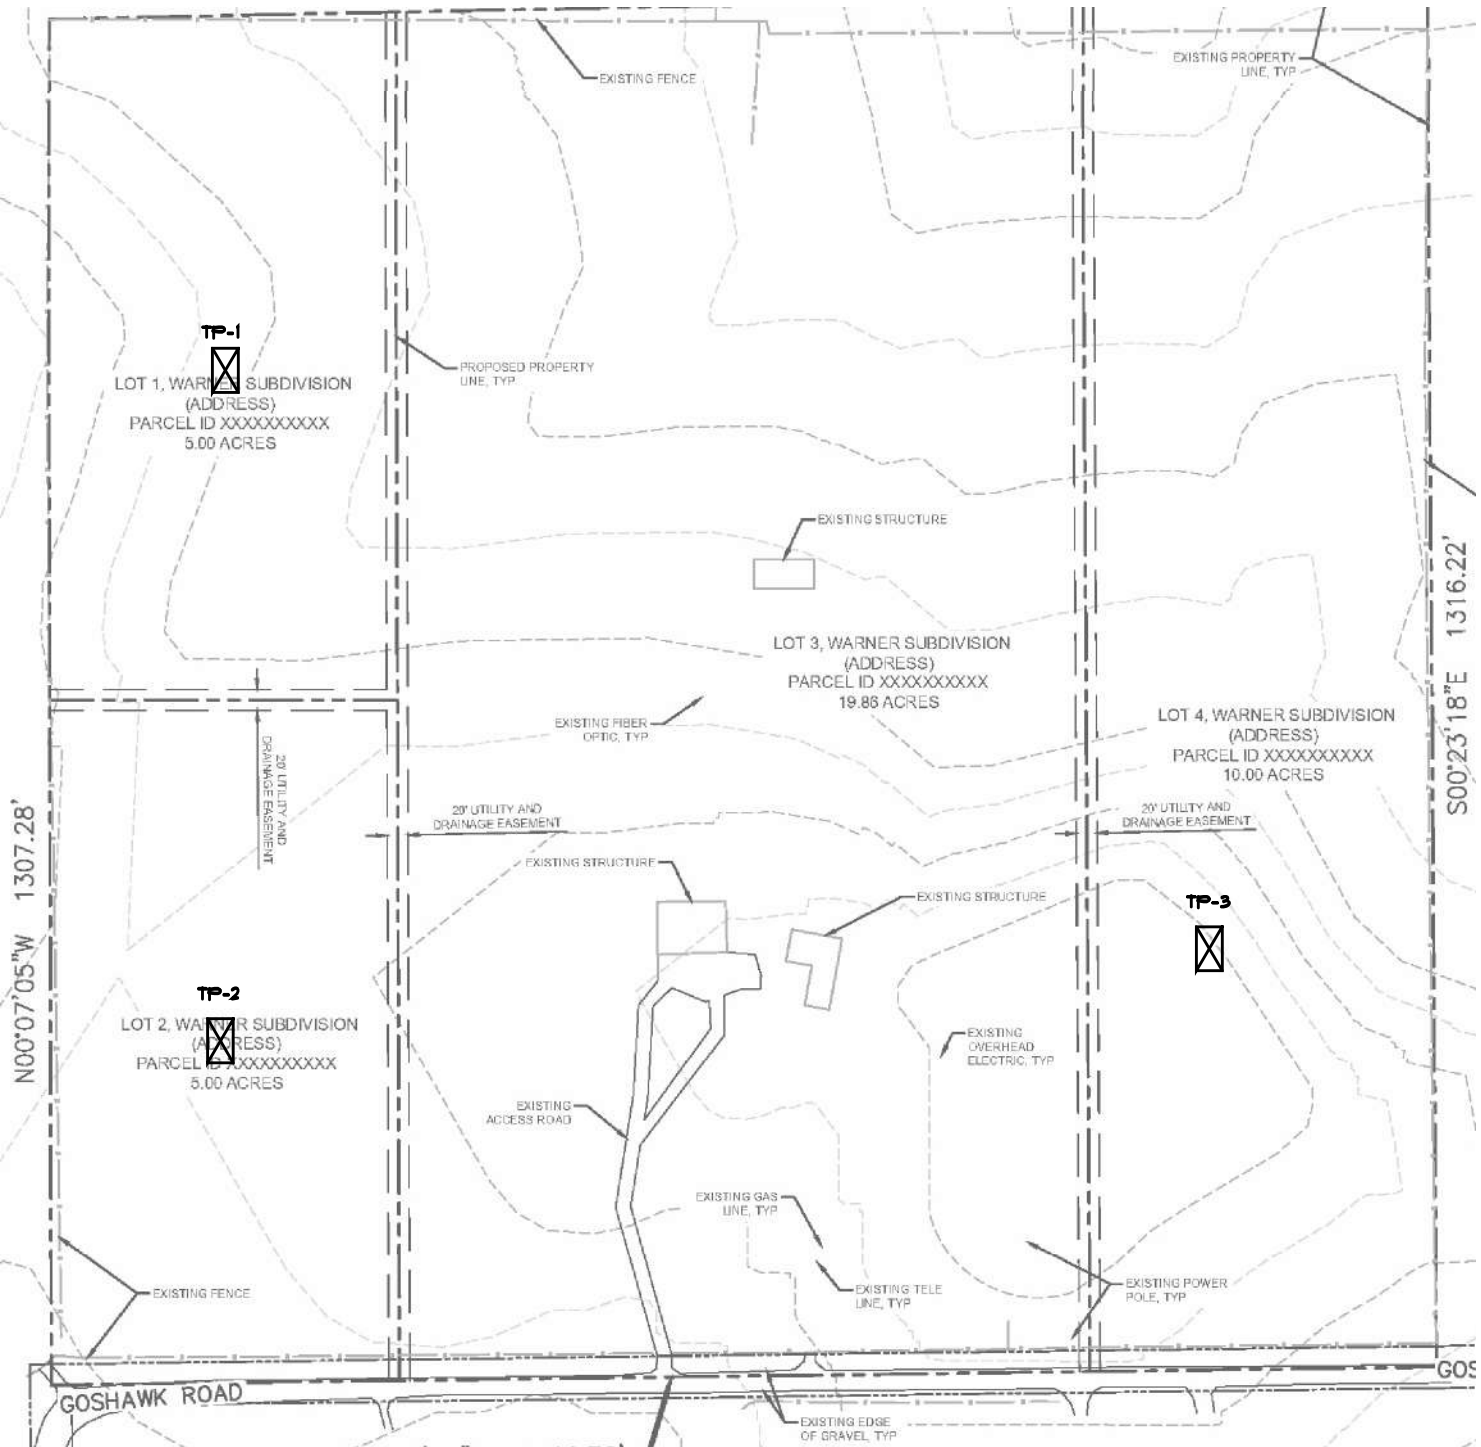
FIG No. 2

N00°07'05"W 1307.28'

S00°23'18"E 1316.22'

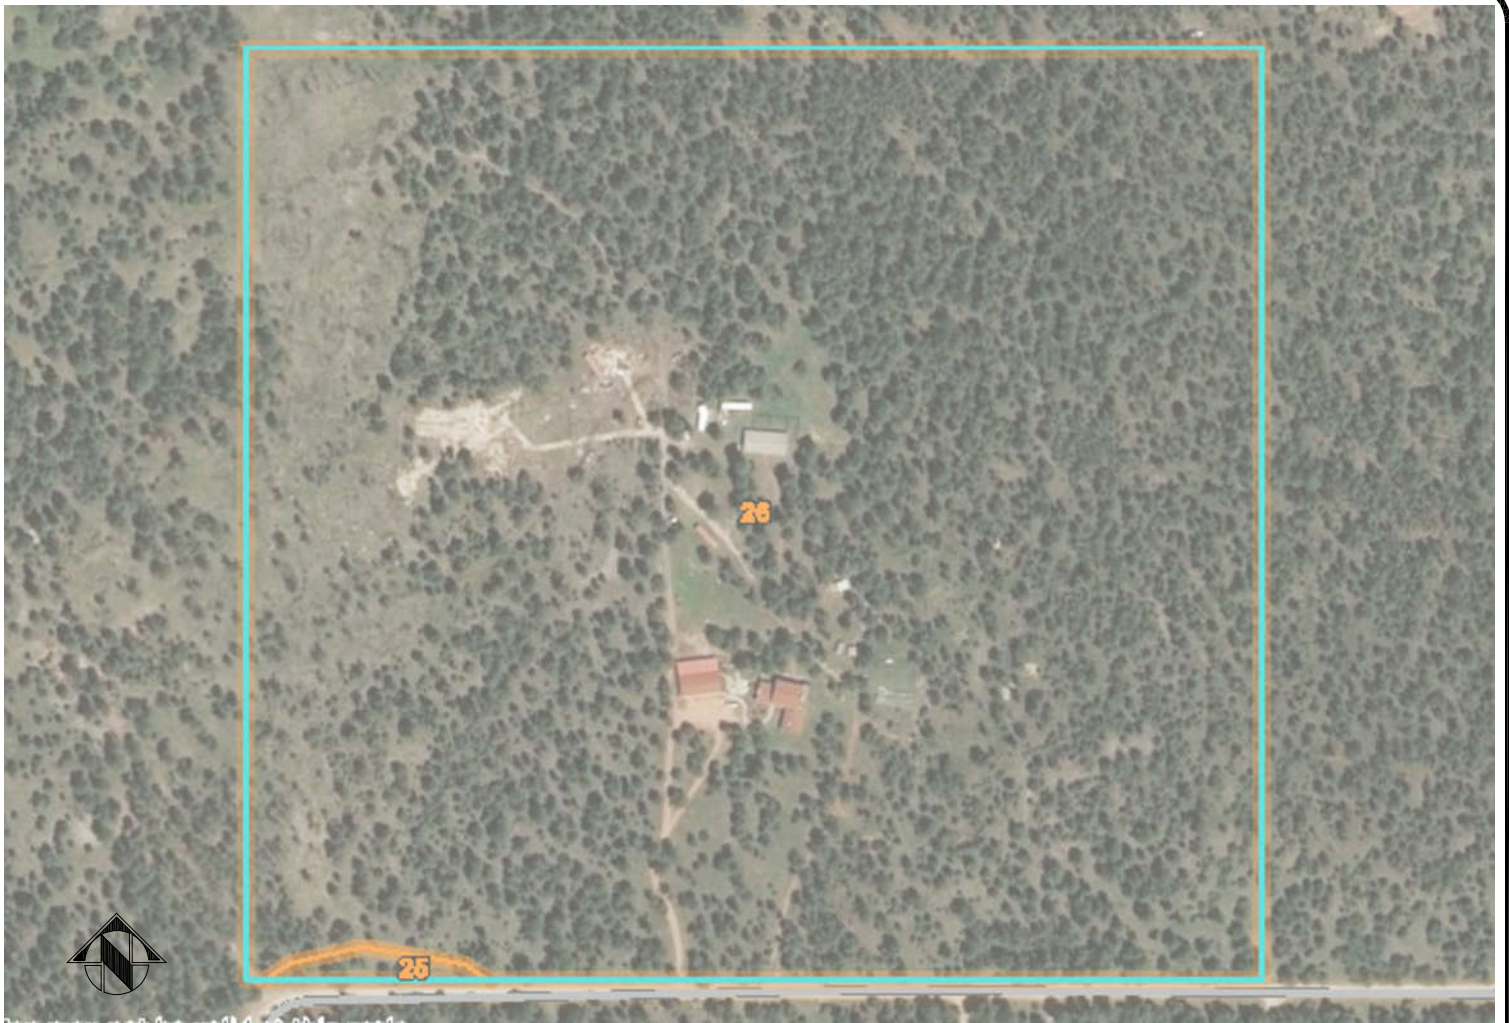
FIG No. 3

- Each new lot shall be laid out to insure that a minimum of 2 sites are appropriate for an OWTS and do not fall within any restricted areas, (e.g. utility easements, right of ways). Based on the test pit observations performed, each new lot has a minimum of two locations for the OWTS, as presented on the OWTS Suitability Map, Figure 3.
