**PLOT PLAN CHECK LIST:**

Parts of the S1/4NE1/4, S1/4SE1/4 & SE1/4SW1/4, Section 20, The E1/4 & NW1/4NE1/4 and Parts of the SW1/4NE1/4, SW1/4SE1/4 & NW1/4SE1/4, Section 29 and The E1/4NE1/4, SW1/4NE1/4, SE1/4NW1/4 and parts of the NW1/4NE1/4 & NE1/4NW1/4, Section 32, T-14-S, R-62-W, 6th P.M., El Paso County, Colorado. Containing 733.7 acres more or less.

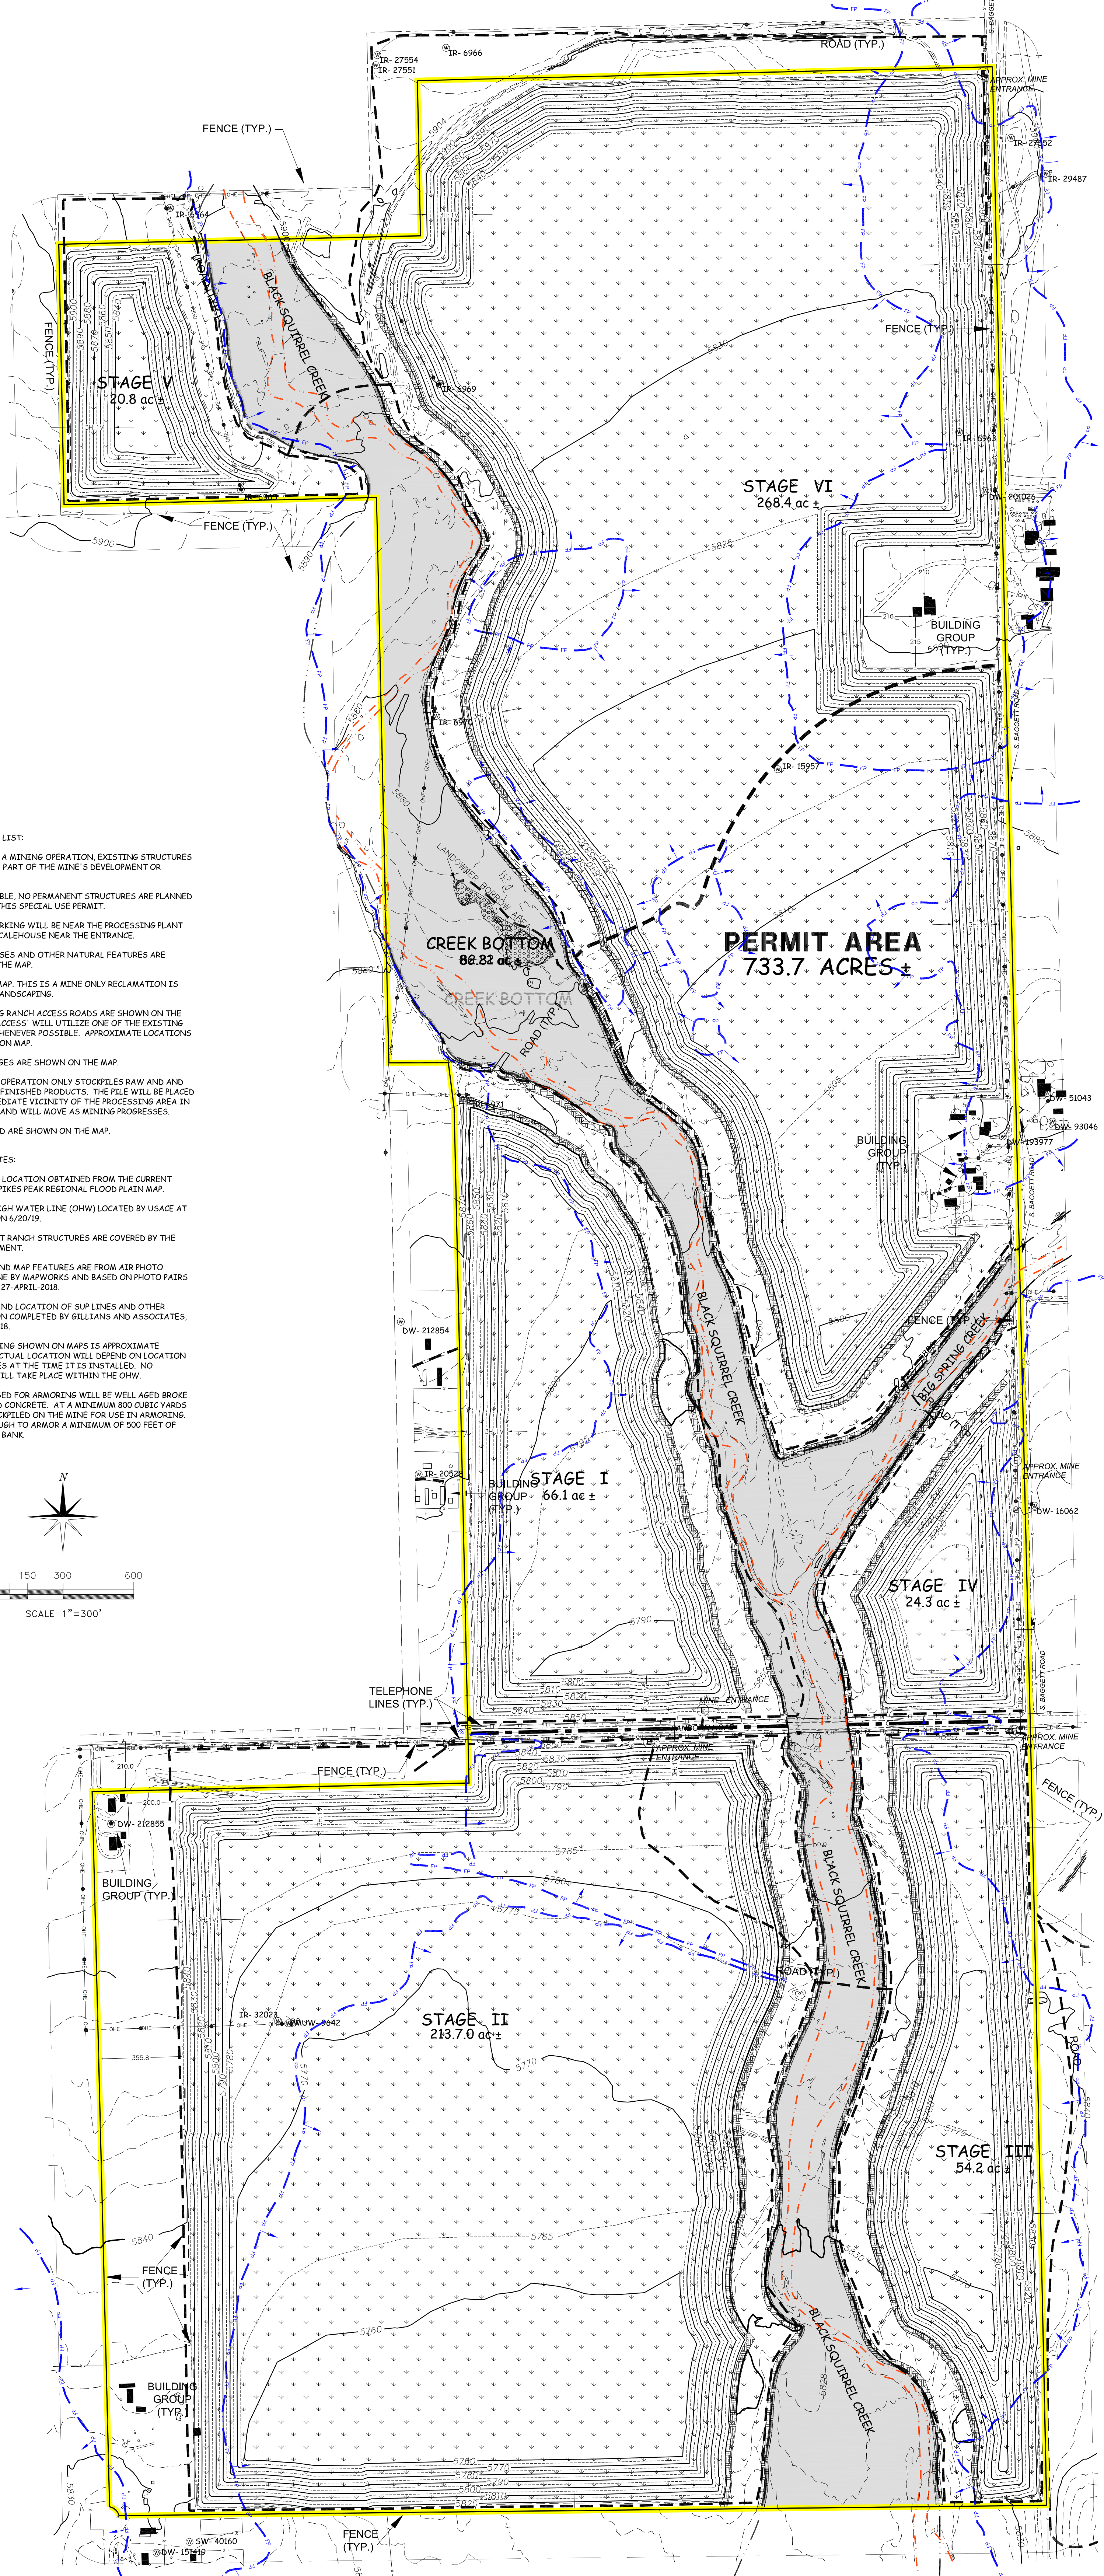
- THIS SITE IS A MINING OPERATION, EXISTING STRUCTURES WILL NOT BE PART OF THE MINE'S DEVELOPMENT OR OPERATION.
- NOT APPLICABLE, NO PERMANENT STRUCTURES ARE PLANNED AS PART OF THIS SPECIAL USE PERMIT.
- EMPLOYEE PARKING WILL BE NEAR THE PROCESSING PLANT OR AT THE SCALEHOUSE NEAR THE ENTRANCE.
- WATER COURSES AND OTHER NATURAL FEATURES ARE SHOWN ON THE MAP.
- SHOWN ON MAP, THIS IS A MINE ONLY RECLAMATION IS DONE, NOT LANDSCAPING.
- ALL EXISTING RANCH ACCESS ROADS ARE SHOWN ON THE MAP. MINE ACCESS WILL UTILIZE ONE OF THE EXISTING ACCESSES WHENEVER POSSIBLE. APPROXIMATE LOCATIONS ARE SHOWN ON MAP.
- MINING STAGES ARE SHOWN ON THE MAP.
- THE MINING OPERATION ONLY STOCKPILES RAW AND GRAVEL AND FINISHED PRODUCTS. THE PILE WILL BE PLACED IN THE IMMEDIATE VICINITY OF THE PROCESSING AREA IN EACH STAGE AND WILL MOVE AS MINING PROGRESSES.
- ITEMS LISTED ARE SHOWN ON THE MAP.

- FLOOD PLAIN LOCATION OBTAINED FROM THE CURRENT (01-14-2019) Pikes Peak REGIONAL FLOOD PLAIN MAP.
- ORDINARY HIGH WATER LINE (OHW) LOCATED BY USACE AT SITE VISIT ON 6/20/19.
- ALL SCHUBERT RANCH STRUCTURES ARE COVERED BY THE LEASE AGREEMENT.
- CONTOURS AND MAP FEATURES ARE FROM AIR PHOTO MAPPING DONE BY MAPWORKS AND BASED ON PHOTO PAIRS FLOWN DATE 27-APRIL-2018.
- SURVEYING AND LOCATION OF SUP LINES AND OTHER INFORMATION COMPLETED BY GILLIANS AND ASSOCIATES, INC. APRIL 2018.
- BANK ARMORING SHOWN ON MAPS IS APPROXIMATE LOCATION. ACTUAL LOCATION WILL DEPEND ON LOCATION OF OHW LINES AT THE TIME IT IS INSTALLED. NO ARMORING WILL TAKE PLACE WITHIN THE OHW.
- MATERIAL USED FOR ARMORING WILL BE WELL AGED BROKE ASPHALT AND CONCRETE. AT A MINIMUM 800 CUBIC YARDS WILL BE STOCKPILED ON THE MINE FOR USE IN ARMORING. THIS IS ENOUGH TO ARMOR A MINIMUM OF 500 FEET OF EXCAVATION BANK.
