PAVEMENT DESIGN REPORT

The Ridge at Lorson Ranch – Filing No. 2

El Paso County, Colorado

JOB NO. 186386-2

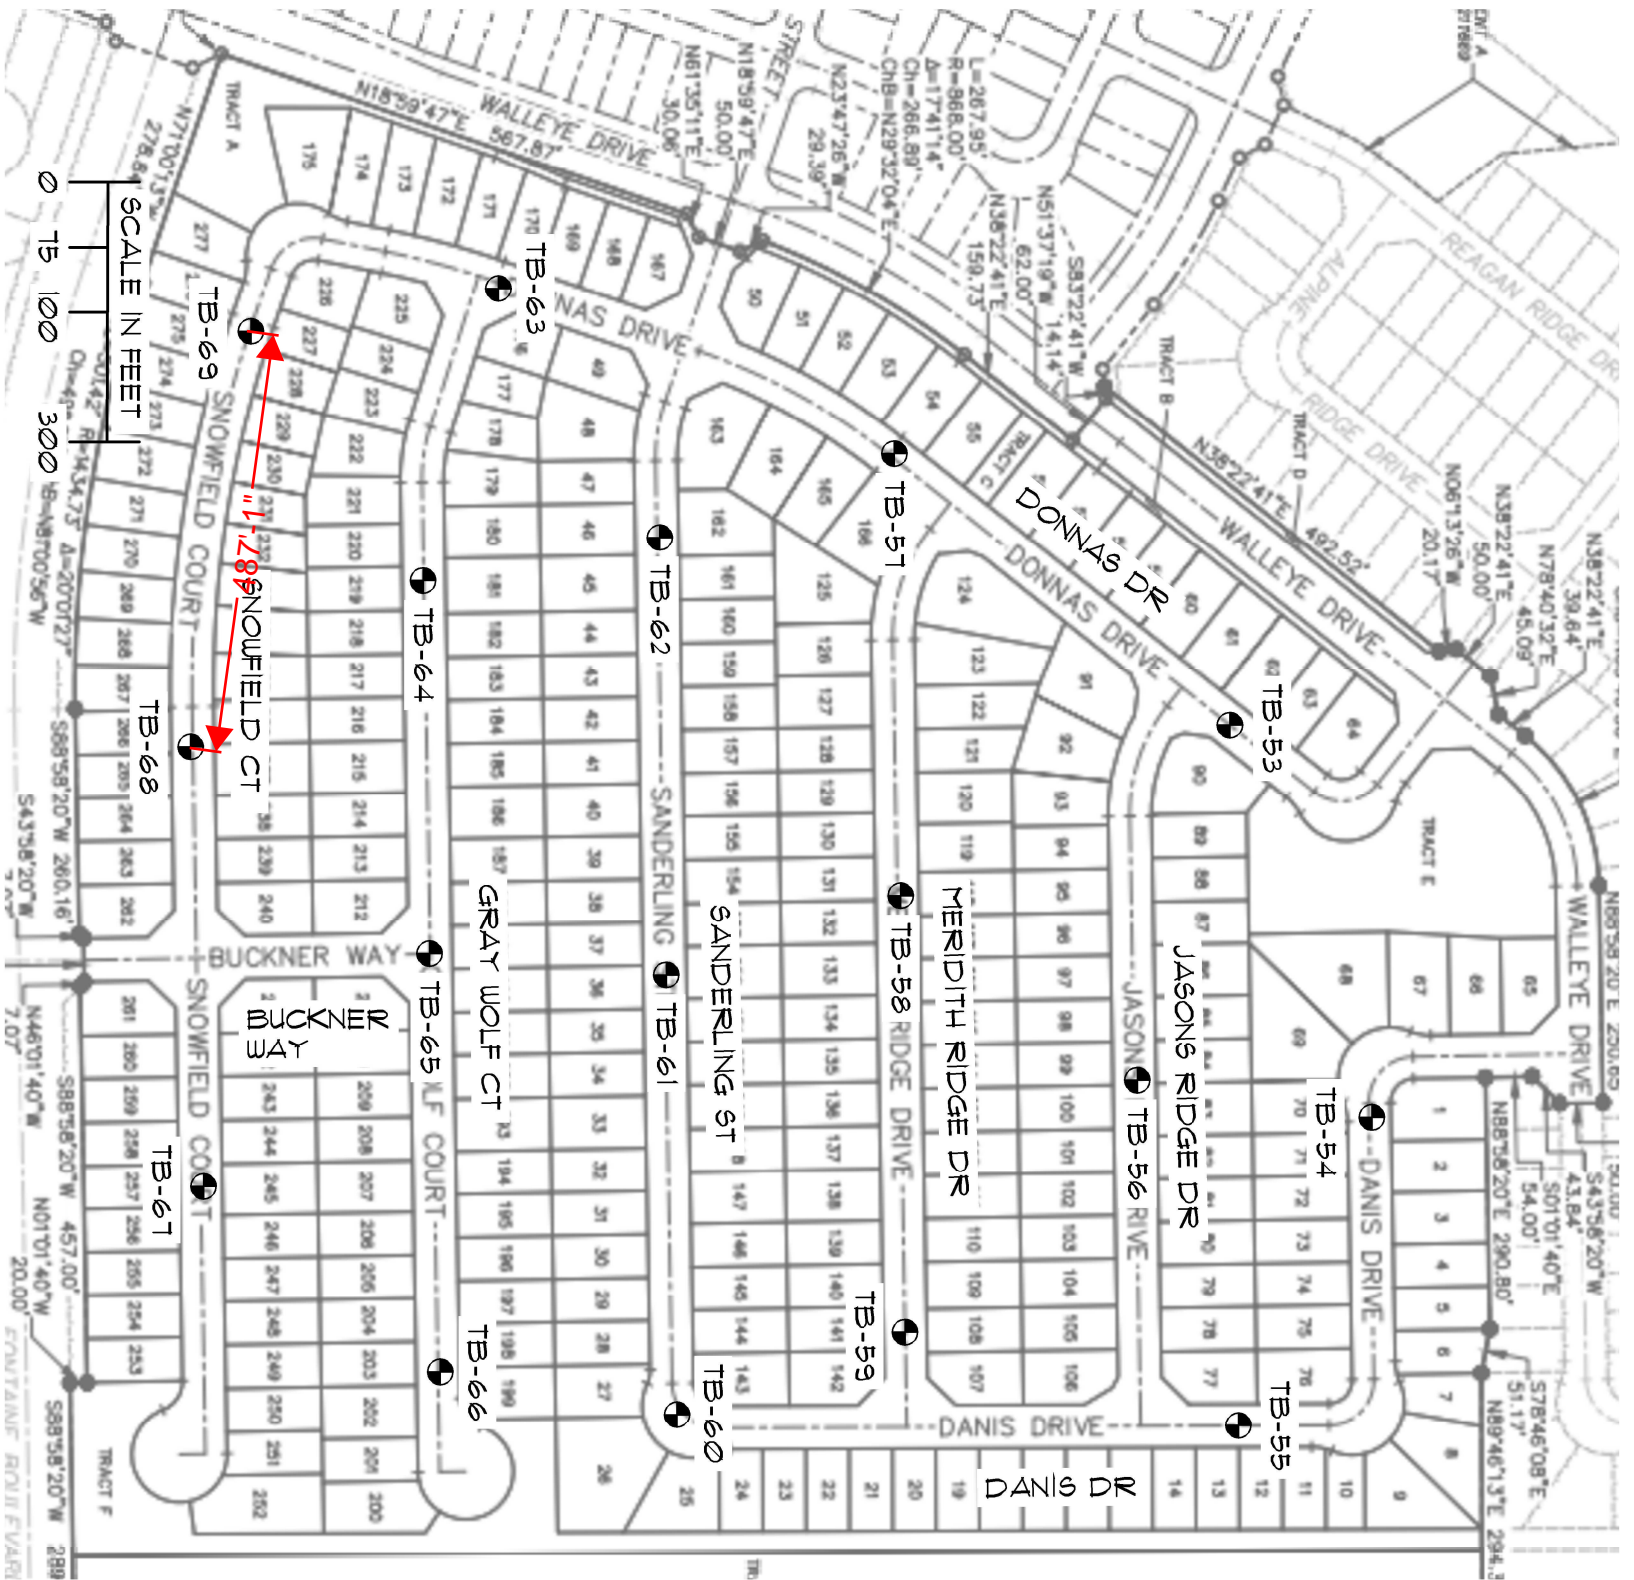
TEST BORING LAYOUT PLAN
SHEET No. **FIG-2.1**

⊕ DENOTES APPROXIMATE LOCATION OF TEST BORINGS

The subsurface conditions on the site were investigated by drilling seventeen exploratory test borings. The approximate locations of the test borings are presented in the Test Boring Location Plan, Figure 2.1.
