Stormwater Management Facility Operation and Maintenance (O&M) Plan Template

***LatigoTrails - Filing 10
EPC Project Number SF2421***

***Southeast Corner of the intersection of
Eastonville Road and Latigo Boulevard***

November 2024

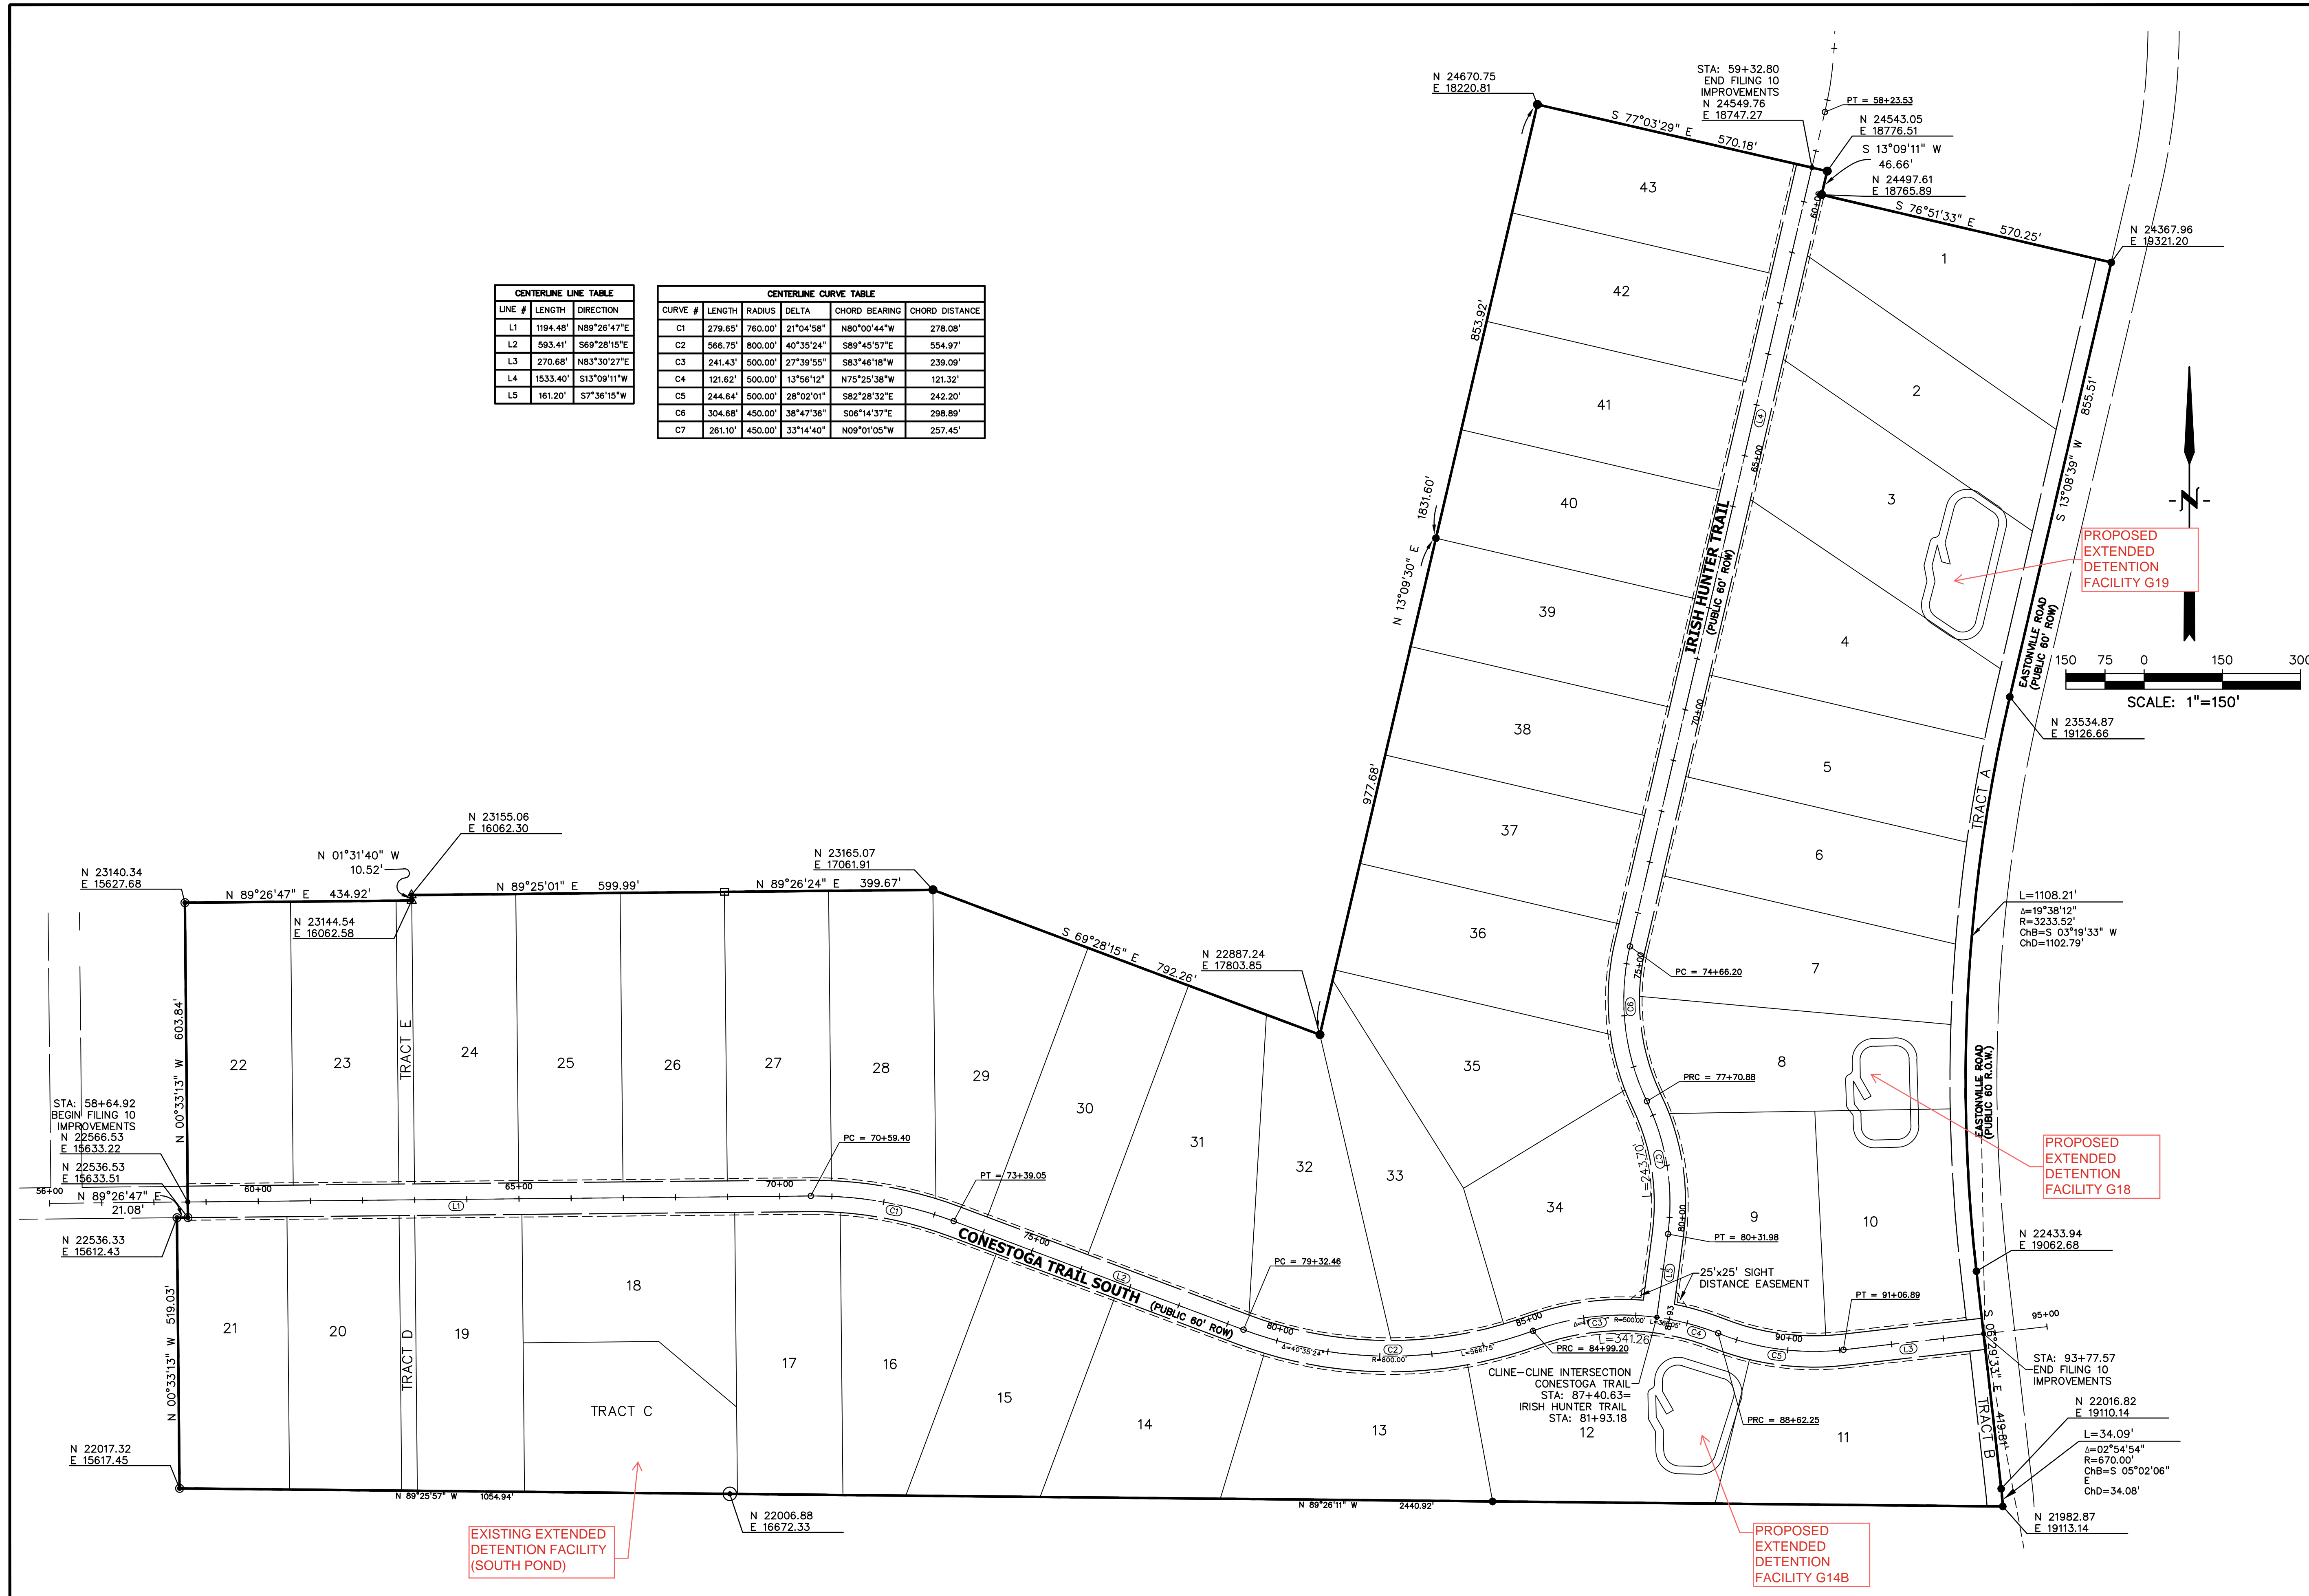
Stormwater Facilities Map

PROPOSED EXTENDED DETENTION FACILITY G19

PROPOSED EXTENDED DETENTION FACILITY G14B

EXISTING EXTENDED DETENTION FACILITY (SOUTH POND)
