December 11, 2023  
Revised September 6, 2024

**ENTECH**  
ENGINEERING, INC.

Re: Wastewater Study  
Lazy Y and Rockin' J Subdivision  
12960 North Peyton Highway  
Parcel No. 63070-00-007  
El Paso County, Colorado  
Entech Job No. 230520

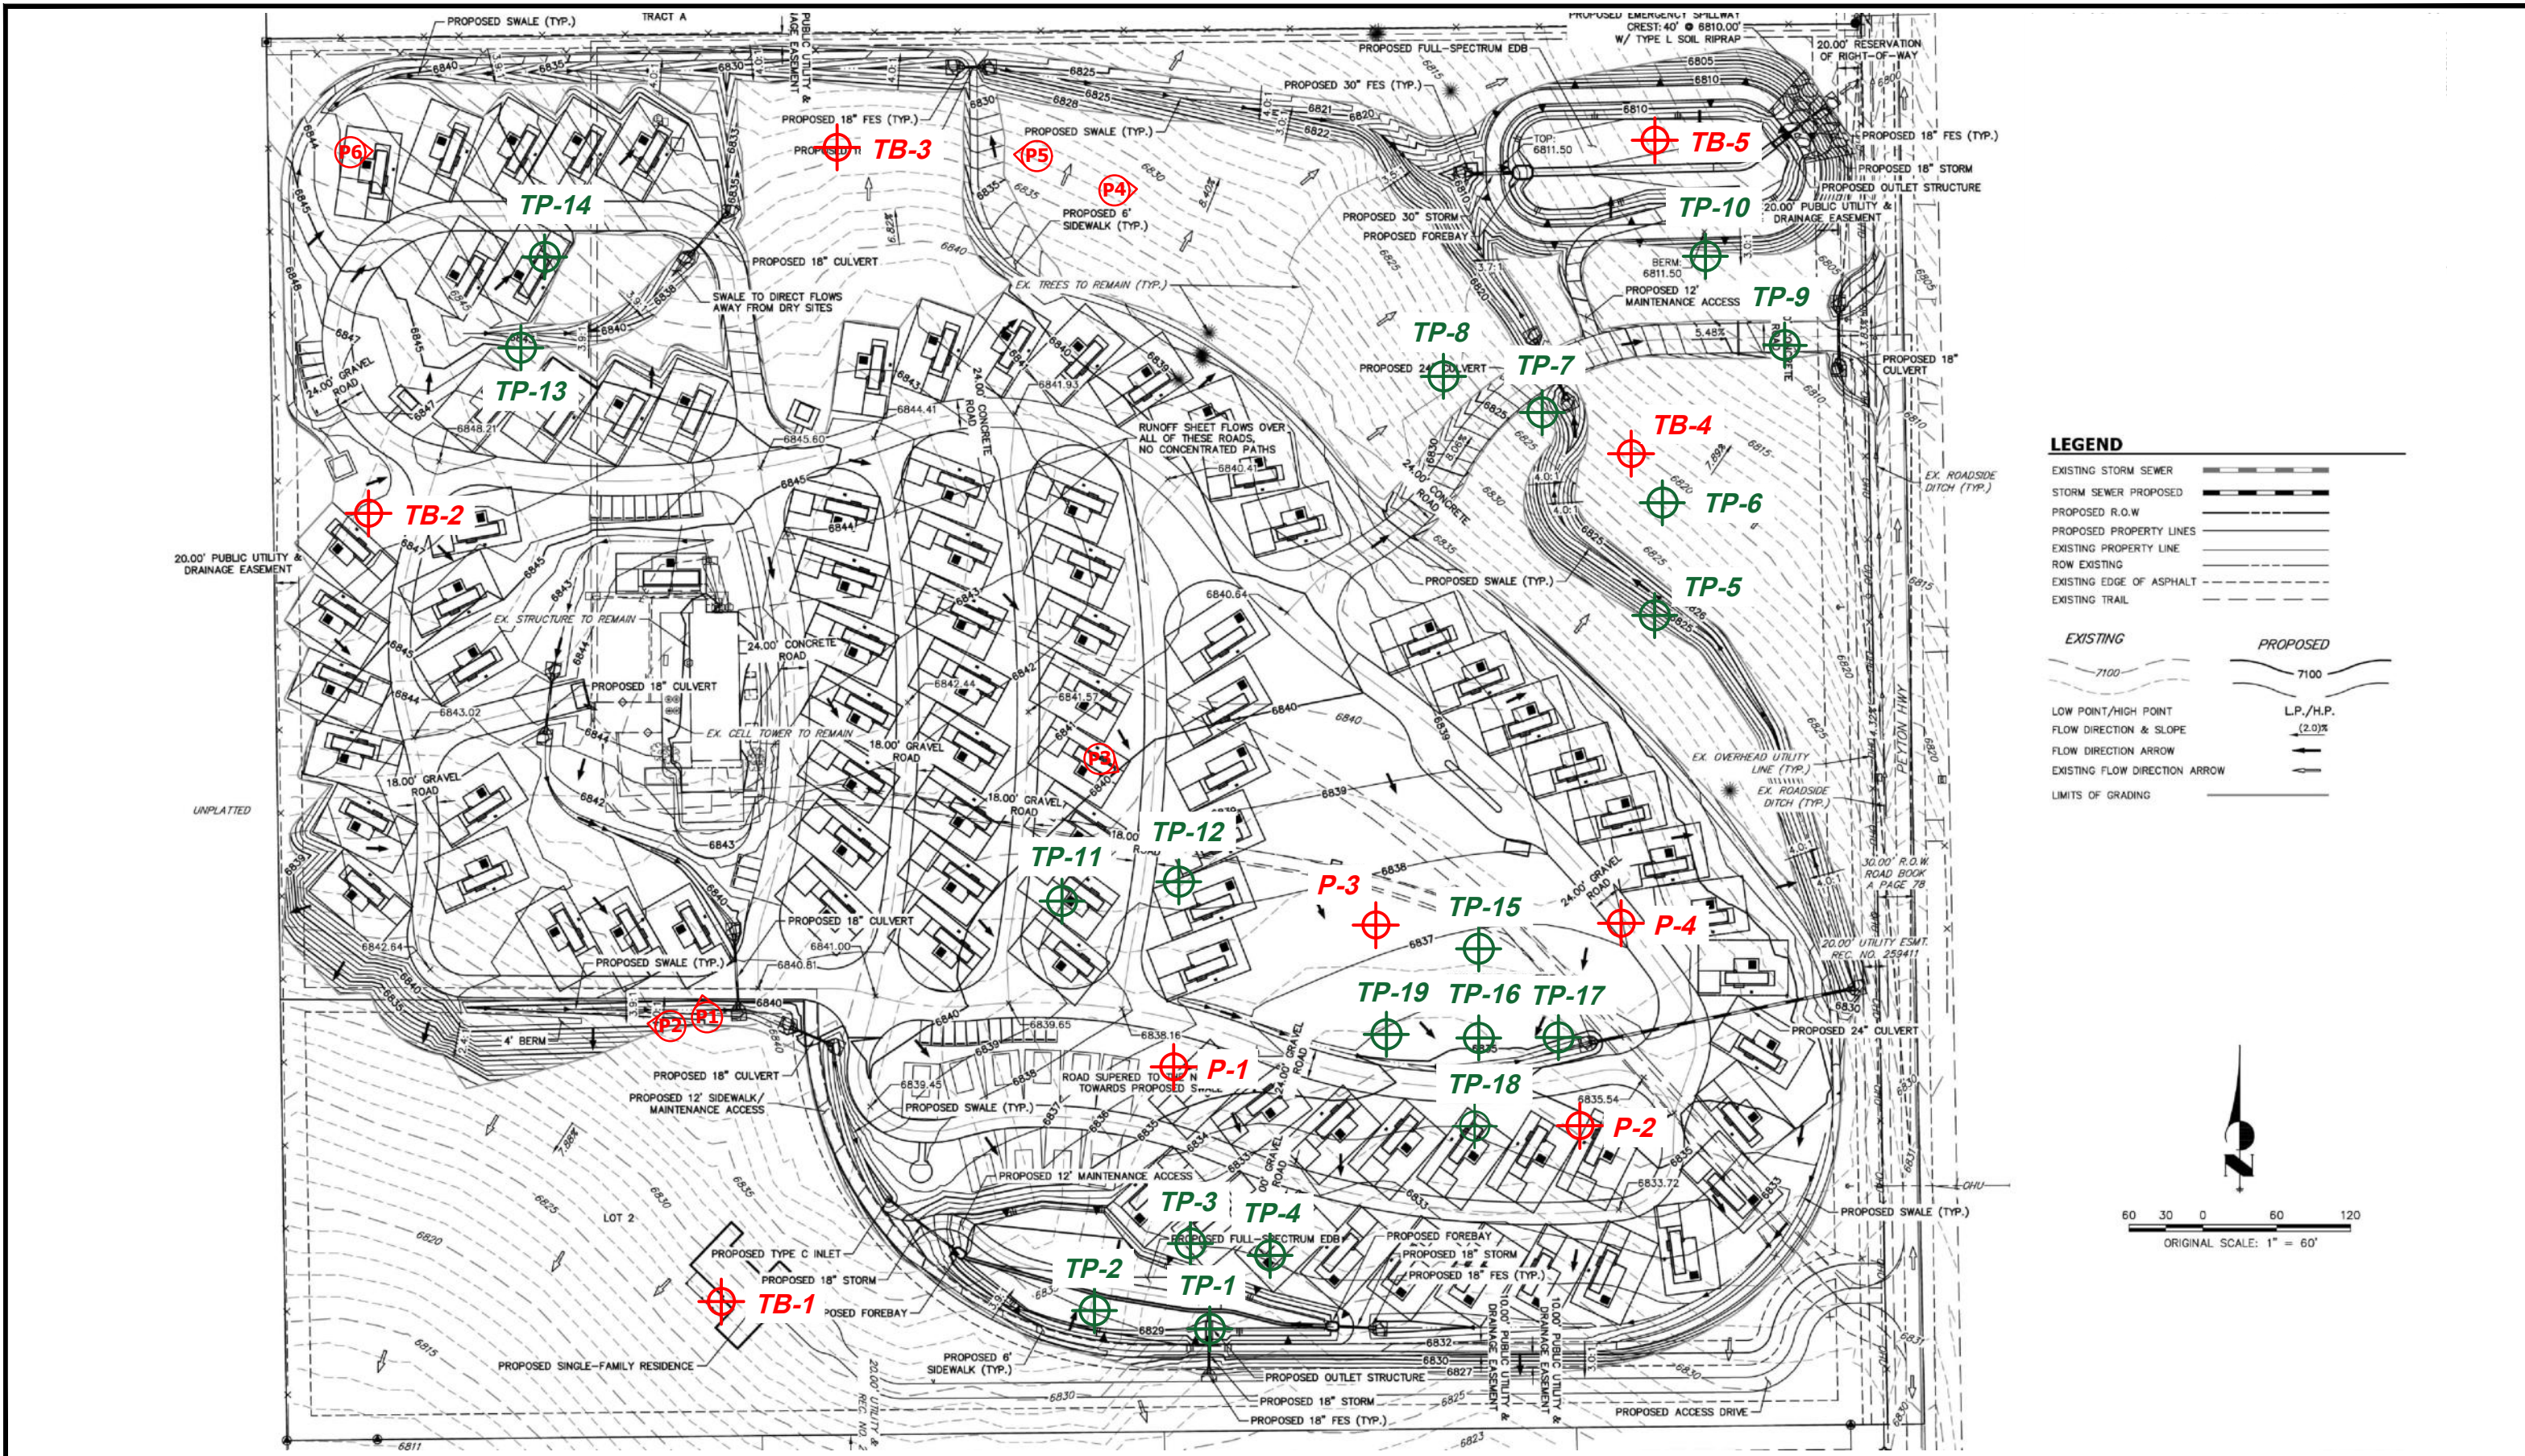
**FIG. 3**

Total acreage involved in the proposed subdivision is 36.24-acres. The existing structures, outbuildings, on-site wastewater treatment system, and water well located on the proposed RV Park Lot will remain. The new residential lot will be serviced by a new water well and on-site wastewater treatment system (OWTS), and the RV Park will be serviced by a new water well and OWTS. According to the preliminary grading plans new gravel roadways will be constructed for the RV Park with a detention pond proposed in the northeastern portion of the site. The Site Plan with the proposed replat is presented in Figure 3.

- ⊕ - APPROXIMATE TEST BORING LOCATION AND NUMBER
- ⊕ - APPROXIMATE TEST PIT LOCATION AND NUMBER
- ⊕ - APPROXIMATE PIEZOMETER LOCATION AND NUMBER
- ⊕ - APPROXIMATE PHOTOGRAPH LOCATION AND NUMBER

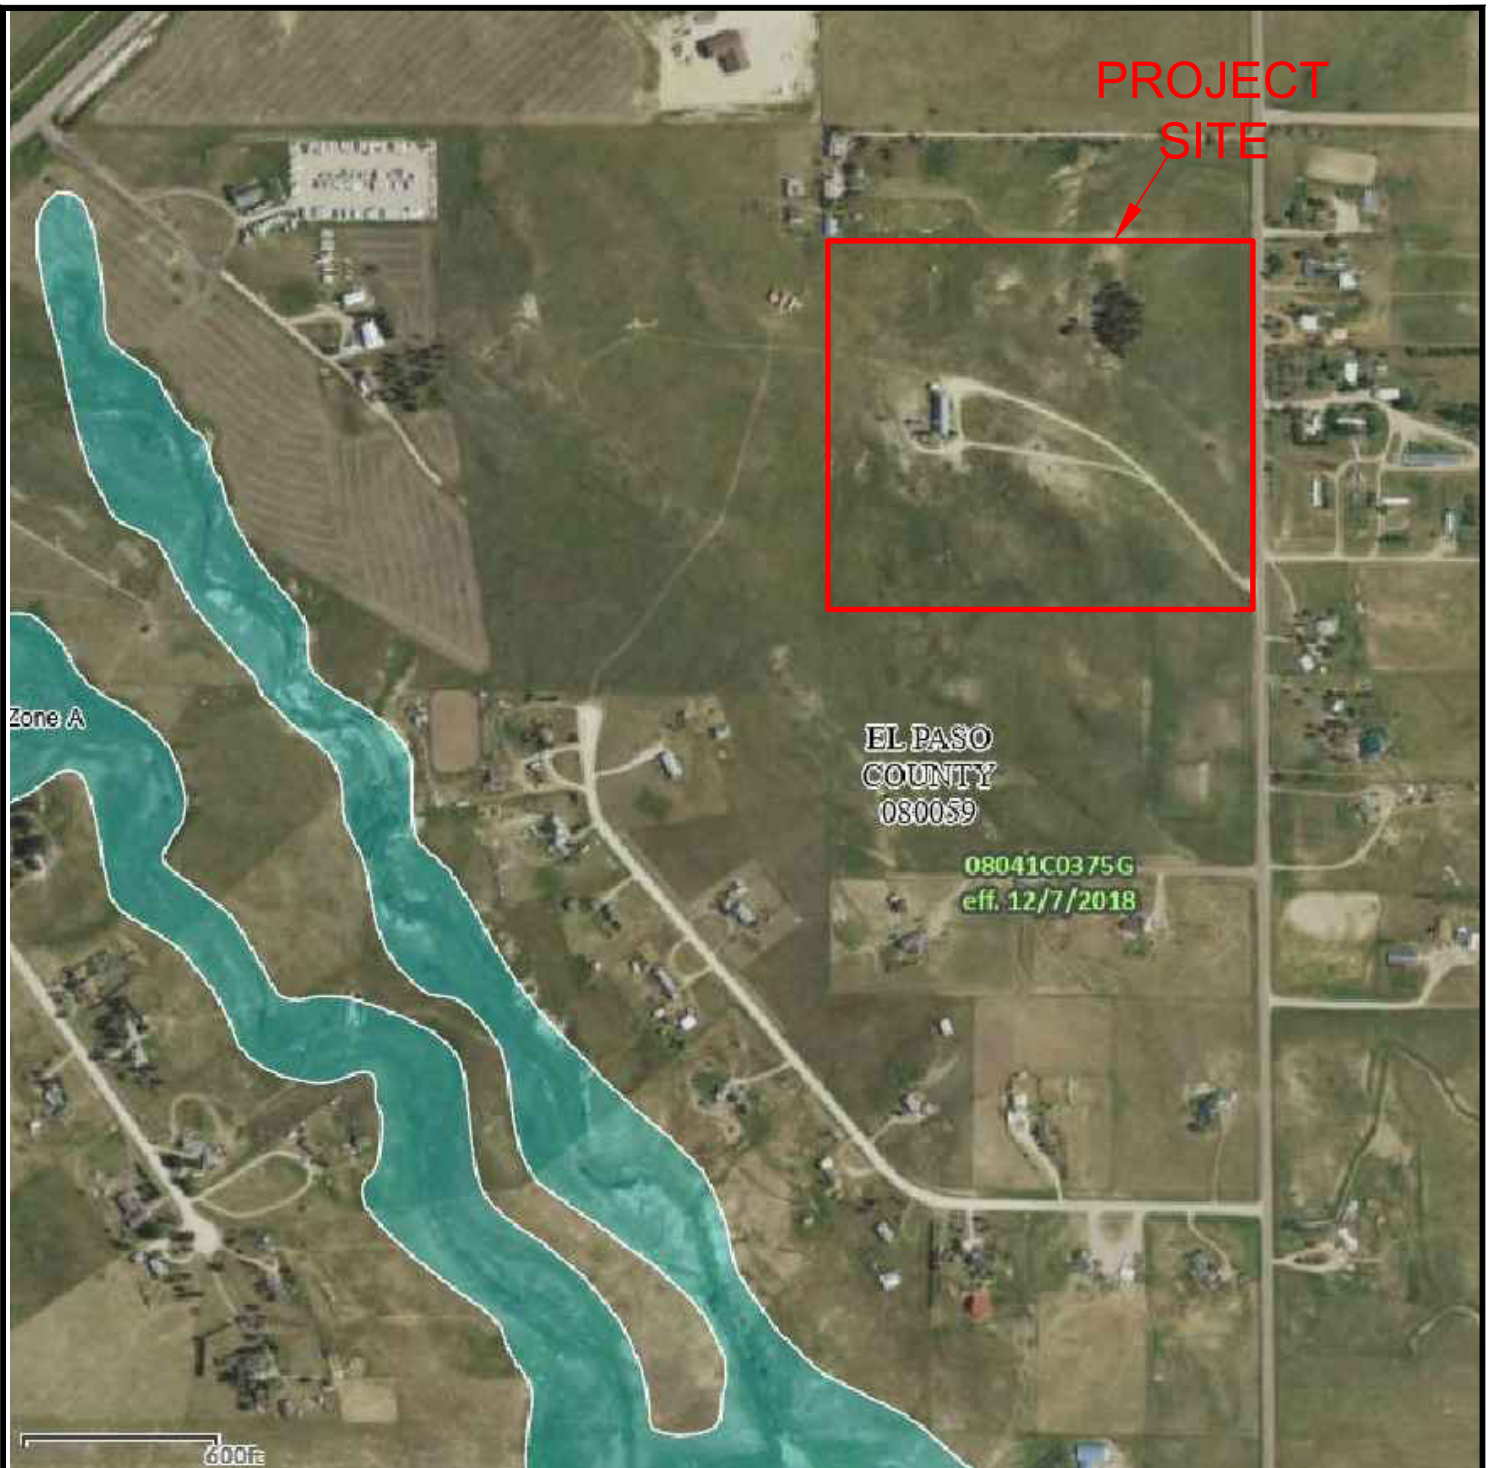
## FEMA FLOODPLAIN MAP

The site is not mapped within any floodplains according to the FEMA Map No. 08041CO375G, dated December 7, 2018 (Figure 7, Reference 7). No drainages or areas of shallow water were observed on the site. Groundwater was encountered in TB-4 at 7 feet in the proposed detention pond location, and in P-1 at 46.5 feet located south of the anticipated soil treatment area for the RV Park. **Specific drainage studies are beyond the scope of this report.**

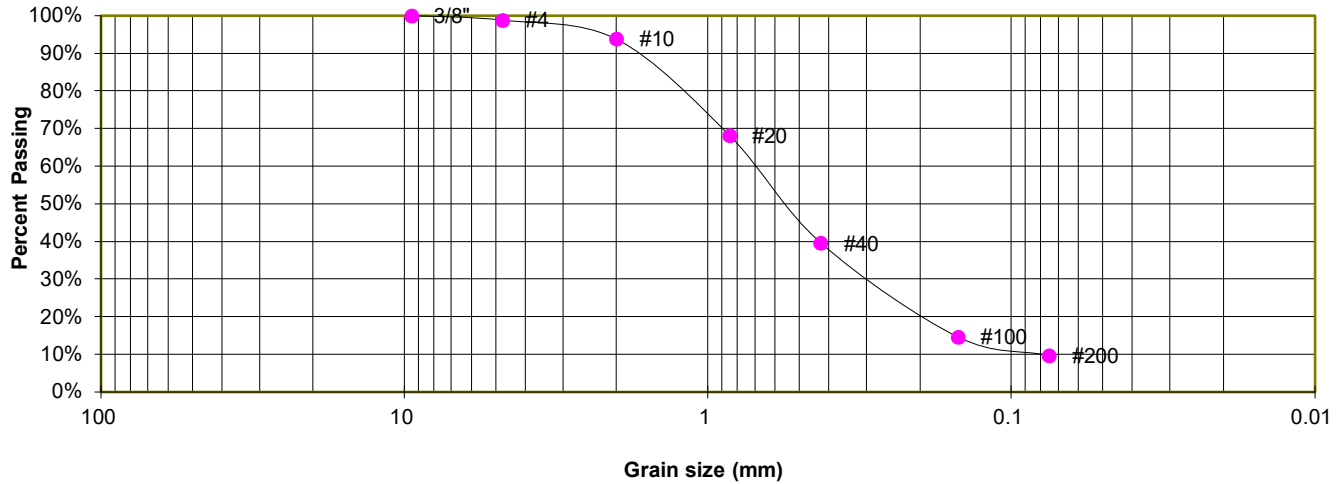
**Sieve Analysis  
Grain Size Distribution**

U.S. Sieve #	Percent Finer
3"	
1 1/2"	
3/4"	
1/2"	
3/8"	100.0%
4	98.9%
10	93.8%
20	68.2%
40	39.6%
100	14.7%
200	9.7%

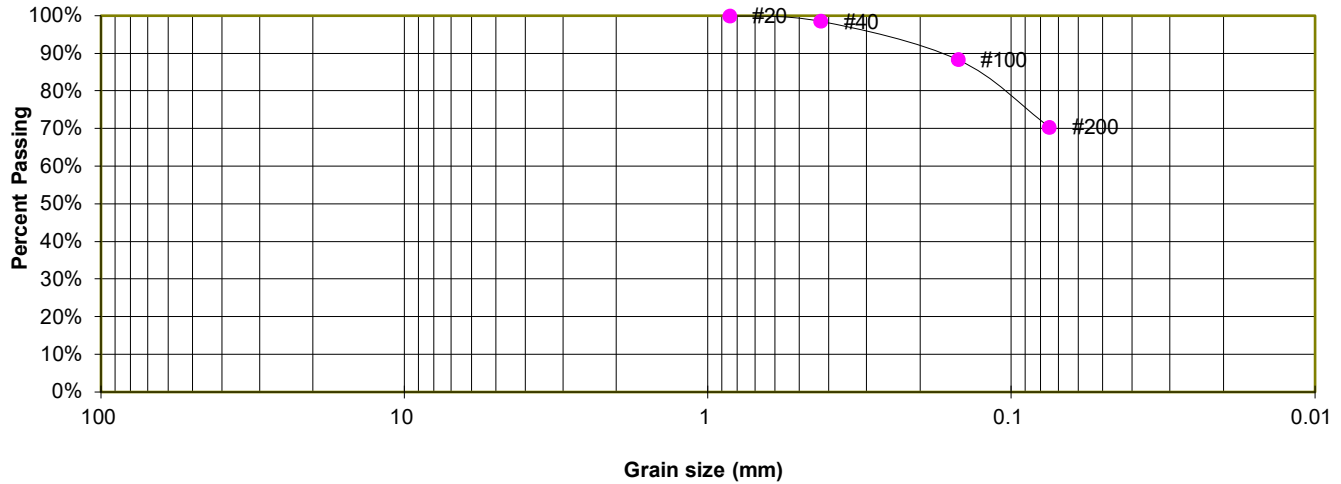
### Sieve Analysis Grain Size Distribution

U.S. Sieve #	Percent Finer
3"	
1 1/2"	
3/4"	
1/2"	
3/8"	
4	
10	
20	100.0%
40	98.5%
100	88.4%
200	70.4%

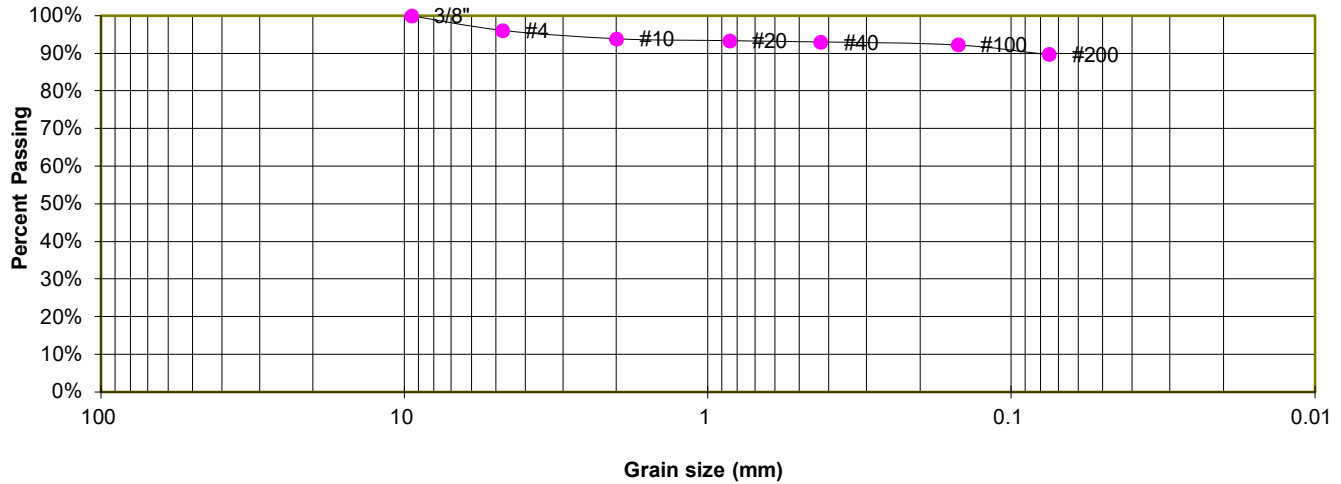
**Sieve Analysis  
Grain Size Distribution**

U.S. Sieve #	Percent Finer
3"	
1 1/2"	
3/4"	
1/2"	
3/8"	100.0%
4	96.1%
10	93.9%
20	93.4%
40	93.0%
100	92.3%
200	89.7%

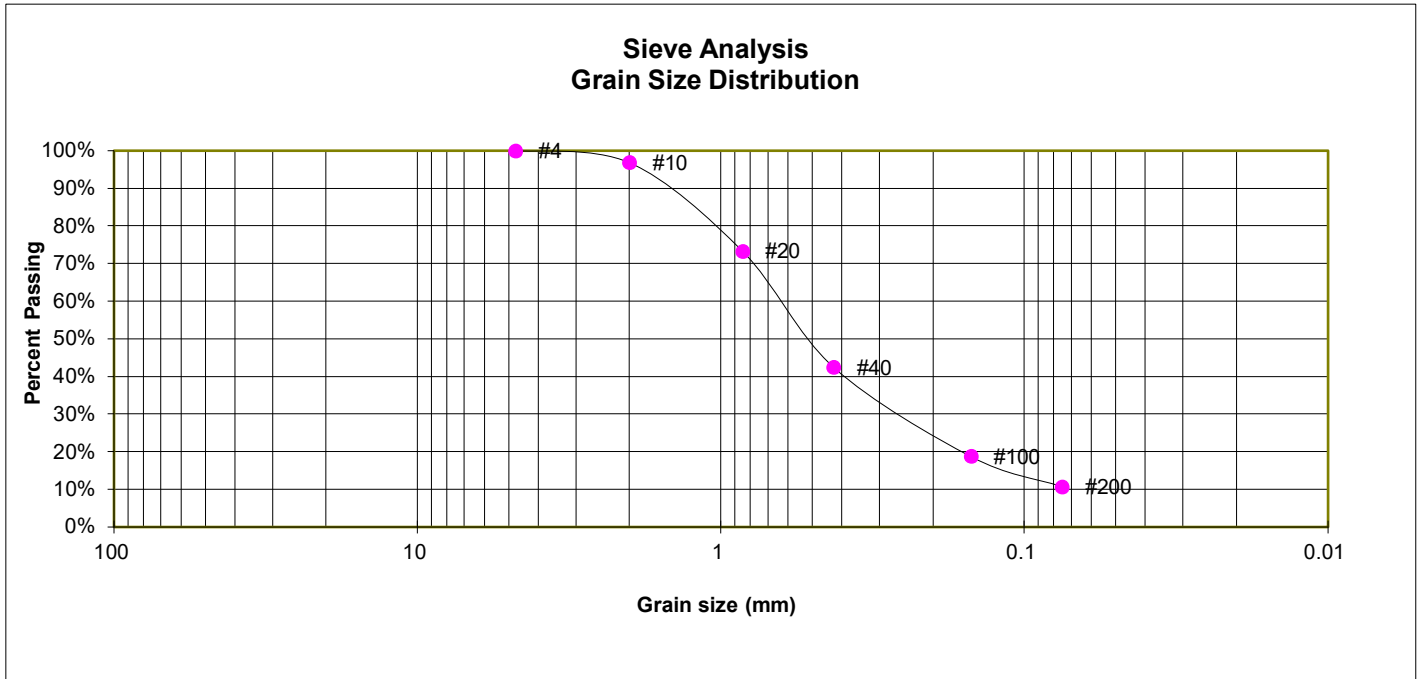
SOIL DESCRIPTION SANDSTONE (SAND, WITH SILT)  
SOIL TYPE 3

U.S. Sieve #	Percent Finer
3"	
1 1/2"	
3/4"	
1/2"	
3/8"	
4	100.0%
10	96.9%
20	73.3%
40	42.4%
100	18.8%
200	10.7%

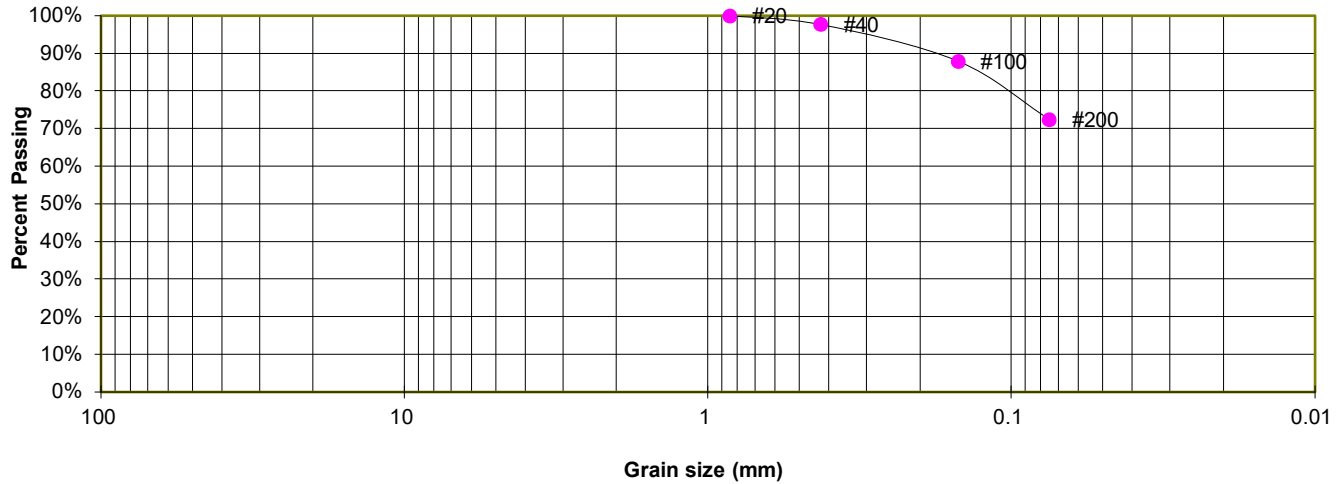
**Sieve Analysis  
Grain Size Distribution**

U.S. Sieve #	Percent Finer
3"	
1 1/2"	
3/4"	
1/2"	
3/8"	
4	
10	
20	100.0%
40	97.7%
100	88.0%
200	72.5%

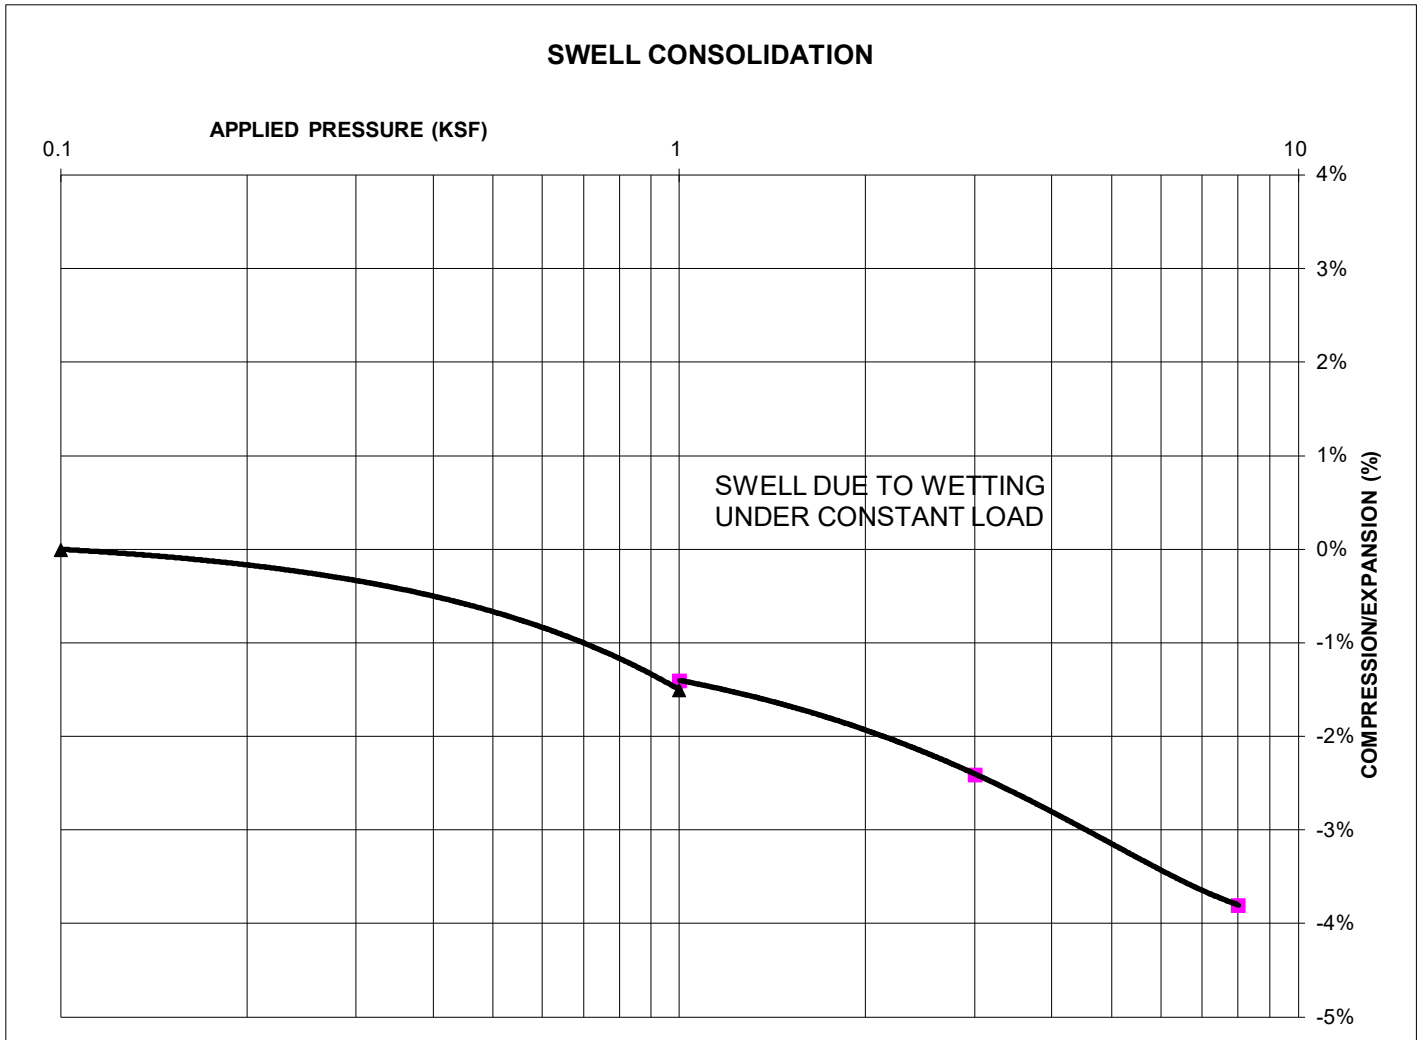
SOIL DESCRIPTION SANDSTONE (SAND, SILTY)  
SOIL TYPE 3

**SWELL/CONSOLIDATION TEST RESULTS**

NATURAL UNIT DRY WEIGHT (PCF): 114  
NATURAL MOISTURE CONTENT: 14.3%  
SWELL/CONSOLIDATION (%): 0.1%

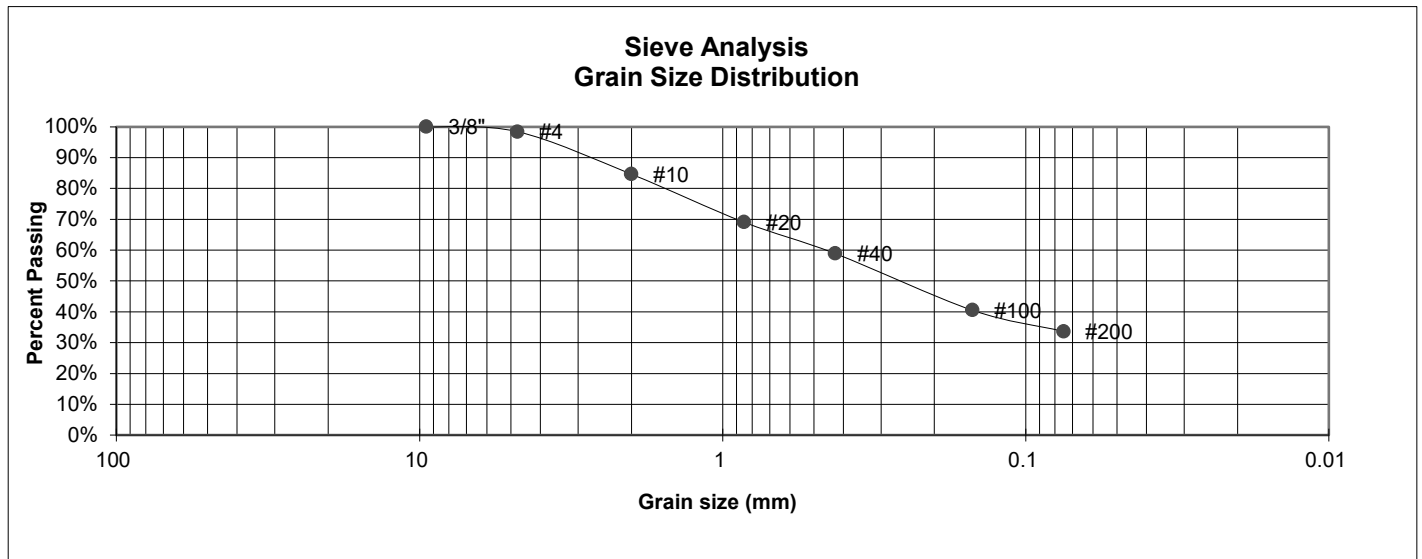
<u>UNIFIED CLASSIFICATION</u>	SC	<u>CLIENT</u>	LAZY Y AND ROCKIN' J
<u>SOIL TYPE #</u>	4A	<u>PROJECT</u>	12960 NORTH PEYTON HIGHWAY
<u>TEST BORING #</u>	TP-6	<u>JOB NO.</u>	230520
<u>DEPTH (FT)</u>	3.5	<u>TEST BY</u>	BL

<u>U.S. Sieve #</u>	<u>Percent Finer</u>
3"	
1 1/2"	
3/4"	
1/2"	
3/8"	100.0%
4	98.4%
10	84.6%
20	69.0%
40	58.9%
100	40.5%
200	33.6%

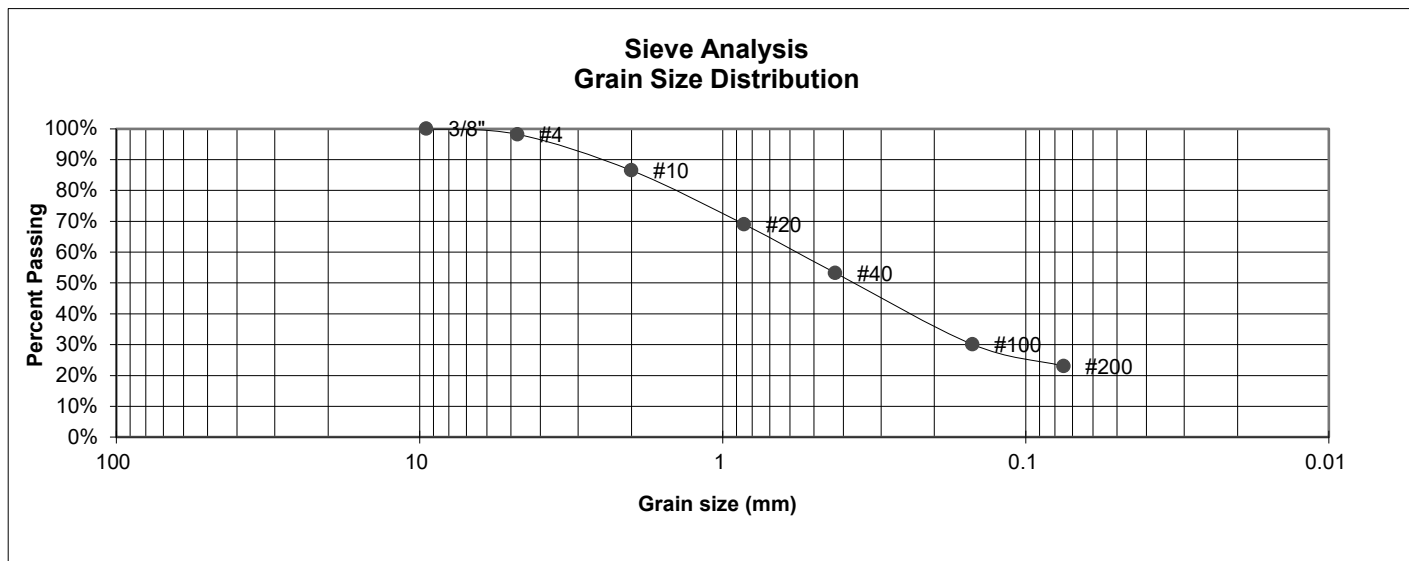
<b>UNIFIED CLASSIFICATION</b>	SC	<b>CLIENT</b>	LAZY Y AND ROCKIN' J
<b>SOIL TYPE #</b>	4A	<b>PROJECT</b>	12960 NORTH PEYTON HIGHWAY
<b>TEST BORING #</b>	TP-7	<b>JOB NO.</b>	230520
<b>DEPTH (FT)</b>	2.5	<b>TEST BY</b>	BL

<u>U.S. Sieve #</u>	<u>Percent Finer</u>
3"	
1 1/2"	
3/4"	
1/2"	
3/8"	100.0%
4	98.2%
10	86.5%
20	69.0%
40	53.2%
100	30.1%
200	23.1%

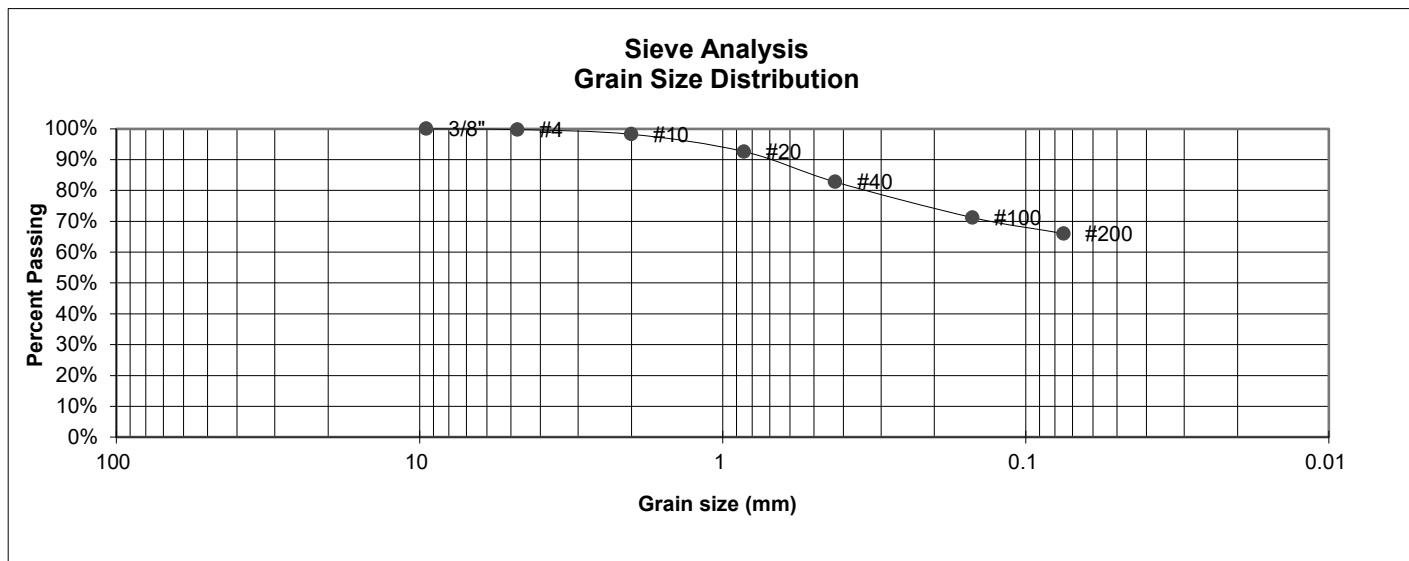
<u>UNIFIED CLASSIFICATION</u>	CL	<u>CLIENT</u>	LAZY Y AND ROCKIN' J
<u>SOIL TYPE #</u>	4A	<u>PROJECT</u>	12960 NORTH PEYTON HIGHWAY
<u>TEST BORING #</u>	TP-10	<u>JOB NO.</u>	230520
<u>DEPTH (FT)</u>	2	<u>TEST BY</u>	BL

<u>U.S. Sieve #</u>	<u>Percent Finer</u>
3"	
1 1/2"	
3/4"	
1/2"	
3/8"	100.0%
4	99.7%
10	98.2%
20	92.6%
40	82.8%
100	71.2%
200	66.0%

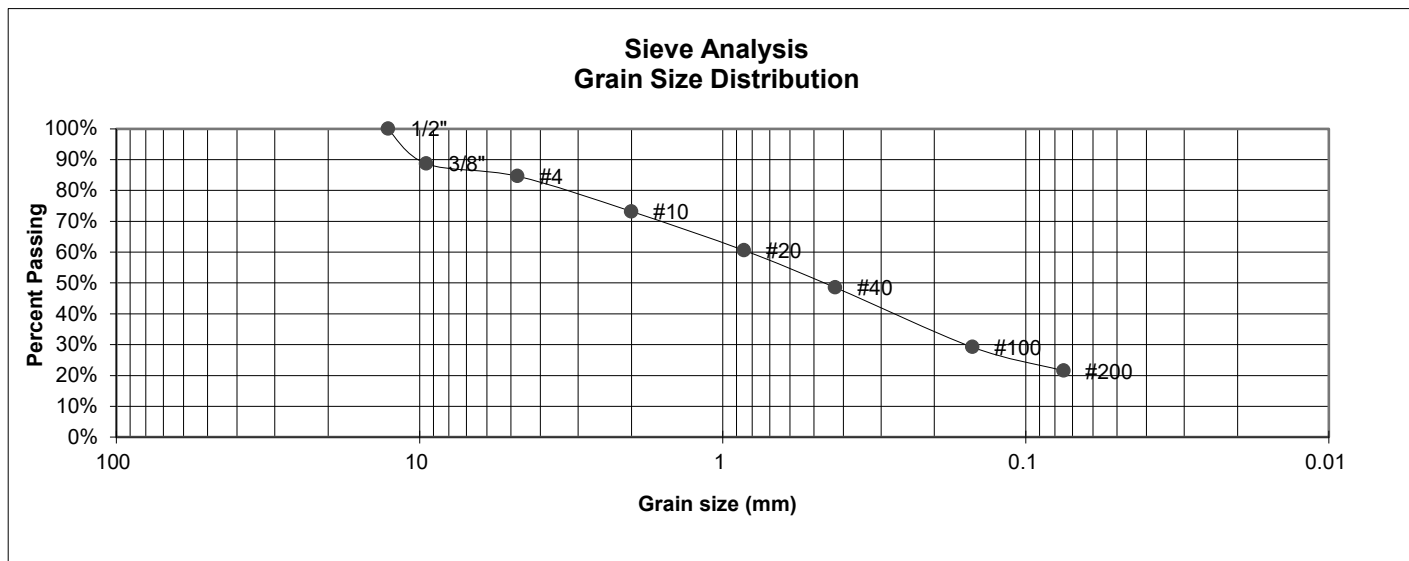
<u>UNIFIED CLASSIFICATION</u>	SC	<u>CLIENT</u>	LAZY Y AND ROCKIN' J
<u>SOIL TYPE #</u>	4A	<u>PROJECT</u>	12960 NORTH PEYTON HIGHWAY
<u>TEST BORING #</u>	TP-12	<u>JOB NO.</u>	230520
<u>DEPTH (FT)</u>	7.5	<u>TEST BY</u>	BL

<u>U.S. Sieve #</u>	<u>Percent Finer</u>
3"	
1 1/2"	
3/4"	
1/2"	100.0%
3/8"	88.7%
4	84.6%
10	73.2%
20	60.6%
40	48.5%
100	29.2%
200	21.5%

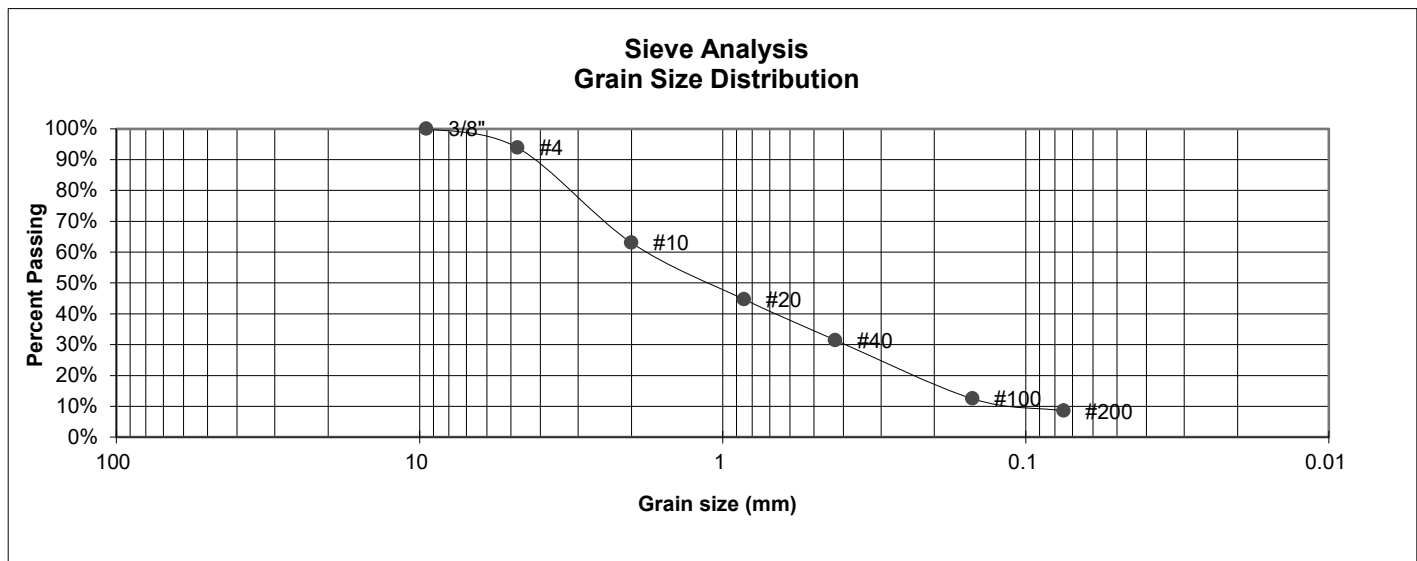
<u>UNIFIED CLASSIFICATION</u>	SM-SW	<u>CLIENT</u>	LAZY Y AND ROCKIN' J
<u>SOIL TYPE #</u>	2/R1	<u>PROJECT</u>	12960 NORTH PEYTON HIGHWAY
<u>TEST BORING #</u>	TP-13	<u>JOB NO.</u>	230520
<u>DEPTH (FT)</u>	3	<u>TEST BY</u>	BL

<u>U.S. Sieve #</u>	<u>Percent Finer</u>
3"	
1 1/2"	
3/4"	
1/2"	
3/8"	100.0%
4	93.9%
10	63.0%
20	44.7%
40	31.5%
100	12.5%
200	8.5%

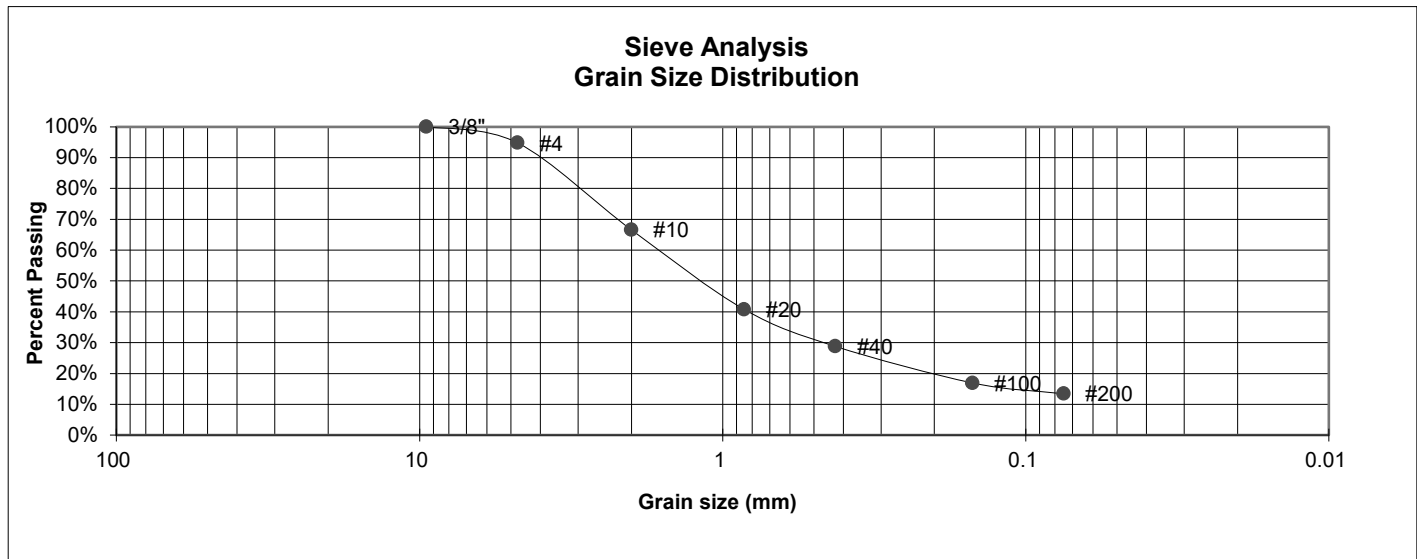
<u>UNIFIED CLASSIFICATION</u>	SC	<u>CLIENT</u>	LAZY Y AND ROCKIN' J
<u>SOIL TYPE #</u>	3A/R1	<u>PROJECT</u>	12960 NORTH PEYTON HIGHWAY
<u>TEST BORING #</u>	15	<u>JOB NO.</u>	230520
<u>DEPTH (FT)</u>	3.5	<u>TEST BY</u>	BL

<u>U.S. Sieve #</u>	<u>Percent Finer</u>
3"	
1 1/2"	
3/4"	
1/2"	
3/8"	100.0%
4	94.8%
10	66.6%
20	40.8%
40	28.8%
100	16.9%
200	13.4%

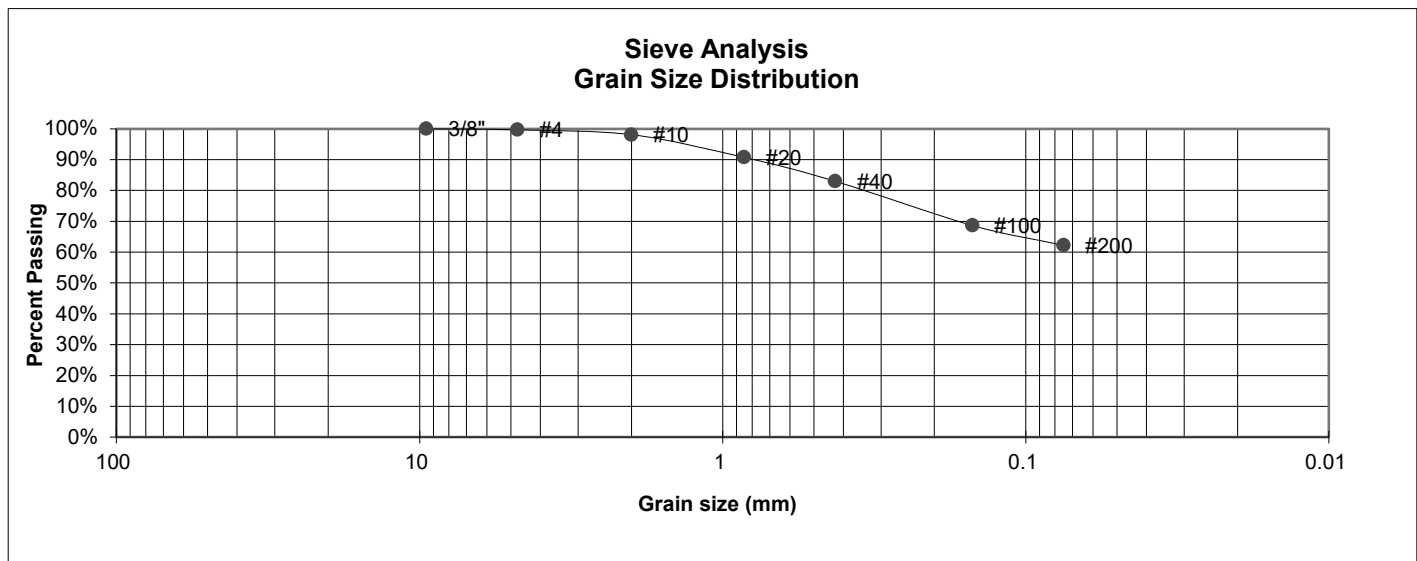
<u>UNIFIED CLASSIFICATION</u>	CL	<u>CLIENT</u>	LAZY Y AND ROCKIN' J
<u>SOIL TYPE #</u>	4A	<u>PROJECT</u>	12960 NORTH PEYTON HIGHWAY
<u>TEST BORING #</u>	17	<u>JOB NO.</u>	230520
<u>DEPTH (FT)</u>	3	<u>TEST BY</u>	BL

<u>U.S. Sieve #</u>	<u>Percent Finer</u>
3"	
1 1/2"	
3/4"	
1/2"	
3/8"	100.0%
4	99.7%
10	98.1%
20	90.7%
40	83.0%
100	68.6%
200	62.2%
