**Figure 4-39**  
**Future Conditions Deficiency Map**  
**Falcon DBPS**  
**El Paso County, CO**

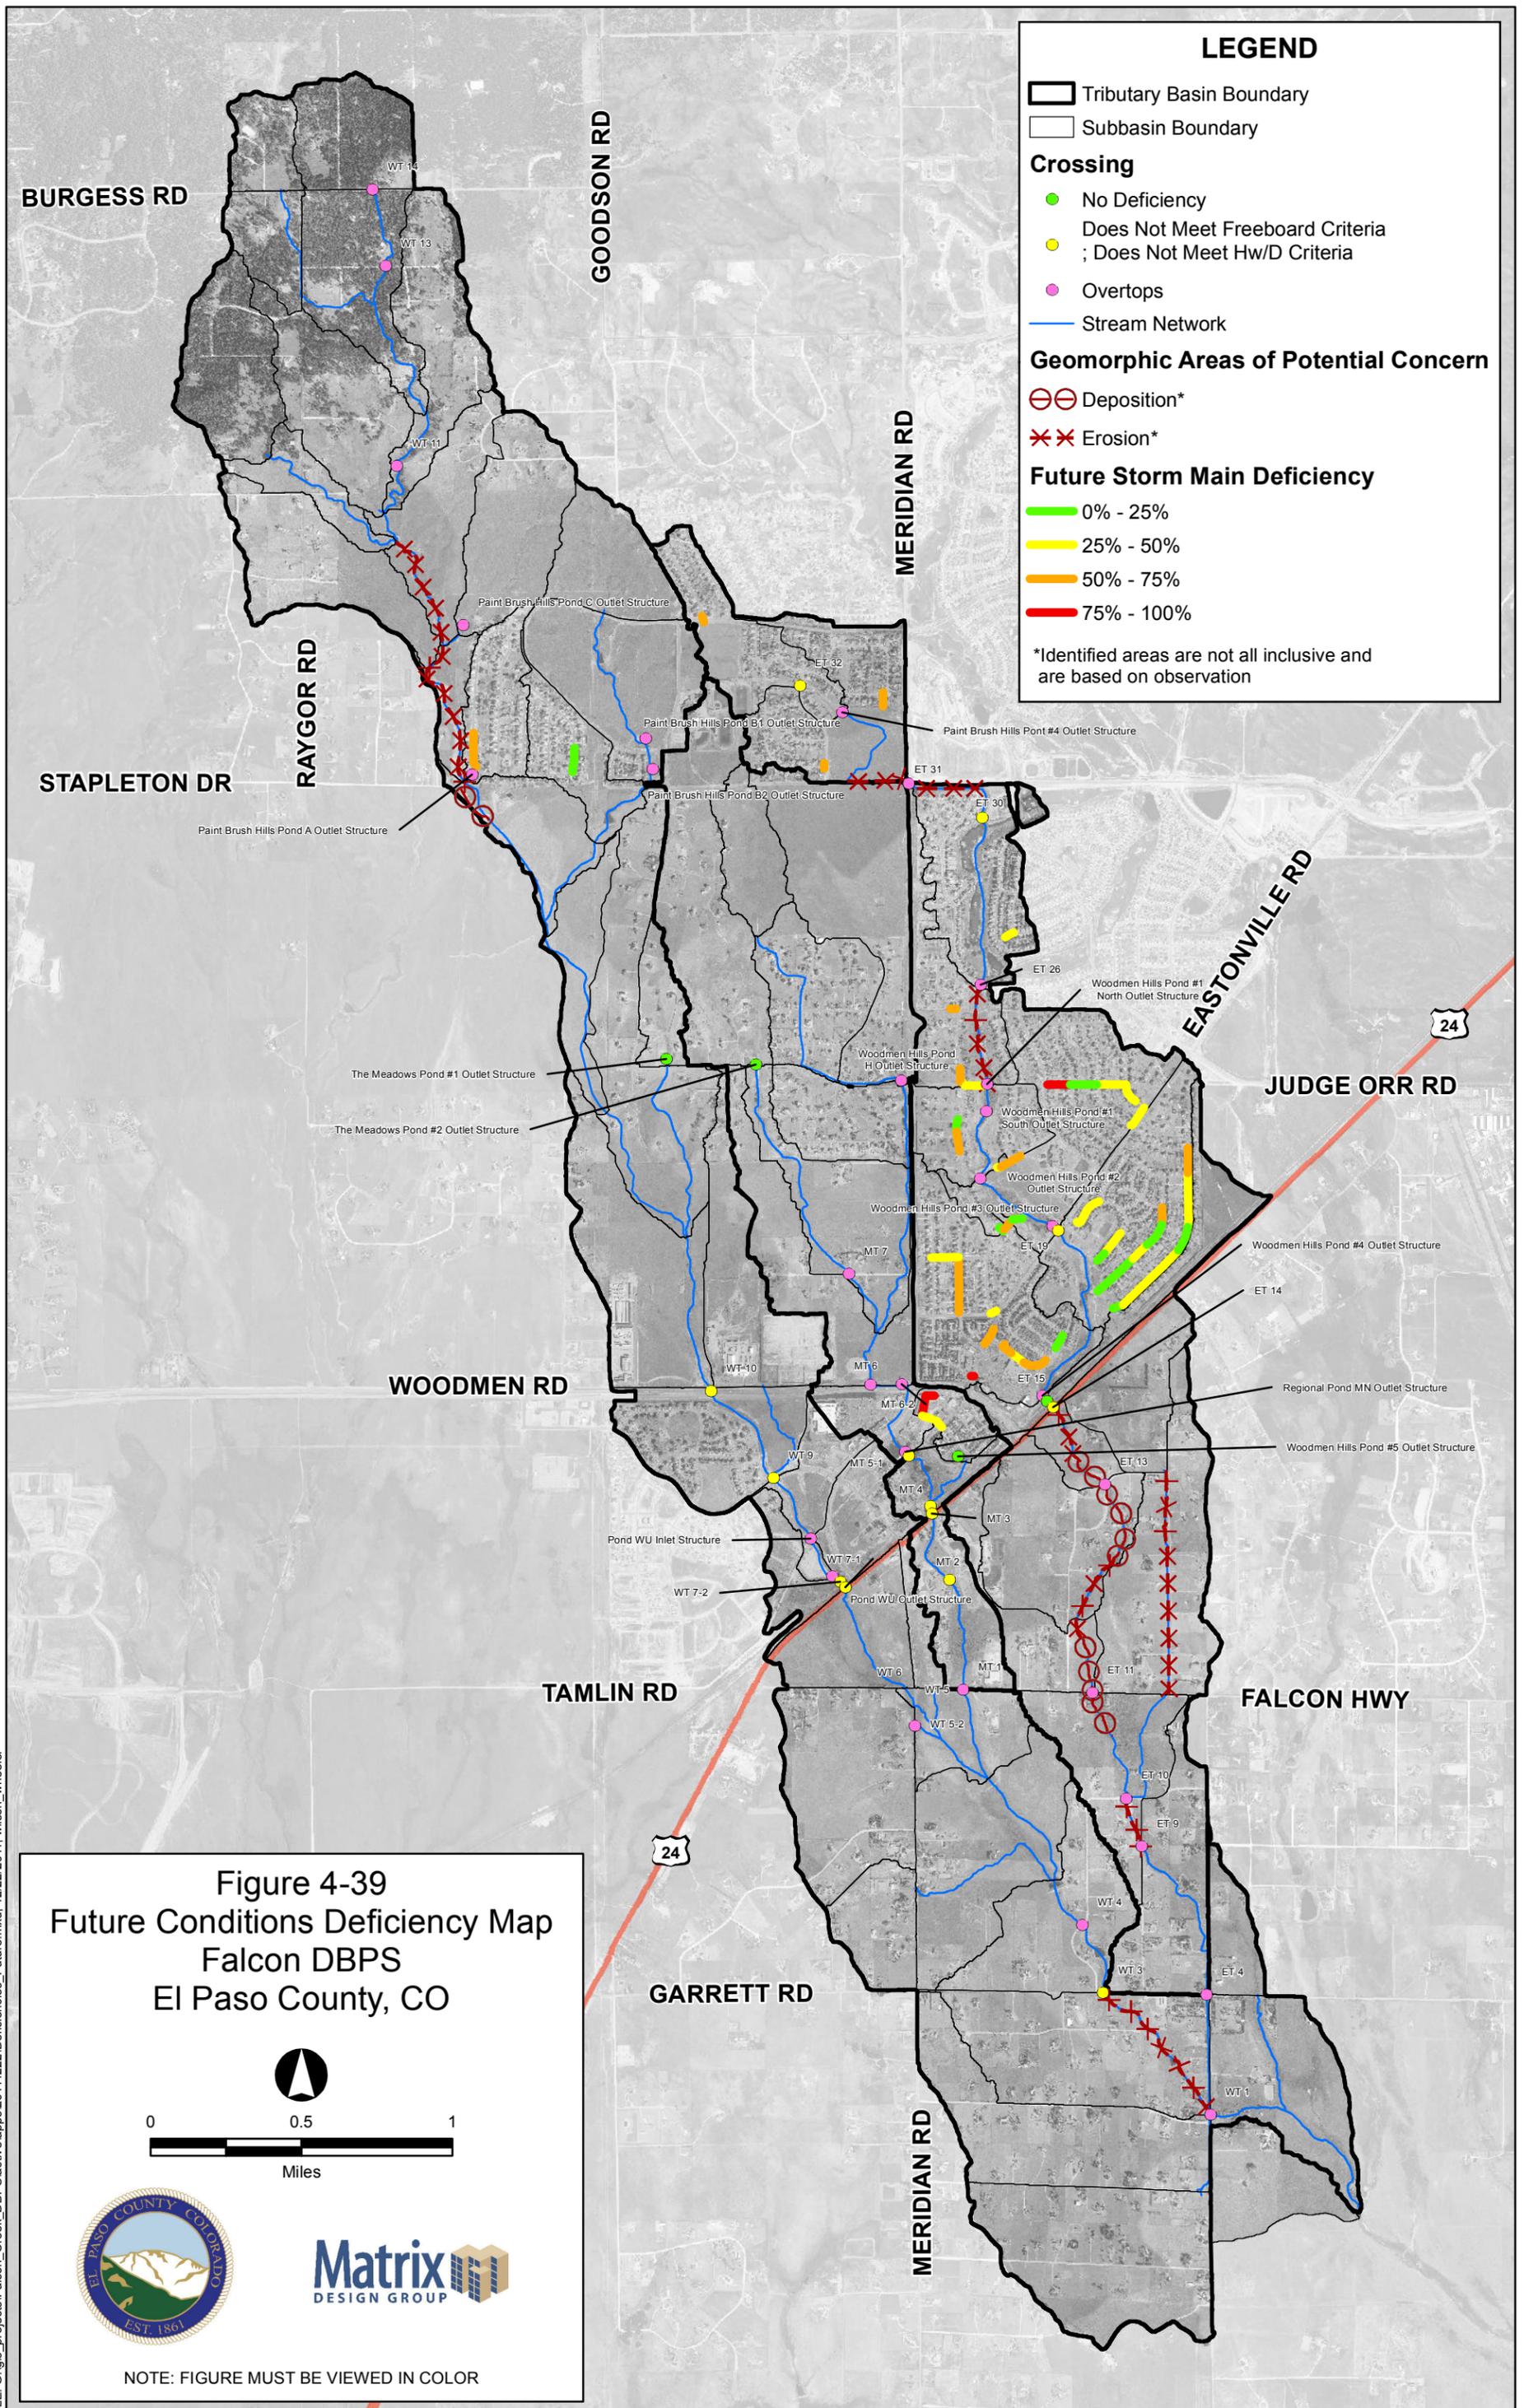
\*Identified areas are not all inclusive and are based on observation
