**Figure 4-38**  
**Existing Conditions Deficiency Map**  
**Falcon DBPS**  
**El Paso County, CO**

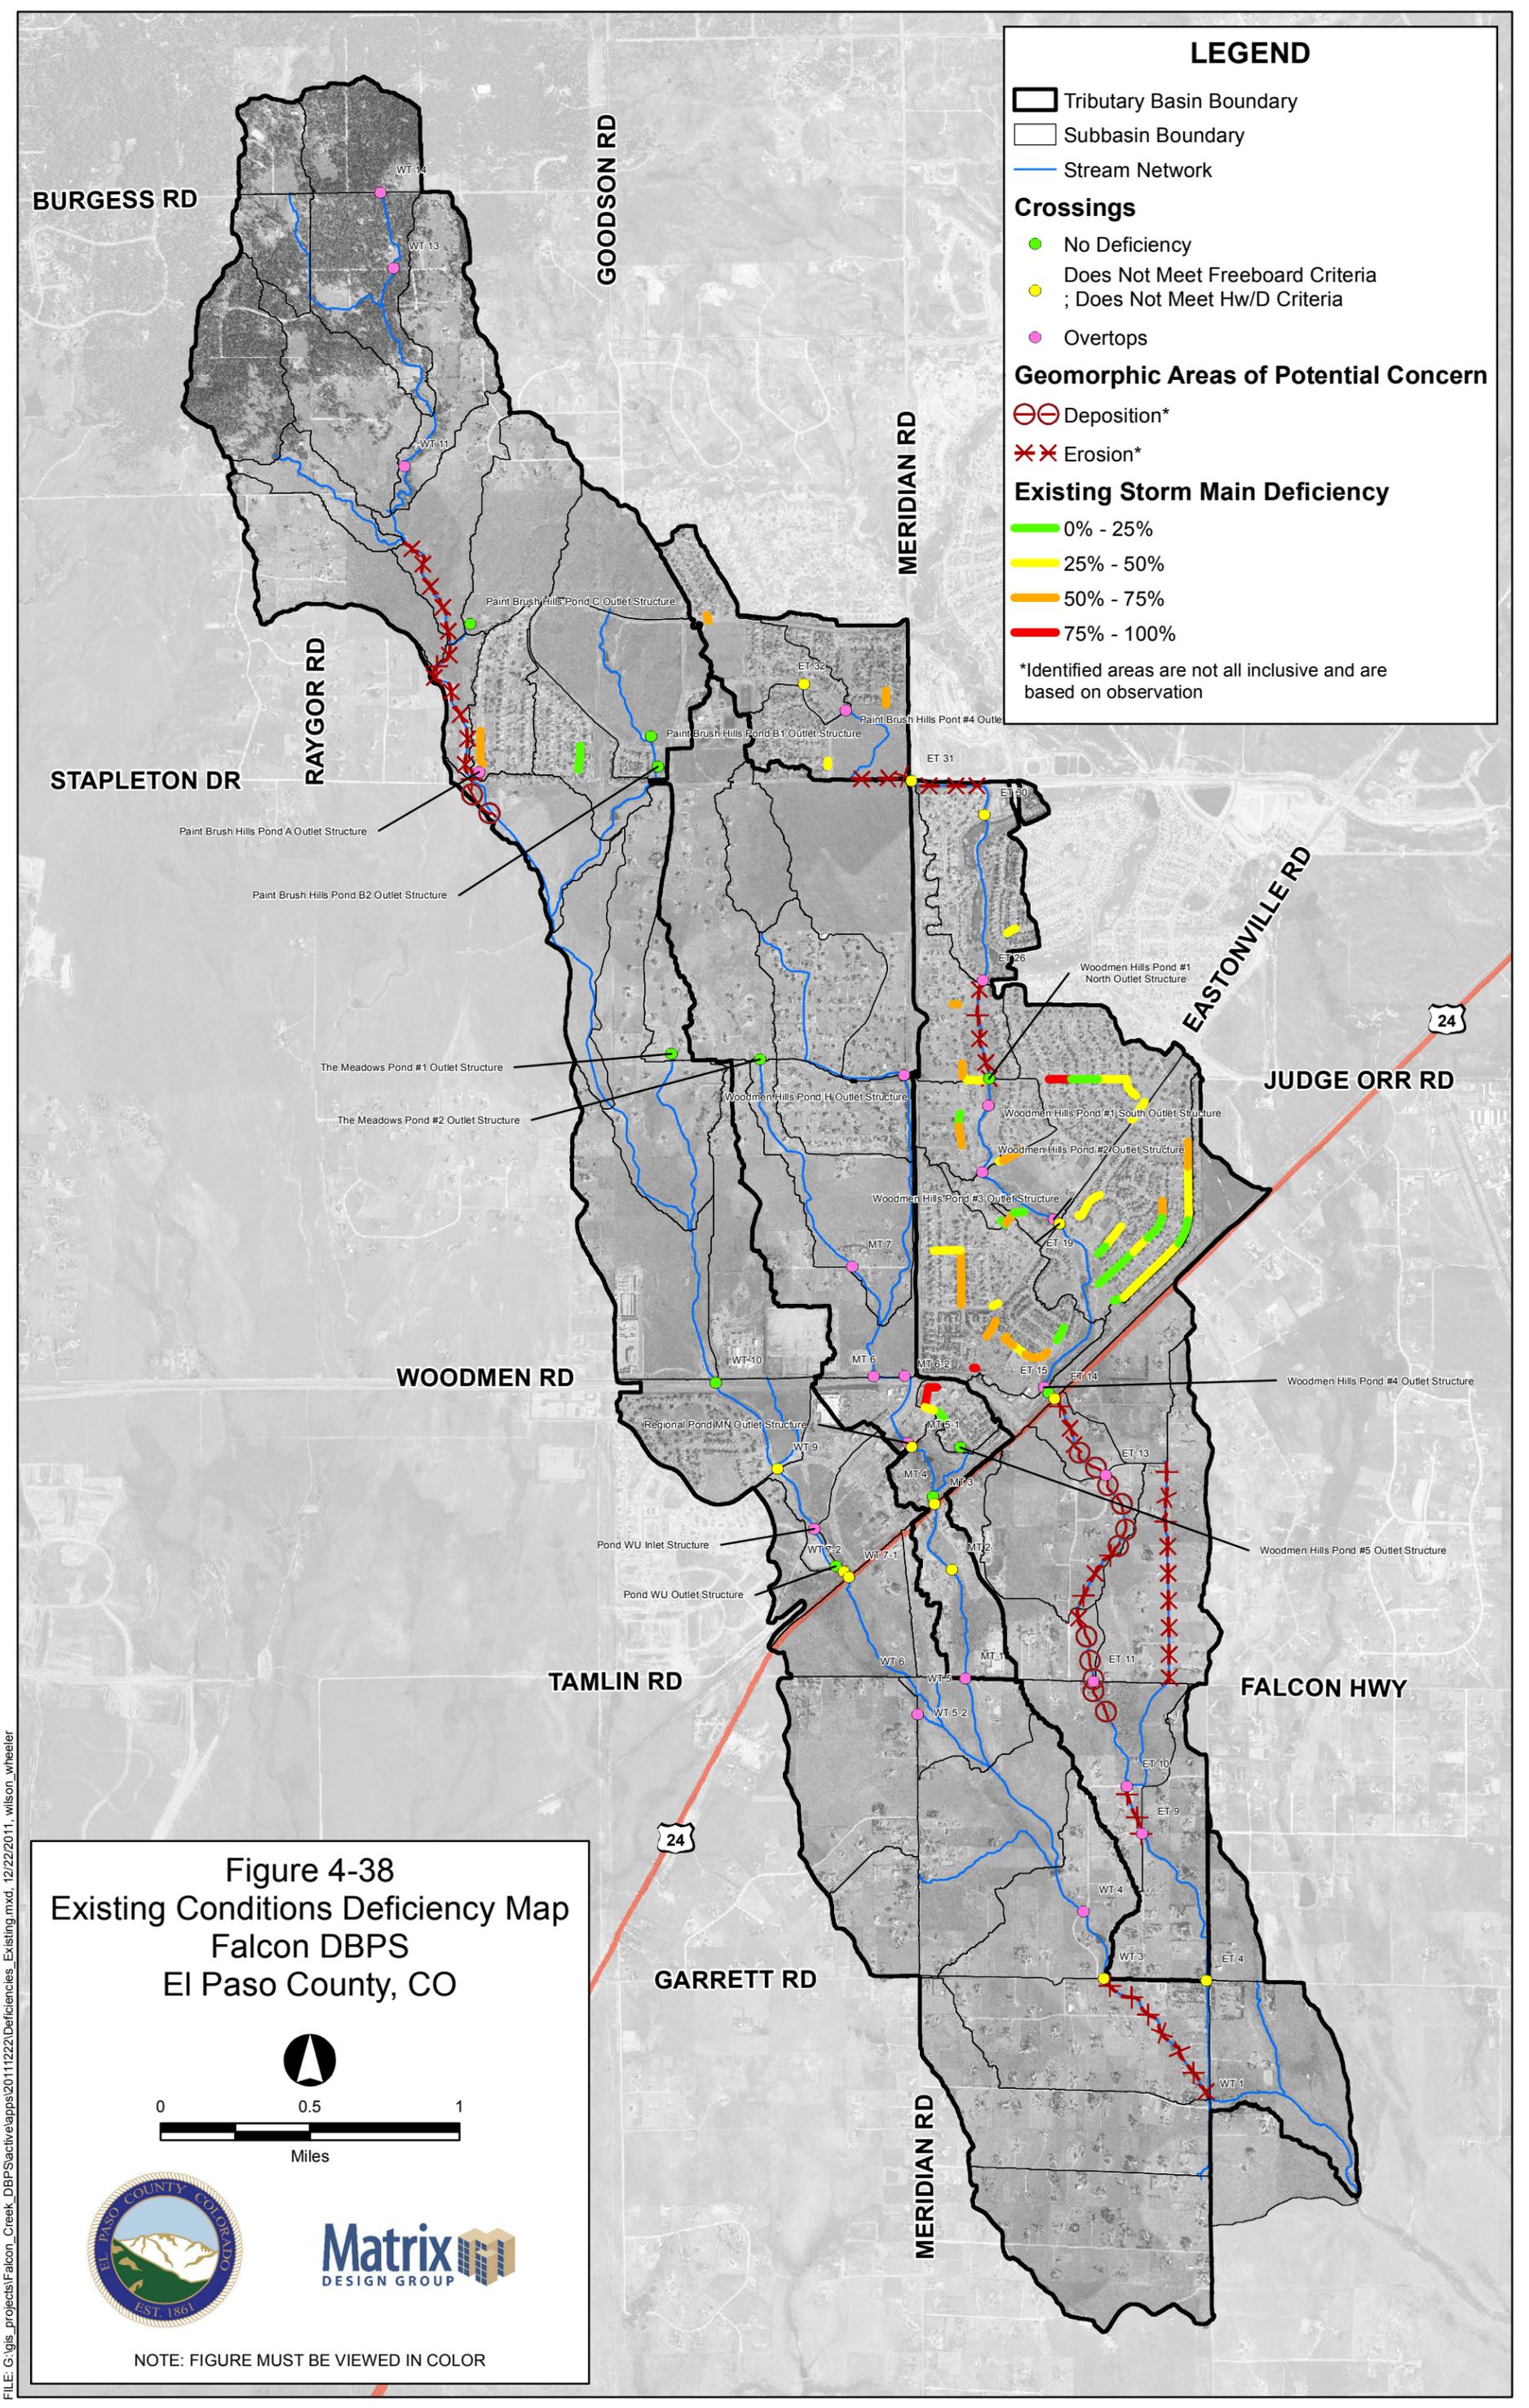
- No Deficiency
- Does Not Meet Freeboard Criteria ; Does Not Meet Hw/D Criteria
- Overtops

- ⊖ Deposition\*
- ✖ Erosion\*

- 0% - 25%
- 25% - 50%
- 50% - 75%
- 75% - 100%

\*Identified areas are not all inclusive and are based on observation
