## SOIL, GEOLOGY, AND WASTEWATER STUDY

**22755 McDaniels Road  
El Paso County, Colorado**

**JOB NO. 184735**

**December 20, 2021  
Amended November 21, 2022**

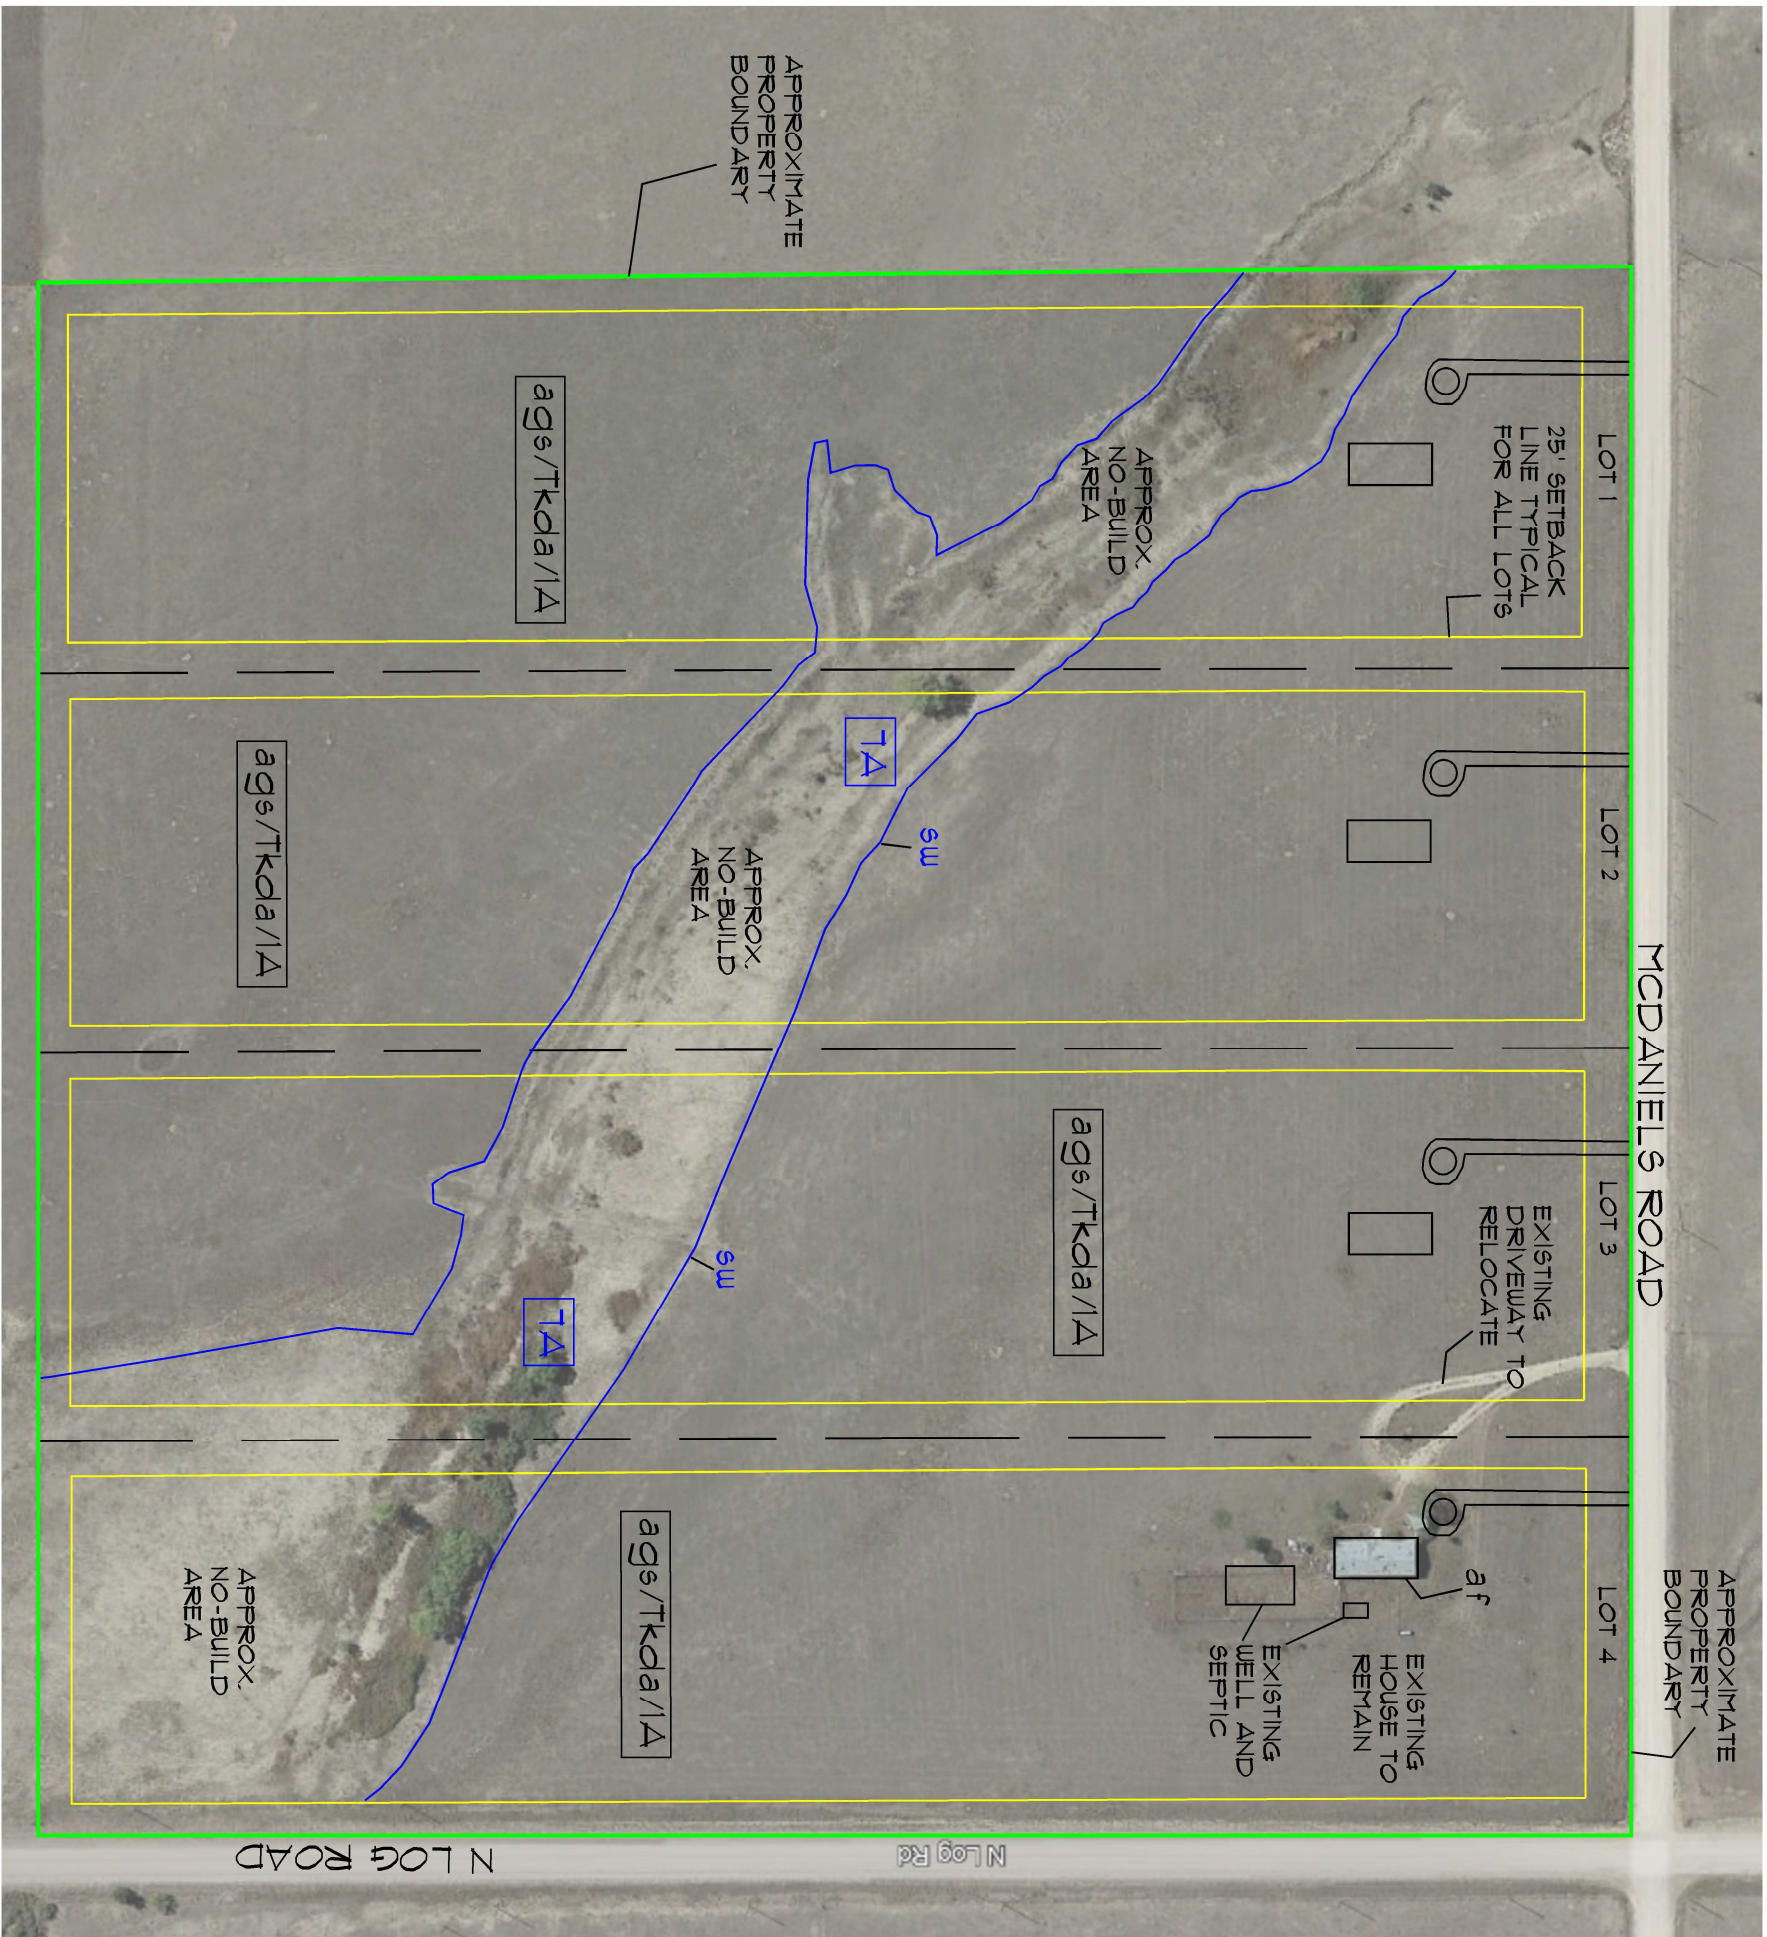
Based on our field observations and review of relevant geologic maps, a geologic map was prepared which identifies the geologic conditions affecting the development. The geologic conditions affecting the development are presented in the Engineering and Geology Map, Figure 6.

It is our recommendation that the floodplain within the property boundary be designated as a "No-Build" area. This "No-Build" area is shown in Figure 6, the Engineering and Geology Map.
