PAVEMENT DESIGN REPORT

**Falcon Meadows at Bent Grass, Filing No. 3
El Paso County, Colorado**

JOB NO. 195343

June 14, 2024

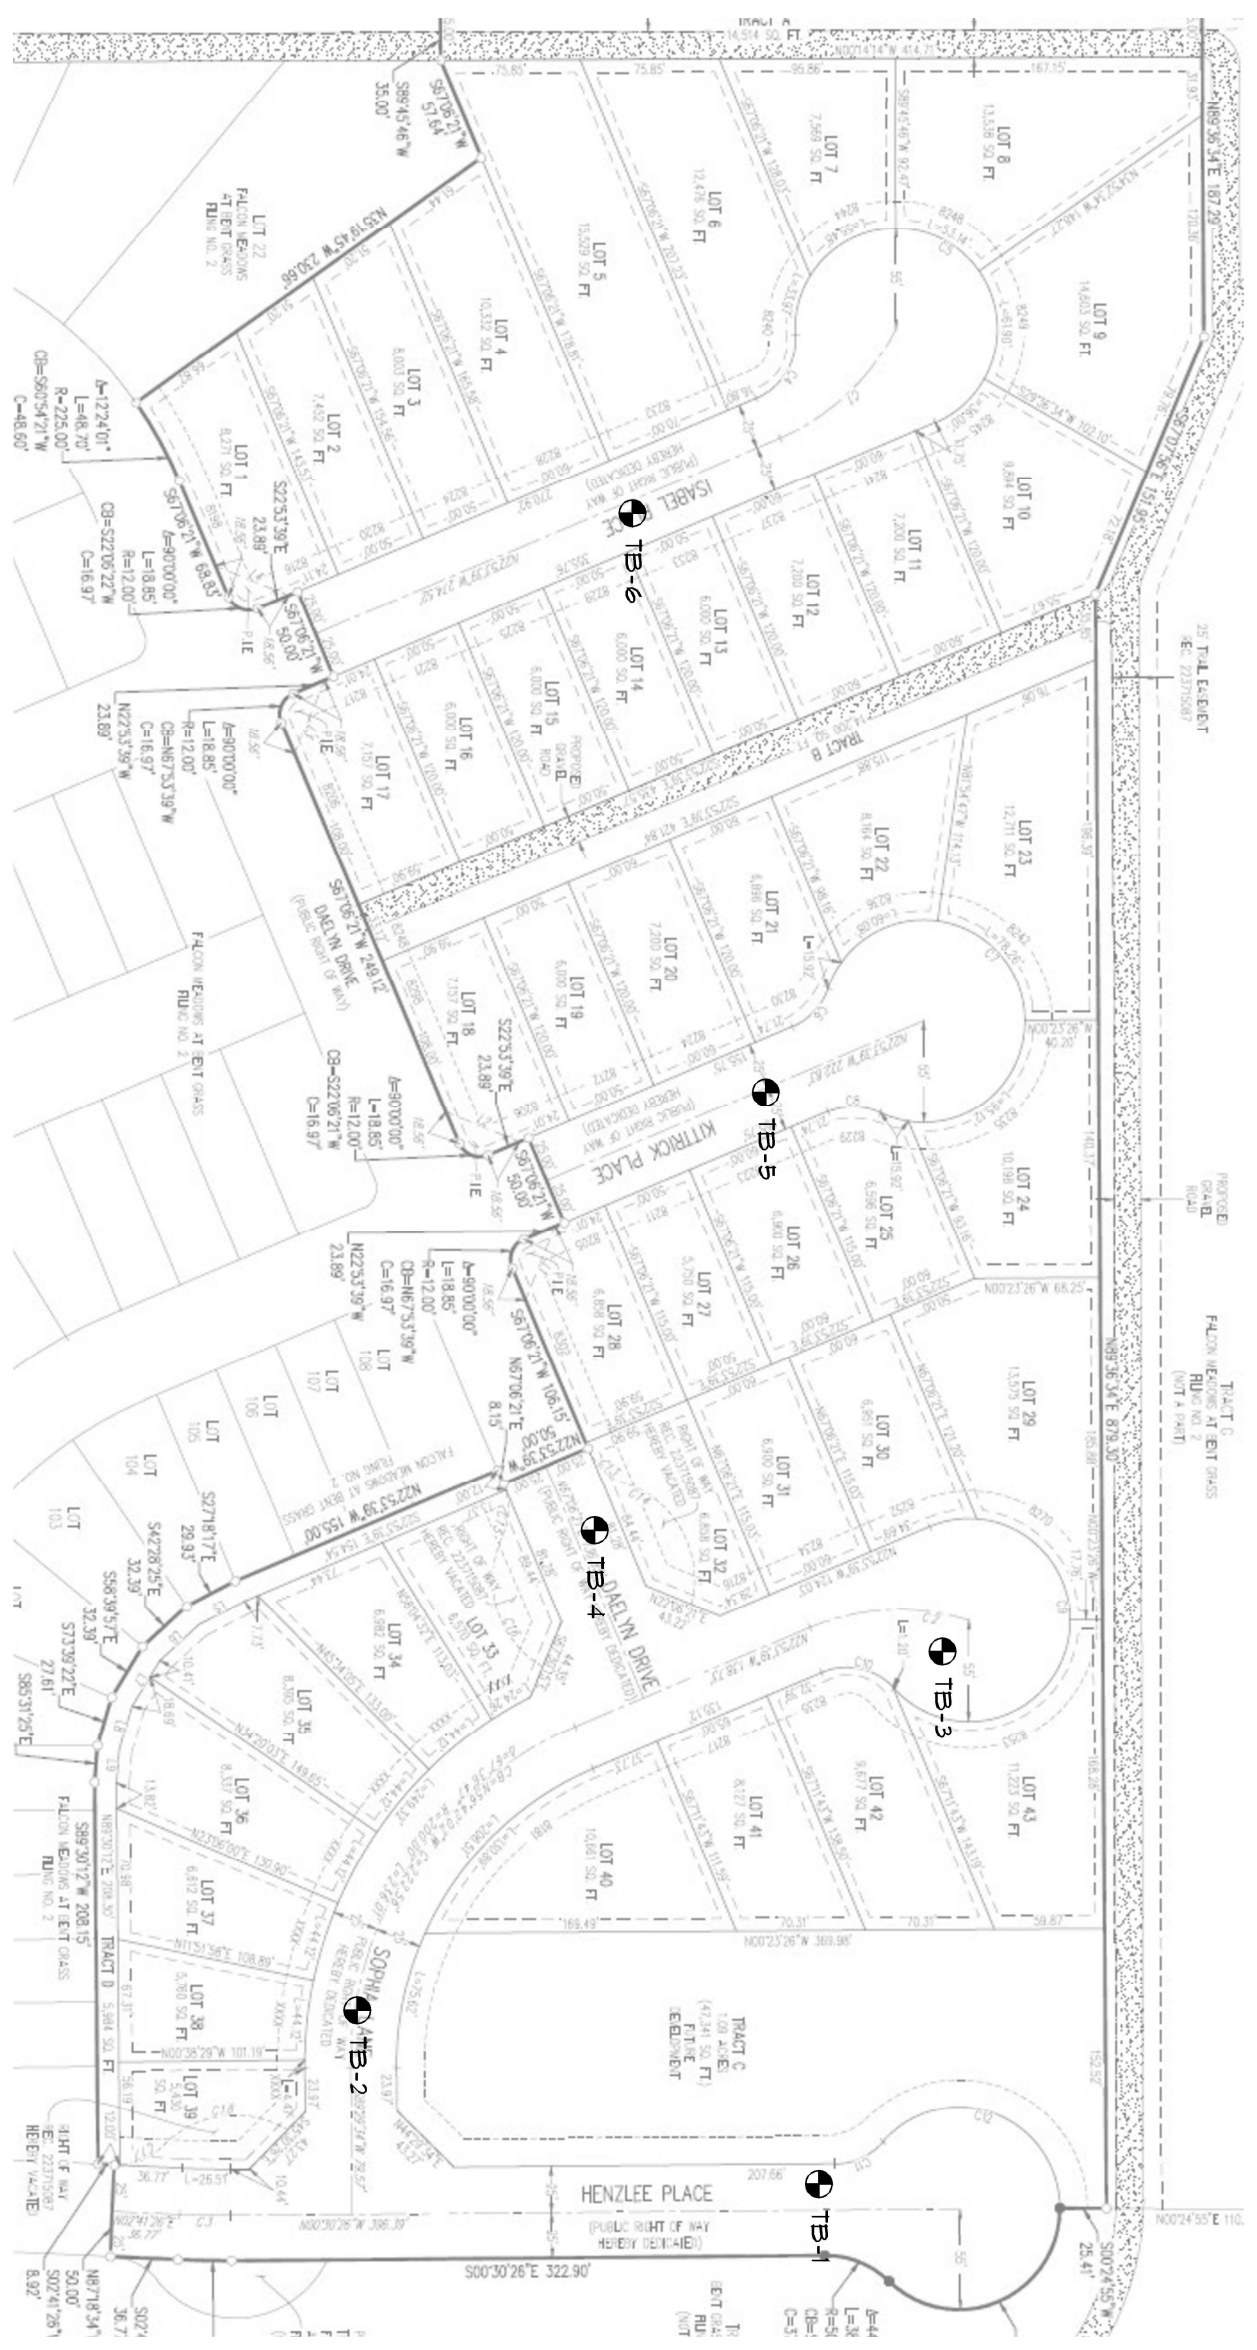
SHEET No.
FIG-2.1

TEST BORING
LOCATION PLAN

⊕ DENOTES LOTS WHERE TEST BORINGS WERE PERFORMED

The subsurface conditions on the site were investigated by drilling six exploratory test borings. The approximate locations of the test borings are presented in the Test Boring Location Plan, Figure 2.1.

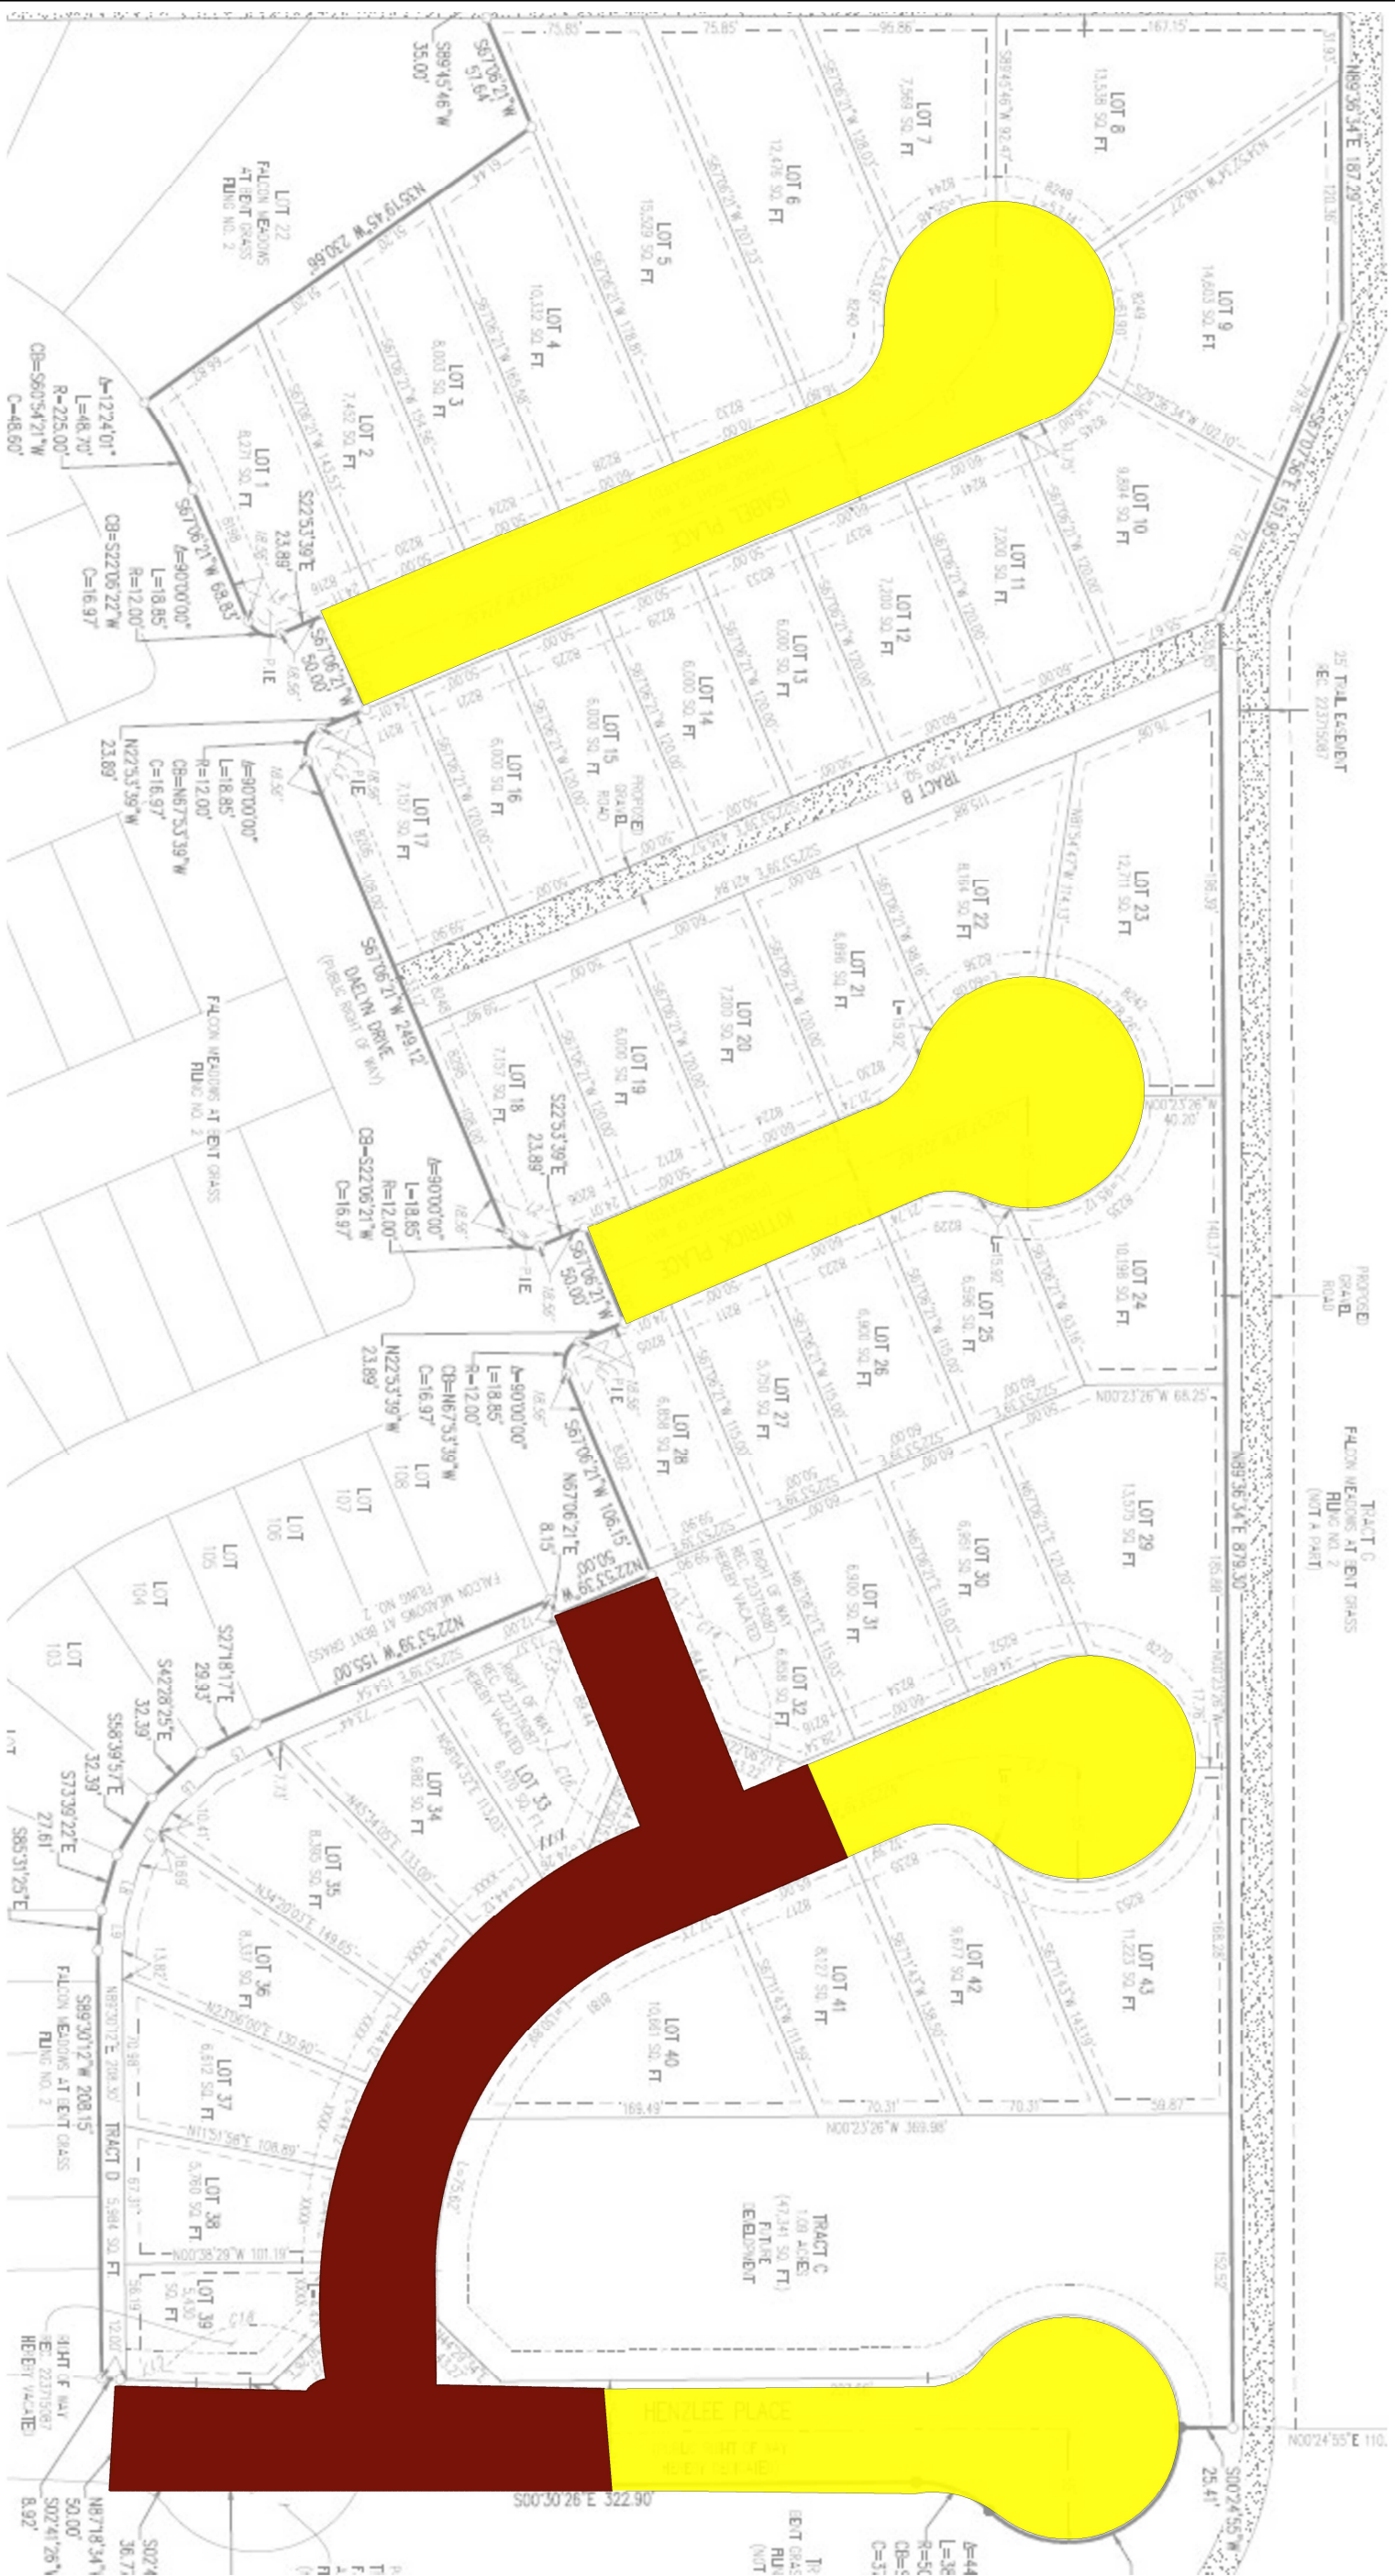
SHEET NO.
FIG-2.2

Urban Local low volume: 3" HMA
over 4" ABC

Urban Local: 3.5" HMA over 8"
ABC

PAVEMENT
RECOMMENDATIONS

Based on the design calculations, the recommended pavement sections are presented below and on Figure 2.2.

Street	Sample	Required SN	HMA (in.)	ABC (in.)	CTS (in.)	Calculated SN	OK
Isabel Place, Kittrick Place, Sophia Lane, and Henzlee Place	CBR-Proctor	0.745	3	4	0	1.76	Y
Sophia Lane, and Henzlee Place	CBR-Proctor	1.18	3.5	8	0	2.42	Y

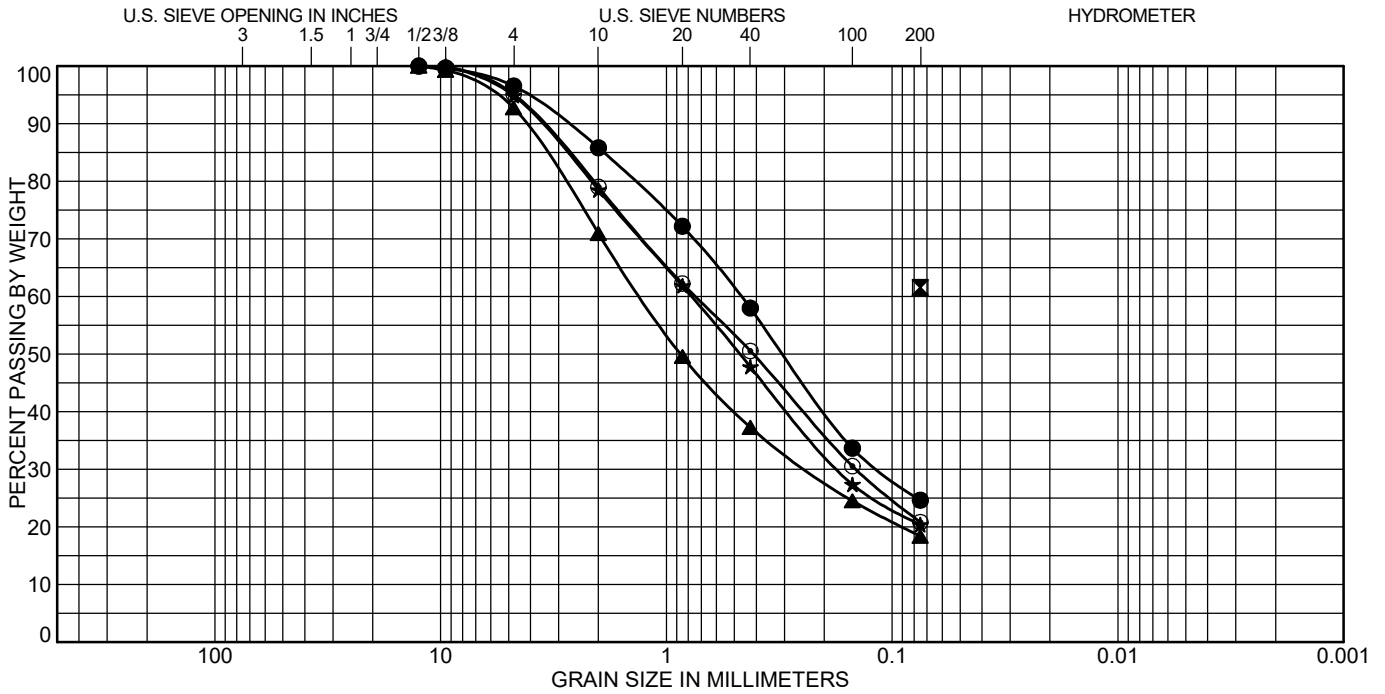
FIGURE No. 8

Test Boring	Depth (ft)	Classification	LL	PL	PI
● 1	0.0	SILTY SAND(SM)	NP	NP	NP
☒ 1	4.0	SANDY LEAN CLAY(CL)	37	19	18
▲ 2	0.0	SILTY SAND(SM)	NP	NP	NP
★ 3	0.0	SILTY SAND(SM)	NP	NP	NP
⊙ 4	0.0	SILTY SAND(SM)	NP	NP	NP

Test Boring	Depth (ft)	%Gravel	%Sand	%Silt	%Clay
● 1	0.0	3.5	71.9	24.6	
☒ 1	4.0			61.6	
▲ 2	0.0	7.3	74.4	18.4	
★ 3	0.0	5.1	74.5	20.4	
⊙ 4	0.0	4.9	74.3	20.8

SOIL CLASSIFICATION DATA

The moisture content for the recovered samples was obtained in the laboratory. Grain-size analysis and Atterberg Limits tests were performed on selected samples for purposes of classification and to develop pertinent engineering properties. A Summary of Laboratory Test Results is presented in Figure 7. Soil Classification Data are presented in Figures 8 and 9.

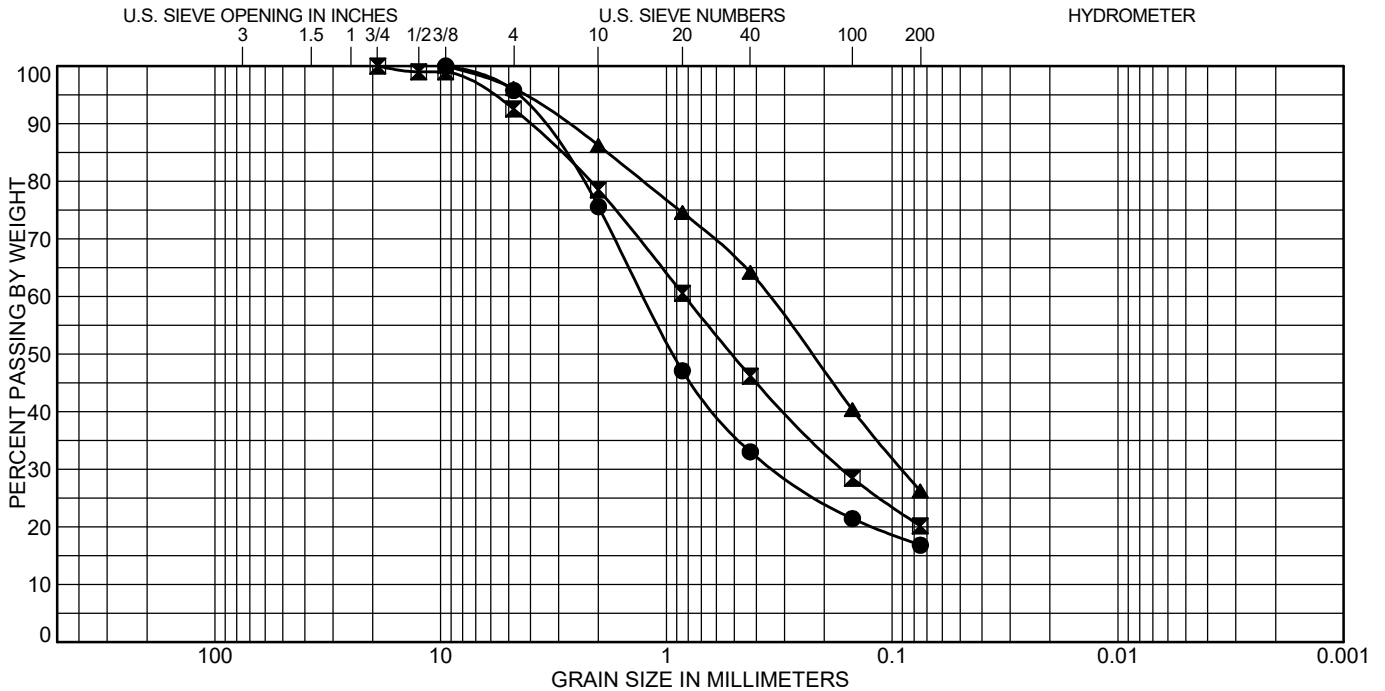
FIGURE No. 9

Test Boring	Depth (ft)	Classification	LL	PL	PI
● 4	2.0	SILTY SAND(SM)	NP	NP	NP
⊠ 5	0.0	SILTY SAND(SM)	NP	NP	NP
▲ 6	0.0	SILTY SAND(SM)	NP	NP	NP

Test Boring	Depth (ft)	%Gravel	%Sand	%Silt	%Clay
● 4	2.0	4.2	78.9	16.8	
⊠ 5	0.0	7.5	72.4	20.2	
▲ 6	0.0	3.9	69.8	26.2

SOIL CLASSIFICATION DATA

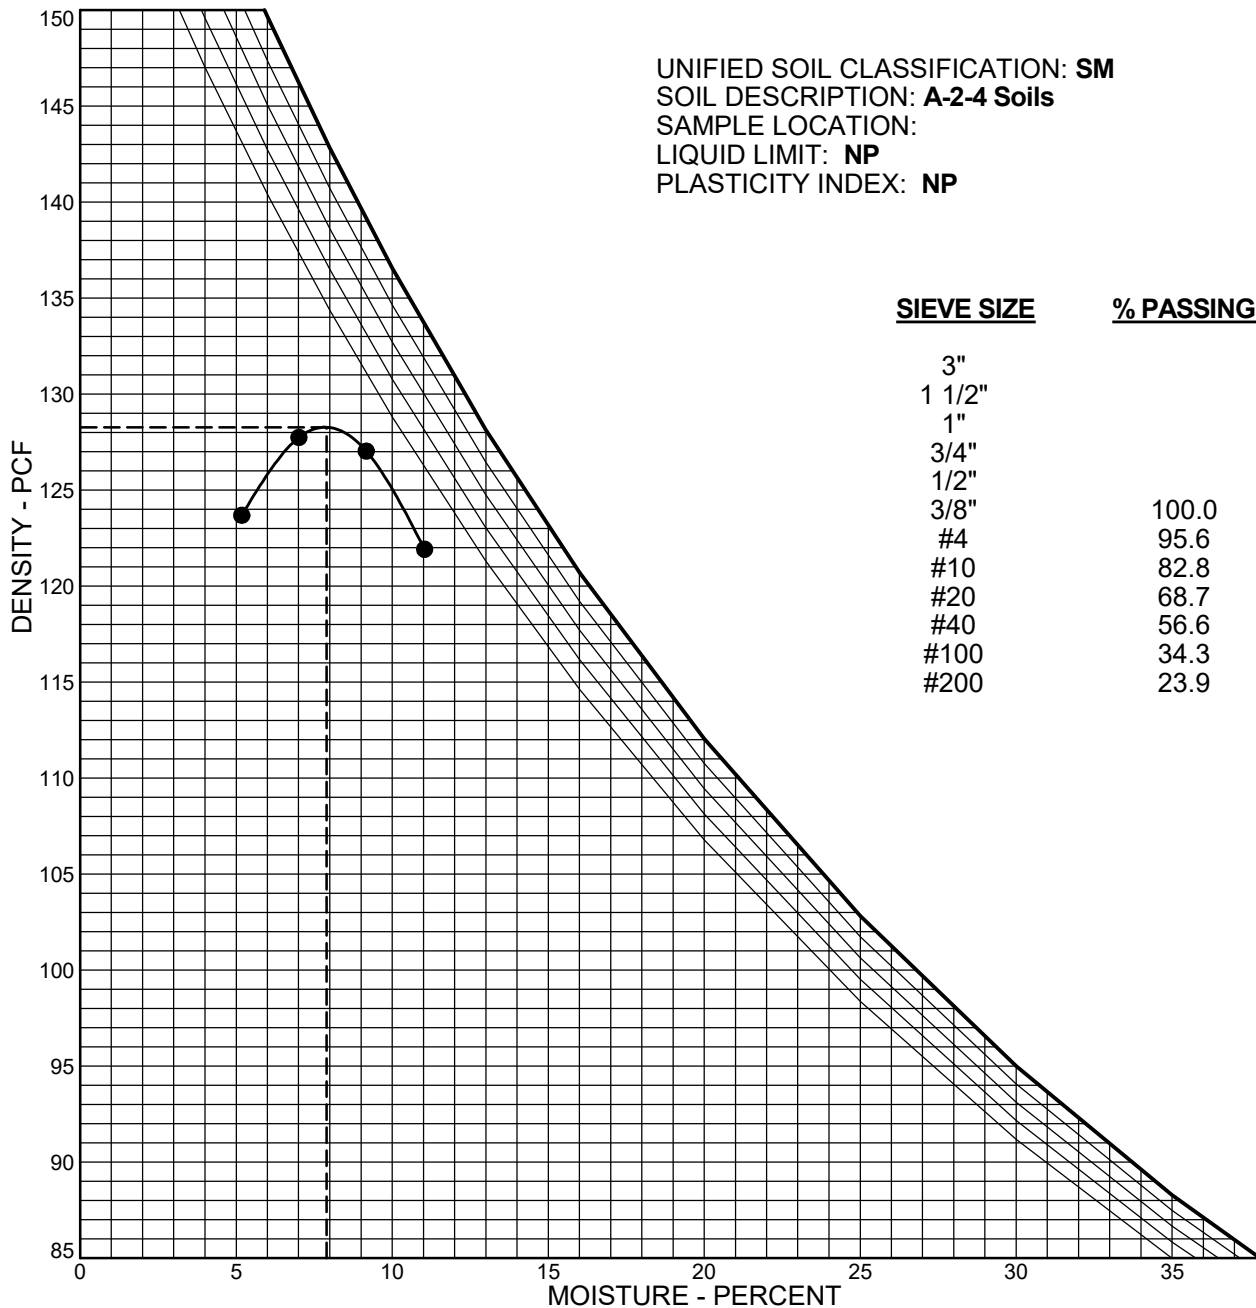
FIGURE No. 10

UNIFIED SOIL CLASSIFICATION: **SM**
SOIL DESCRIPTION: **A-2-4 Soils**
SAMPLE LOCATION:
LIQUID LIMIT: **NP**
PLASTICITY INDEX: **NP**

DESIGNATION **ASTM D-1557A**
MAX. DRY DENSITY **128.3 pcf**
OPTIMUM MOISTURE **7.9 %**
FRACTION USED **#4**
MOLD VOLUME **0.0333 cu.ft.**

NOTE: ZERO AIR VOIDS CURVES PLOTTED FOR:

- Gs = 2.60
- Gs = 2.65
- Gs = 2.70
- Gs = 2.75
- Gs = 2.80

MOISTURE-DENSITY RELATION CURVE

A composite bulk sample from the TB-1, TB-4, and TB-6 Test Borings, A-2-4 soil, was tested to determine its moisture-density relationship curve in accordance with ASTM D1557 (Modified Proctor compaction test). Maximum Dry Density proved to be 128.3 pcf at 7.9 percent moisture. A CBR test was performed at varying densities at moisture content near optimum. At 95% of the maximum Modified Proctor density, 121.9 pcf, the CBR of the bulk sample was 34.7.

A combined bulk sample of A-2-4 soil was tested to determine the optimum moisture-density relationship in accordance with ASTM D-1557 (Standard Proctor compaction test). California Bearing Ratio, CBR tests were performed at varying densities with moisture content near optimum. At 95% of the maximum Standard Proctor density, the CBR of the bulk sample was 34.7. The Moisture-Density Relation Curve is presented in Figure 10. The CBR Test Results are presented in Figures 11 and 12.

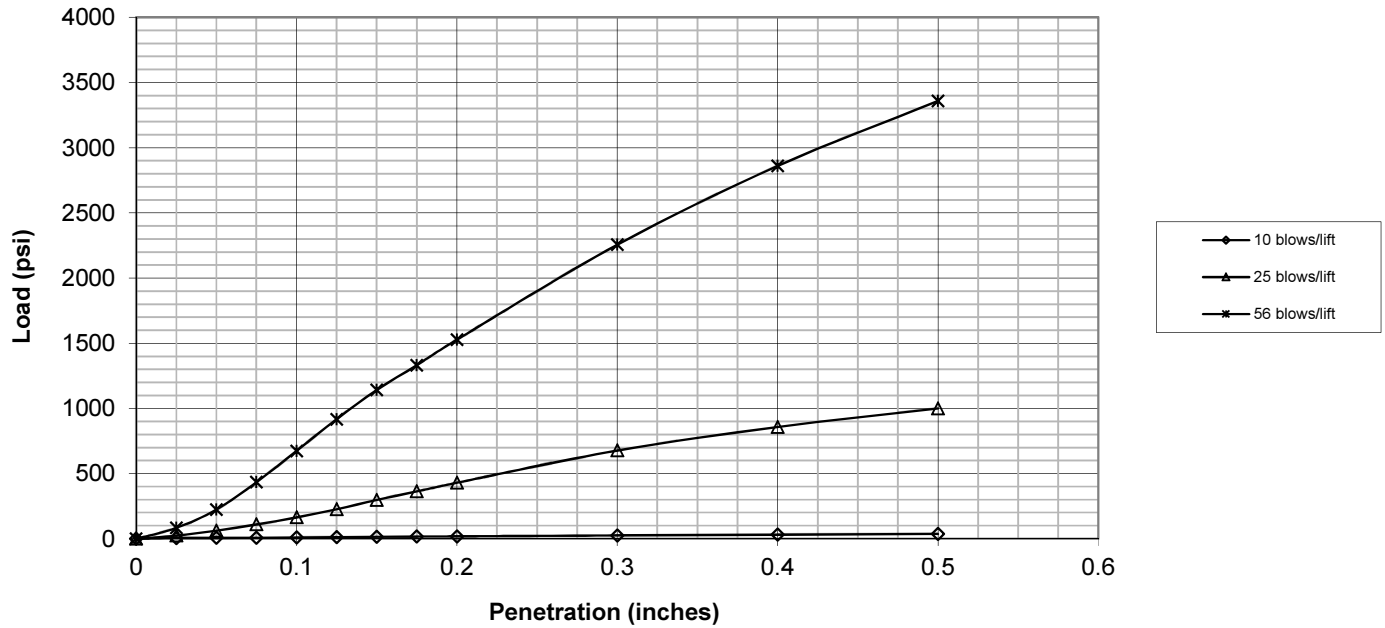
Figure No. 11

CALIFORNIA BEARING RATIO TEST RESULTS

Project: Falcon Meadows at Bent Grass, Filing No. 3
 Job No.: 195343
 AASHTO Classification: A-2-4
 Sample Number: CBR
 Sample Location: Combined Bulk Sample
 Soil Description: Silty Sand

Penetration (in)	10 blows/lift	25 blows/lift	56 blows/lift
	Load (psi)	Load (psi)	Load (psi)
0.000	0.0	0.0	0.0
0.025	6.0	23.9	83.3
0.050	6.7	62.1	224.1
0.075	7.7	109.5	434.0
0.100	9.4	163.6	673.5
0.125	11.8	225.7	917.1
0.150	14.4	297.6	1141.2
0.175	16.8	362.8	1331.6
0.200	18.5	429.7	1527.2
0.300	25.5	676.6	2255.5
0.400	31.2	857.6	2859.8
0.500	36.6	999.1	3359.3

Corrected Penetration (in)	Corrected Load (psi)
10 blows/lift	0.100	0.9
25 blows/lift	0.100	16.4
56 blows/lift	0.100	67.4

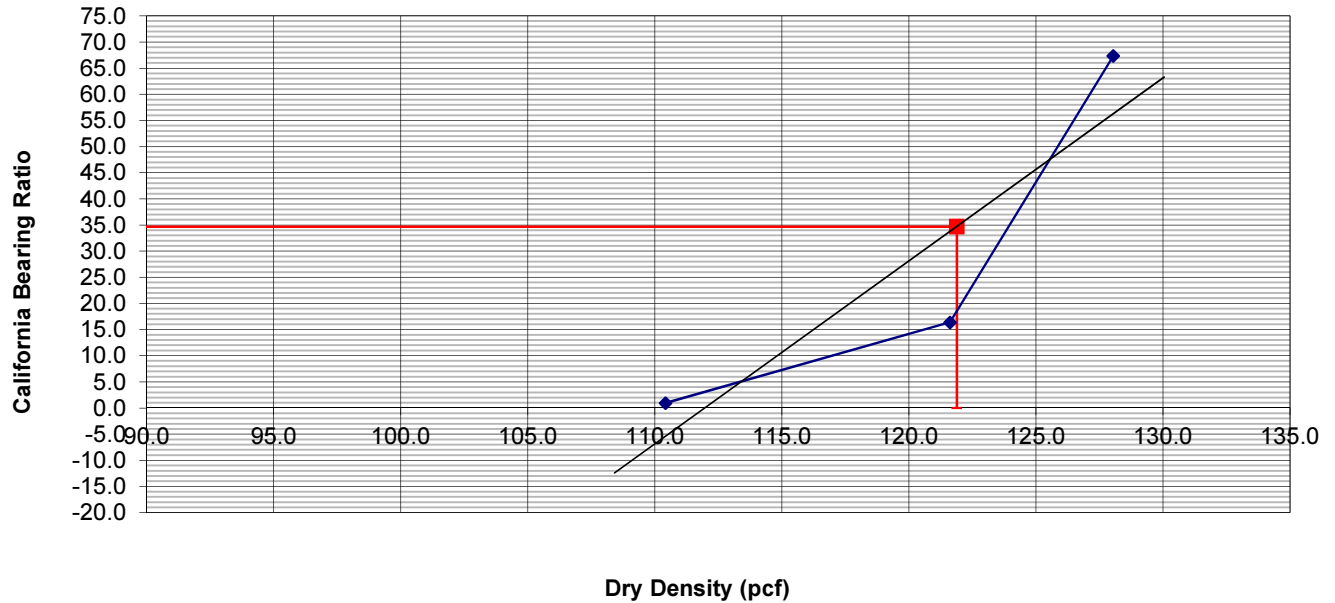
Figure No. 12

CALIFORNIA BEARING RATIO TEST RESULTS

10 blows/lift	25 blows/lift	56 blows/lift
Corrected California Bearing Ratio	0.9	16.4	67.4
Dry Density (pcf)	110.4	121.6	128.0
Percent Compaction	86	95	100
Percent Moisture After Soaking	14.0	12.2	10.6
Percent Expansion (+) / Compression (-)	0.1%	-0.1%	0.0%
Surcharge Weight (lbs)	12.60	12.60	12.60

California Bearing Ratio	34.7
Dry Density (pcf)	128.3
Percent Compaction	95%
Target Dry Density	121.9
Compaction Test Method	ASTM D-1557A
Condition of sample	Soaked

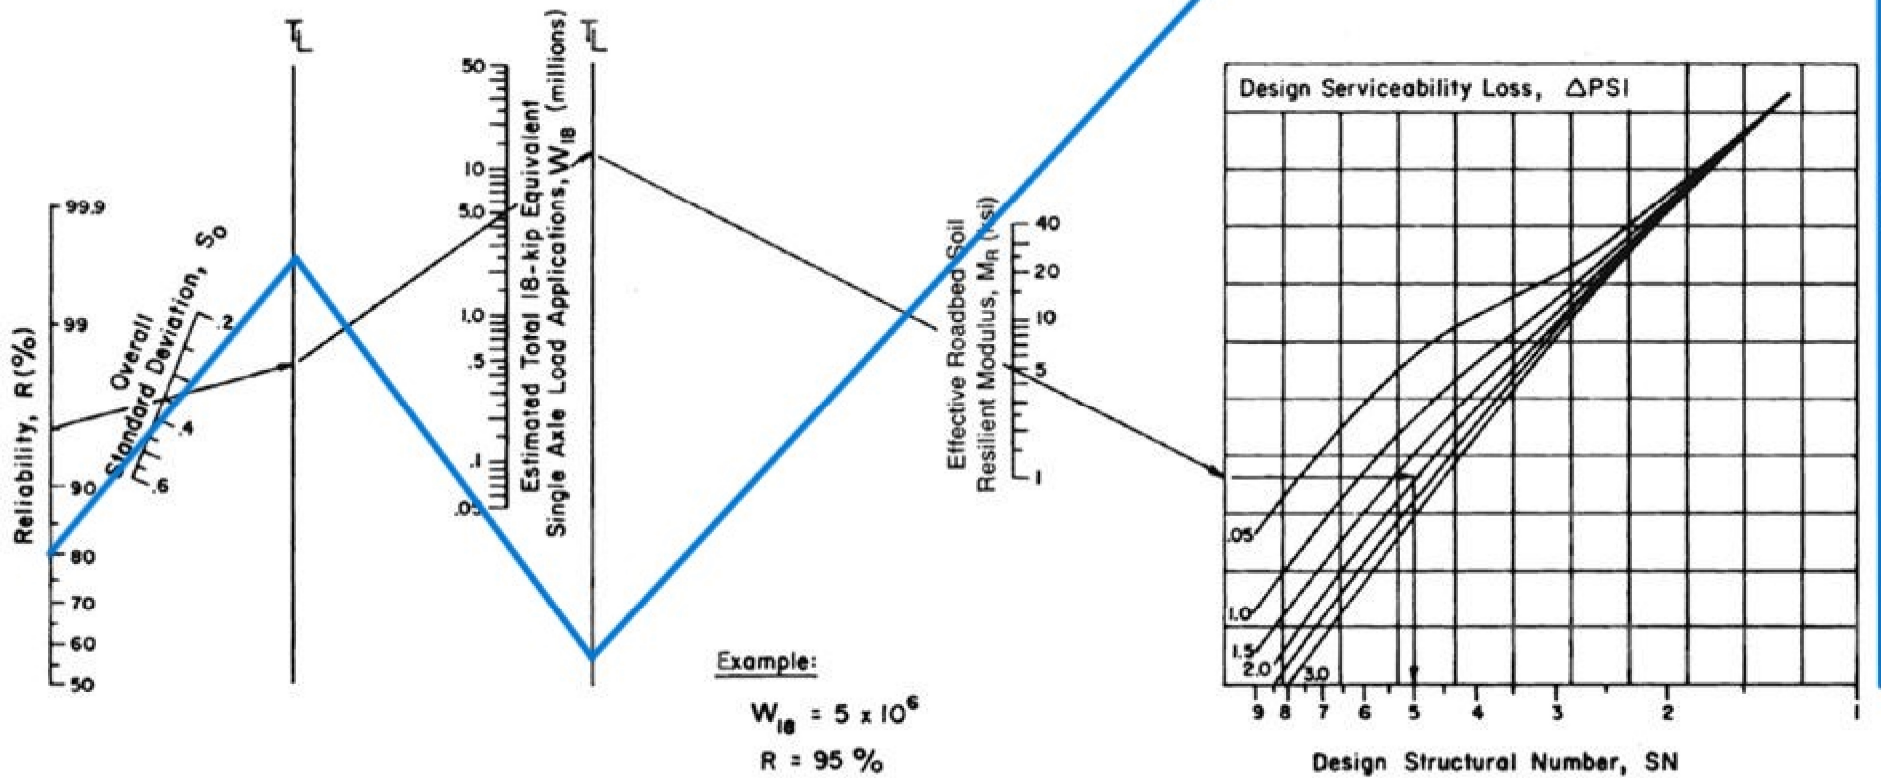
Figure D-1. Flexible Pavement Nomograph

NOMOGRAPH SOLVES:

$$\log_{10} W_{18} = Z_R * S_o + 9.36 * \log_{10}(SN+1) - 0.20 + \frac{\log_{10} \left[\frac{\Delta \text{PSI}}{4.2 - 1.5} \right]}{0.40 + \frac{1094}{(SN+1)^{5.19}}} + 2.32 * \log_{10} M_R - 8.07$$

Example:

$W_{18} = 5 \times 10^6$

$R = 95 \%$

$S_o = 0.35$

$M_R = 5000 \text{ psi}$

$\Delta \text{PSI} = 1.9$

Solution: $SN = 5.0$

- 3) Subgrade
 $M_r = \text{CBR} \times 1500 = 34.7 \times 1500 = 52,050 \text{ psi}$
- 4) Structural number (SN) = 1.18 (per 1993 AASHTO Empirical Equation for Flexible Pavements, presented in Appendix A)

4) Structural number (SN) = 0.745 (per 1993 AASHTO Empirical Equation for Flexible Pavements, presented in Appendix A)

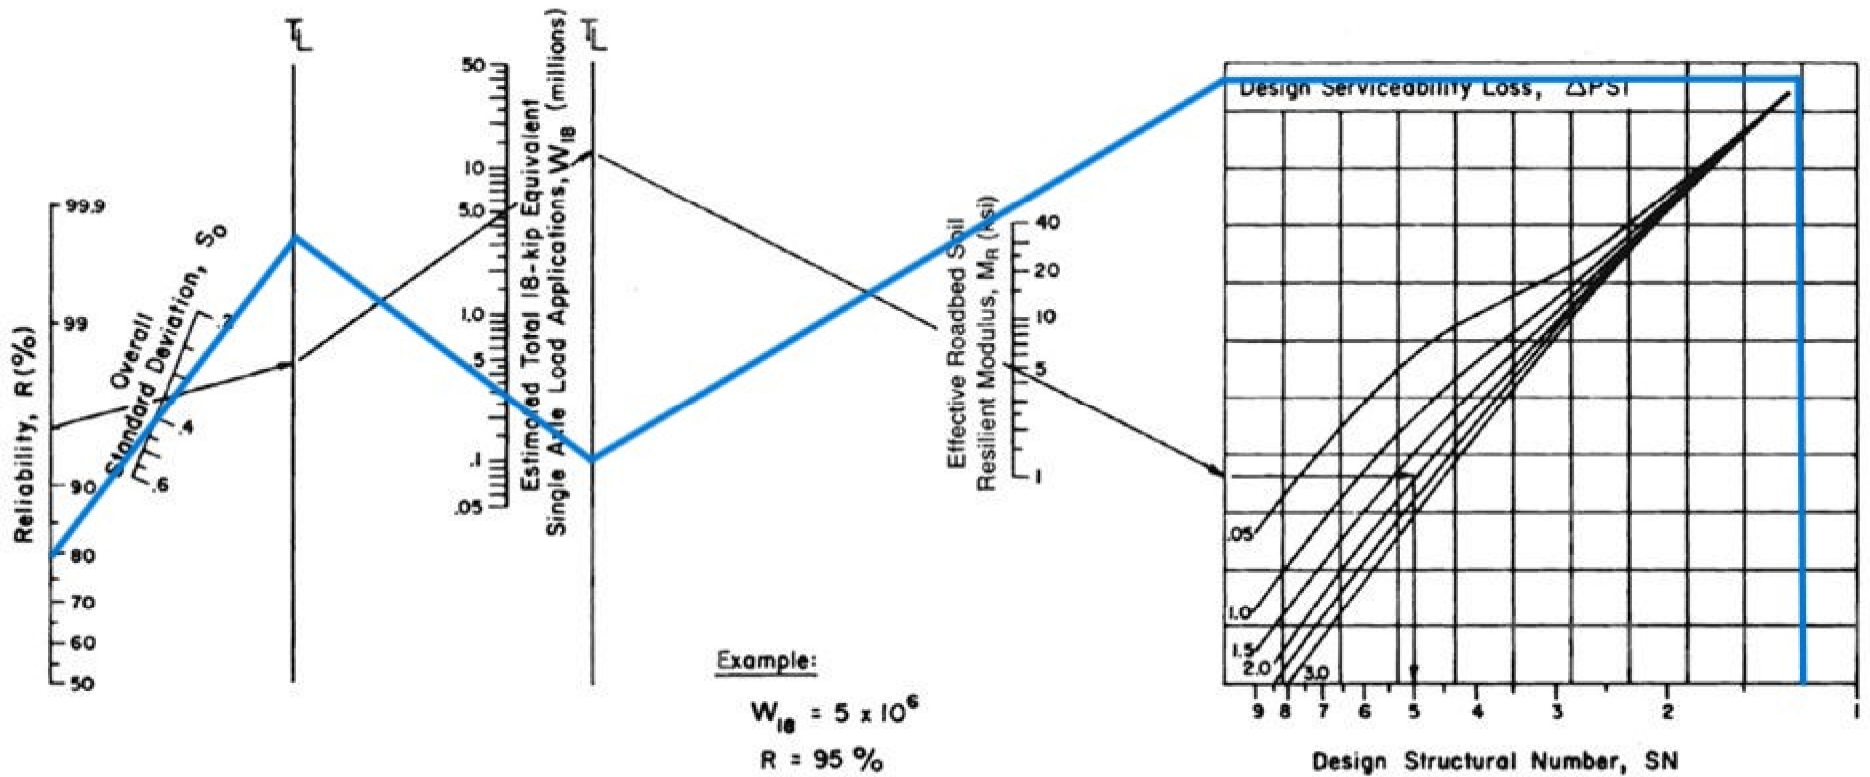
NOMOGRAPH SOLVES:

$$\log_{10} W_{18} = Z_R * S_o + 9.36 * \log_{10}(SN+1) - 0.20 + \frac{\log_{10} \left[\frac{\Delta \text{PSI}}{4.2 - 1.5} \right]}{0.40 + \frac{1094}{(SN+1)^{5.19}}} + 2.32 * \log_{10} M_R - 8.07$$

Example:
 $W_{18} = 5 \times 10^6$
 $R = 95 \%$
 $S_o = 0.35$
 $M_R = 5000 \text{ psi}$
 $\Delta \text{PSI} = 1.9$
 Solution: $SN = 5.0$
