SOIL AND GEOLOGY STUDY

**Davis Subdivision
6 parcels totaling 398.91 acres
EL Paso County, Colorado**

JOB NO. 190392

April 27, 2023

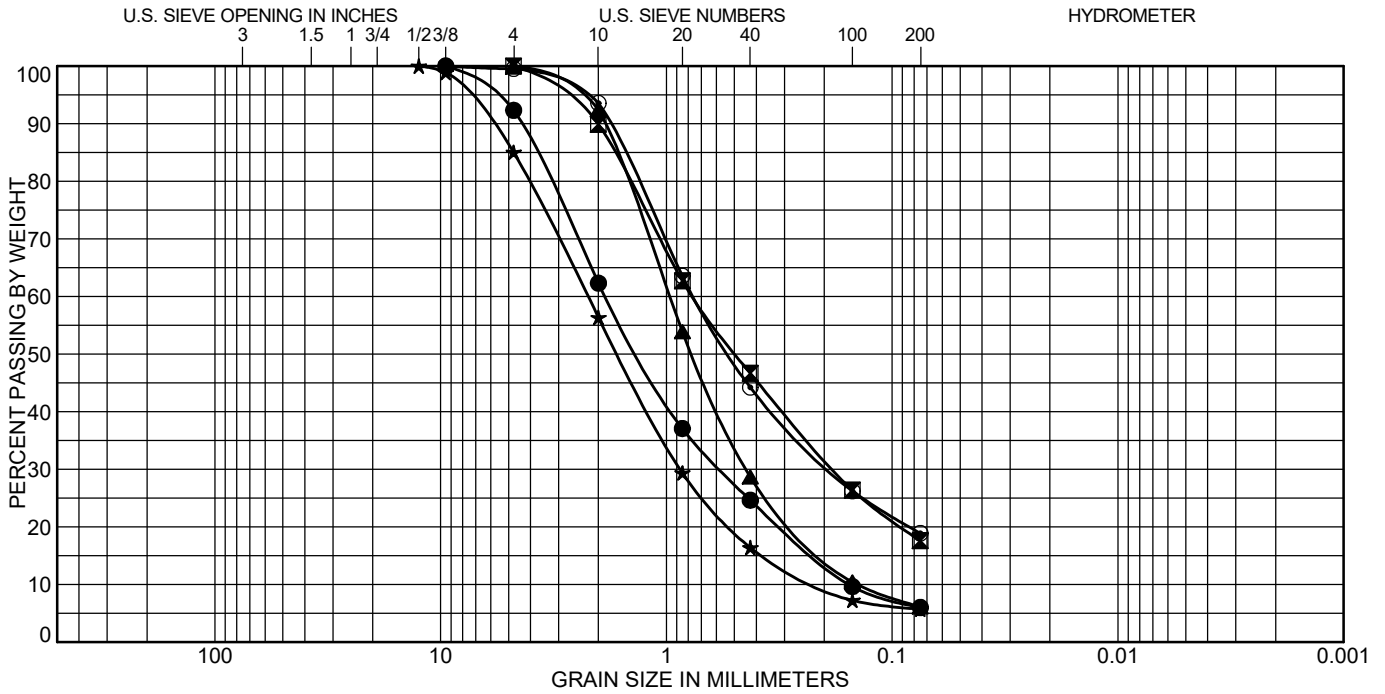
FIGURE No. 18

Test Boring	Depth (ft)	Classification	LL	PL	PI
● 1	7.0	WELL-GRADED SAND with SILT(SW-SM)	NP	NP	NP
☒ 1	24.0	SILTY SAND(SM)	NP	NP	NP
▲ 2	4.0	WELL-GRADED SAND with SILT(SW-SM)	NP	NP	NP
★ 3	9.0	WELL-GRADED SAND with SILT(SW-SM)	NP	NP	NP
⊙ 4	14.0	SILTY SAND(SM)	NP	NP	NP

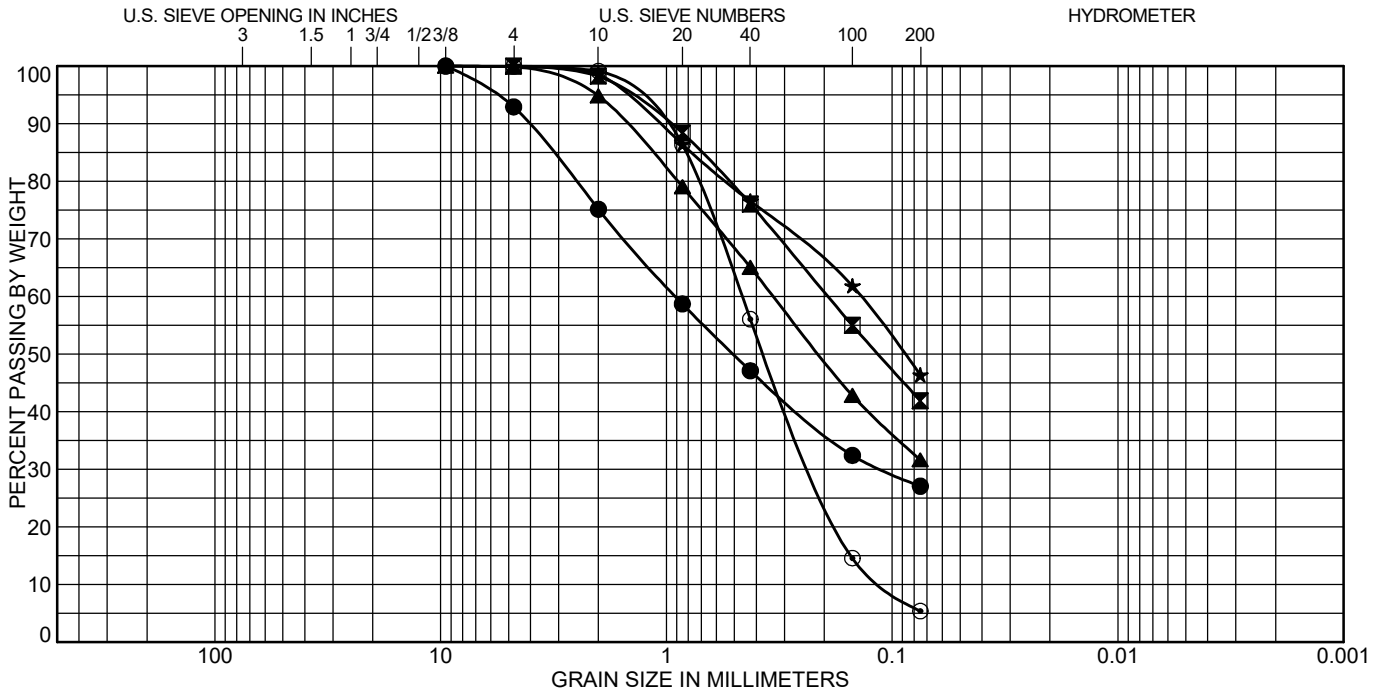
FIGURE No. 20

Test Boring	Depth (ft)	Classification	LL	PL	PI
● 10	4.0				
☒ 11	7.0	CLAYEY SAND(SC)	44	16	28
▲ 11	29.0	CLAYEY SAND(SC)	32	13	19
★ 12	14.0	SILTY SAND(SM)	NP	NP	NP
⊙ 13	2.0	POORLY GRADED SAND with SILT(SP-SM)	NP	NP	NP

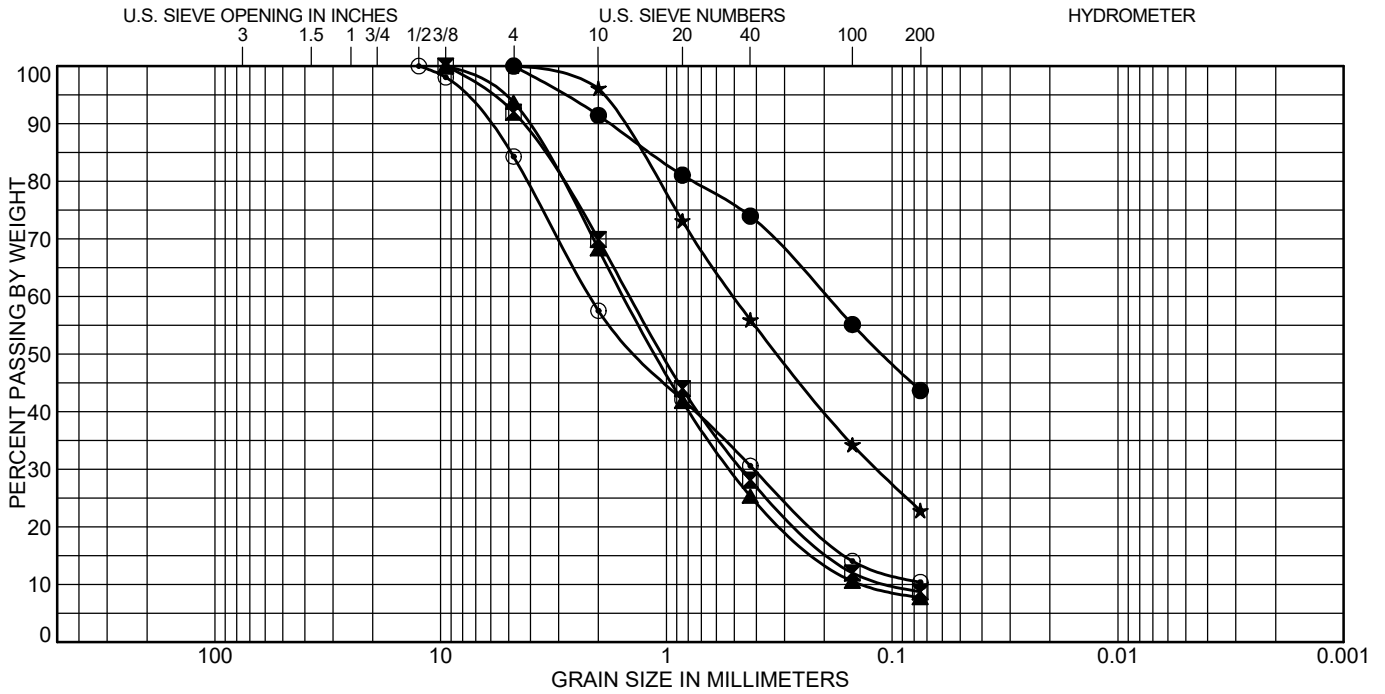
FIGURE No. 21

Test Boring	Depth (ft)	Classification	LL	PL	PI
● 14	9.0	CLAYEY SAND(SC)	27	11	16
⊠ 15	7.0	WELL-GRADED SAND with SILT(SW-SM)	NP	NP	NP
▲ 16	4.0	WELL-GRADED SAND with SILT(SW-SM)	NP	NP	NP
★ 16	24.0	SILTY SAND(SM)	NP	NP	NP
⊙ 17	2.0	WELL-GRADED SAND with SILT and GRAVEL(SW-SM)	NP	NP	NP

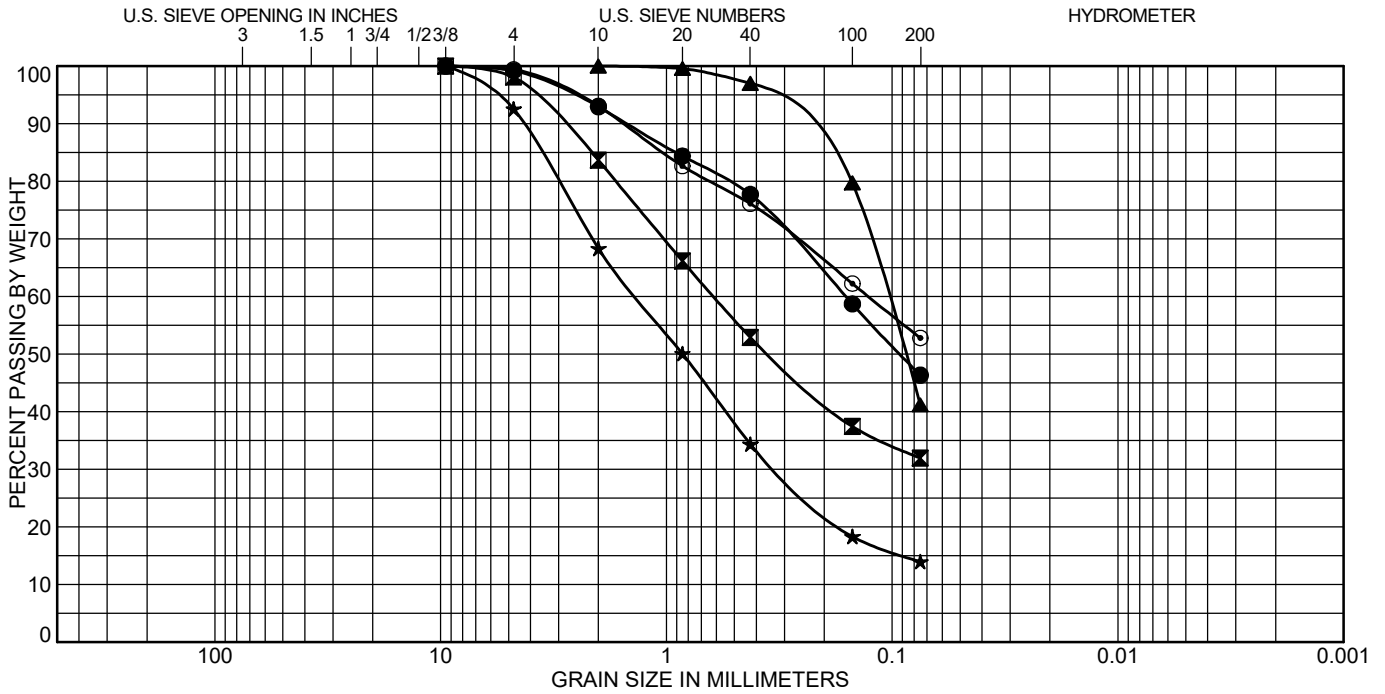
FIGURE No. 22

Test Boring	Depth (ft)	Classification	LL	PL	PI
● 18	9.0	CLAYEY SAND(SC)	34	14	20
☒ 19	7.0	CLAYEY SAND(SC)	27	14	13
▲ 20	4.0				
★ 21	7.0	SILTY SAND(SM)	NP	NP	NP
⊙ 22	9.0	SANDY LEAN CLAY(CL)	30	16	14

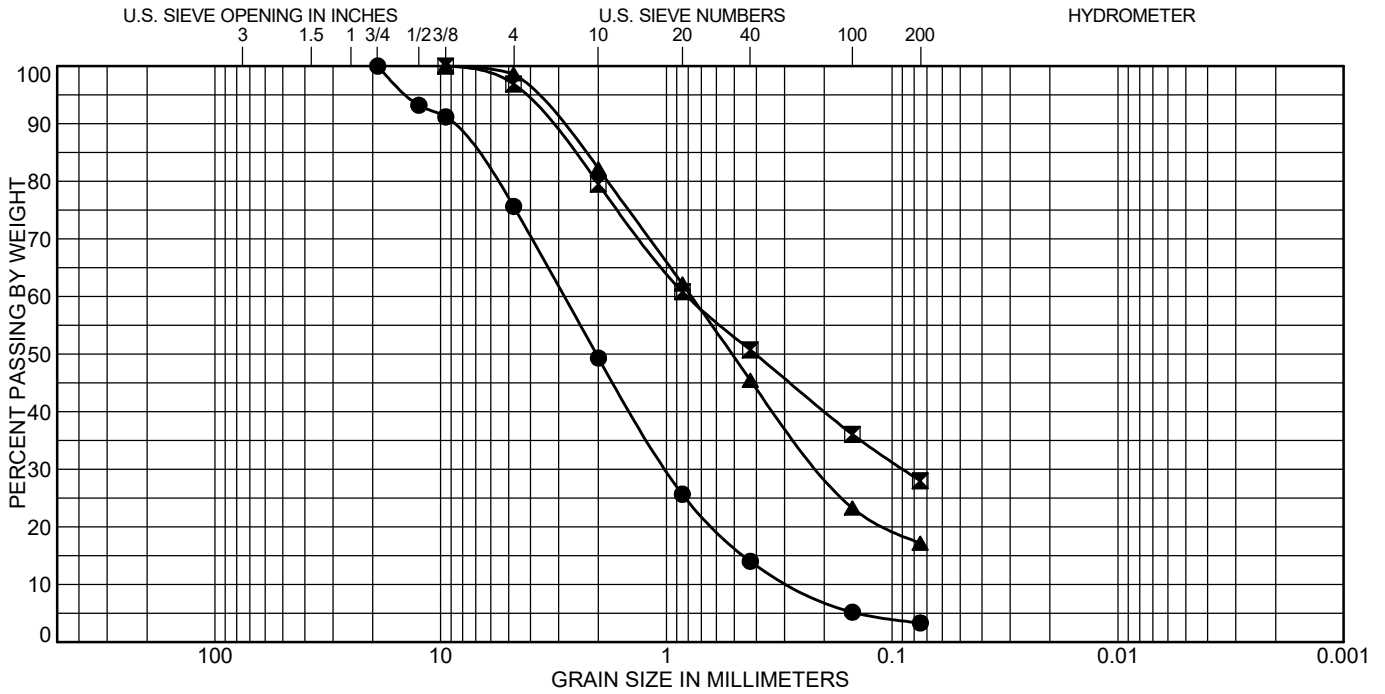
FIGURE No. 23

Test Boring	Depth (ft)	Classification	LL	PL	PI
● 23	7.0	WELL-GRADED SAND with GRAVEL(SW)	NP	NP	NP
☒ 24	9.0	CLAYEY SAND(SC)	35	14	21
▲ 24	24.0	SILTY SAND(SM)	NP	NP	NP

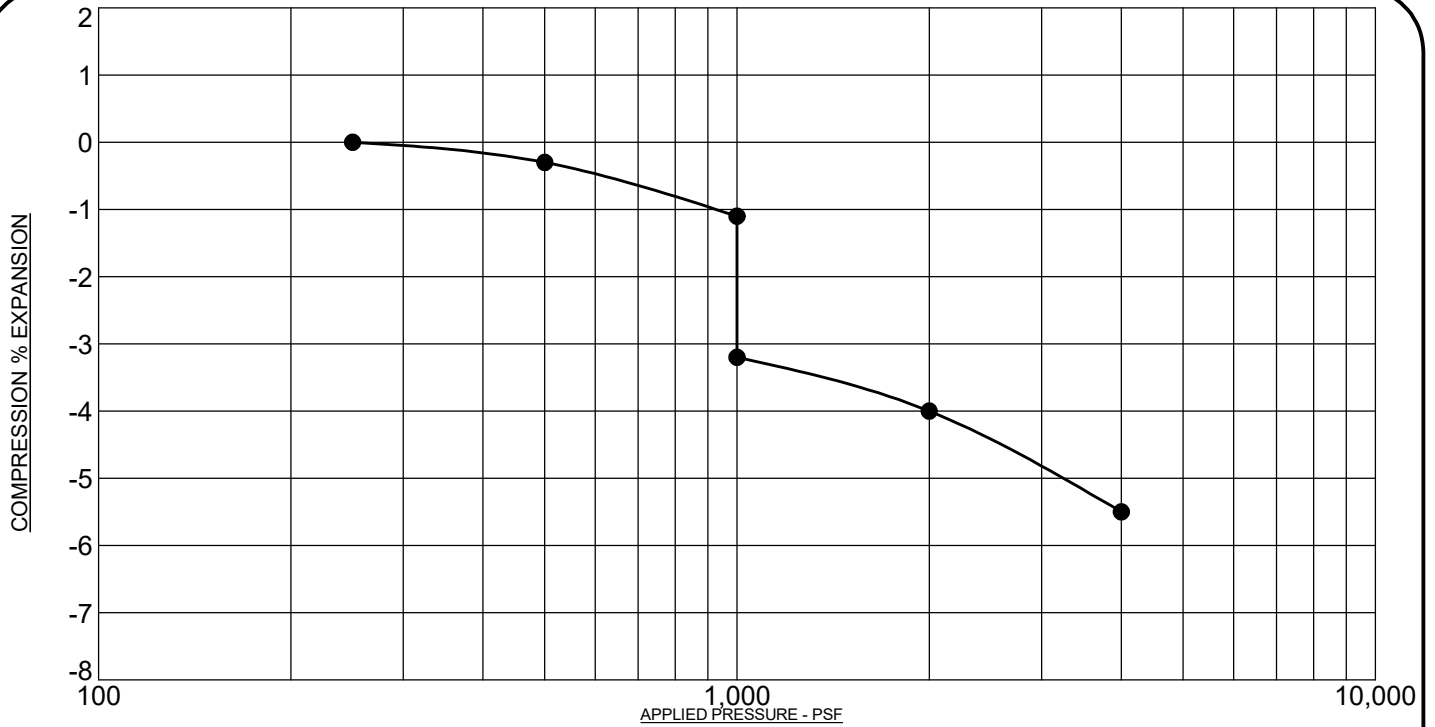
FIGURE No. 24

PROJECT: Judge Orr Rd, Davis Sub, El Paso County, Colorado
 SAMPLE DESCRIPTION: SAND, CLAYEY
 NOTE: SAMPLE WAS INUNDATED WITH WATER AT 1,000 PSF

SAMPLE LOCATION: 9 @ 7 FT
 NATURAL DRY UNIT WEIGHT: 115.7 PCF
 NATURAL MOISTURE CONTENT: 12.1%
 PERCENT SWELL/COMPRESSION: - 2.1

Soil laboratory testing was performed as part of this investigation. The laboratory tests included moisture content, grain-size analyses, Atterberg Limit tests and one swell test. A Summary of Laboratory Test Results is presented in Figure 17. Soils Classification Data is presented in Figures 18 through 23. The Swell/Consolidation Test Results are presented in Figure 24.

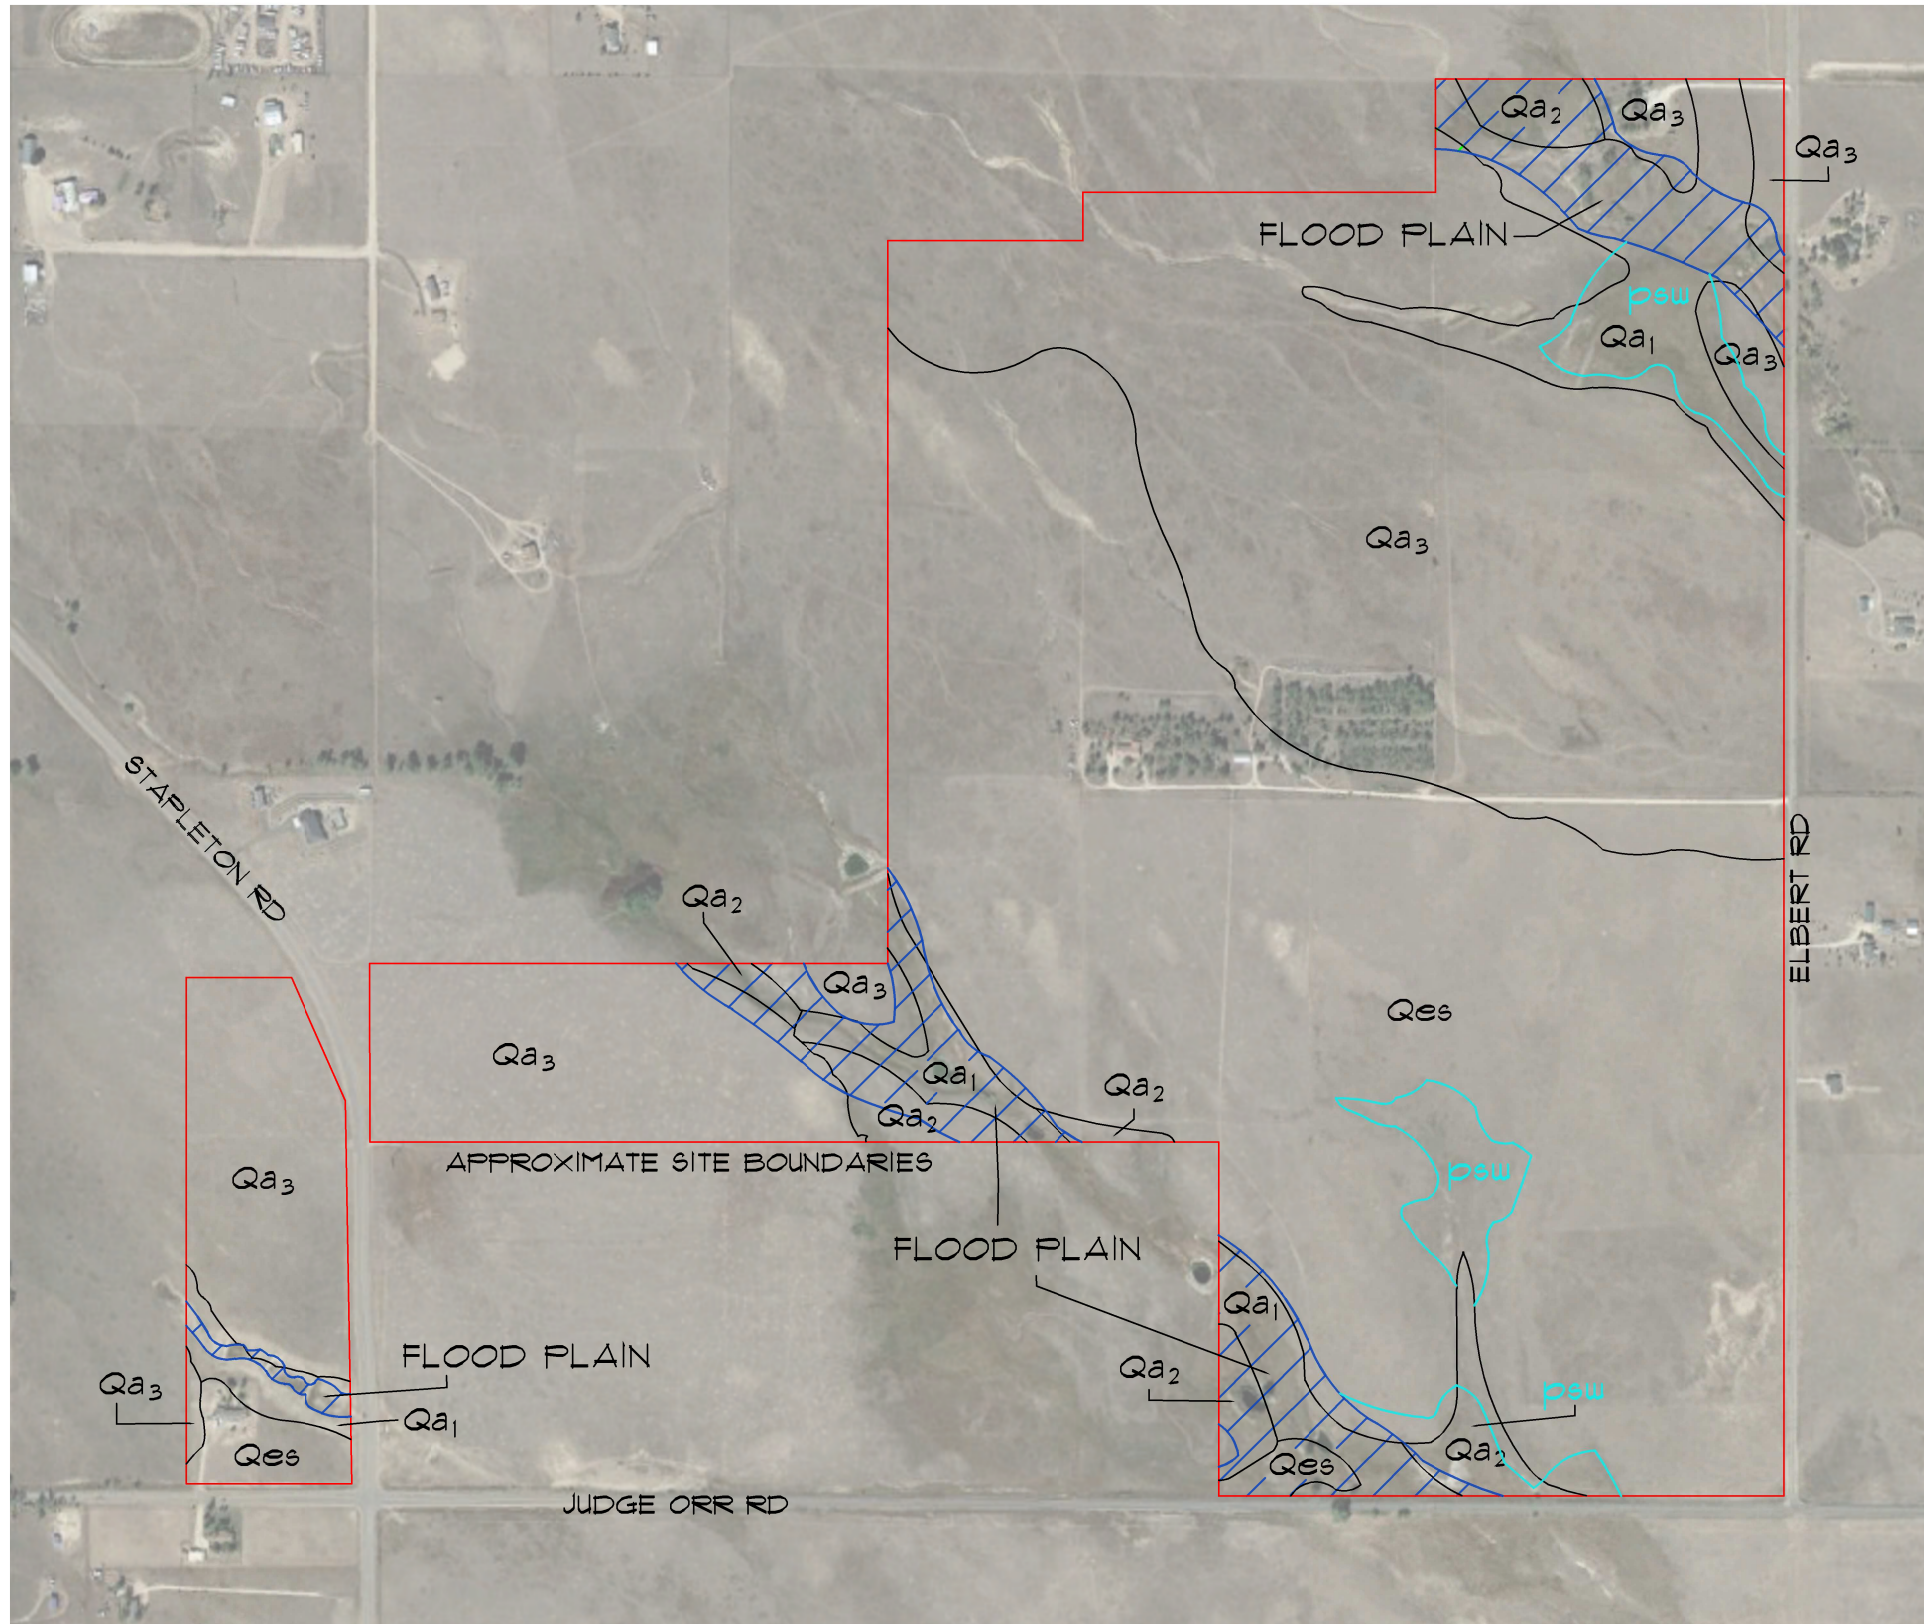
GEOLOGIC CONDITIONS

Qes - Eolian Sand (Holocene to upper Pleistocene) Fine to coarse grained sand. Unit is faintly stratified, non-cohesive, and drains well. Unit may exceed 5 feet in thickness

Based on our field observations and review of relevant geologic maps, we identified the geologic conditions (listed below) affecting the development, as shown on the Engineering Geology Map, Figure 26.

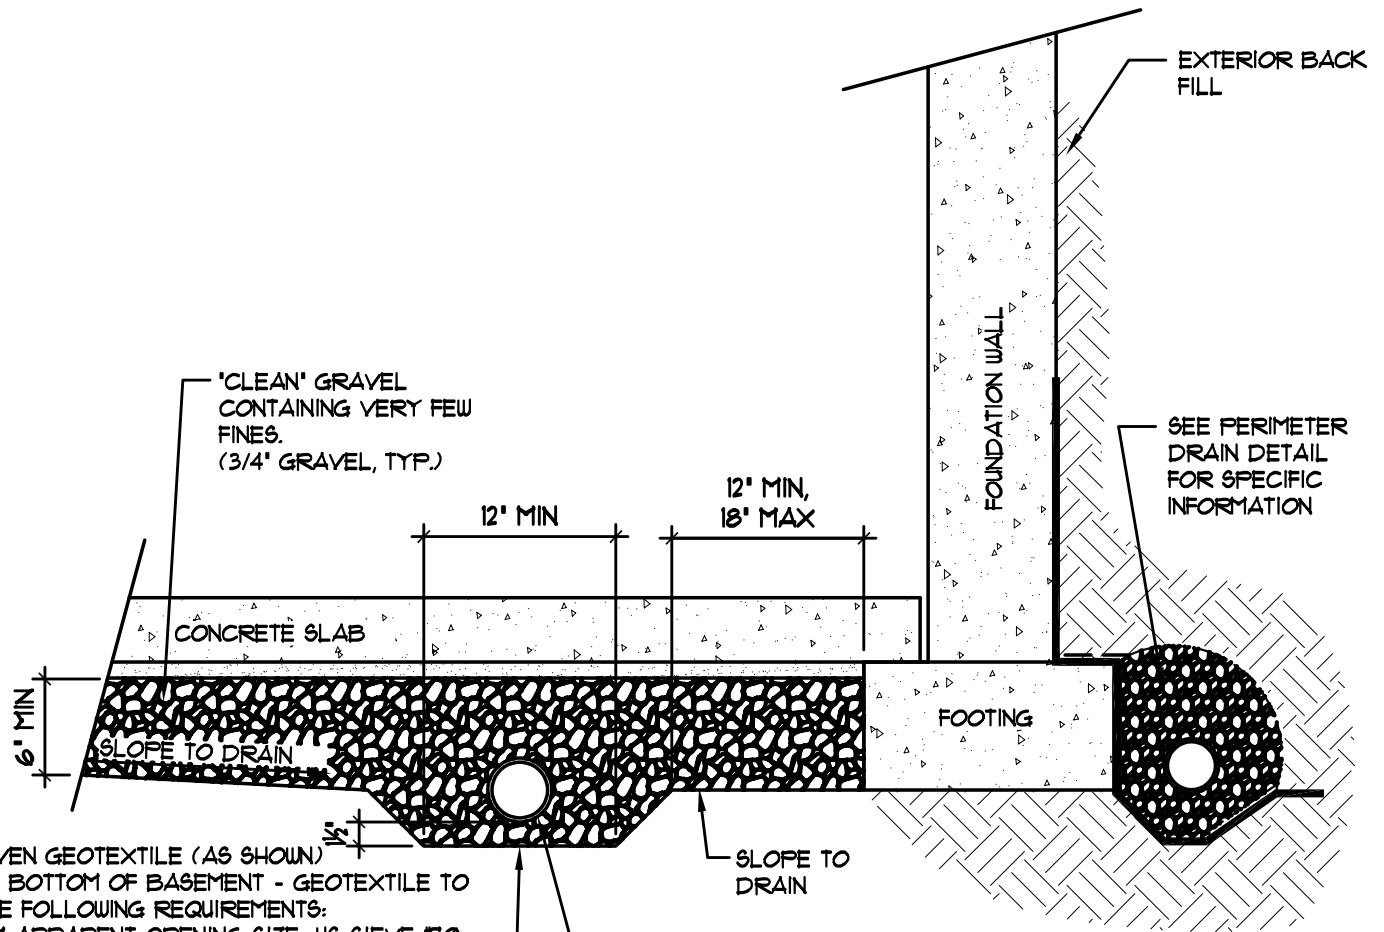
NON-WOVEN GEOTEXTILE (AS SHOWN) ACROSS BOTTOM OF BASEMENT - GEOTEXTILE TO MEET THE FOLLOWING REQUIREMENTS:
 MAXIMUM APPARENT OPENING SIZE: US SIEVE #10
 MINIMUM WATER FLOW RATE: 135 GAL/MIN/FT²
 MINIMUM TRAPEZOIDAL TEAR STRENGTH: 40 lbs
 MINIMUM CBR PUNCTURE STRENGTH: 250 lbs
 MINIMUM GRAB TENSILE STRENGTH: 90 lbs

3' DIAMETER RIGID PERFORATED PIPE CONNECTED TO A SUITABLE GRAVITY OUTFALL SUCH AS AN UNDERDRAIN LOCATED IN THE UTILITY TRENCH IN THE STREET WITH A MIN. GRADE OF PIPE = 15%. IF A FREE GRAVITY OUTFALL CANNOT BE ACHIEVED, A SUMP PIT AND PUMP SHOULD BE PROVIDED.

The feasibility of basement construction should be evaluated prior to the site-specific Subsurface Soil Investigation for each lot. Seasonal variations in underground water conditions are expected due to the unnamed drainageway. It is assumed underground water beneath the subject site predominates in fractured weathered consolidated sedimentary bedrock located at depth. If shallow underground water conditions are encountered during the site-specific Subsurface Soil Investigations and/or Open Excavation Observations, mitigations may include restricting basement construction, raising the grade of the residence and/or a combination of surface and subsurface drainage systems, vertical drainboard, etc.

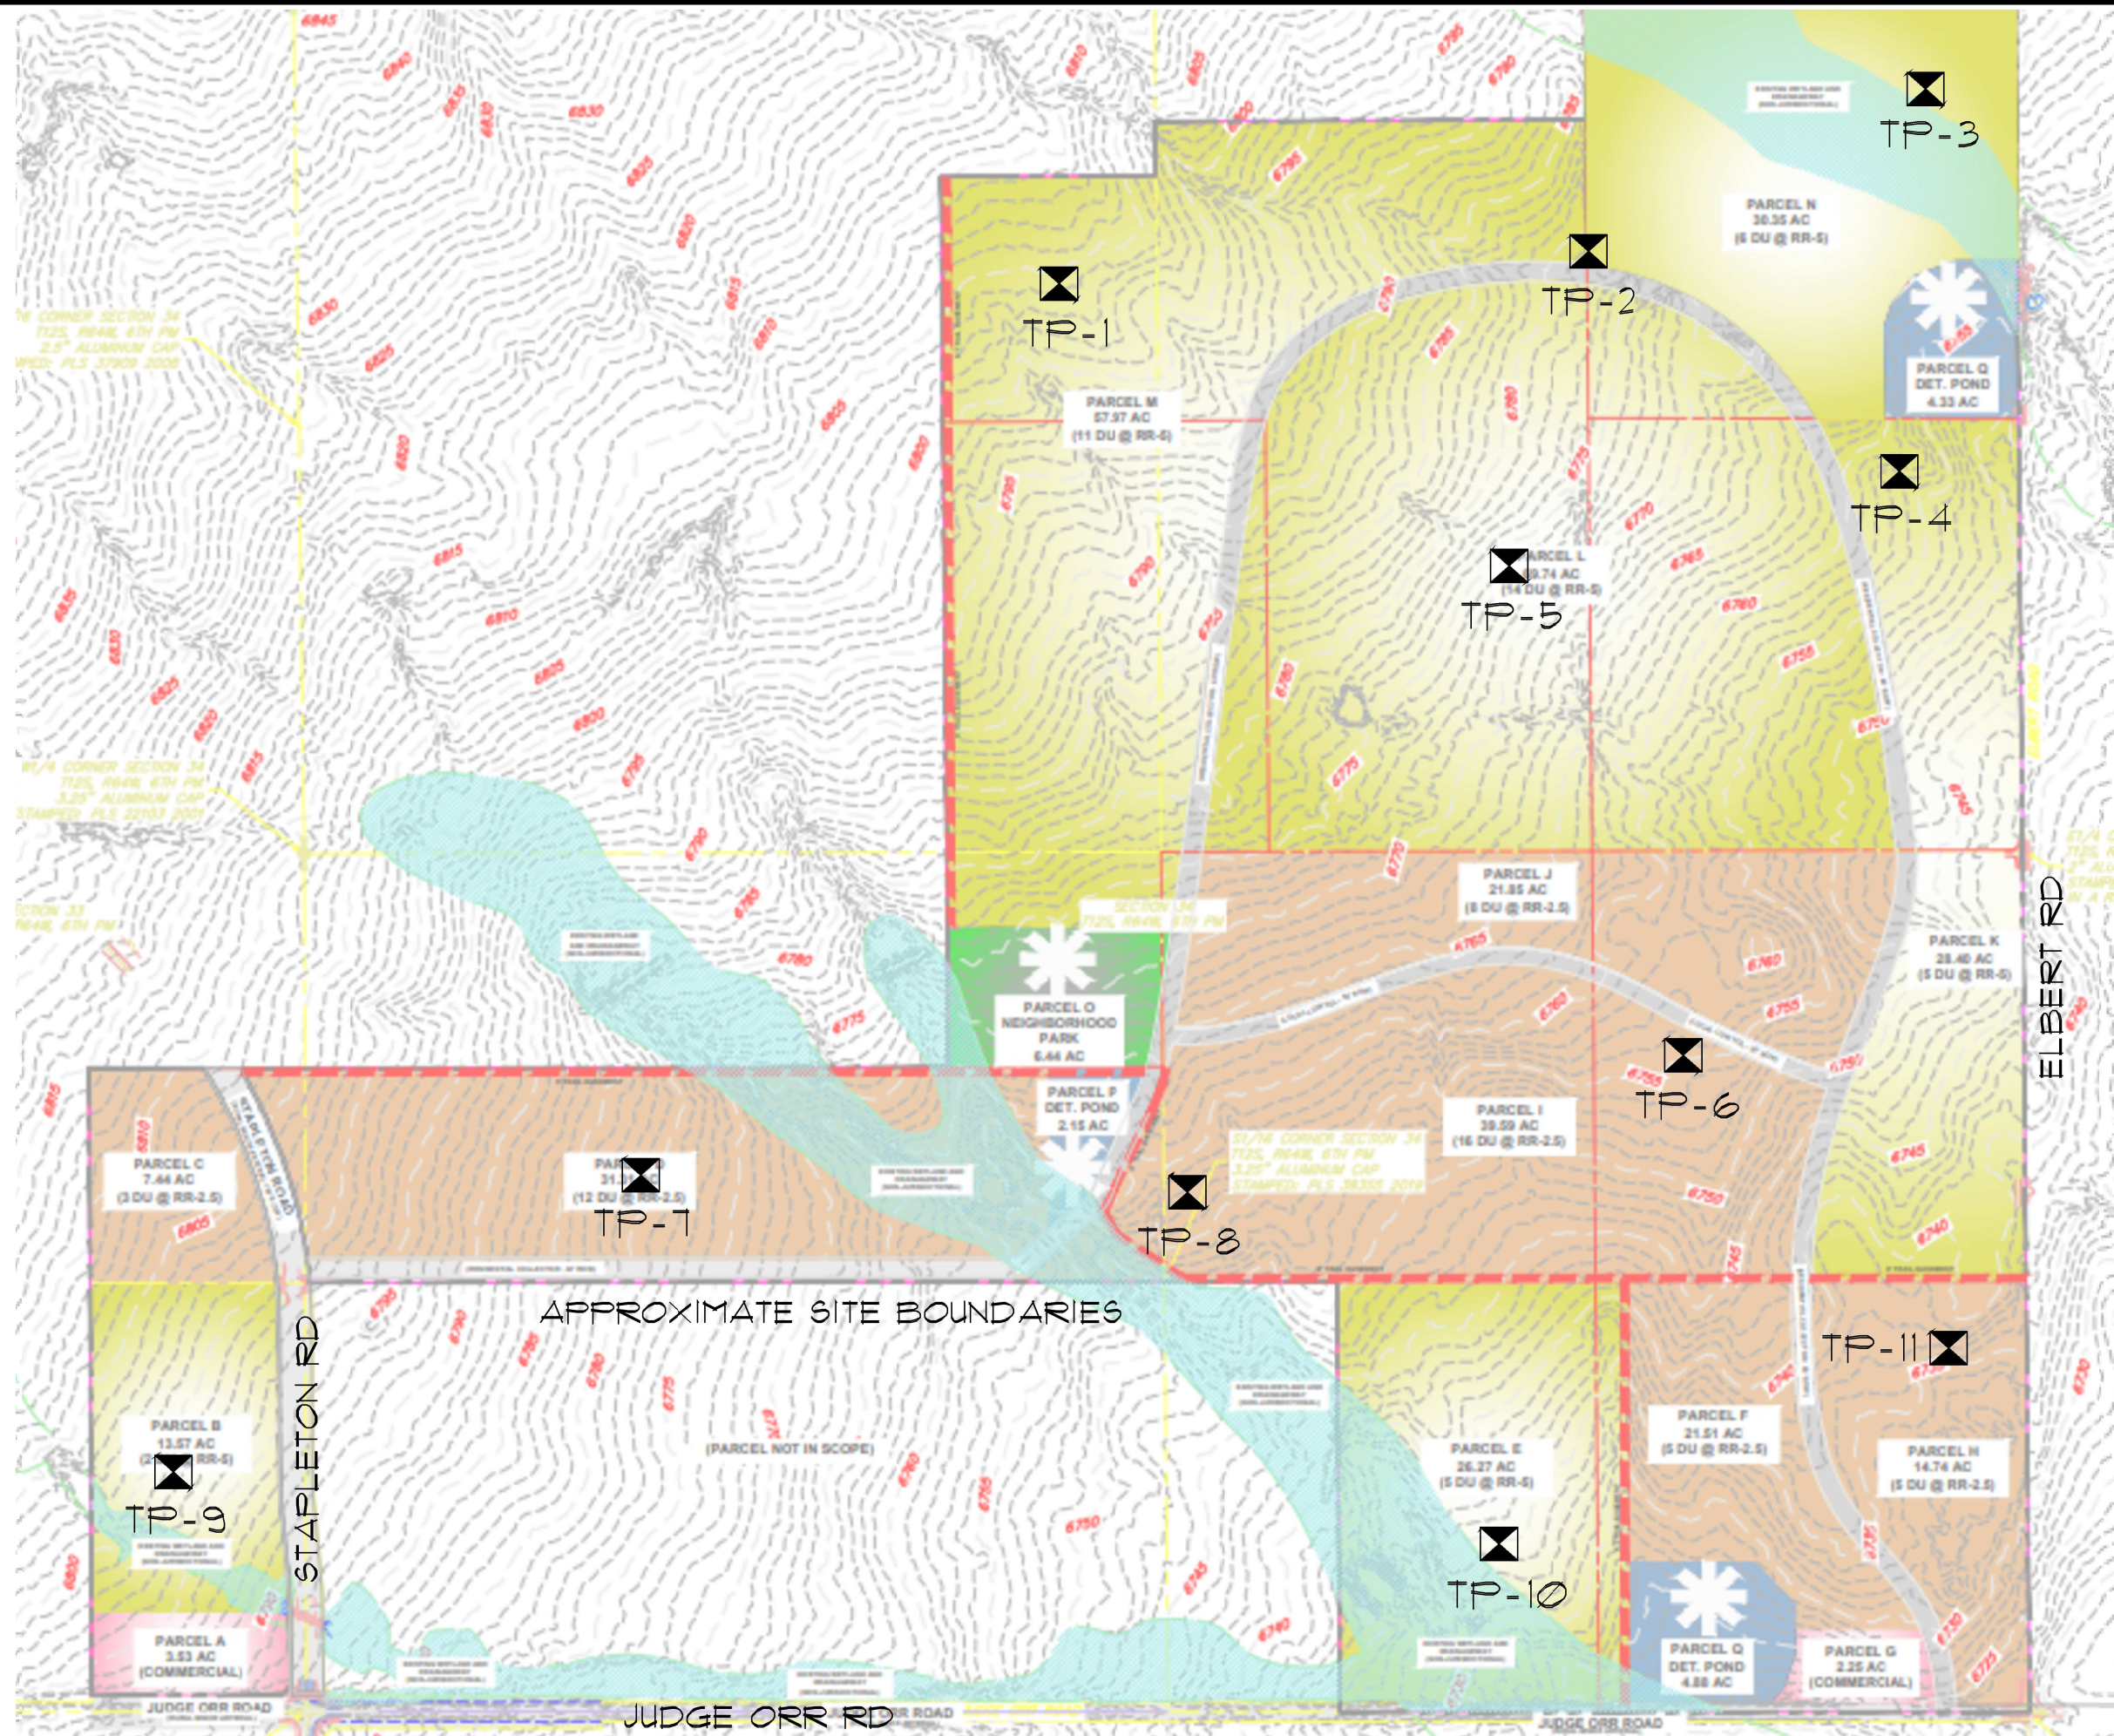
DENOTES APPROXIMATE LOCATION OF TEST PITS

The subsurface conditions were explored by drilling twenty-four (24) exploratory borings on February 8 and 13, 2023, extending to depths of approximately 20 to 35 feet below the existing ground surface. Eleven (11) test pits to depths of 6 to 8 feet were observed on February 24, 2023. The test borings and test pits were spaced to provide preliminary soil information across the site for future residential foundations and on-site wastewater treatment systems. The Test Boring/Test Pit Layout Plan is presented in Figure 3.
