# ***WASTEWATER DISPOSAL REPORT***

***William Guman and Associates, Ltd.  
Davis Ranch Subdivision***

WASTEWATER DISPOSAL REPORT

JUNE 2023

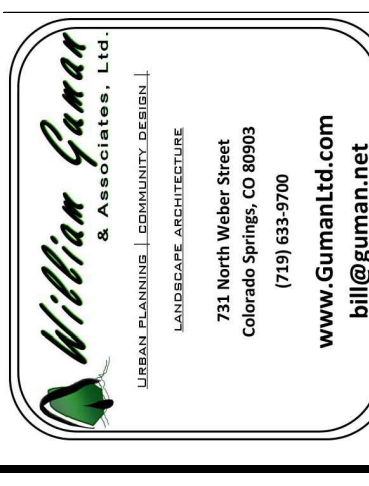
# DAVIS RANCH SKETCH PLAN

TWO PARCELS OF LAND BEING A PORTION OF THE SOUTHEAST QUARTER OF SECTION 33 AND A PORTION OF SECTION 34, BOTH IN TOWNSHIP 12 SOUTH, RANGE 64 WEST OF THE 6TH PRINCIPAL MERIDIAN, COUNTY OF EL PASO, STATE OF COLORADO

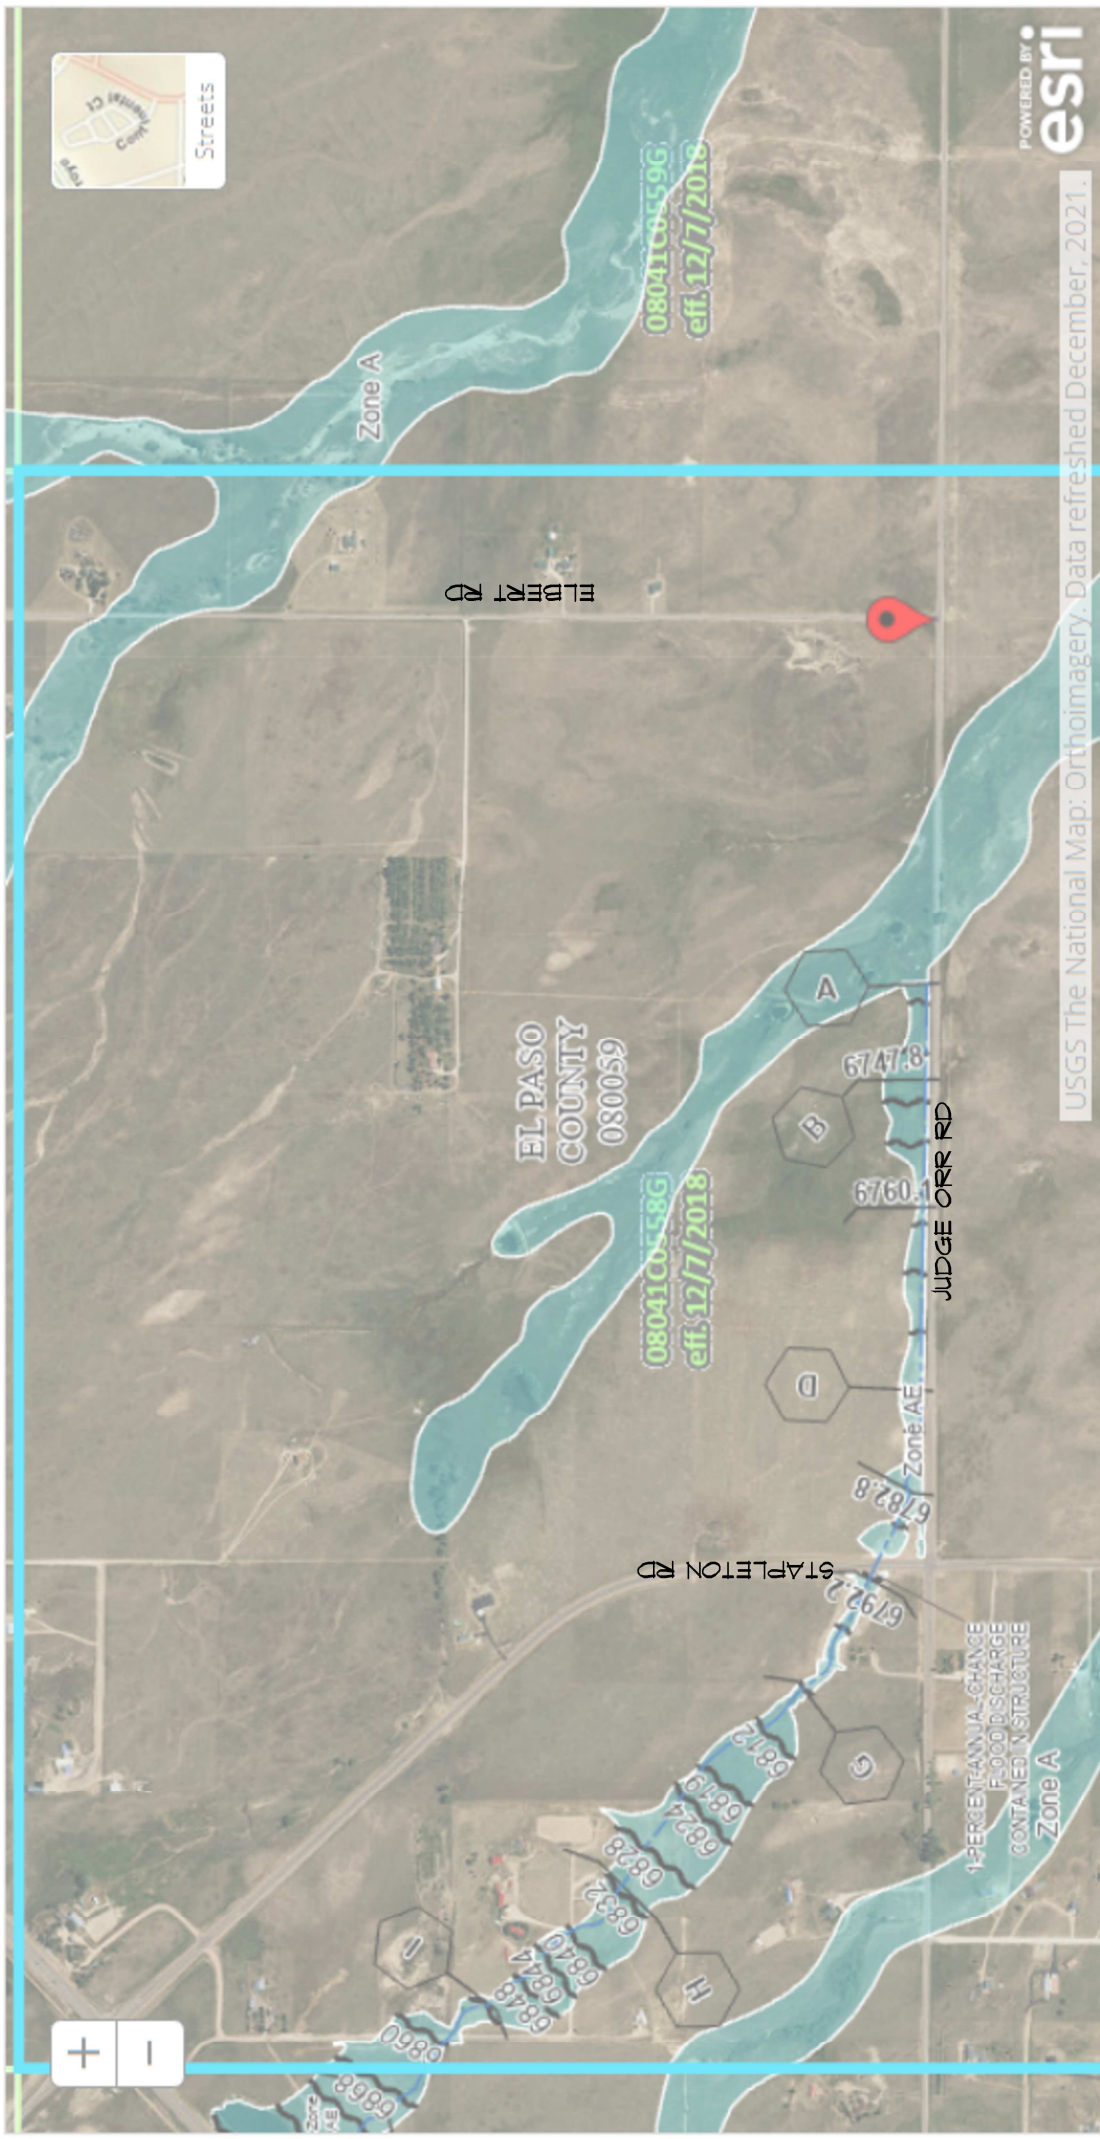
**MAP PANELS**

- NO SCREEN
- Area of Minimal Flood Hazard Zone X
- Effective LOMRS
- Area of Undetermined Flood Hazard Zone D
- Otherwise Protected Area
- coastal Barrier Resource System Area
