Stormwater Management Facility Operation and Maintenance (O&M) Plan Template

Gateway Trucking, LLC

**Stormwater Management Facility
Inspection and Maintenance (I&M) Plan**

GATEWAY TRUCKING SITE
DEVELOPMENT PLAN
SITE DEVELOPMENT PLAN

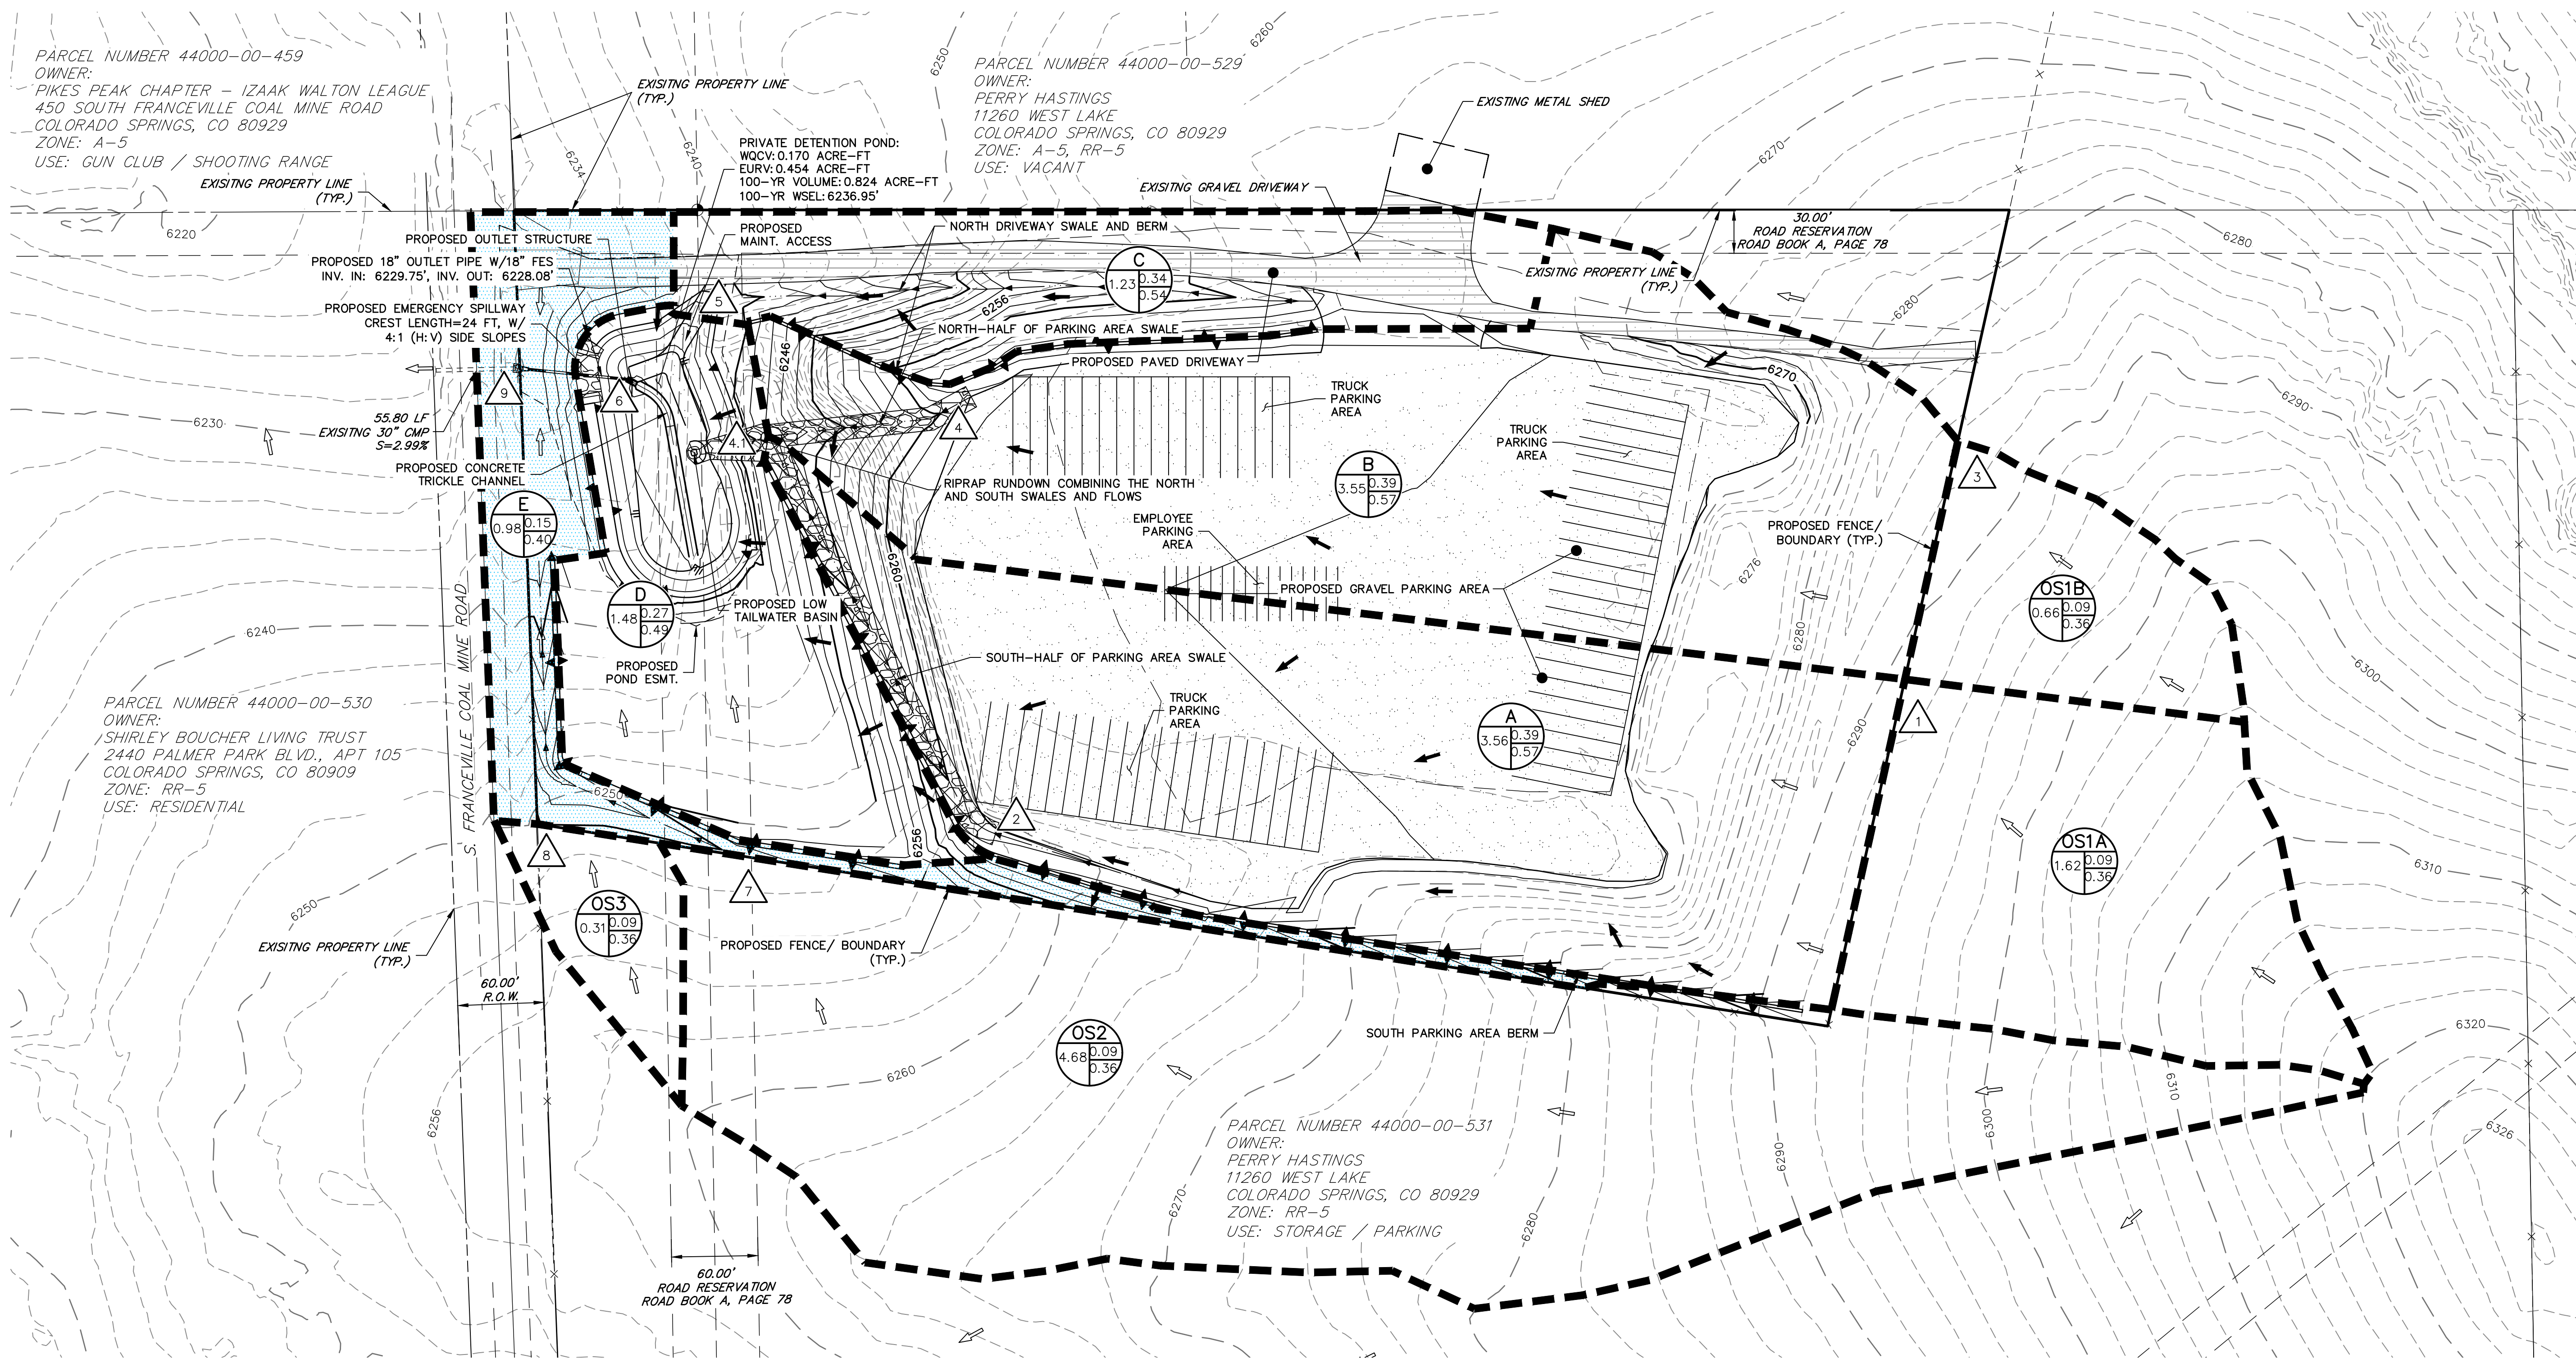
GATEWAY TRUCKING PROPOSED DRAINAGE MAP

Tributary Sub-basin	Area (acres)	Percent Impervious	C _s	C ₁₀₀	t _c (min)	Q _s (cfs)	Q ₁₀₀ (cfs)
A	3.55	48.9%	0.39	0.57	11.9	5.4	13.1
B	3.56	49.3%	0.39	0.57	11.0	5.6	13.5
C	1.23	32.6%	0.34	0.54	12.6	1.6	4.2
D	1.48	23.2%	0.27	0.49	6.1	1.9	5.9
E	0.98	9.0%	0.15	0.40	7.6	0.6	3.0
OS1A	1.62	2.0%	0.09	0.36	17.6	0.5	3.2
OS1B	0.66	2.0%	0.09	0.36	16.1	0.2	1.4
OS2	4.68	2.0%	0.09	0.36	23.1	1.2	8.1
OS3	0.31	2.0%	0.09	0.36	16.9	0.1	0.6

Design Point	Contributing Area (ac)	Q _s (cfs)	Q ₁₀₀ (cfs)
1	1.62	0.5	3.2
2	5.17	5.1	14.3
3	0.66	0.2	1.4
4	4.22	5.0	13.0
4.1	9.39	9.9	26.7
5	1.23	1.6	4.2
6	12.10	12.5	34.4

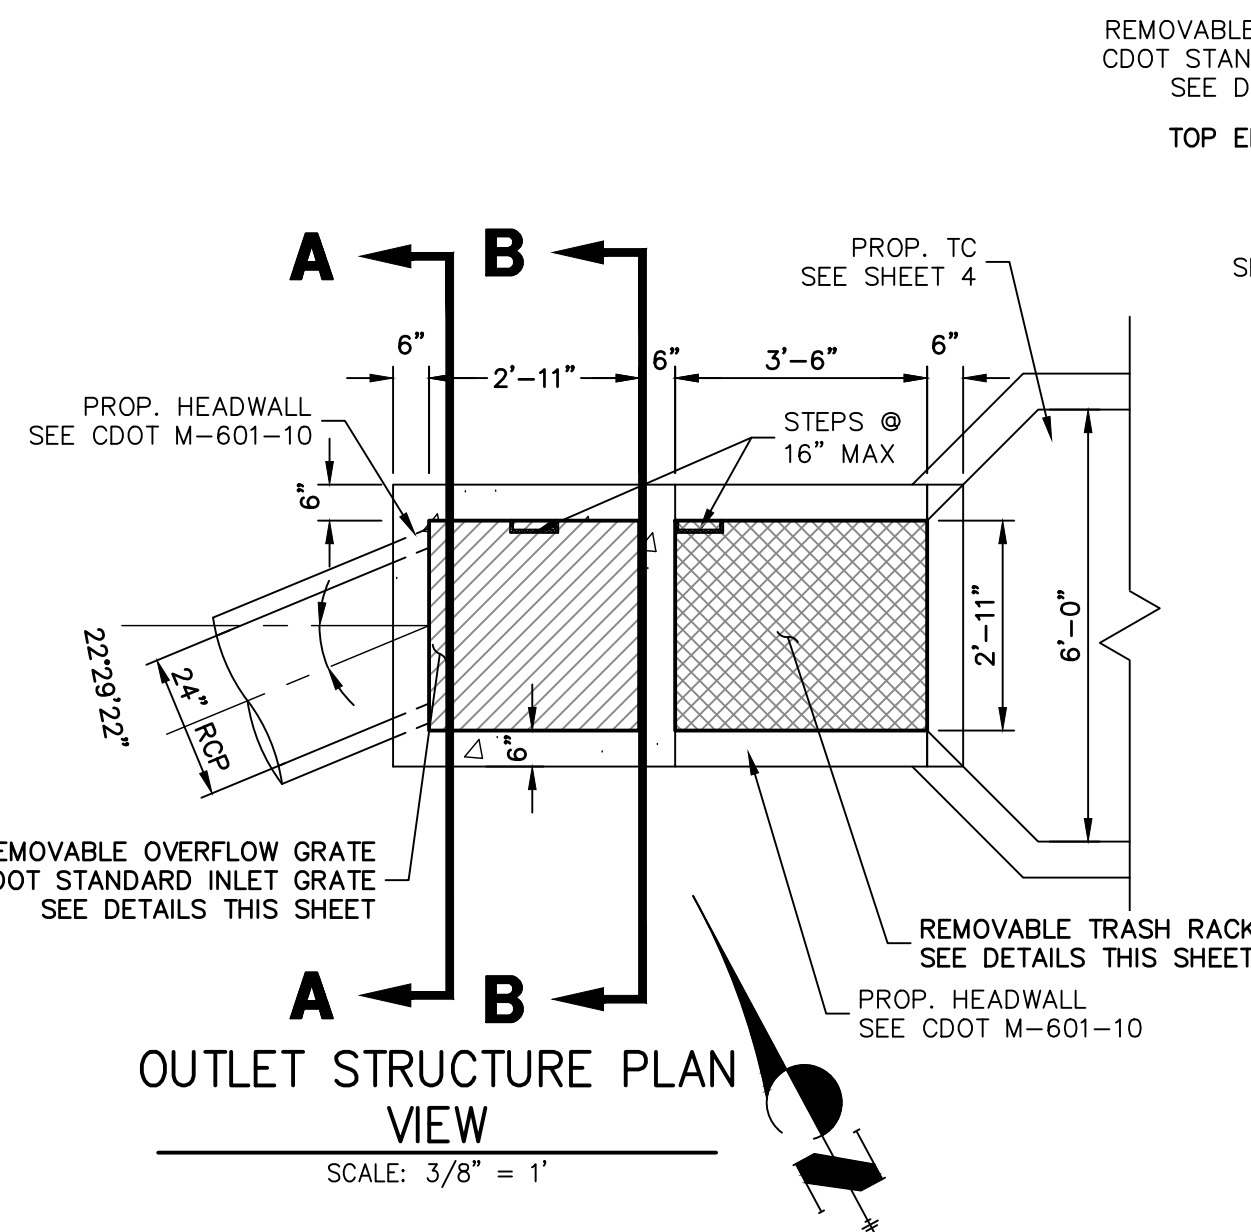
OUTLET STRUCTURE PLAN
VIEW
SCALE: 3/8" = 1'

6. STRUCTURAL STEEL FOR GRATES, ORIFICE PLATES, AND BARS SHALL BE GALVANIZED AND SHALL BE IN ACCORDANCE WITH CDOT STANDARD SPECIFICATIONS, SUBSECTION 712.06.

7. ALL HARDWARE, BOLTS, AND FASTENERS SHALL BE STAINLESS STEEL.
 8. CONTRACTOR SHALL SUBMIT SHOP DRAWINGS FOR ALL PLATES AND GRATING FOR ENGINEER'S APPROVAL PRIOR TO CONSTRUCTION.

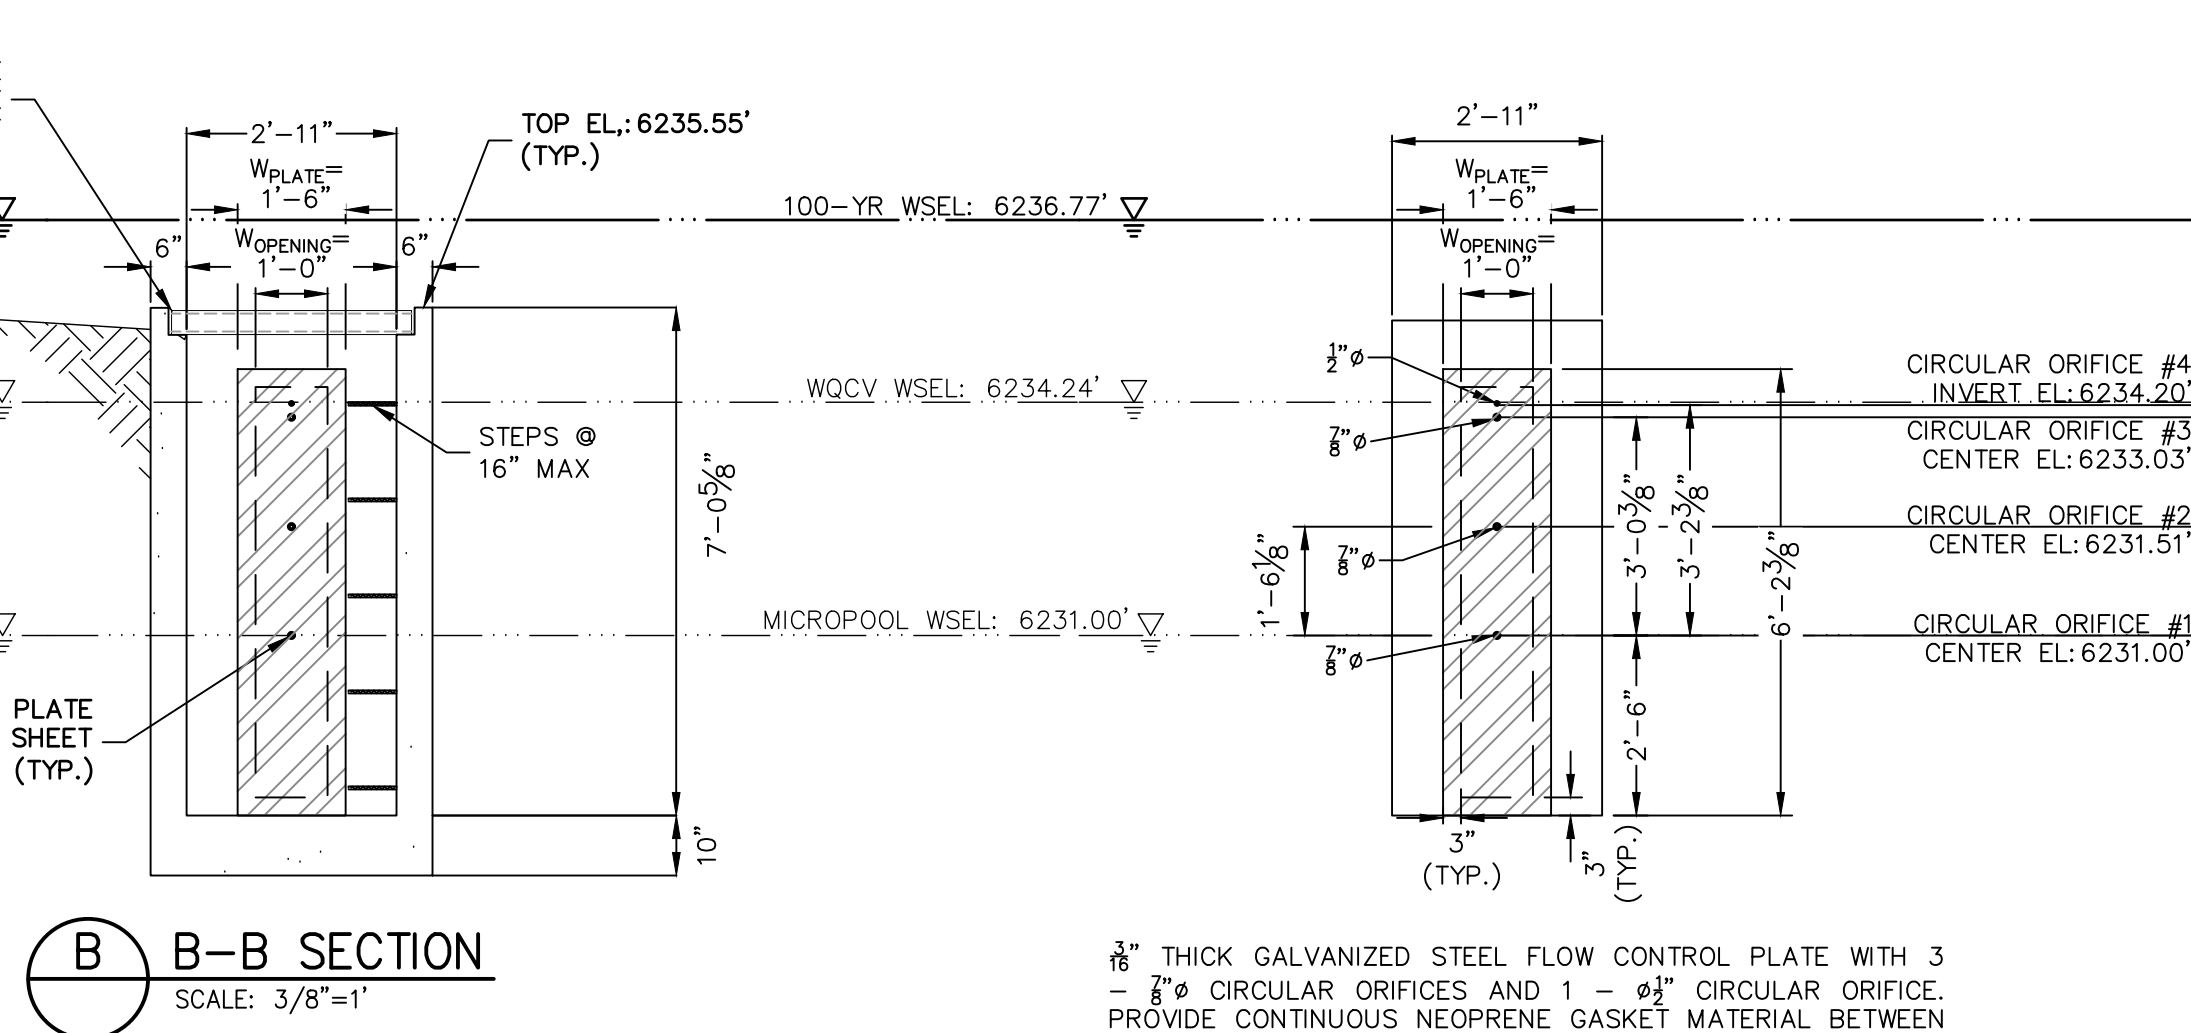
B-B SECTION
SCALE: 3/8" = 1'

3/8" THICK GALVANIZED STEEL FLOW CONTROL PLATE WITH 3 - 3/8" CIRCULAR ORIFICES AND 1 - 3/8" CIRCULAR ORIFICE. PROVIDE CONTINUOUS NEOPRENE GASKET MATERIAL BETWEEN THE ORIFICE PLATE AND CONCRETE. BOLT PLATE TO CONCRETE @ 12" MAX O.C.

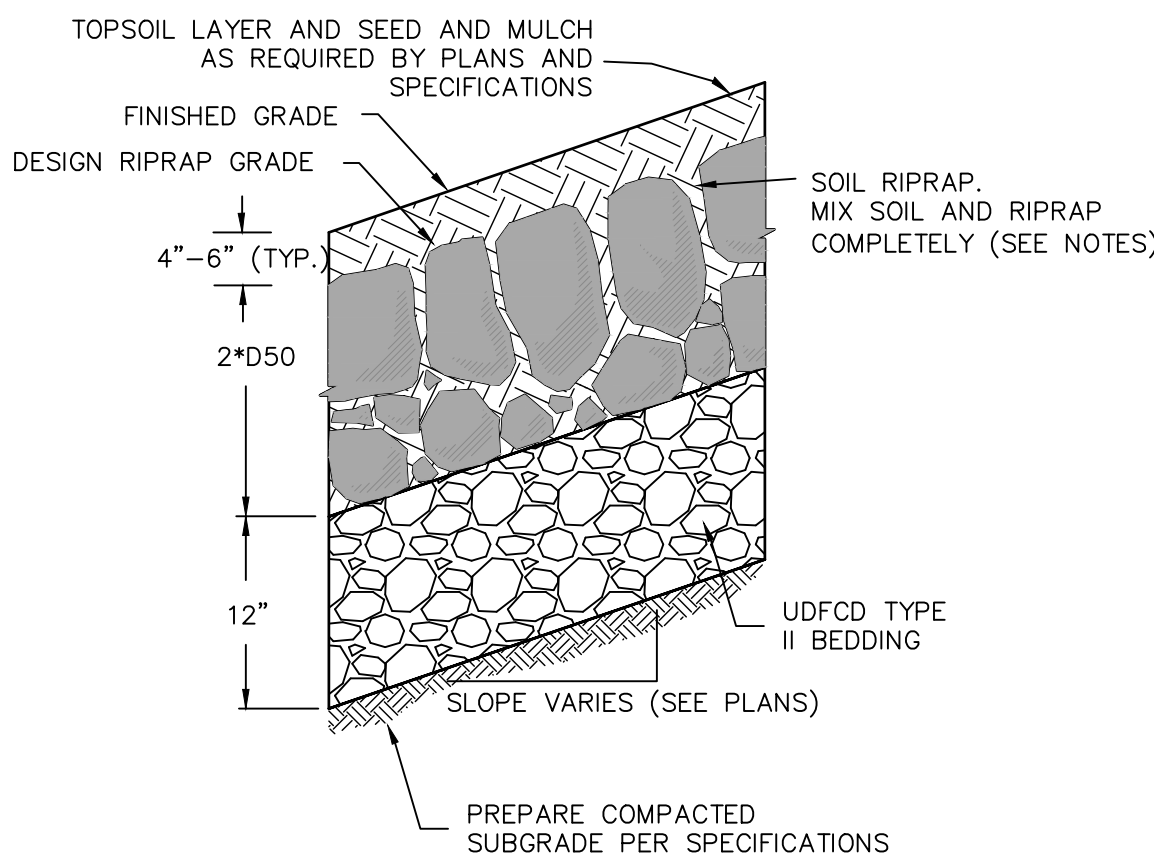
SOIL RIPRAP EMBANKMENT PROTECTION
WITH BEDDING TYP. SECTION
N.T.S.

TYPE VL RIPRAP
