STORMWATER MANAGEMENT FACILITY
OPERATION AND MAINTENANCE PLAN (O&M PLAN)

PROJECT:
Winsome Filing No. 2
El Paso County, CO

LOCATION:
NWC of Hodgen Road and Meridian Road
El Paso County, Colorado

PREPARED BY:
Kimley-Horn and Associates, Inc.
2 North Nevada Avenue, Suite 300
Colorado Springs, CO 80903
Kevin Kofford, P.E.
(719) 453-0180

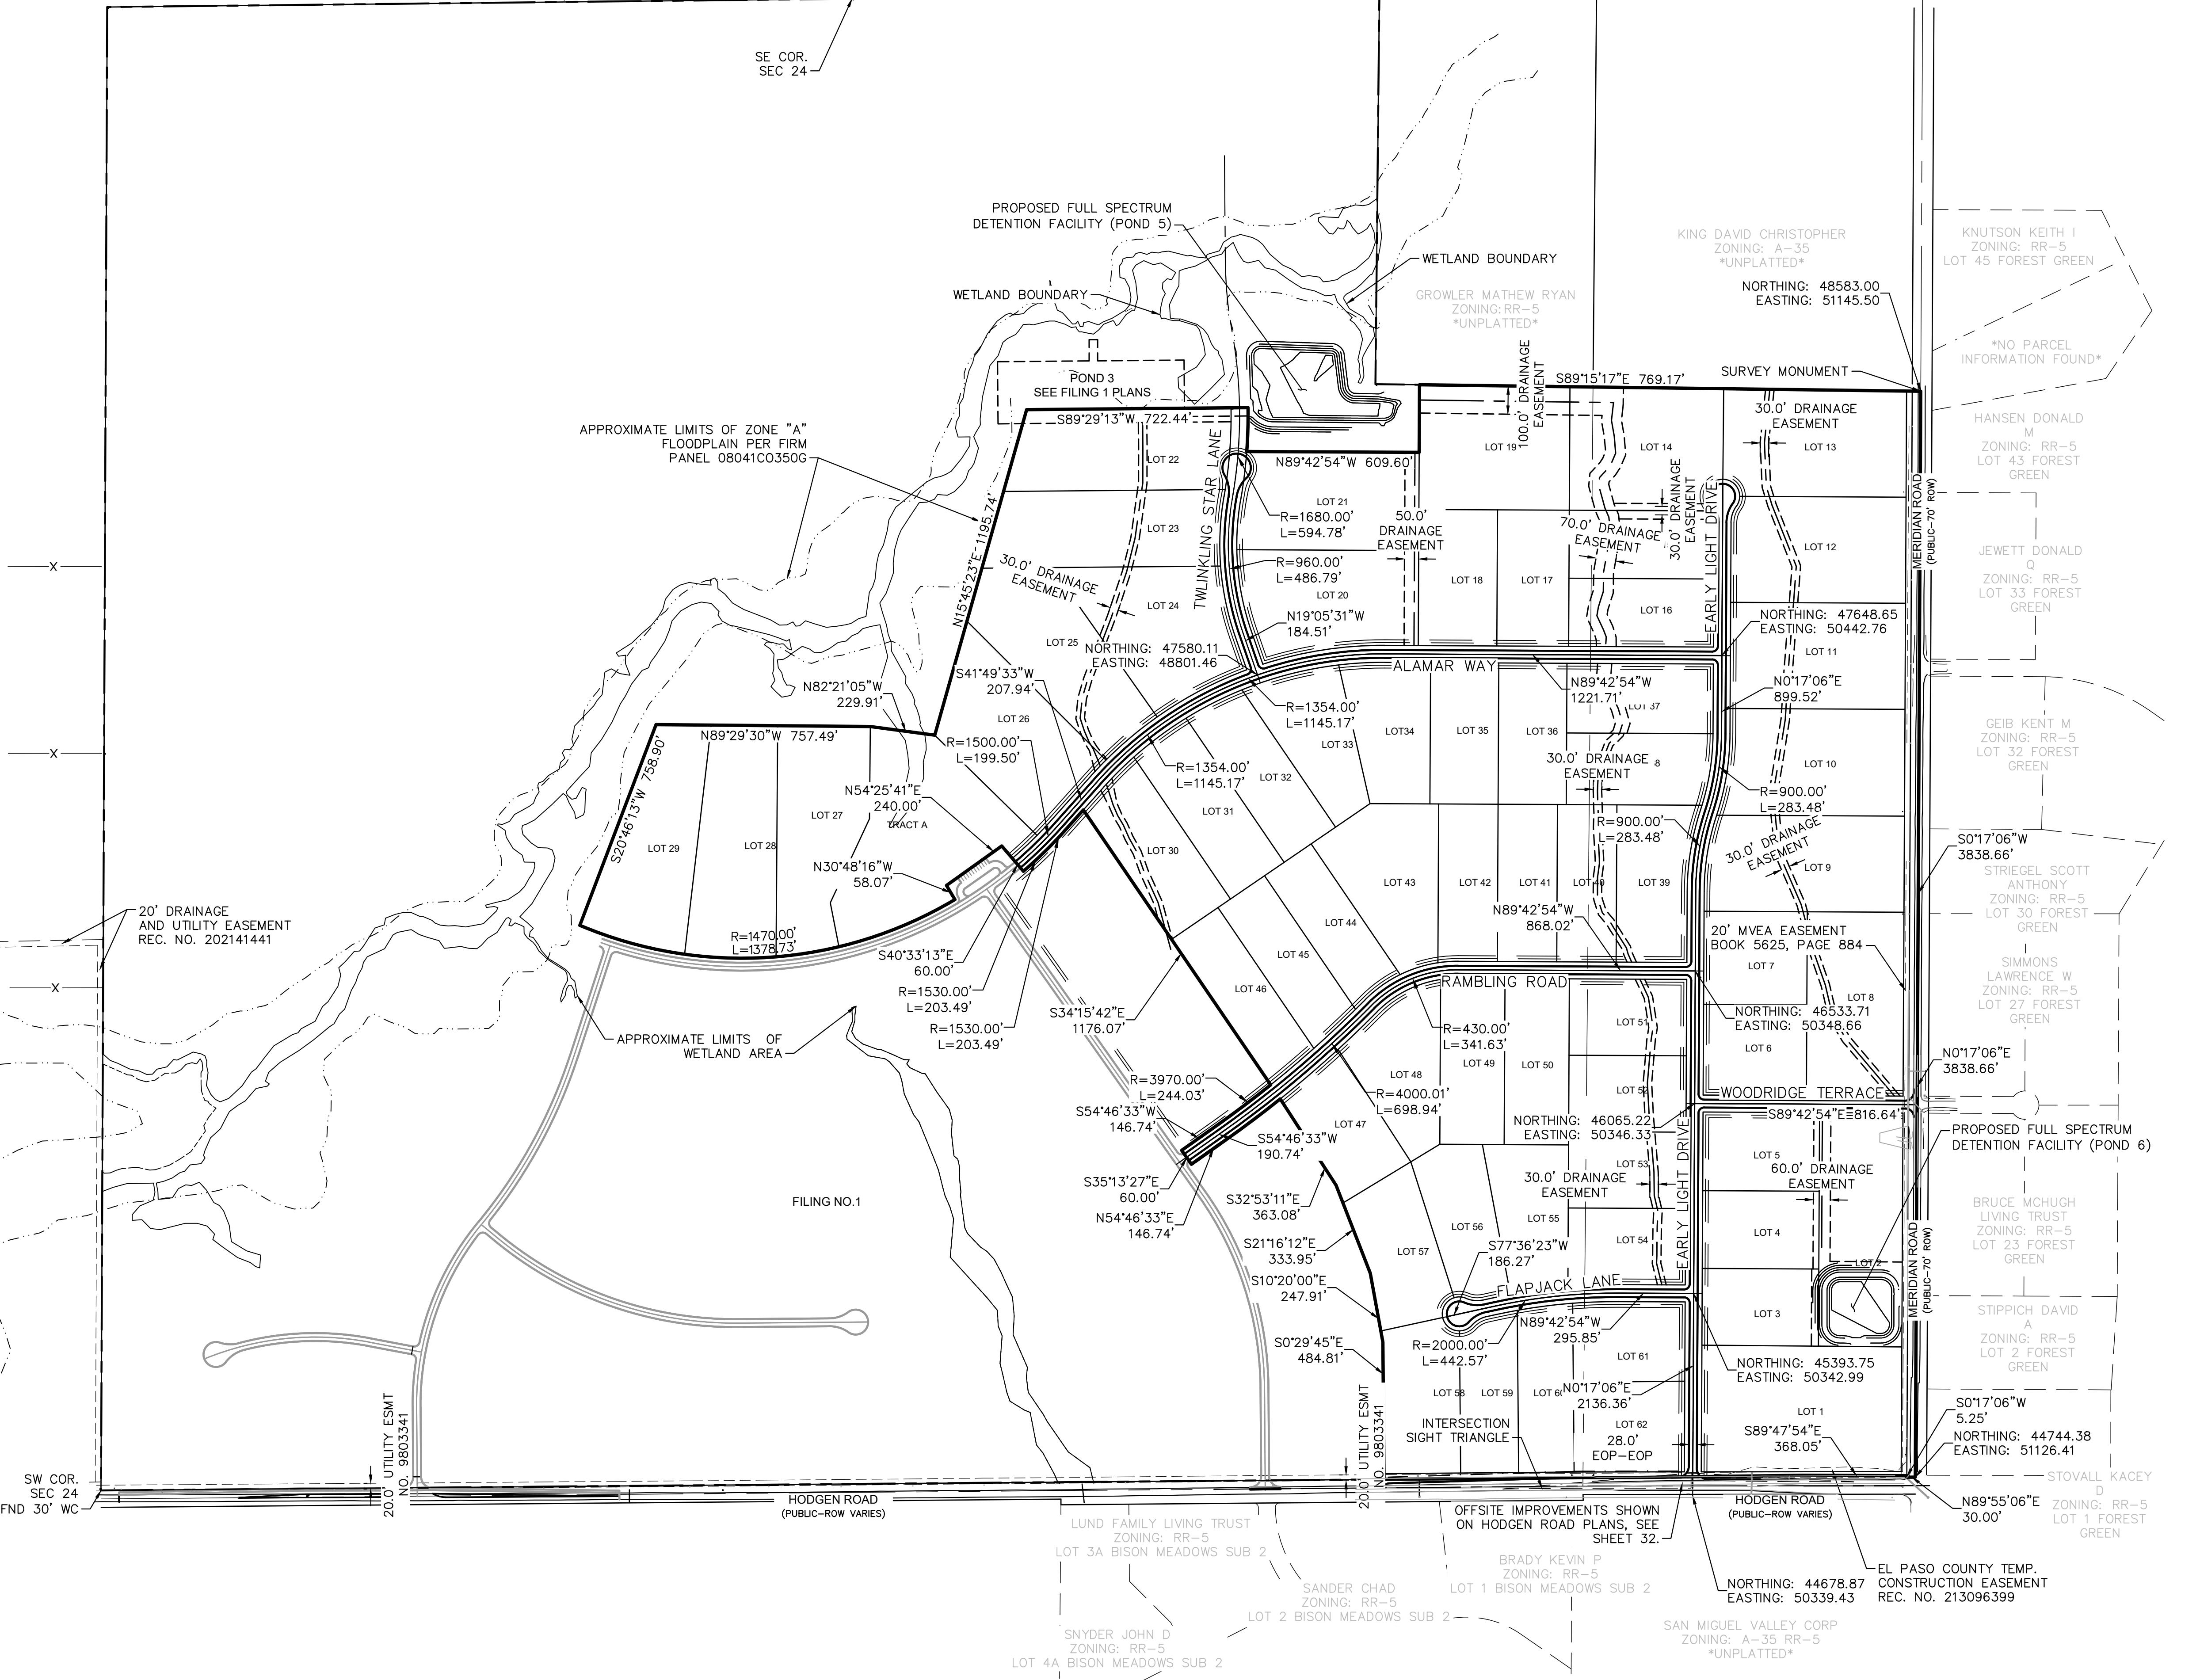
Appendix E – Stormwater Facilities Map

All stormwater management facilities located on the site have both a designated access location as well as required easements. Refer to the Stormwater Facilities Map located in Appendix E for access and easement locations.
