December 11, 2023

ENTECH
ENGINEERING, INC.

Re: Wastewater Study
12960 North Peyton Highway
Parcel No. 63070-00-007
El Paso County, Colorado
Entech Job No. 230520

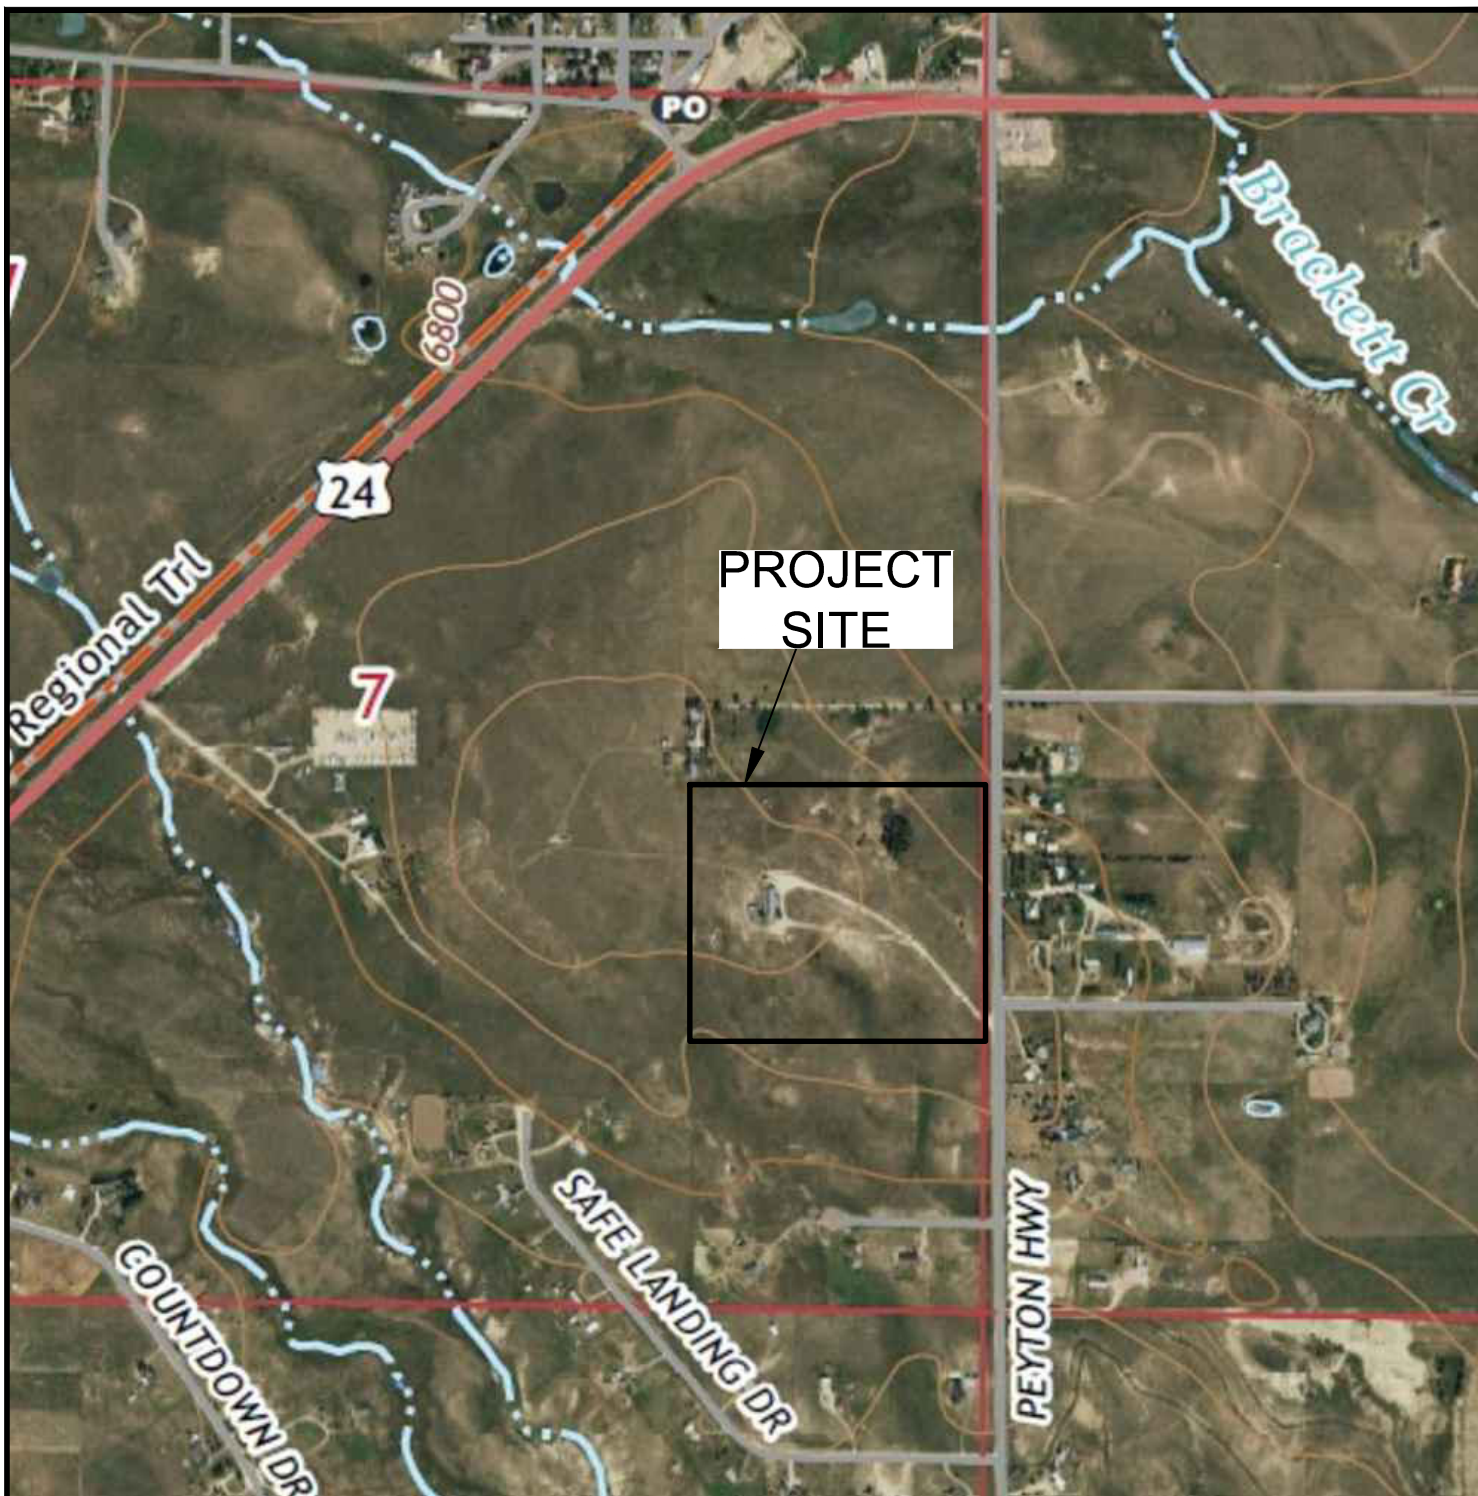
FIG. 2

The topography of the site is gradually sloping to the east and southeast with moderate slopes to the northeast northeastern portion of the site. No drainages area located on the site. Brackett Creek is located $\frac{1}{2}$ mile to the north, and Black Squirrel Creek is located approximately $\frac{1}{2}$ mile to the south of the site. The site boundaries are indicated on the USGS Map, Figure 2. Previous land uses have included undeveloped agricultural grazing pastureland. Site photographs, taken November 21, 2023, are included in Appendix A.

USGS TOPOGRAPHY MAP

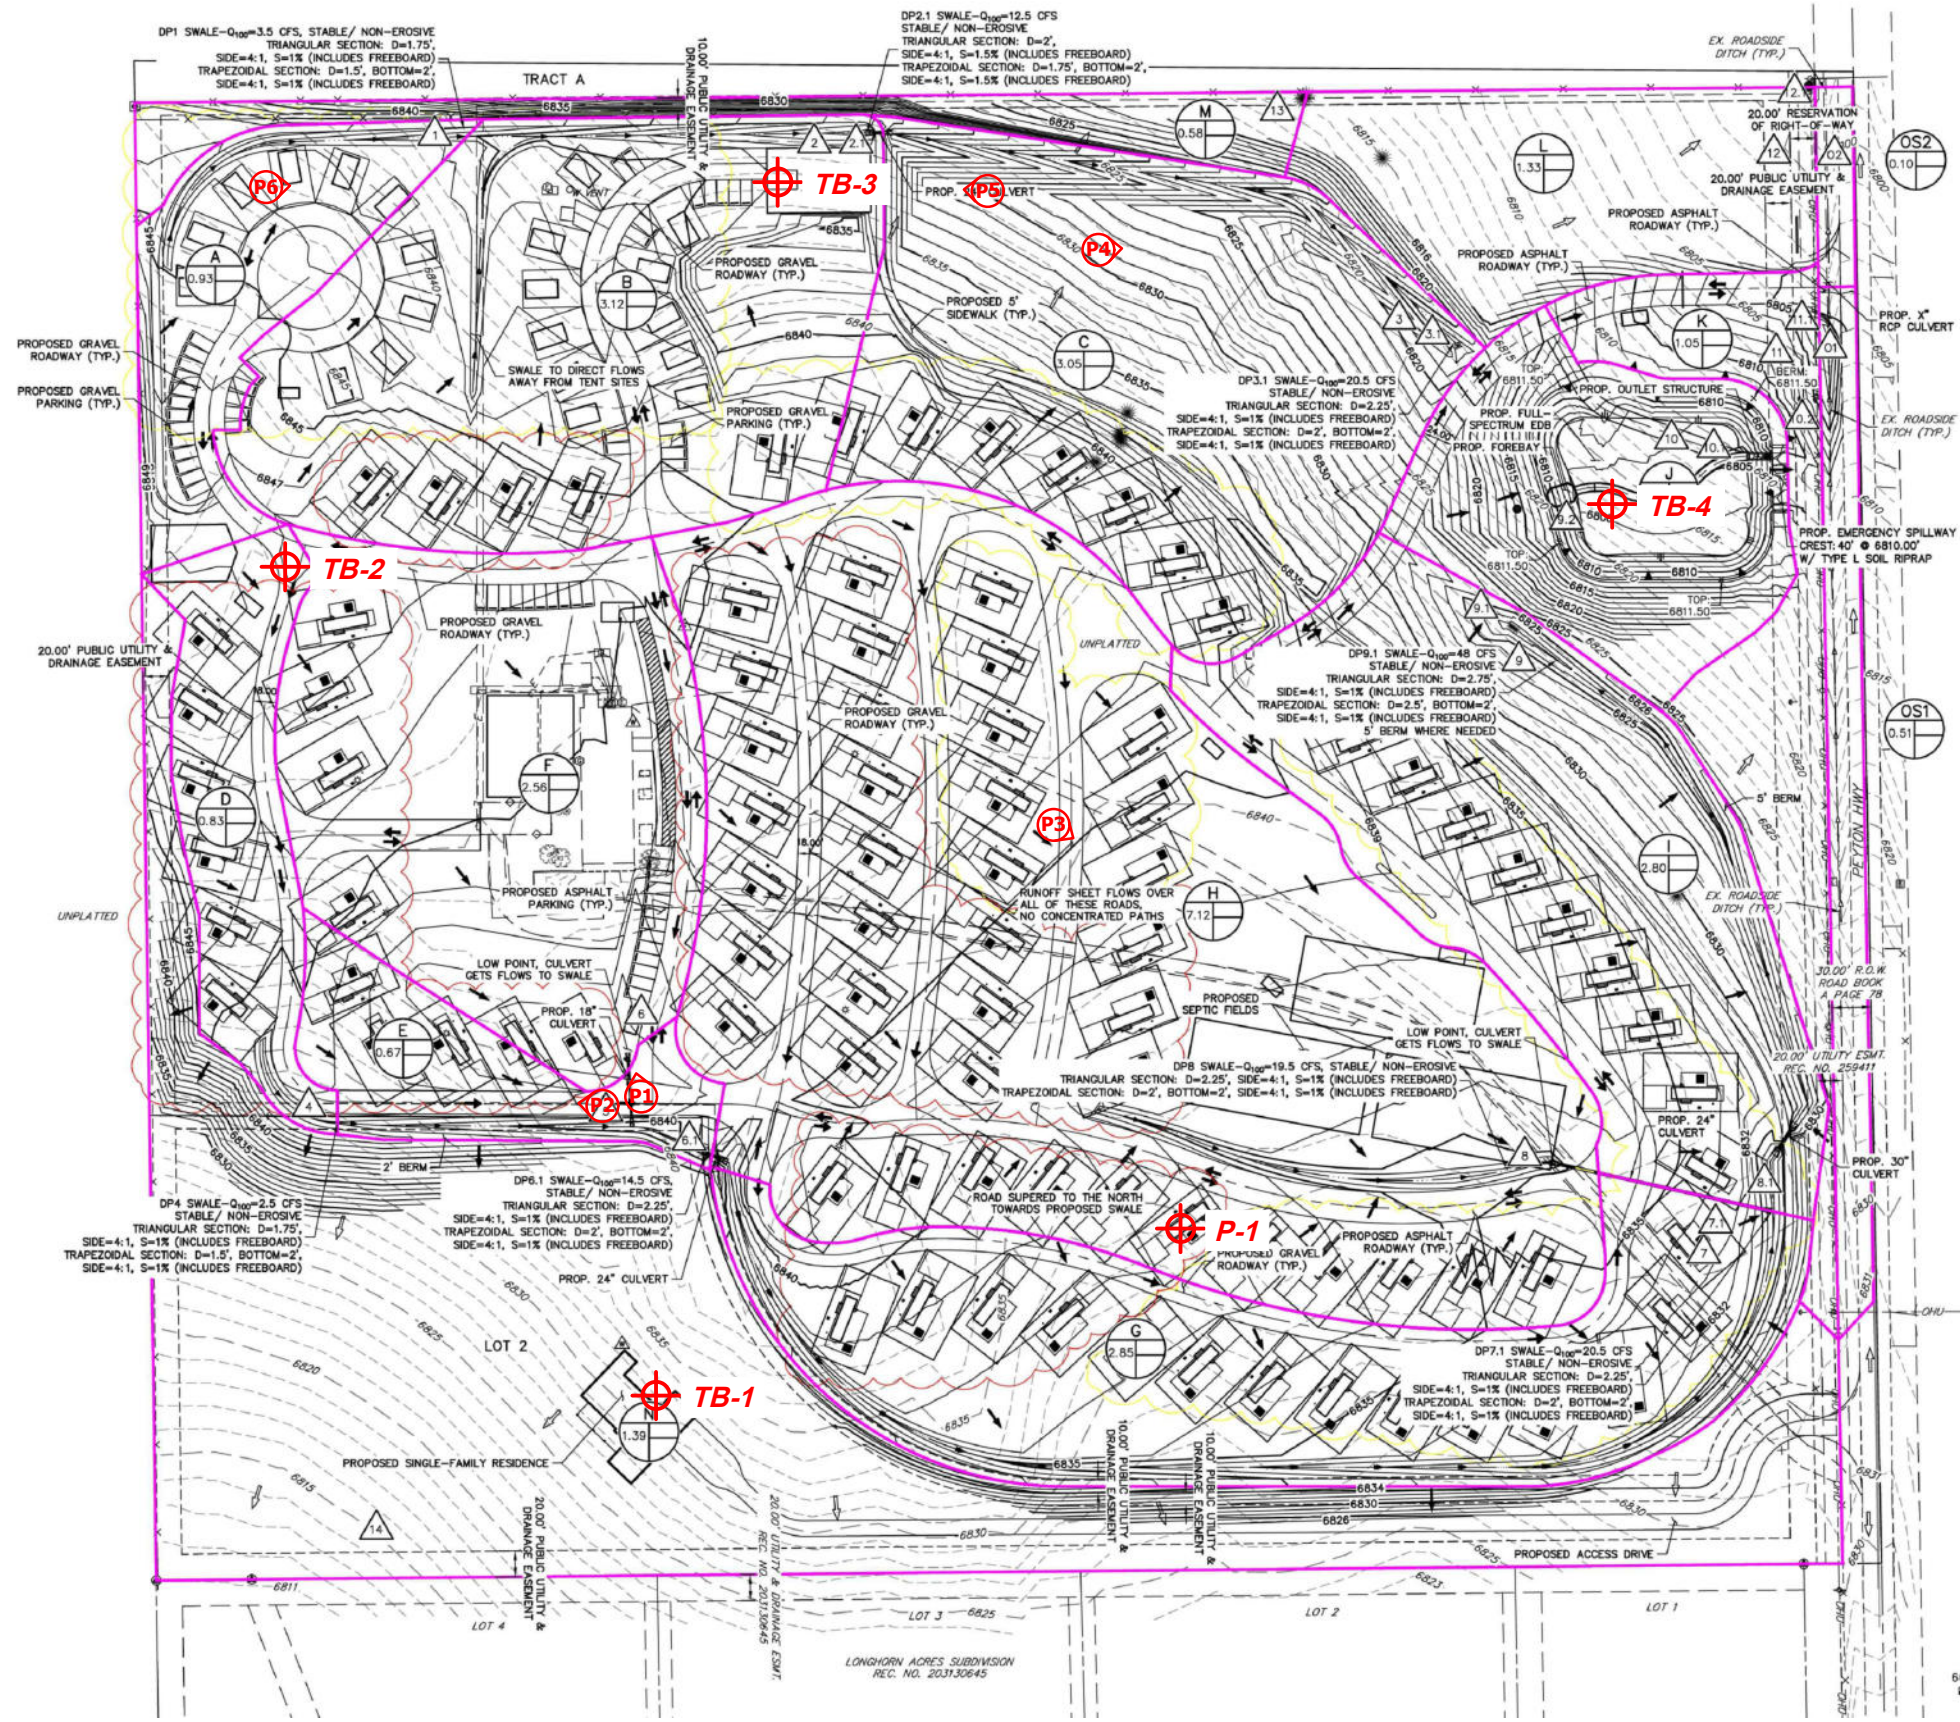
JOB NO.
231532
FIG. 3

Total acreage involved in the proposed subdivision is 36.24-acres. The existing structures, outbuildings, on-site wastewater treatment system, and water well located on the proposed RV Park Lot will remain. The new residential lot will be serviced by a new water well and on-site wastewater treatment system (OWTS), and the RV Park will be serviced by a new water well and OWTS. According to the preliminary grading plans new gravel roadways will be constructed for the RV Park with a detention pond proposed in the northeastern portion of the site. The Site Plan with the proposed replat is presented in Figure 3.

- ⊕ - APPROXIMATE TEST BORING LOCATION AND NUMBER
- ⊕ - APPROXIMATE PIEZOMETER LOCATION AND NUMBER
- Ⓟ - APPROXIMATE PHOTOGRAPH LOCATION AND NUMBER

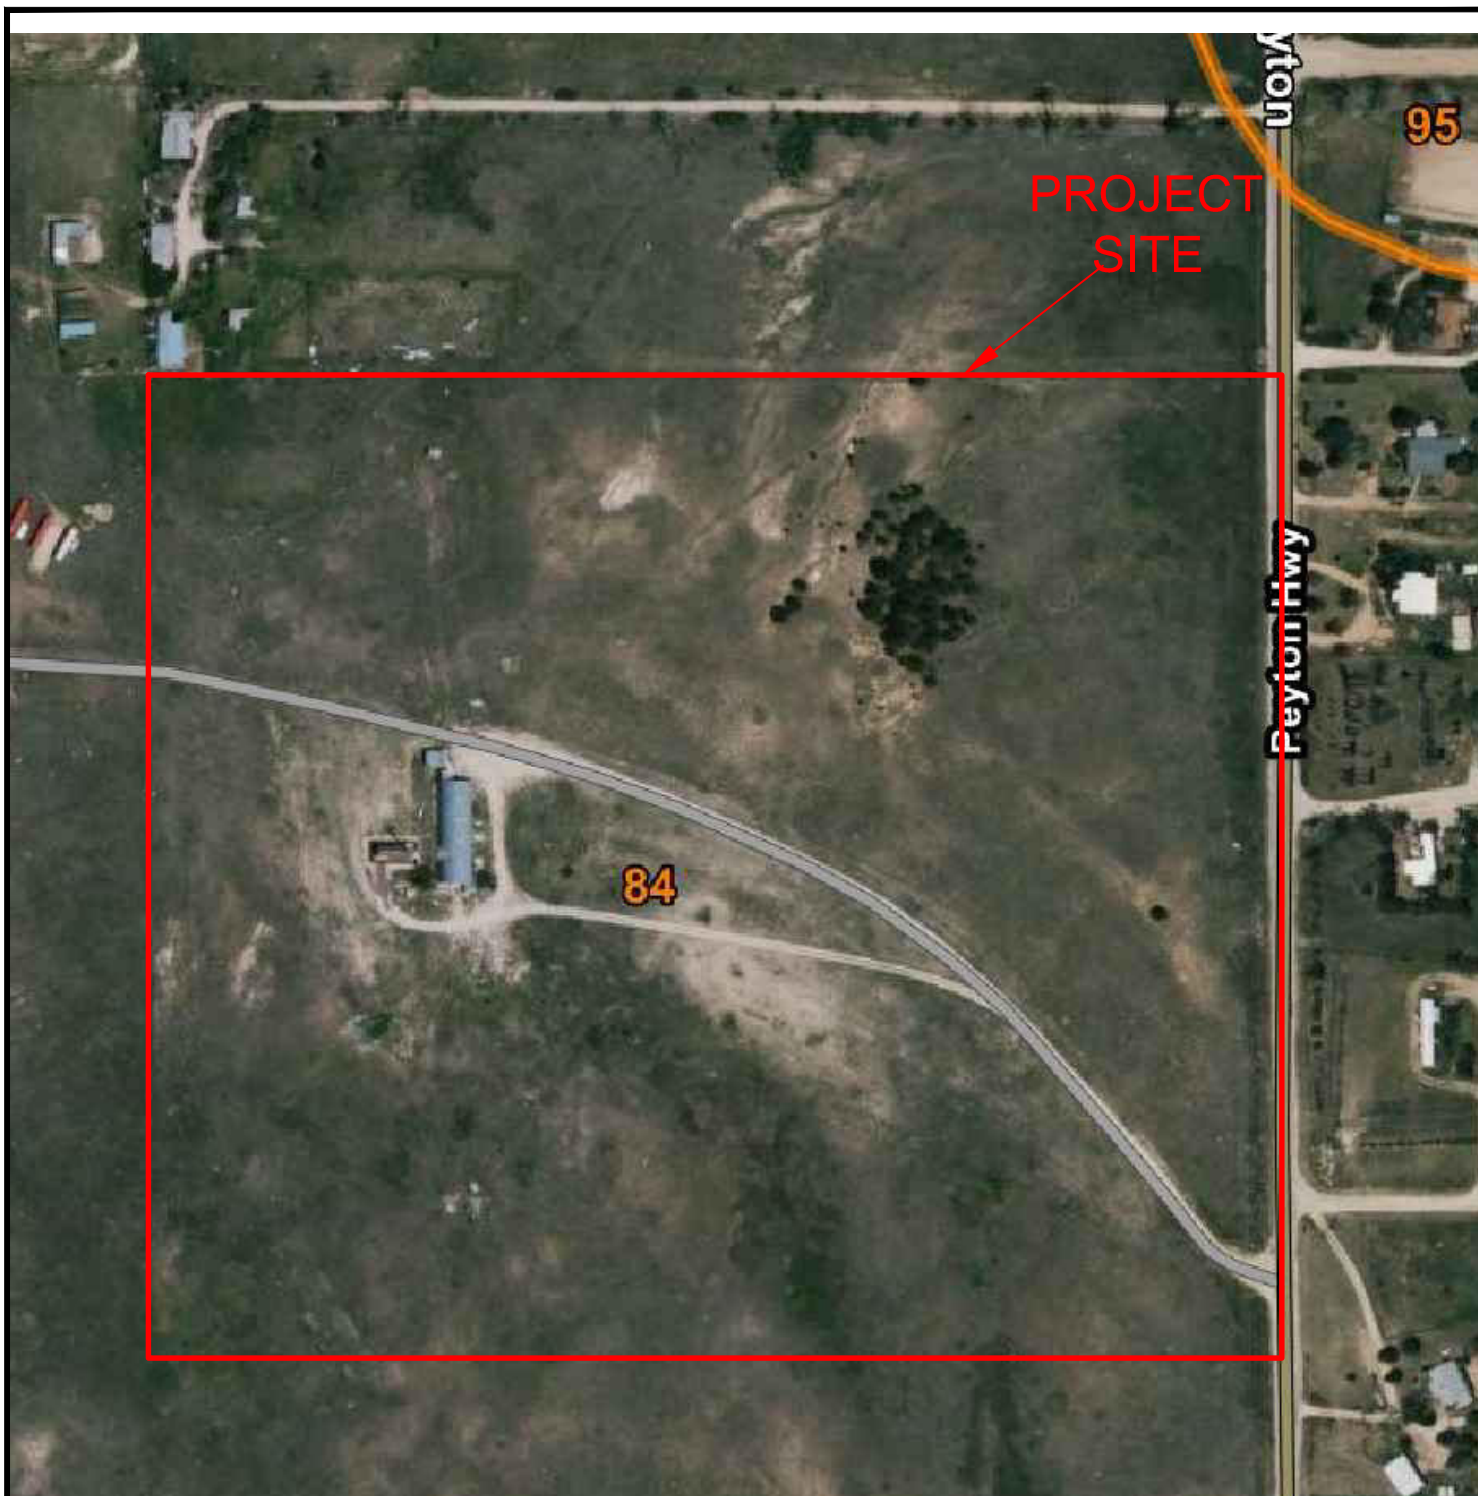
FIG. 4

The soils have been described to have moderate to rapid permeabilities. The soils are described as well suited for use as homesites. Possible hazards with soils erosion are present on the site. The erosion potential can be controlled with vegetation. The soils have been described to have moderate erosion hazards (Reference 2).

SOIL SURVEY MAP

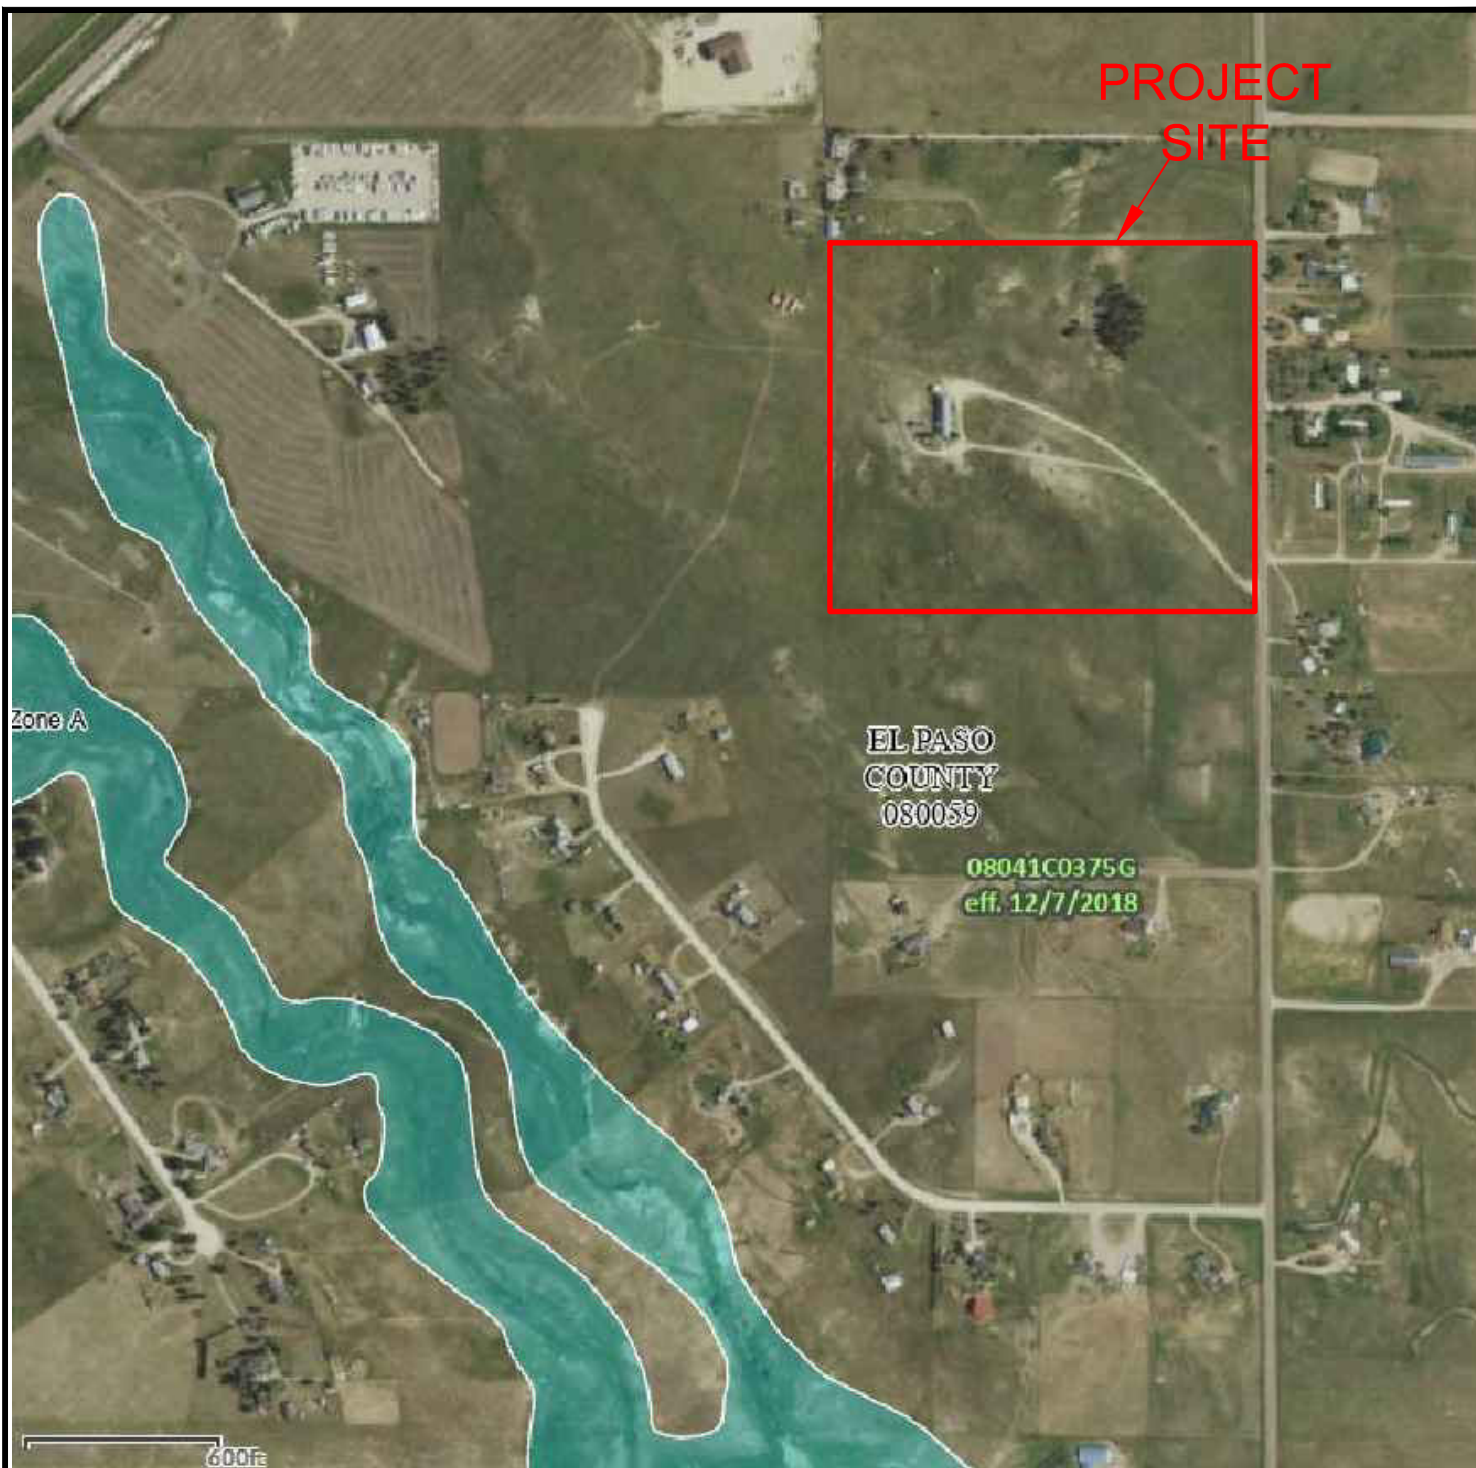
FIG. 7

The site is not mapped within any floodplains according to the FEMA Map No. 08041CO375G, dated December 7, 2018 (Figure 7, Reference 7). No drainages or areas of shallow water were observed on the site. Groundwater was encountered in TB-4 at 7 feet in the proposed detention pond location, and in P-1 at 46.5 feet located south of the anticipated soil treatment area for the RV Park. Preliminary plans indicated cuts up to 13 feet for the detention pond. Additional investigation is recommended as development and grading plans are finalized. **Specific drainage studies are beyond the scope of this report.**

FEMA FLOODPLAIN MAP

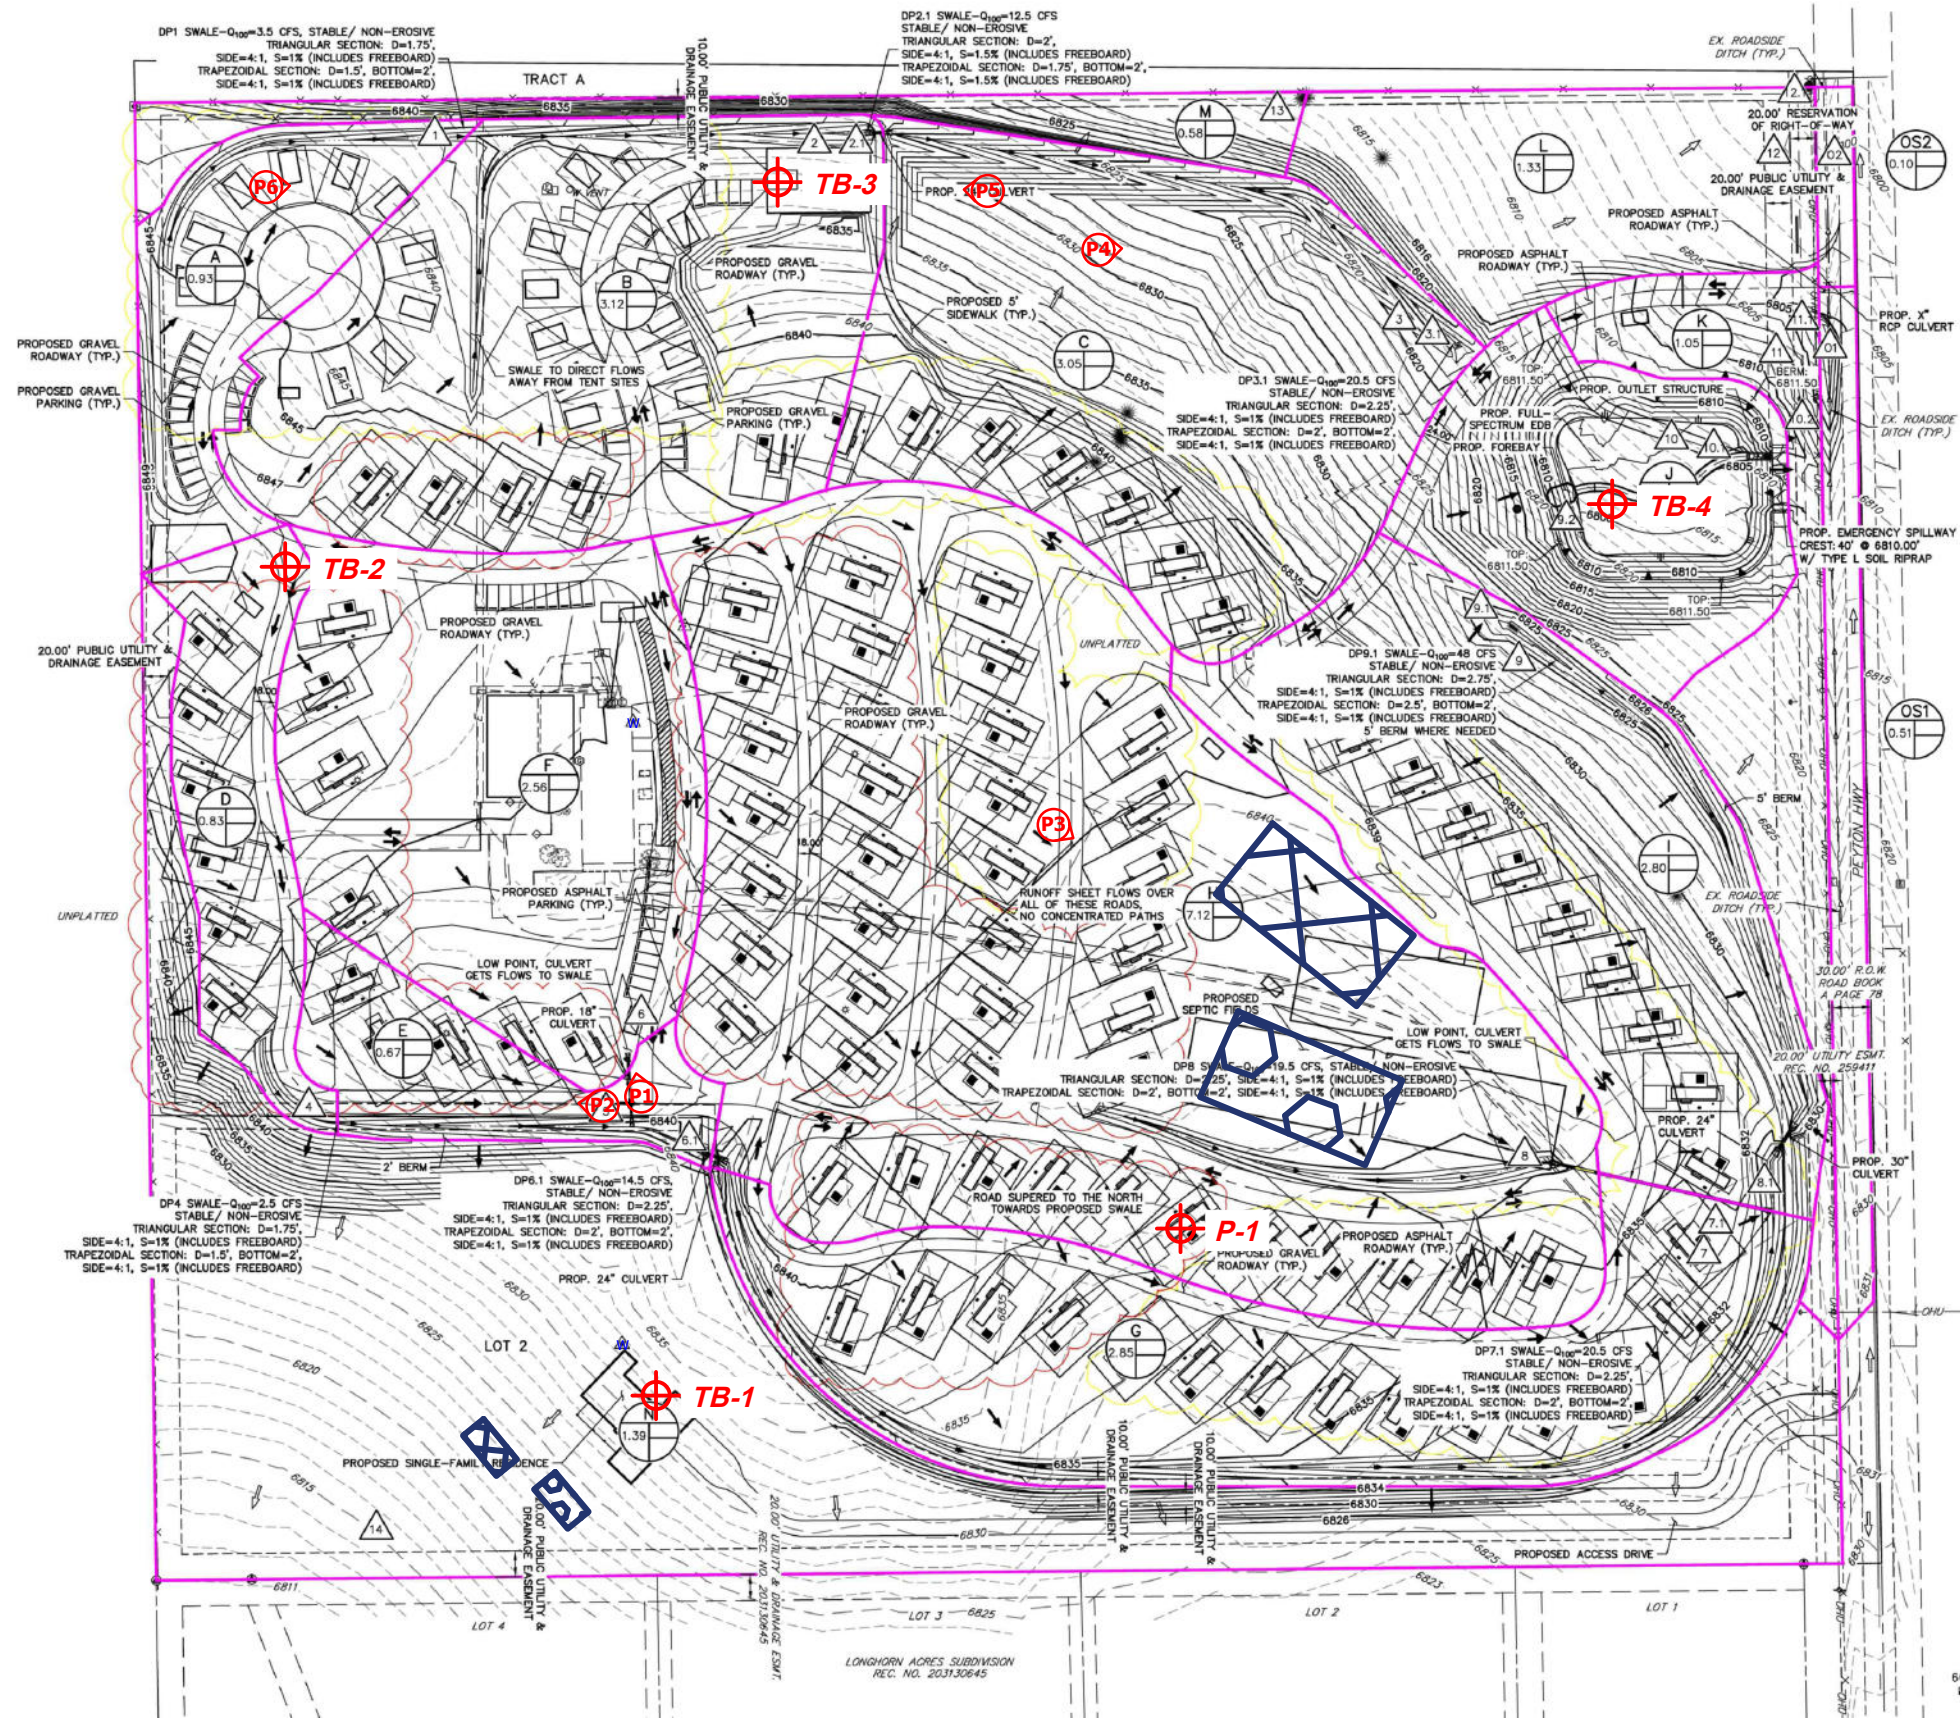
FIG. 8

PROPOSED DRAINAGE MAP
LAZY Y AND ROCKING J SUBDIVISION
JOB NO. 25228.00
11/29/23
SHEET 1 OF 1

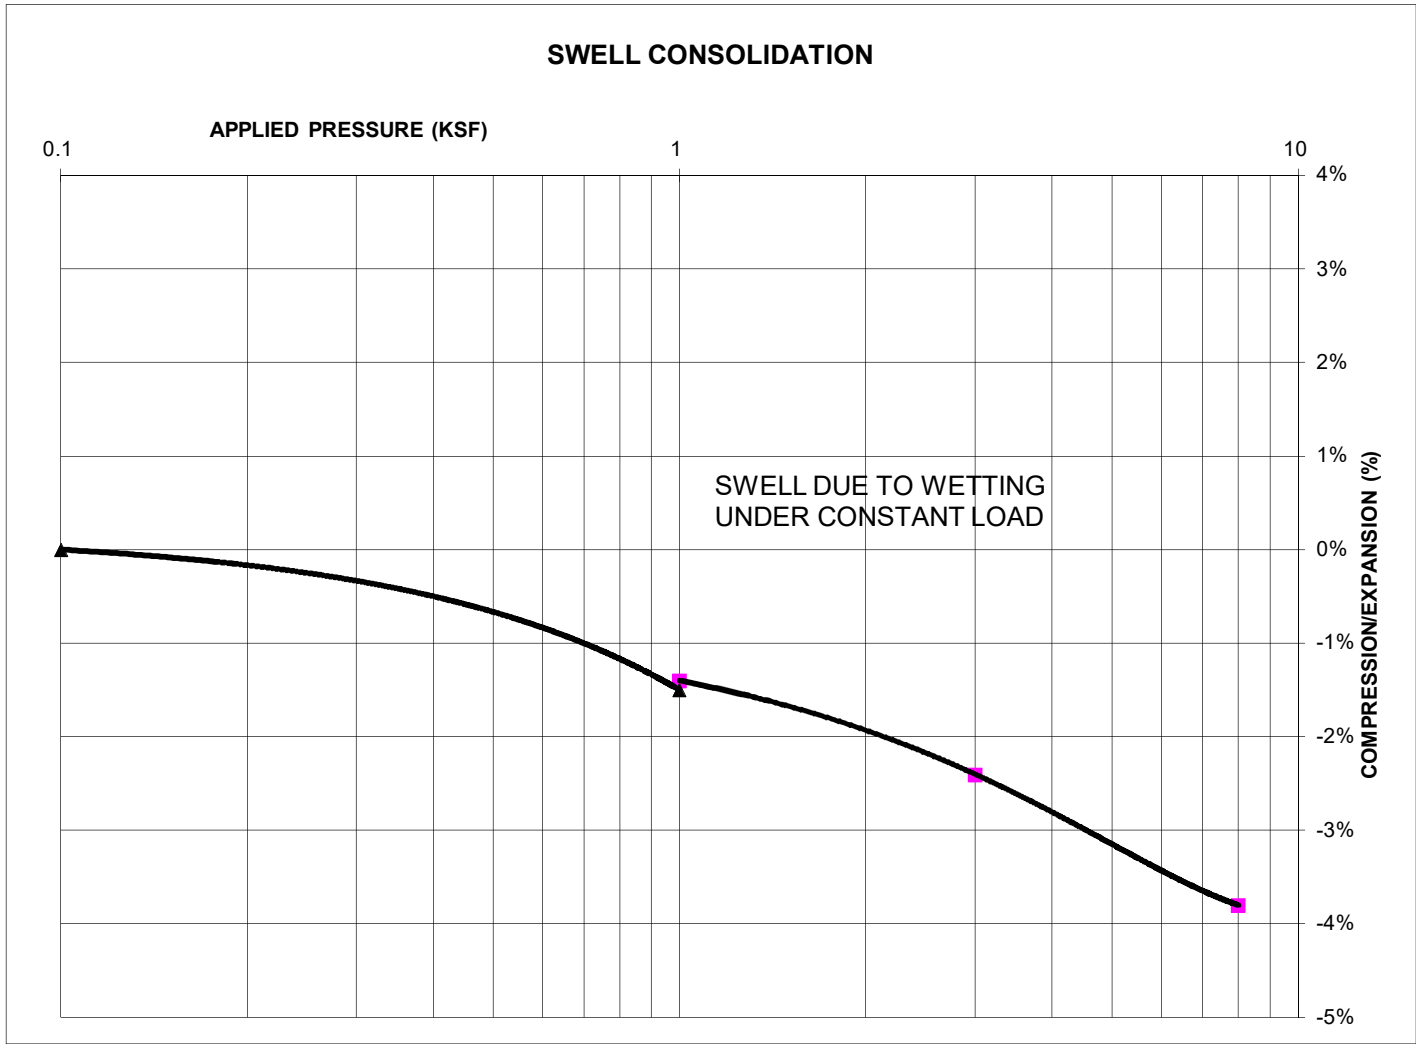
TEST BORING	4	SOIL DESCRIPTION	SANDSTONE (SAND, SILTY)
DEPTH (FT)	20	SOIL TYPE	3

SWELL/CONSOLIDATION TEST RESULTS

NATURAL UNIT DRY WEIGHT (PCF): 114
NATURAL MOISTURE CONTENT: 14.3%
SWELL/CONSOLIDATION (%): 0.1%

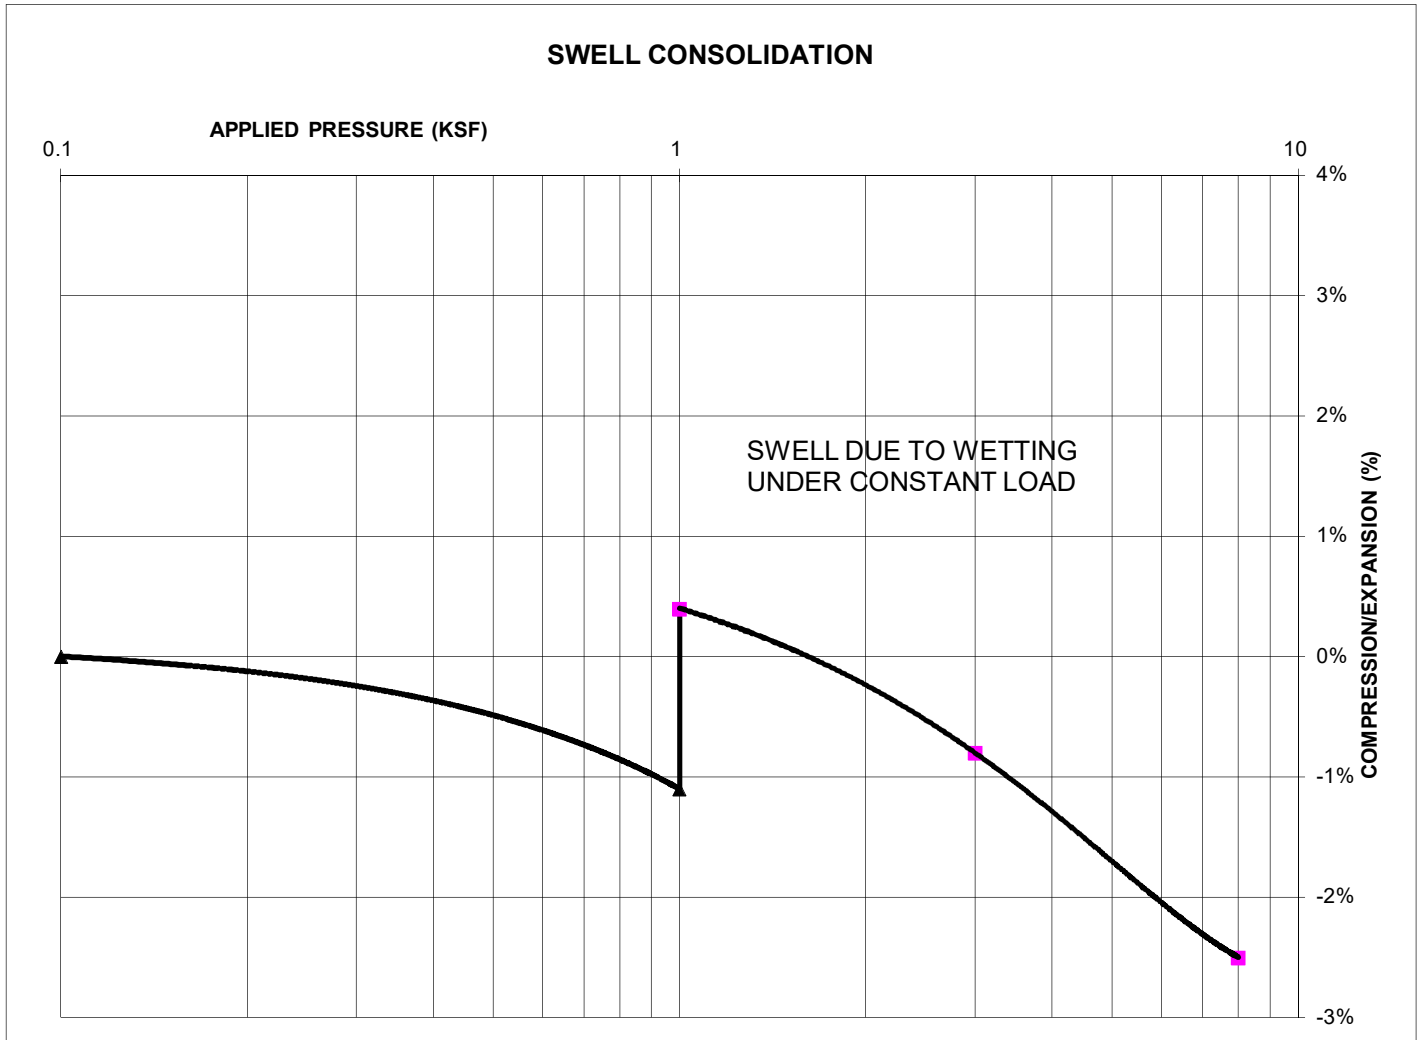
SOIL DESCRIPTION CLAYSTONE (CLAY, SANDY)
SOIL TYPE 4

SWELL/CONSOLIDATION TEST RESULTS

NATURAL UNIT DRY WEIGHT (PCF): 113
NATURAL MOISTURE CONTENT: 14.0%
SWELL/CONSOLIDATION (%): 1.5%
