Re: Response to CGS review comments (dated October 17, 2023) and El Paso County Planning Department comments (not dated)
Meadowlake Industrial, Filing No. 1
Section 9, Township 15 South, Range 65 West
El Paso County, Colorado

RMG - Rocky Mountain Group prepared the "*Soil and Geology Study*" (RMG Job No. 192628, last amended July 24, 2023) for the proposed development project comprising 27 lots. The entire Meadowlake Industrial and Commercial Park site is comprised of 254.7 but at this preliminary stage is to consist of 51.3 acres, zoned I-2 – Limited Industrial, within El Paso County, Colorado. The report was reviewed by personnel of the Colorado Geological Survey (CGS). The purpose of this letter is to provide our response to the latest CGS review comments. The responses and modifications noted herein have been incorporated into our amended report.

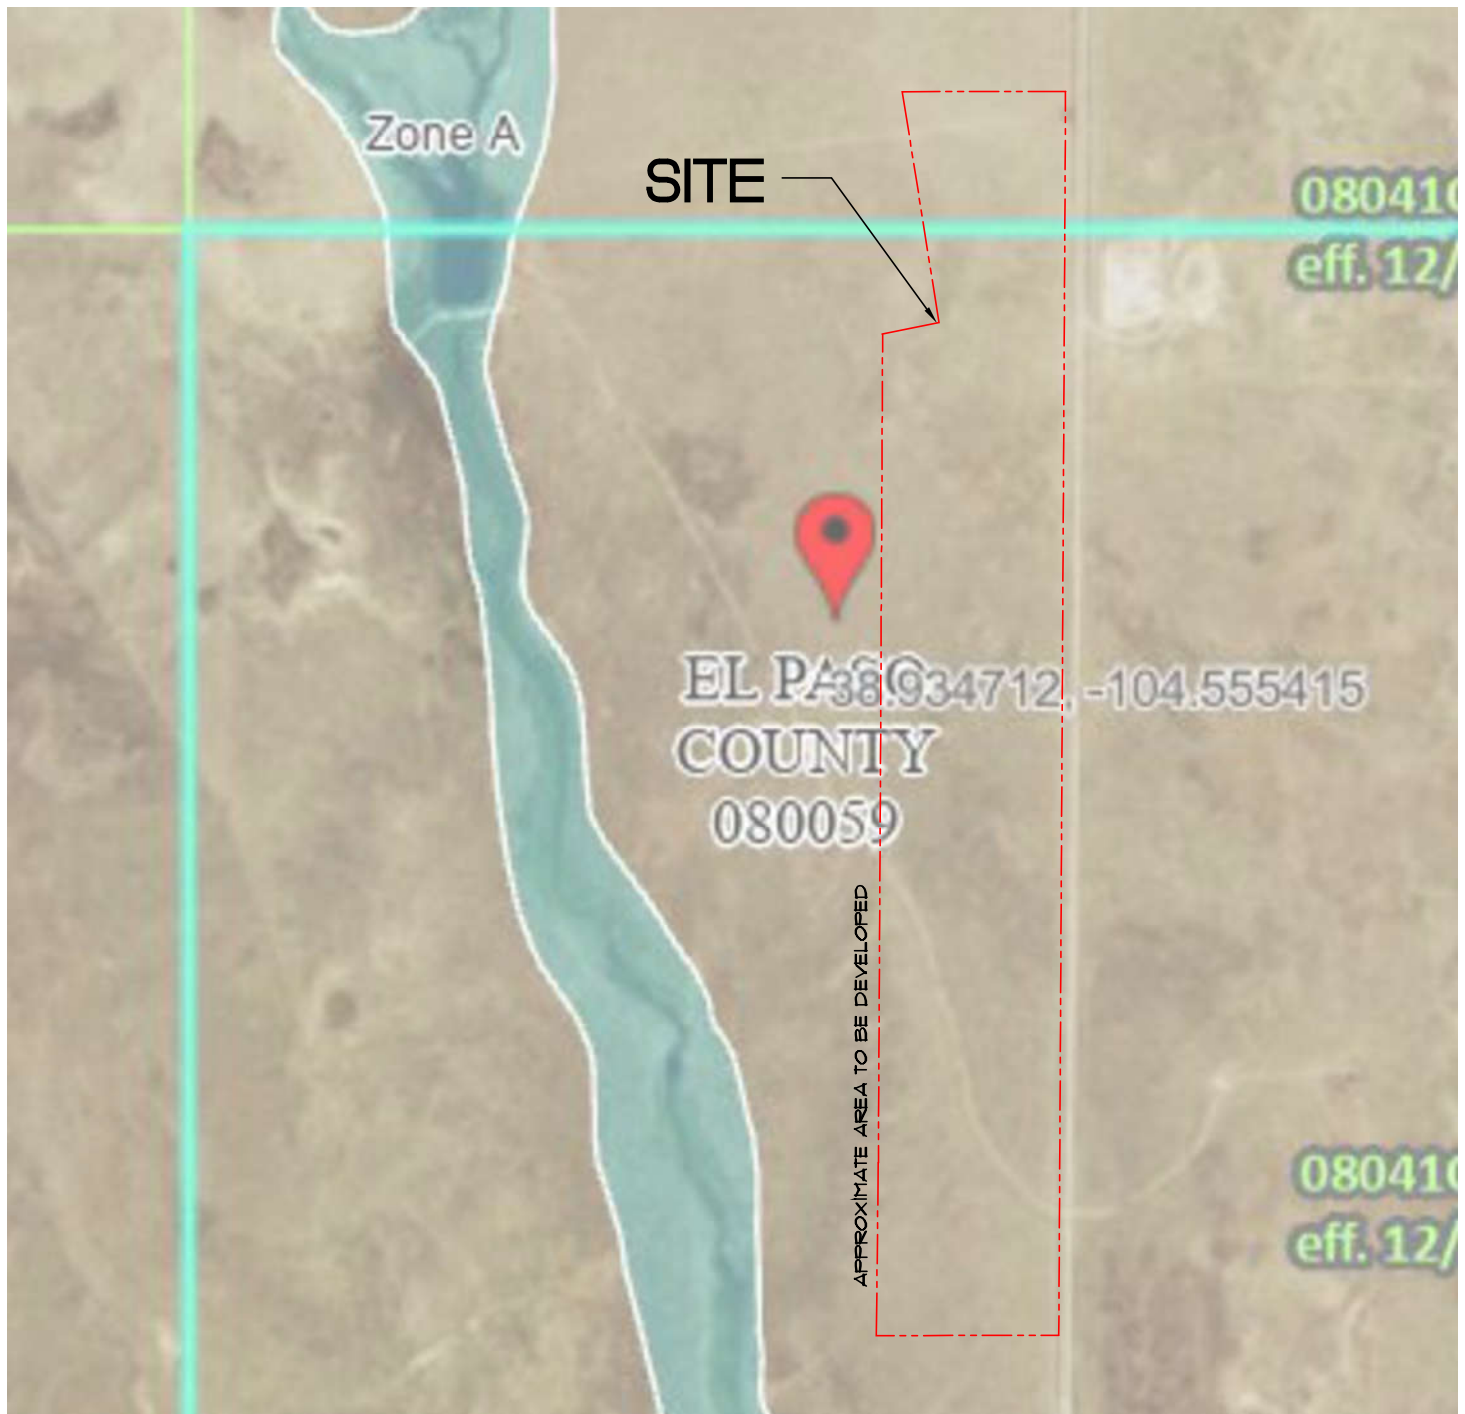
FIG No. 11

Zone X is defined by FEMA as an area of minimal flood hazard that is determined to be outside the Special Flood Hazard Area and higher than the elevation of the 0.2-percent-annual-chance (or 500-year) flood. Zone A is considered a special flood hazard area with a regulatory floodway. The Base Flood Elevations (BFE) for the drainageway have not been defined. All the proposed lots lie within Zone X. The FEMA Map is presented in Figure 11.
