Job No. 192628

Re: Response to CGS review comments (dated October 17, 2023) and El Paso County Planning Department comments (not dated)
Meadowlake Industrial, Filing No. 1
Section 9, Township 15 South, Range 65 West
El Paso County, Colorado

RMG - Rocky Mountain Group prepared the "*Soil and Geology Study*" (RMG Job No. 192628, last amended July 24, 2023) for the proposed development project comprising 27 lots. The entire Meadowlake Industrial and Commercial Park site is comprised of 254.7 but at this preliminary stage is to consist of 51.3 acres, zoned I-2 – Limited Industrial, within El Paso County, Colorado. The report was reviewed by personnel of the Colorado Geological Survey (CGS). The purpose of this letter is to provide our response to the latest CGS review comments. The responses and modifications noted herein have been incorporated into our amended report.

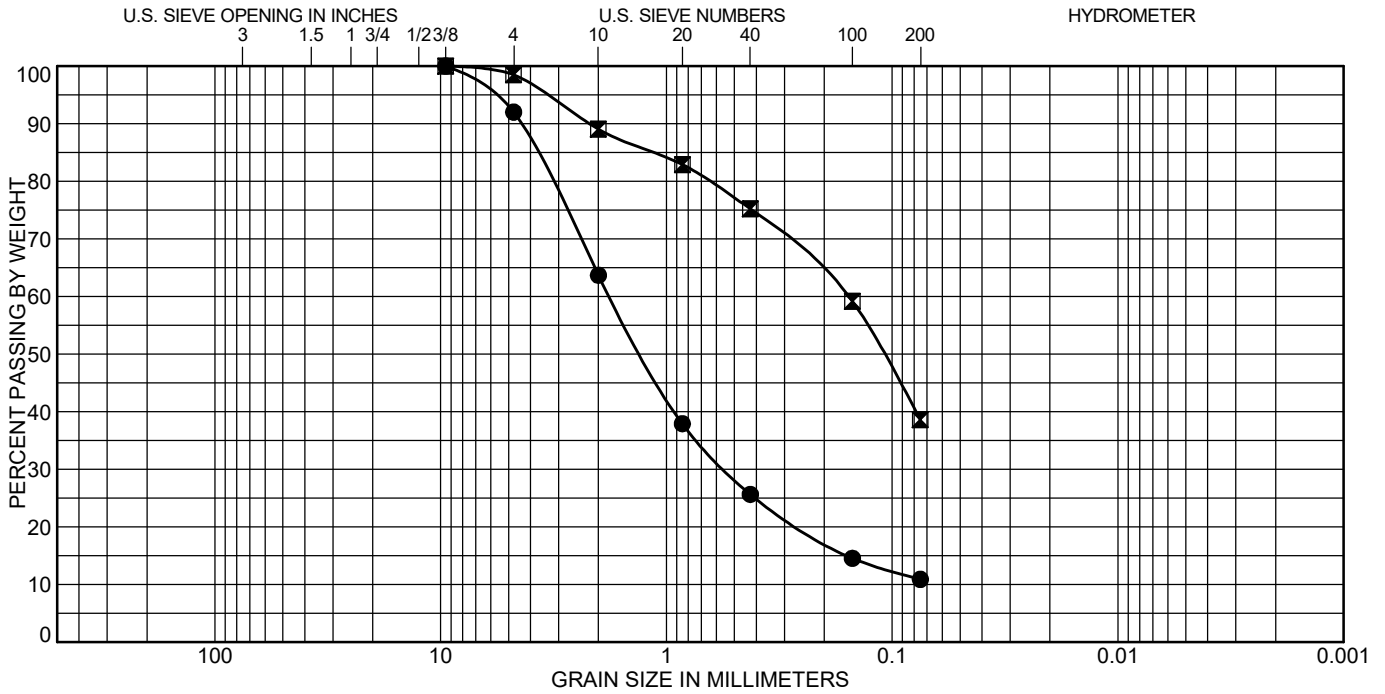
FIGURE No. 7

COBBLES	GRAVEL		SAND			SILT OR CLAY
	coarse	fine	coarse	medium	fine

Test Boring	Depth (ft)	Classification	LL	PL	PI
● 1	4.0	WELL-GRADED SAND with SILT(SW-SM)	NP	NP	NP
☒ 2	2.0	SILTY SAND(SM)	NP	5	NP

Soil laboratory testing was performed as part of this investigation. The laboratory tests included moisture content, grain-size analyses, and Atterberg Limit tests. A Summary of Laboratory Test Results is presented in Figure 6. Soils Classification Data is presented in Figure 7.
