SOIL AND GEOLOGY STUDY

**Meadow Lake Industrial
Section 9, Township 15 South, Range 65 West
El Paso County, Colorado**

JOB NO. 192628

**July 13, 2023
Last Amended September 30, 2024**

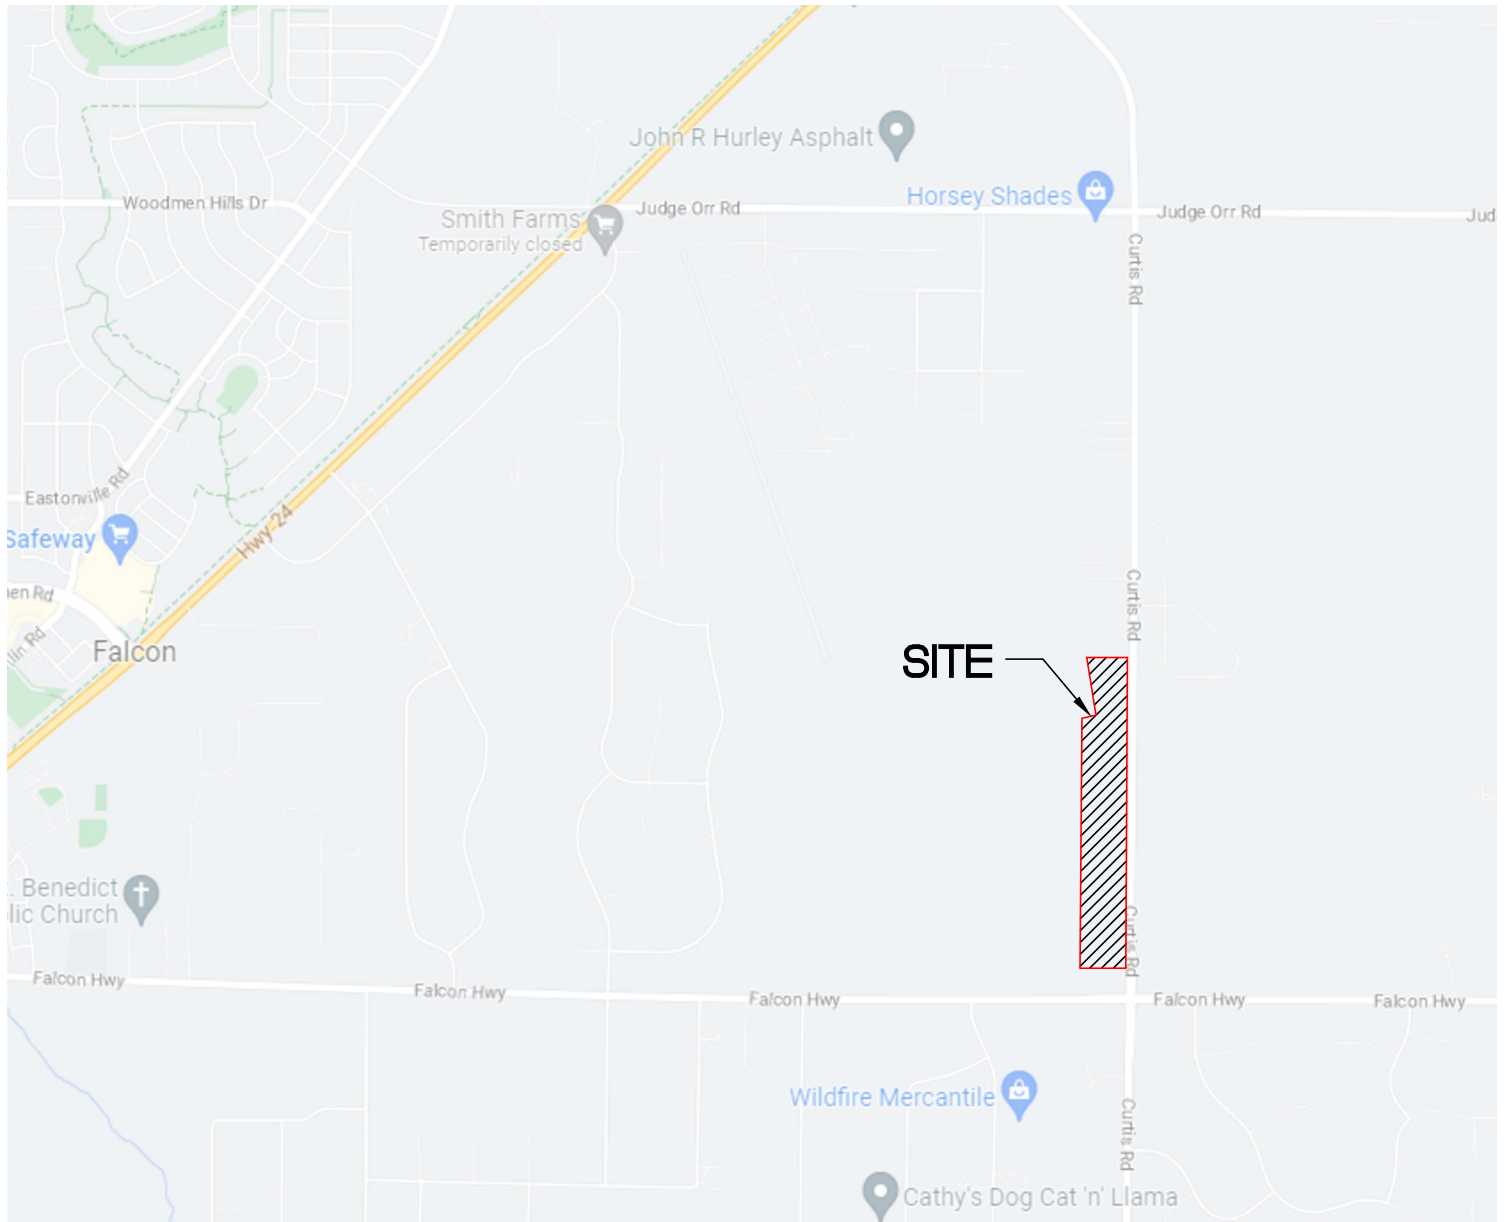
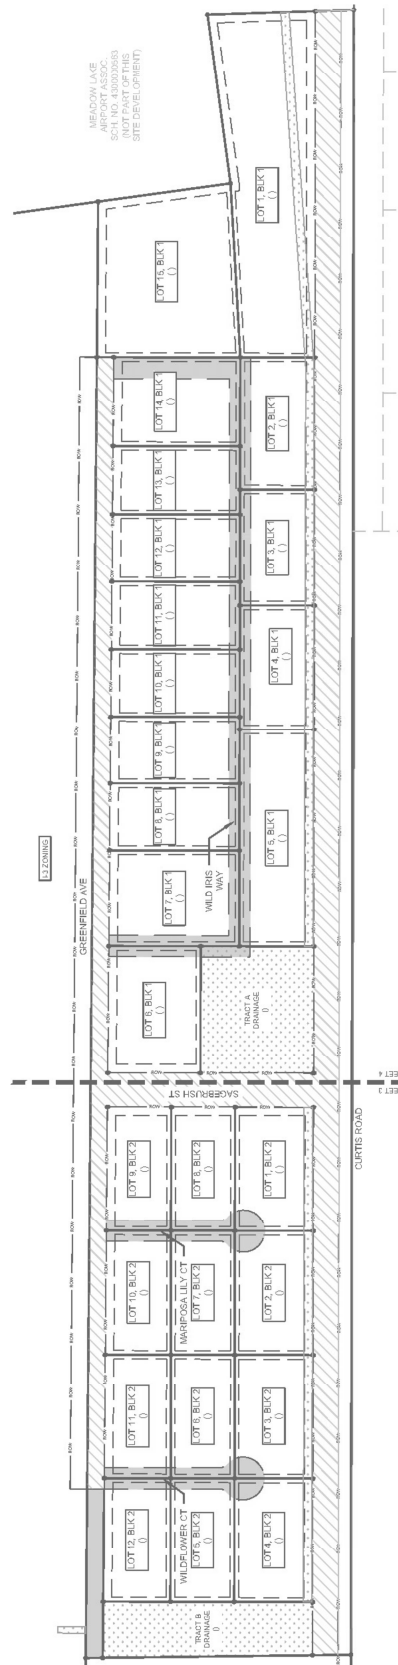
FIG No. 2

PRELIMINARY OVERALL SITE PLAN
MEADOW LAKE INDUSTRIAL FILING NO. 1
A PART OF THE EAST HALF OF SECTION 9, TOWNSHIP 13 SOUTH, RANGE 64 WEST OF
THE SIXTH PRINCIPAL MERIDIAN, COUNTY OF EL PASO, STATE OF COLORADO

interior lots, which will also provide fire access. Currently the proposed concept is to utilize a one shared well and two shared OWTS's. One OWTS is to service the northern portion of the site (Lot 10, Block 1) and a second OWTS is to utilize the southern portion of the site (Lot 7, Block 2). Each OWTS is to service multiple lots. At a future date, the OWTS are to be replaced with a centralized wastewater system. Once the centralized waste system is installed, the original OWTS locations are to be properly disposed of or abandoned and designated as a no build area. The Proposed Site Plan is presented in Figure 2.

Visible evidence of ongoing erosion/scour along the drainageway was not observed. Due to the current alignment of the drainageway and the configuration of the site, the drainageway traverses the western portion of the site. As such, if the lot configuration remains as presented in Figure 2, additional drainage improvements should not be required.

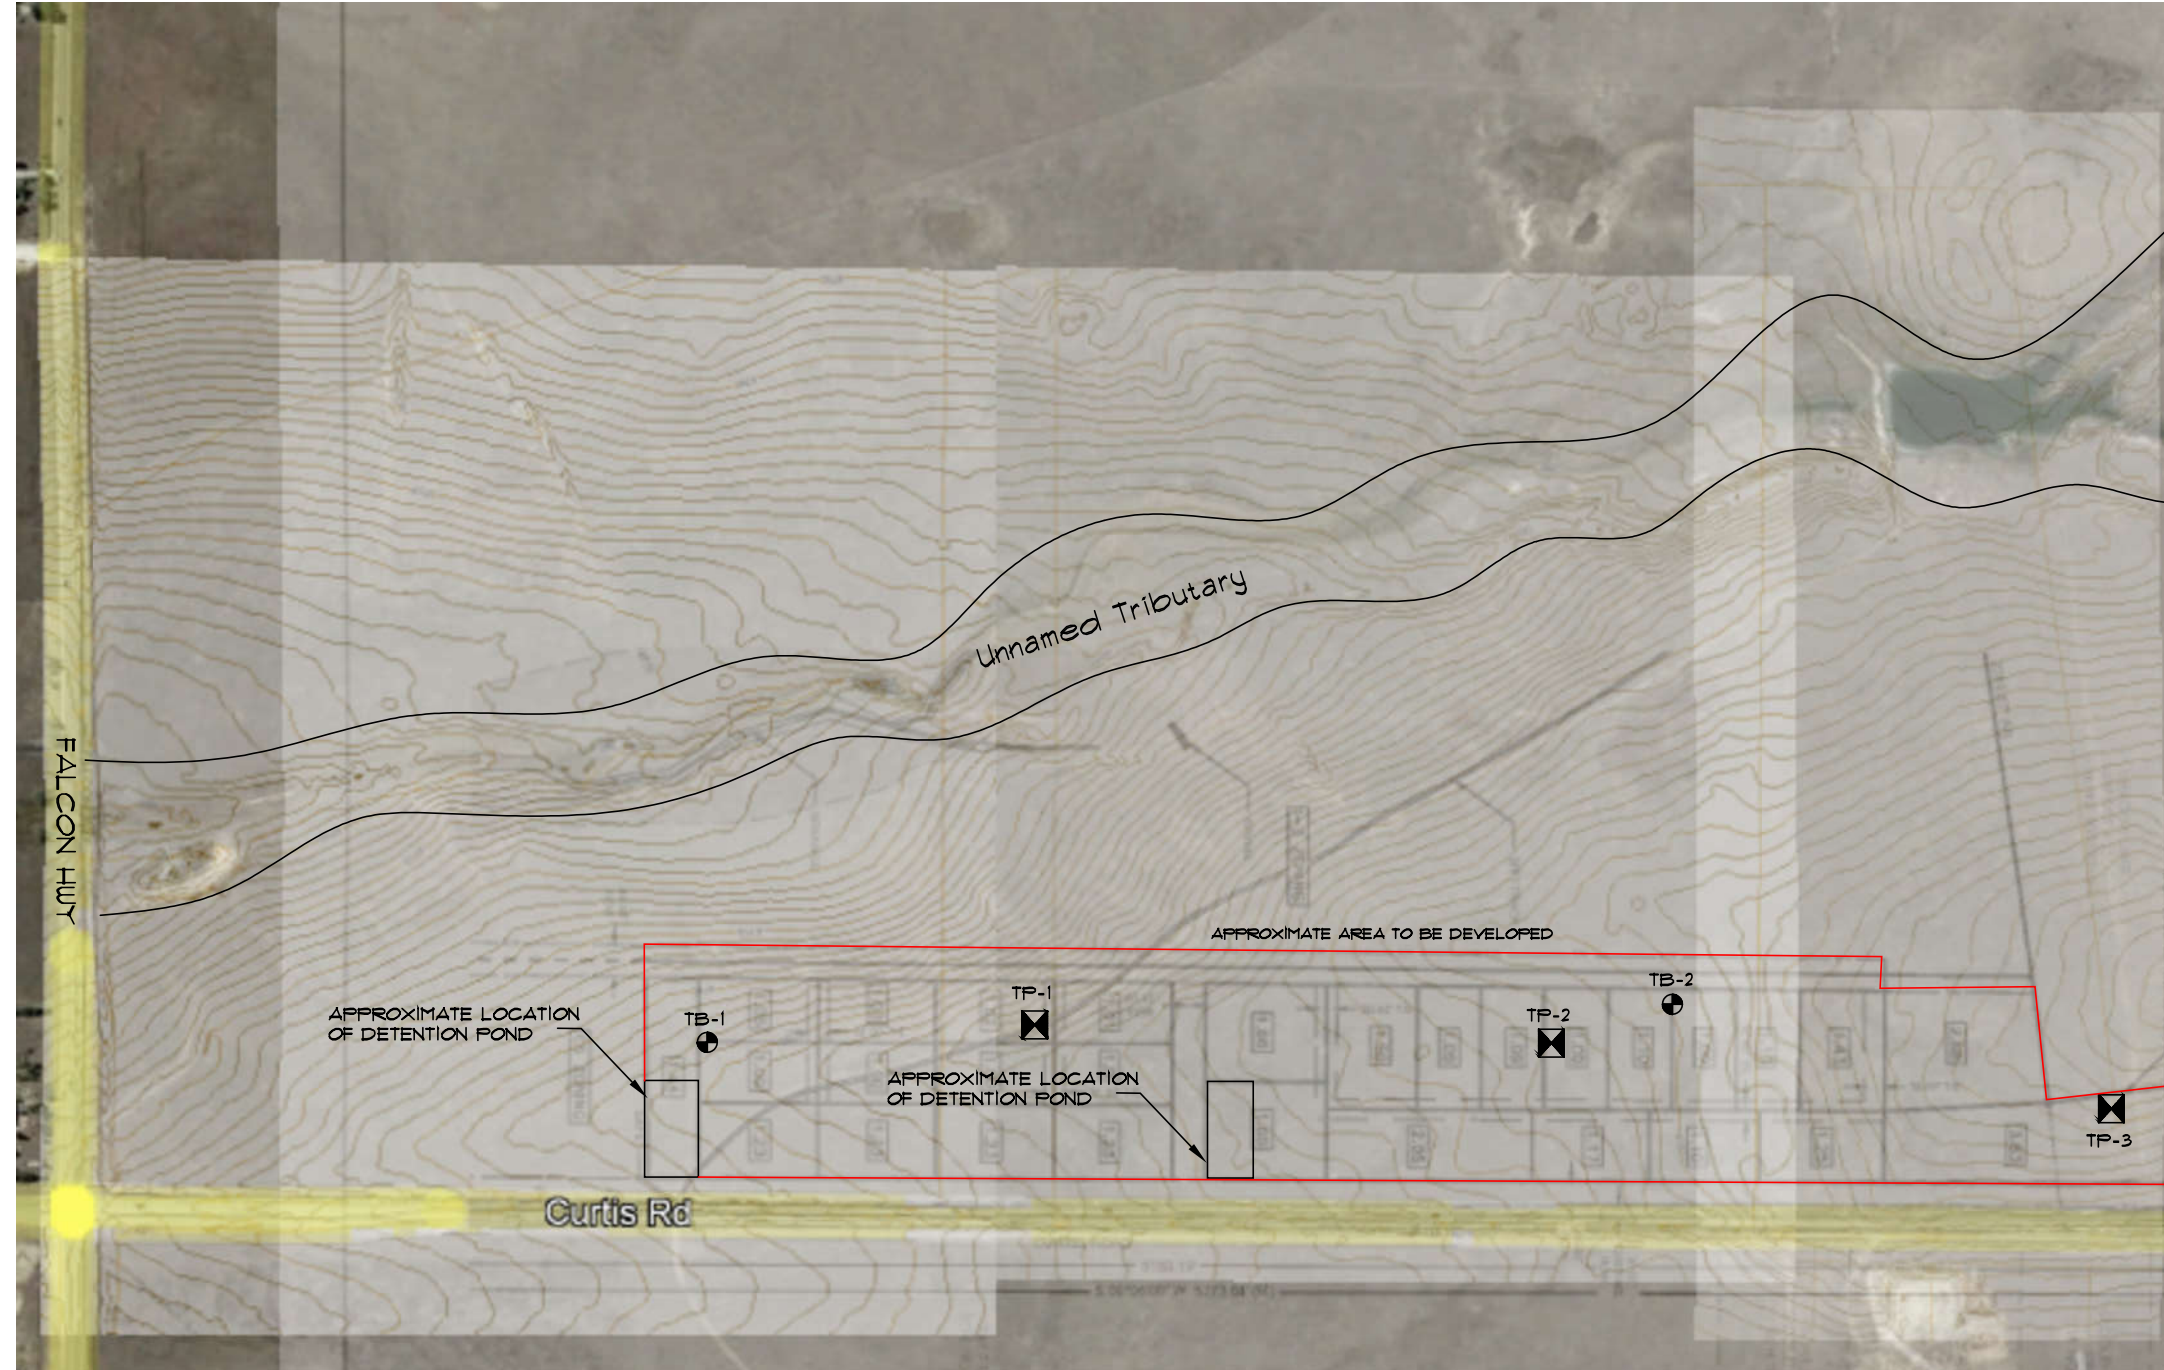
○ DENOTES APPROXIMATE
LOCATION OF TEST BORINGS

The test borings were drilled with a power-driven, continuous-flight auger drill rig. Samples were obtained during drilling of the test boring in general accordance with ASTM D-1586 and D-3550, utilizing a 2-inch O.D. Split Barrel Sampler. The test pits were performed with a mini-excavator, provided by others, and observed by RMG at the time of excavation. An Explanation of Test Boring Logs and the Test Boring Logs are presented in Figures 4 and 5.

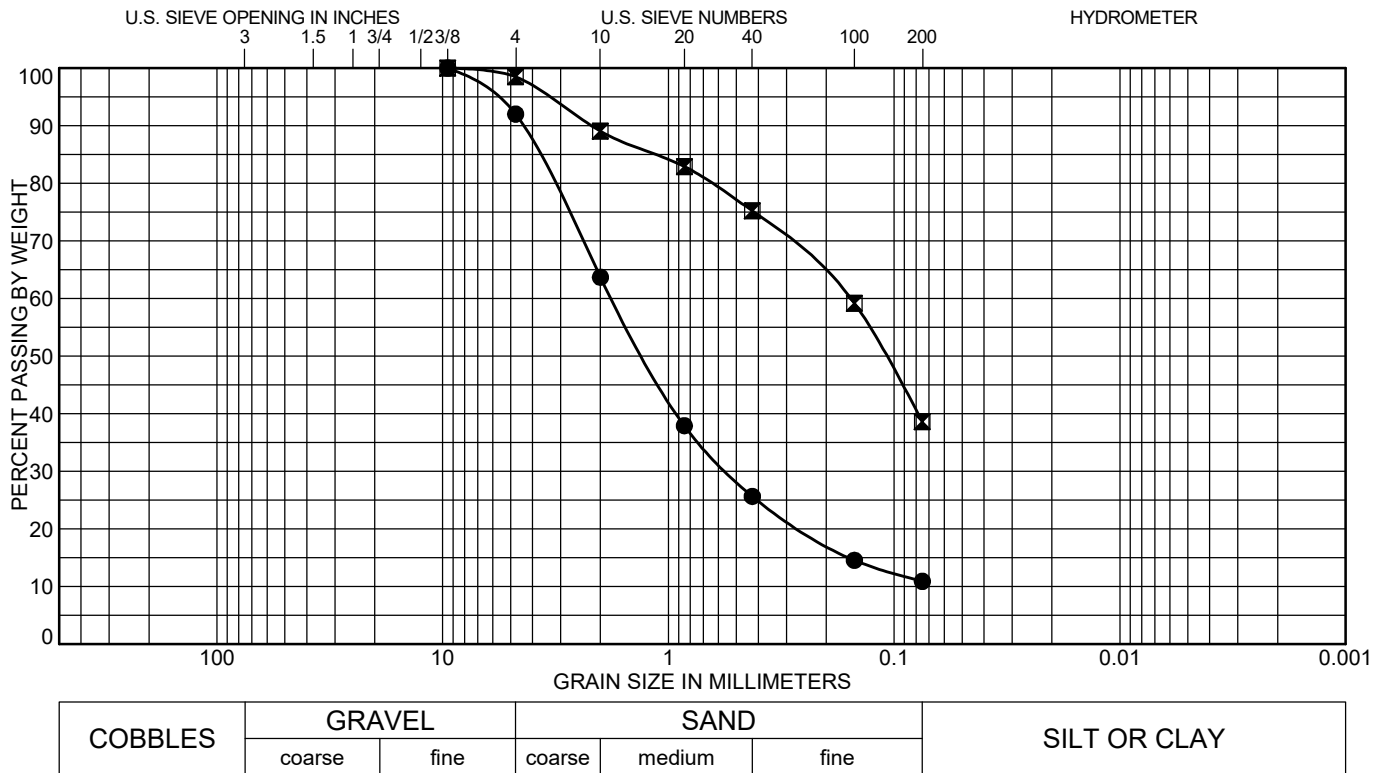
FIGURE No. 7

Test Boring	Depth (ft)	Classification				LL	PL	PI
● 1	4.0	WELL-GRADED SAND with SILT(SW-SM)				NP	NP	NP
☒ 2	2.0	SILTY SAND(SM)				NP	5	NP
Test Boring	Depth (ft)	%Gravel	%Sand	%Silt	%Clay			
● 1	4.0	8.0	81.1	10.9				
☒ 2	2.0	1.5	59.9	38.6

Soil laboratory testing was performed as part of this investigation. The laboratory tests included moisture content, grain-size analyses, and Atterberg Limit tests. A Summary of Laboratory Test Results is presented in Figure 6. Soils Classification Data is presented in Figure 7.

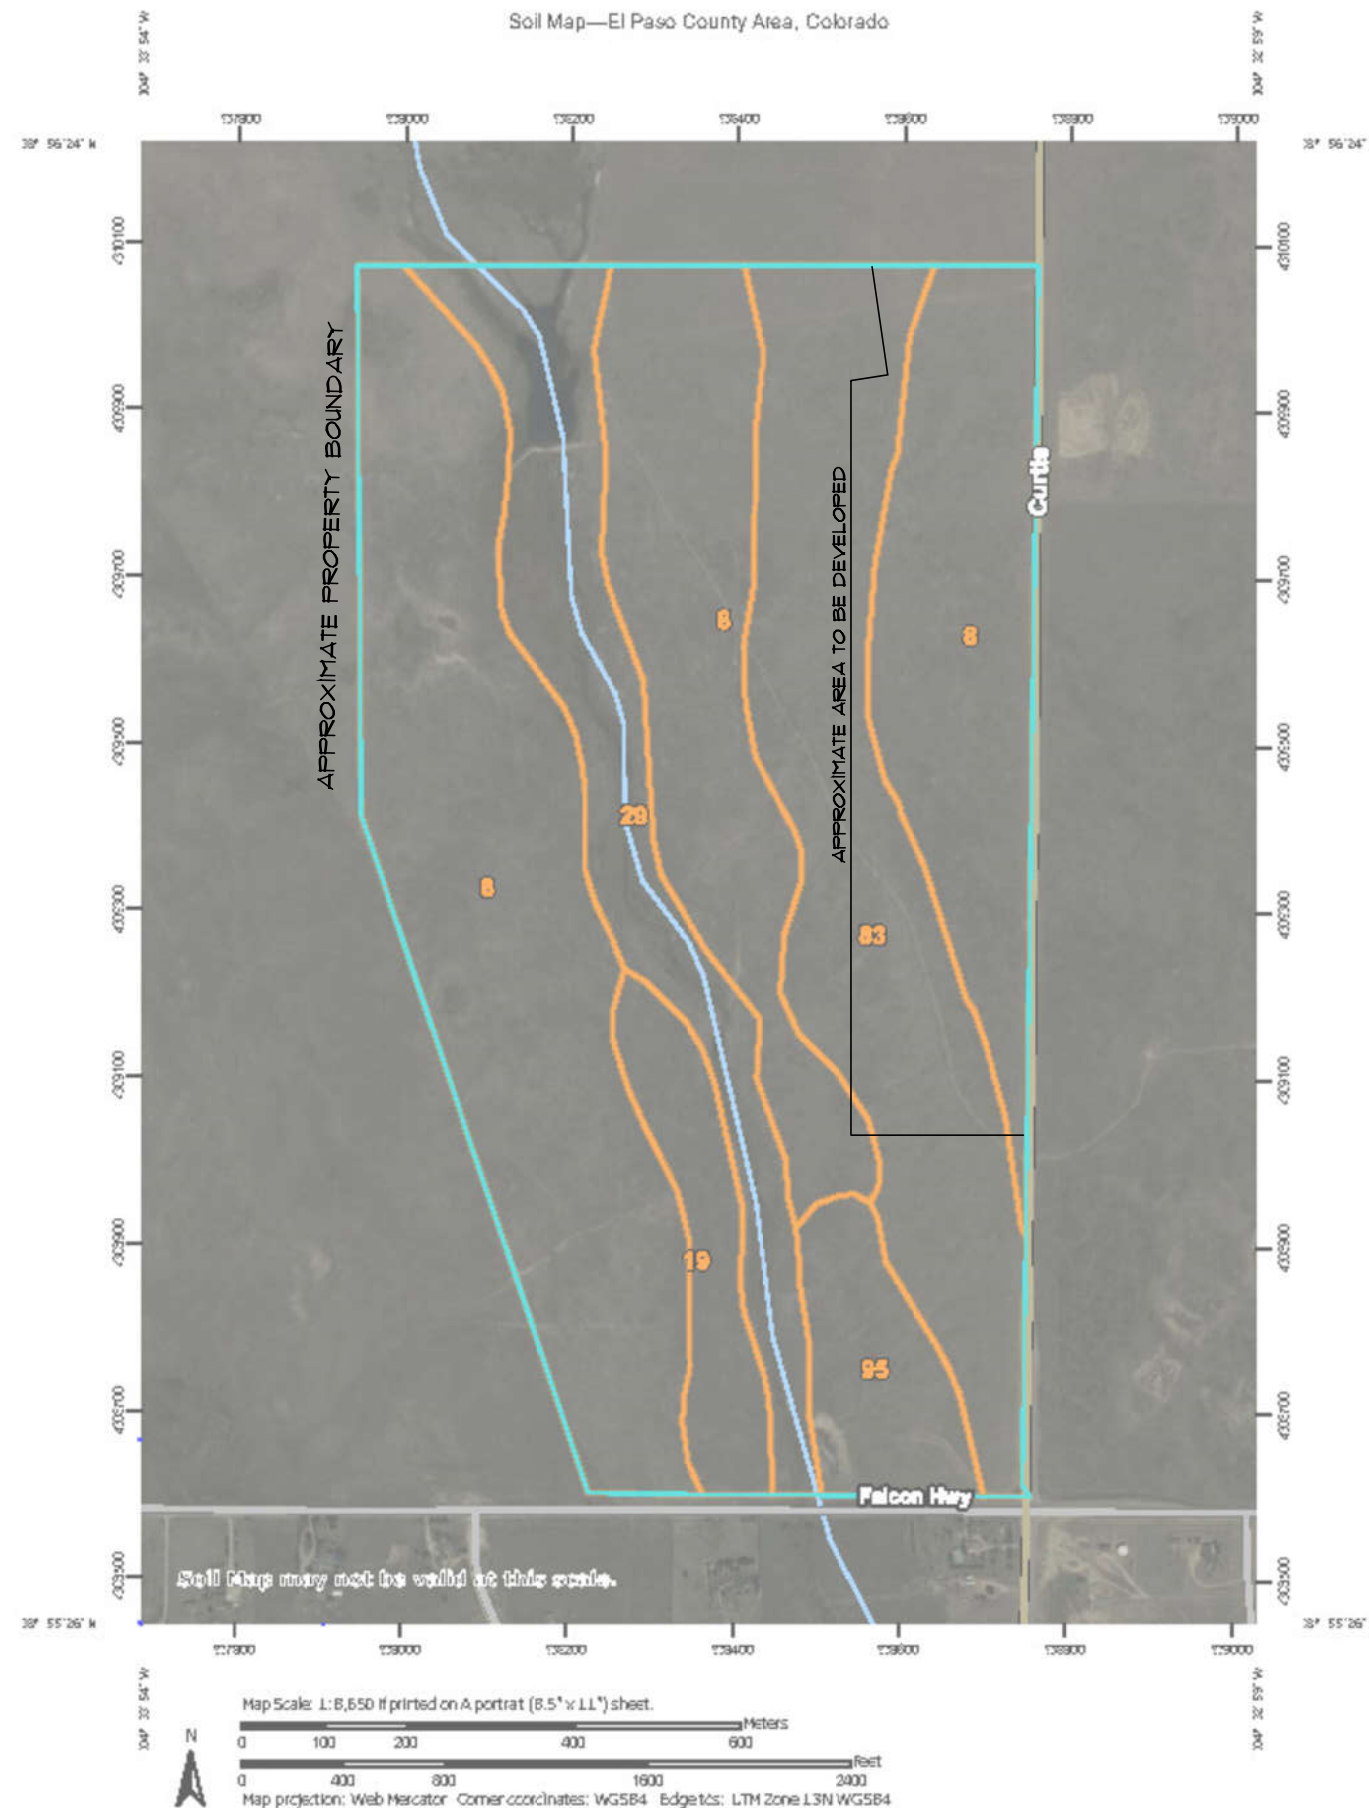
FIG-8

8 - Blakeland Loamy Sand,
1 to 9 percent slopes

83 - Stapleton sandy loam, 3
to 8 percent slopes

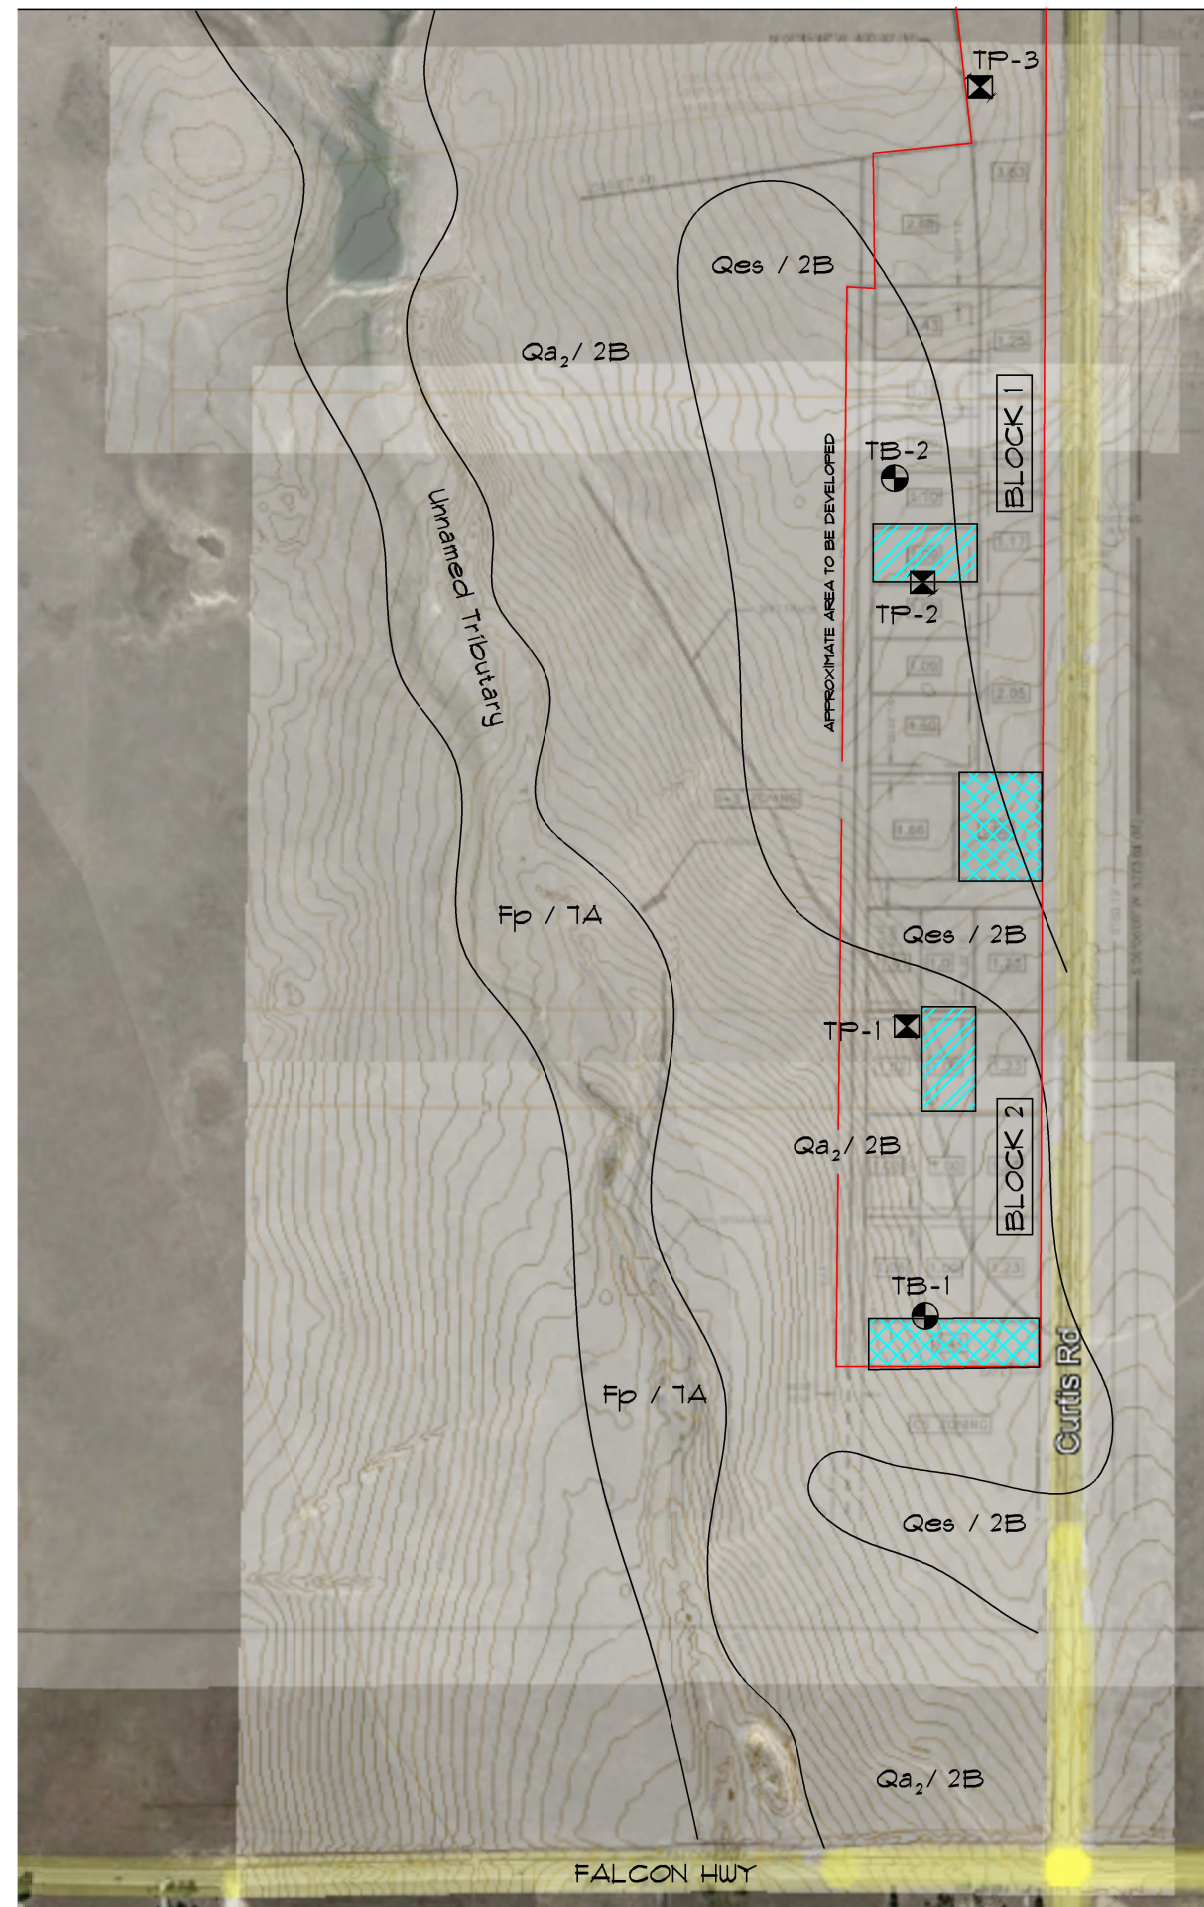
GEOLOGIC CONDITIONS

Qes - Eolian Sand (Holocene to upper Pleistocene) Fine to coarse grained sand. Unit is faintly stratified, non-cohesive, and drains well. Unit may exceed 5 feet in thickness

Based on our field observations and review of relevant geologic maps, we identified the geologic conditions (listed below) affecting the development, as shown on the Engineering Geology Map, Figure 9.

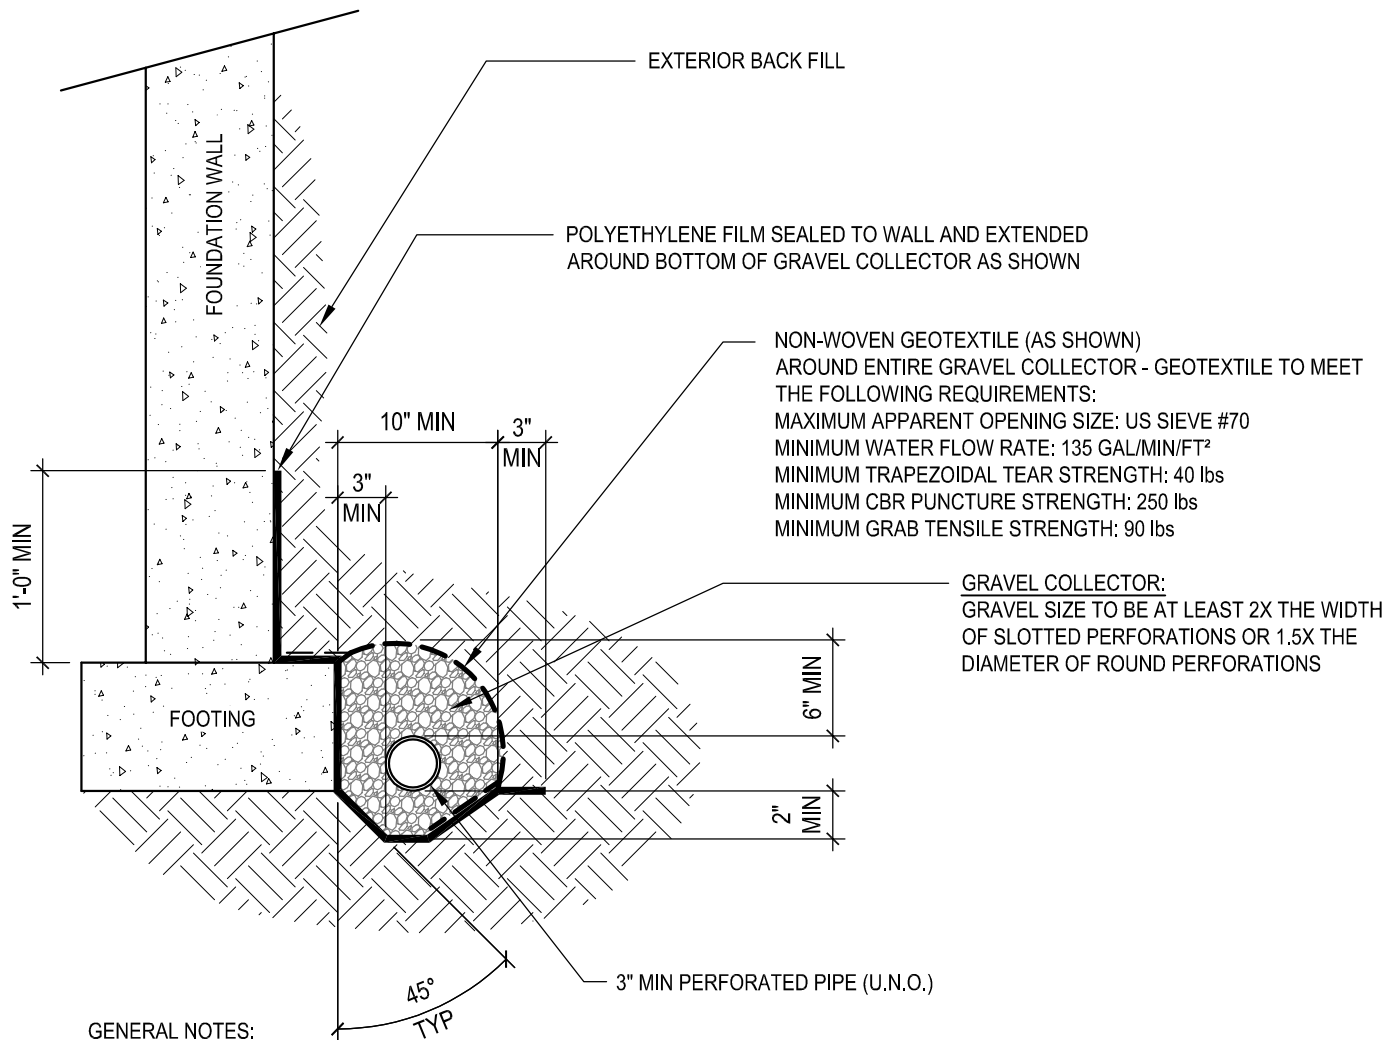
1. BOTTOM OF DRAIN PIPE SHALL BE AT OR BELOW BOTTOM OF FOOTING AT ALL LOCATIONS
2. ALL DRAIN PIPE SHALL BE PERFORATED PLASTIC, WITH THE EXCEPTION OF THE DISCHARGE PORTION WHICH SHALL BE SOLID, NON-PERFORATED PIPE.

Due to the limited cuts and fills proposed, groundwater is not anticipated to be encountered in the excavations or utility trenches. Foundations must have a minimum 30-inch depth for frost protection. Perimeter drains are recommended around portions of the structures (if any) which will have habitable or storage space located below the finished ground surface. This includes crawlspace areas but not the walkout trench, if applicable. Perimeter drains help prevent the intrusion of water into areas below grade. A typical perimeter drain detail is presented in Figure 13.
