SOIL AND GEOLOGY STUDY

**Meadow Lake Industrial
Section 9, Township 15 South, Range 65 West
El Paso County, Colorado**

JOB NO. 192628

**July 13, 2023
Revised July 24, 2023**

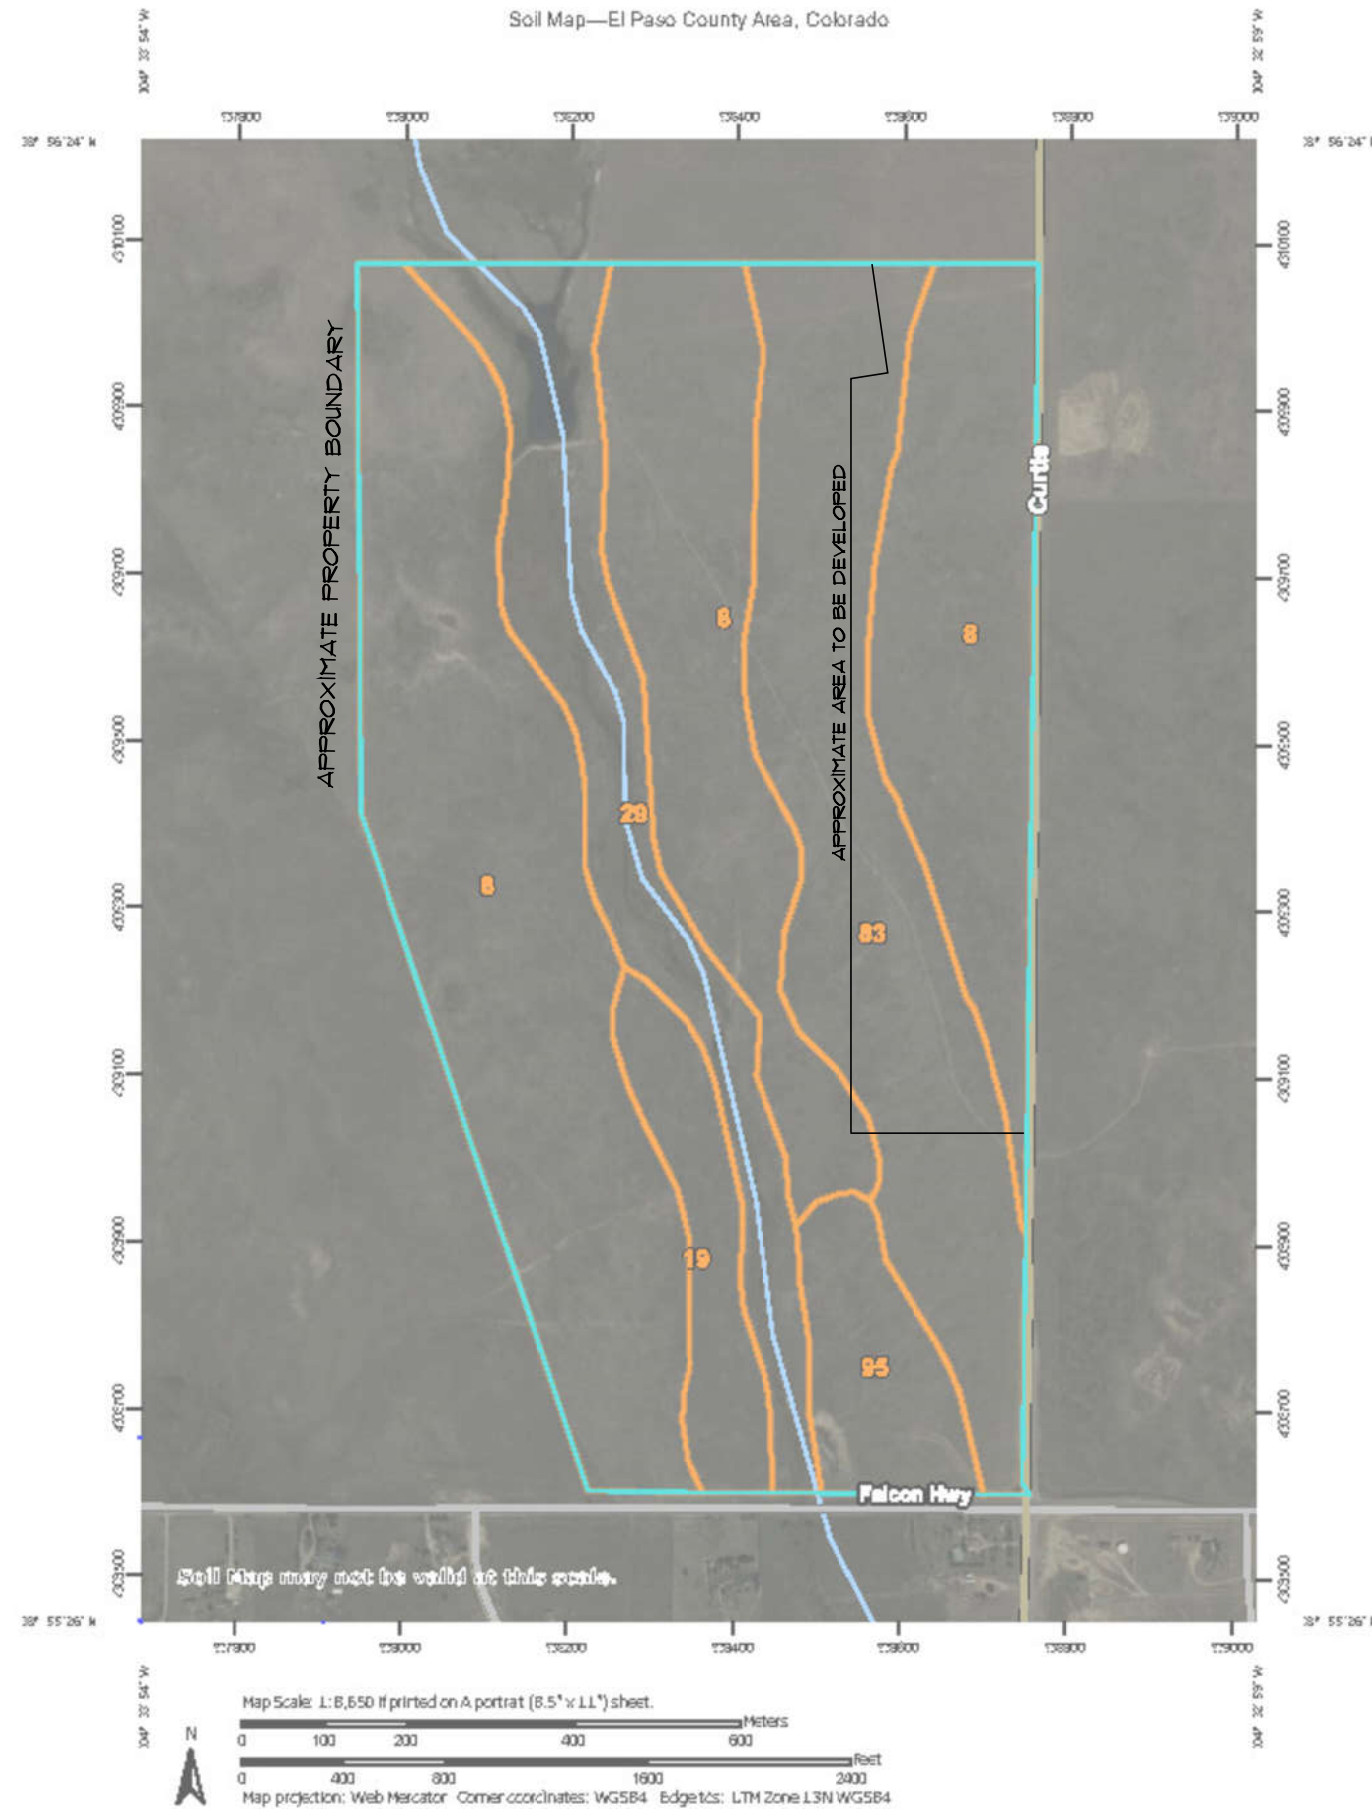
FIG-8

8 - Blakeland Loamy Sand, 1 to 9 percent slopes

83 - Stapleton sandy loam, 3 to 8 percent slopes

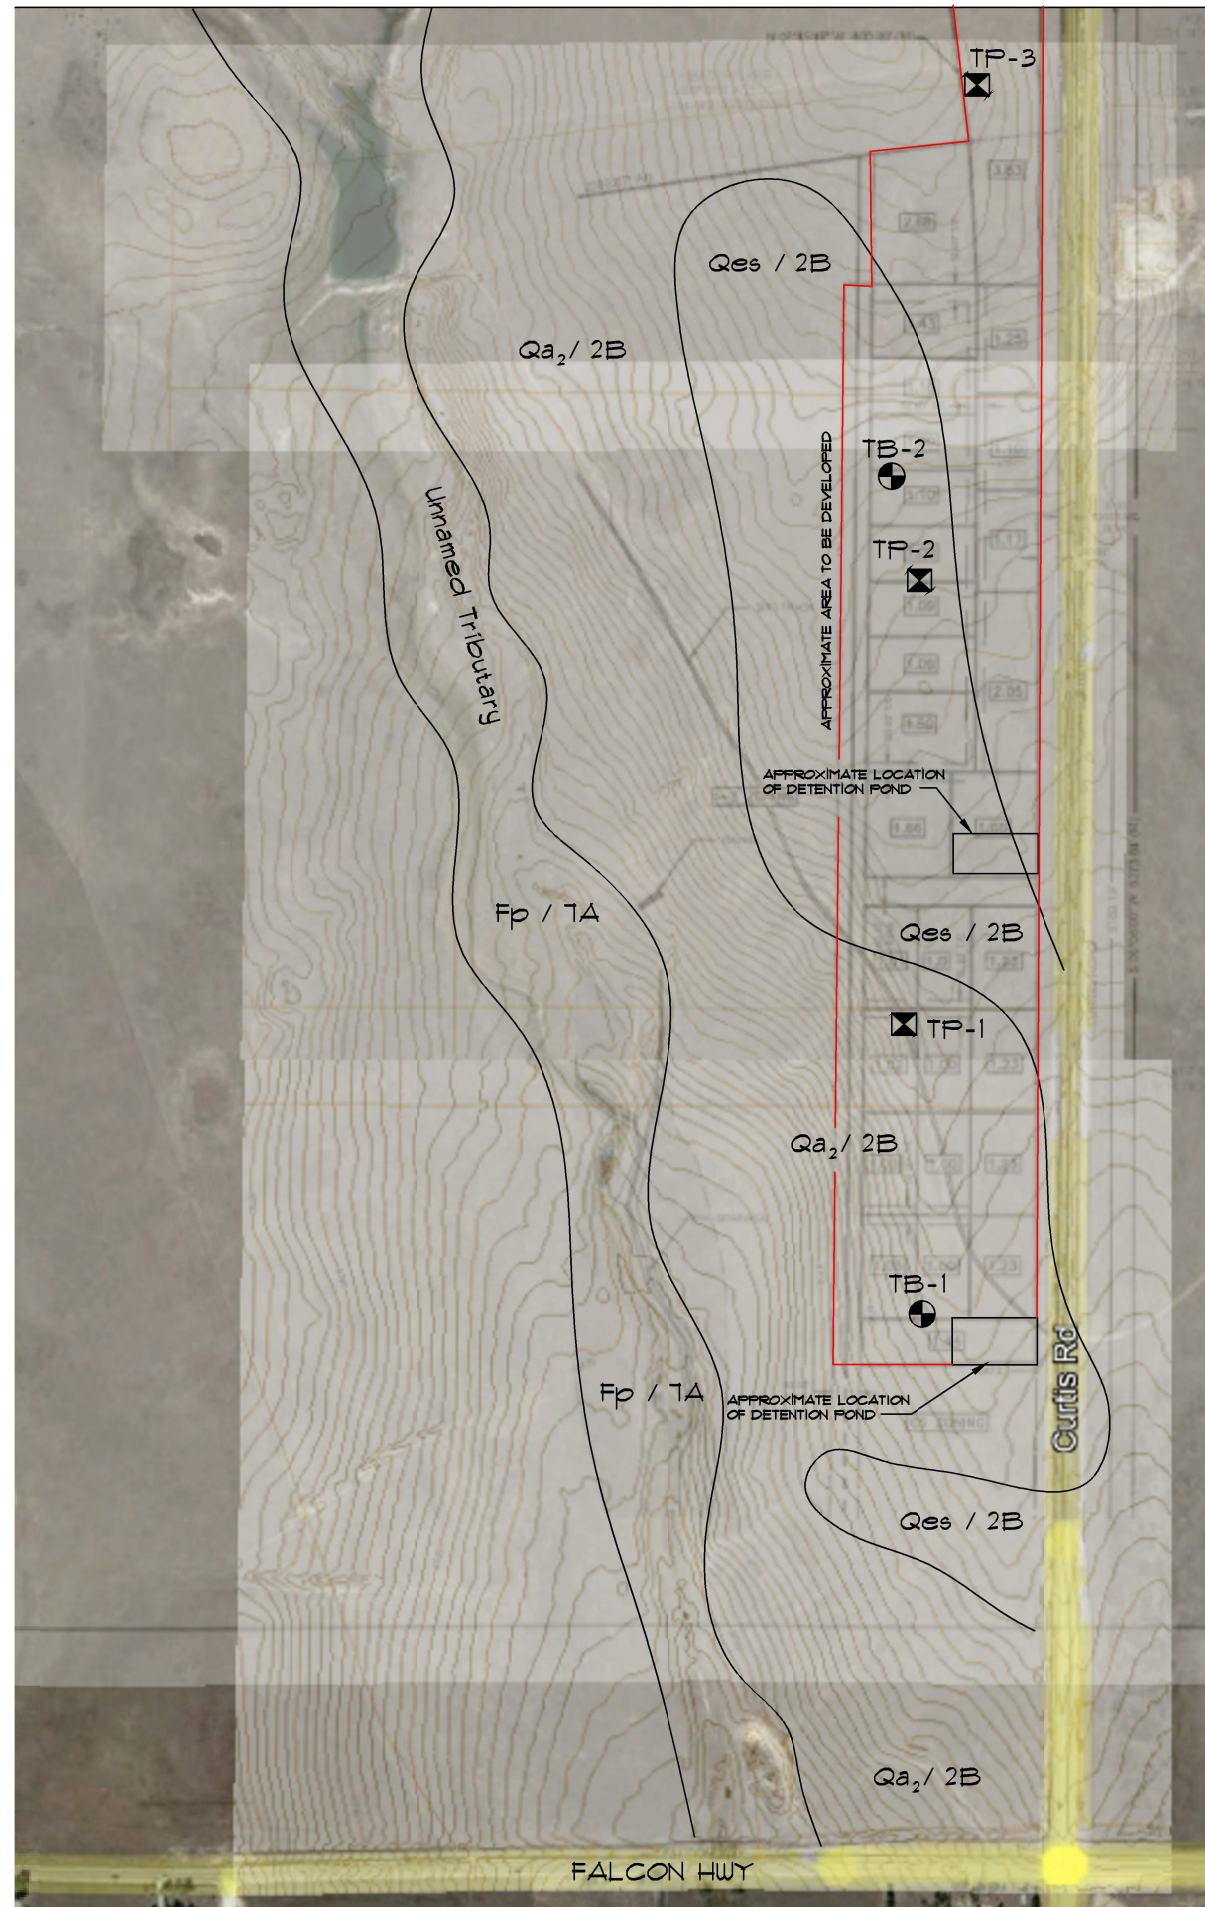
FIG-9

GEOLOGIC CONDITIONS

Qes - Eolian Sand (Holocene to upper Pleistocene) Fine to coarse grained sand. Unit is faintly stratified, non-cohesive, and drains well. Unit may exceed 5 feet in thickness

Based on our field observations and review of relevant geologic maps, we identified the geologic conditions (listed below) affecting the development, as shown on the Engineering Geology Map, Figure 9.

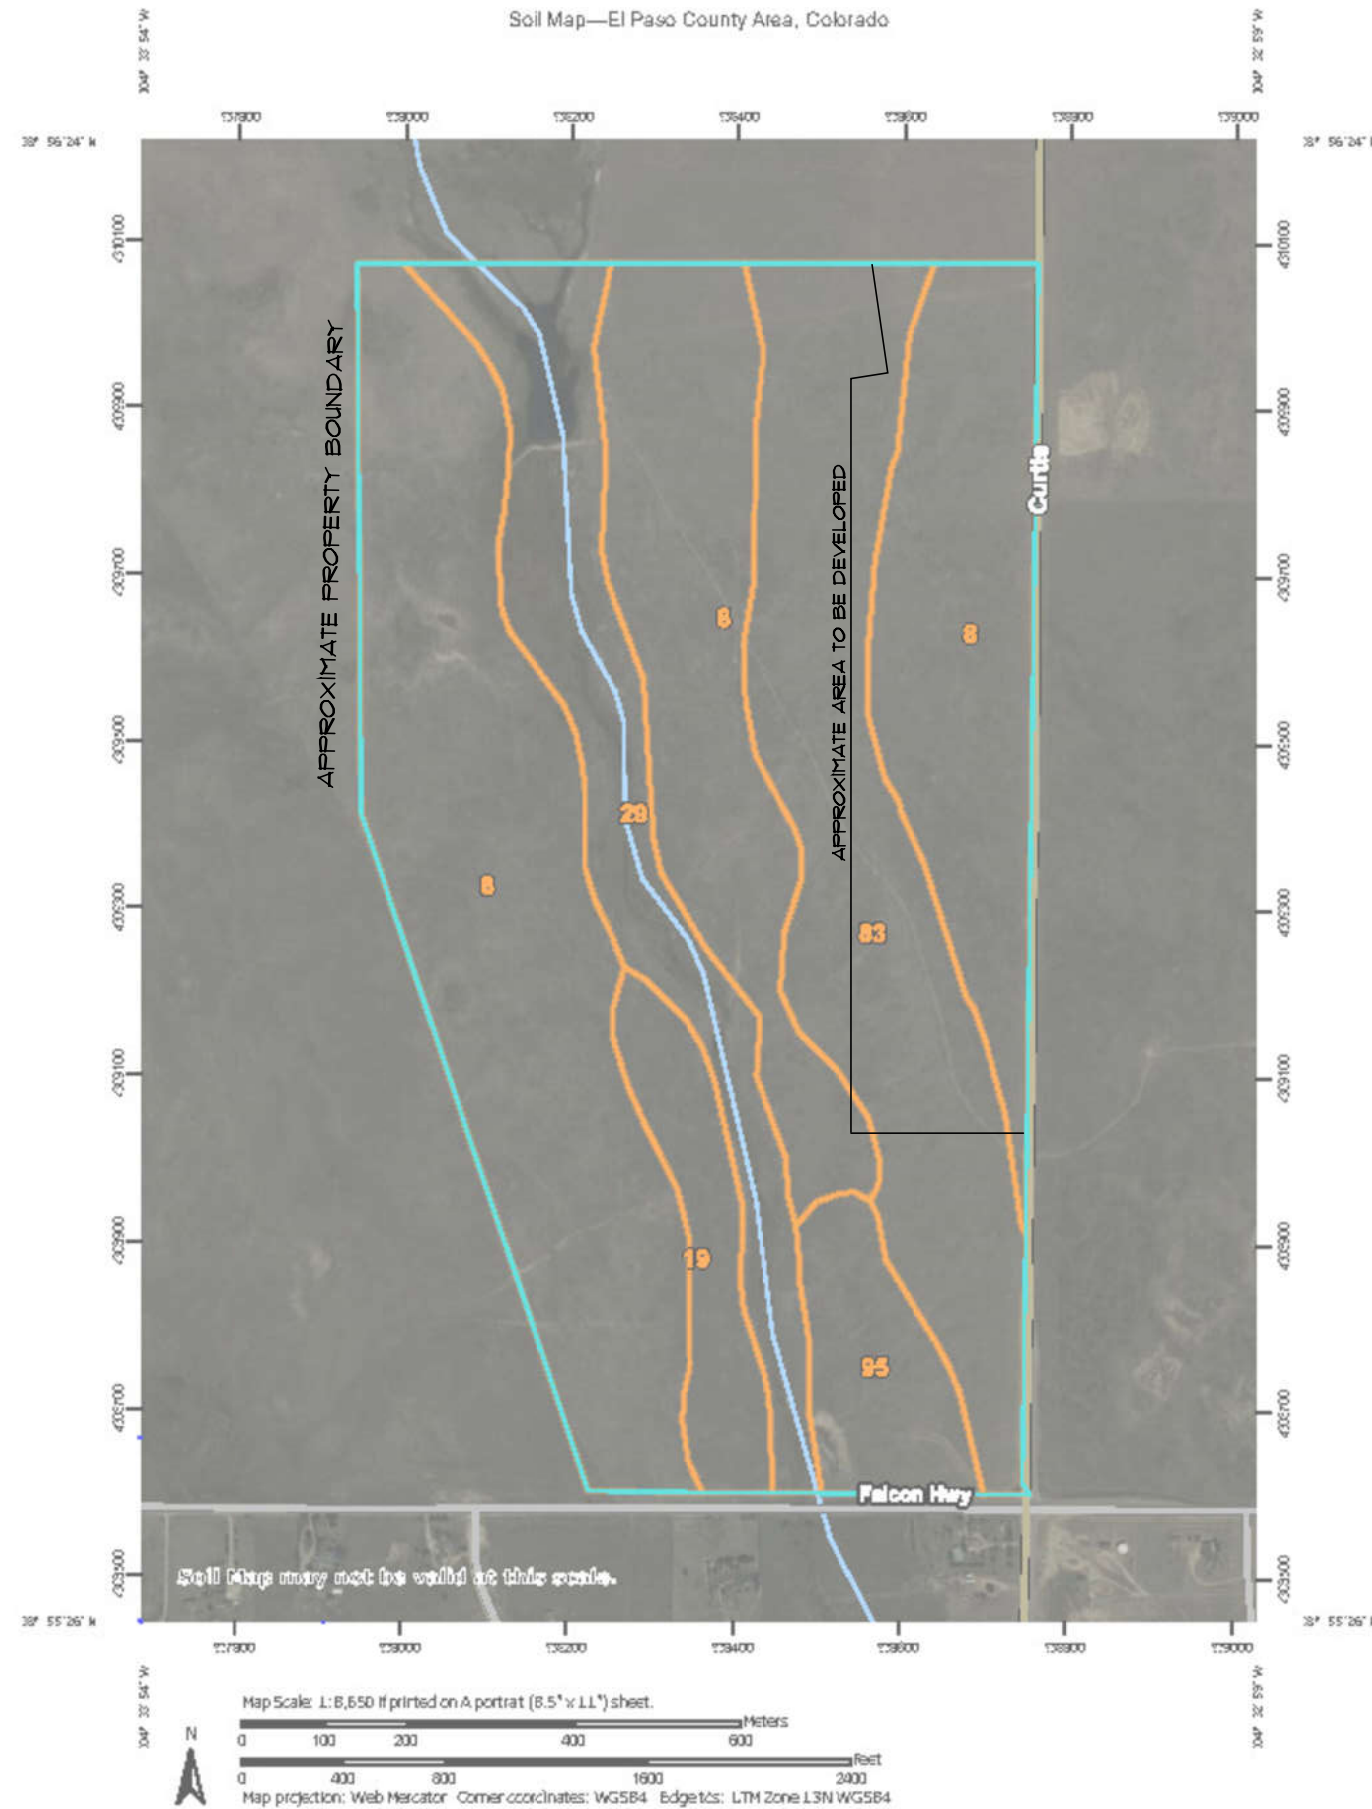
8 - Blakeland Loamy Sand, 1 to 9 percent slopes

83 - Stapleton sandy loam, 3 to 8 percent slopes
