LORSON RANCH EAST

Filing 2

Natural Features Report

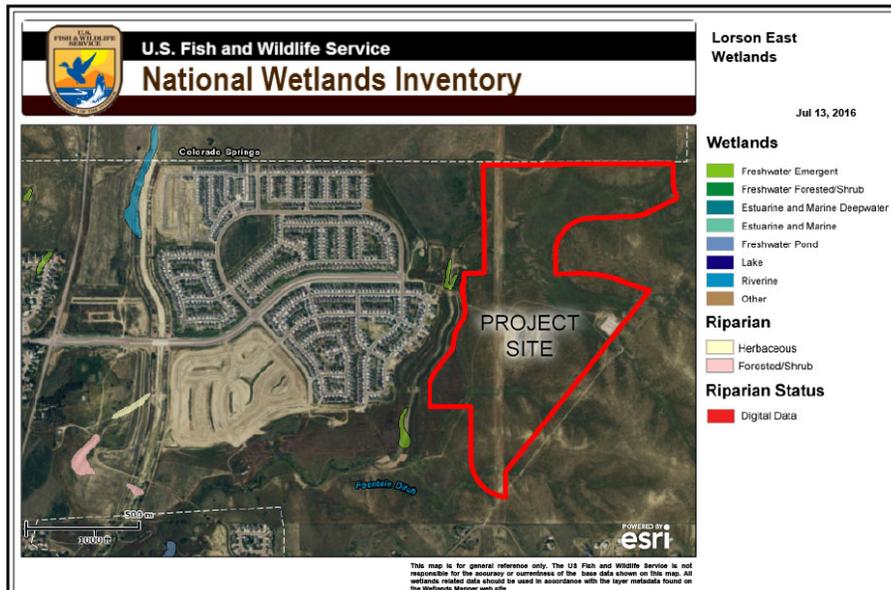
There are no jurisdictional wetlands found on site or within the Jimmy Camp Creek East Tributary as determined during the 404 permit process acquired to complete the existing channel improvements discussed above. In addition, a search of the US Fish and Wildlife Service National Wetlands Inventory mapper website (<https://www.fws.gov/wetlands/>) did not indicate any jurisdictional wetlands although the site does contain the presence of Freshwater Emergent Wetlands within the east tributary north of Fontaine Blvd. These emergent wetlands are coded as (PEM), Palustrine emergent herbaceous march, fen, swale and wet meadow. Any impacts and mitigation will be determined during the LOMR/ CLOMR and 404 Permit Process during the necessary creek improvement study and construction.

The coding is described as follows: *“The (P) Palustrine System includes all nontidal wetlands dominated by trees, shrubs, persistent emergents, emergent mosses or lichens, and all such wetlands that occur in tidal areas where salinity due to ocean-derived salts is below 0.5 ppt. It also includes wetlands lacking such vegetation, but with all of the following four characteristics: (1) area less than 8 ha (20 acres); (2) active wave-formed or bedrock shoreline features lacking; (3) water depth in the deepest part of basin less than 2.5 m (8.2 ft) at low water; and (4) salinity due to ocean-derived salts less than 0.5 ppt.”* In addition, the Emergent Classe (EM) *“is characterized by erect, rooted, herbaceous hydrophytes, excluding mosses and lichens. This vegetation is present for most of the growing season in most years. These wetlands are usually dominated by perennial plants.”*
